DEPARTMENT OF THE INTERIOR  
UNITED STATES GEOLOGICAL SURVEY

GEOLOGIC ROAD LOG  
ALYESKA HAUL ROAD, ALASKA  
JUNE-AUGUST, 1975

OPEN FILE REPORT  
79-227

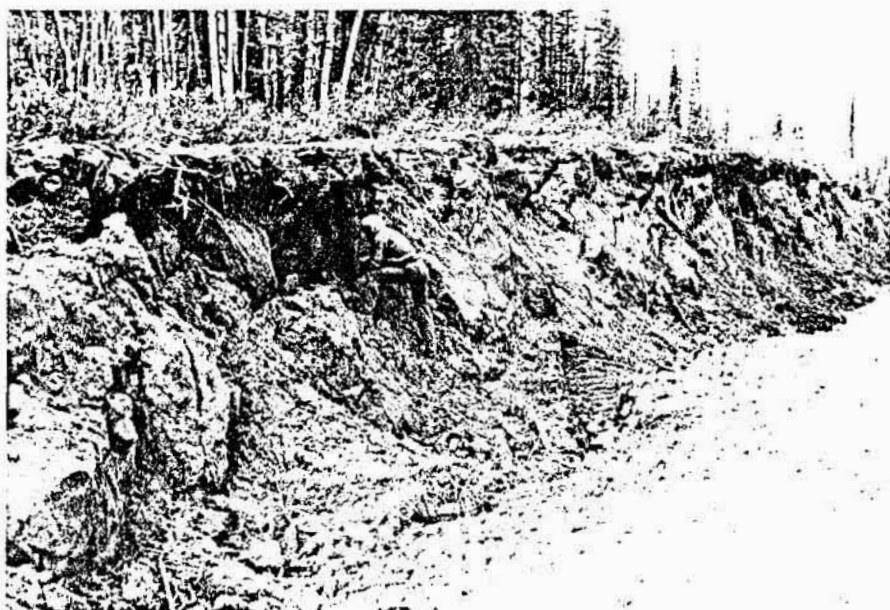
Figure 5. Bedded silt 1.9 miles north of Yukon R. (Site 22). August 1, 1975.

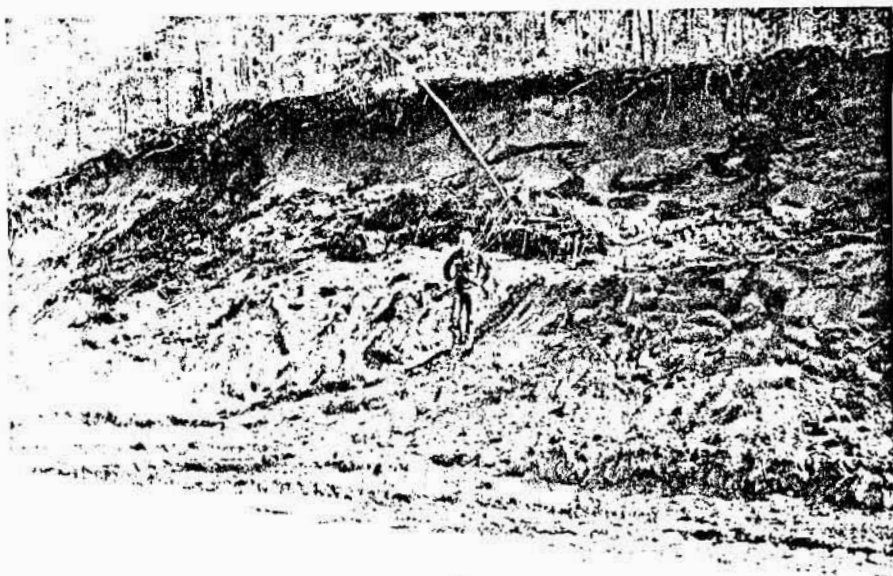
Figure 6. Bedded sand opposite entrance to Fivemile Camp (Site 23). August 1, 1975.

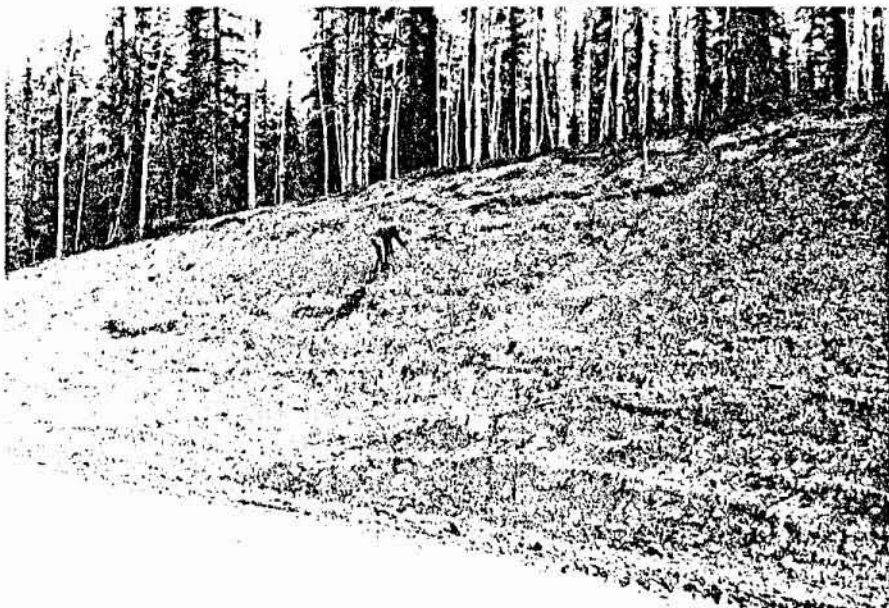
Figure 7. Loess above bedrock at Mile 6.7 (Site 24). Road crosses ridge crest here. June 24, 1975.

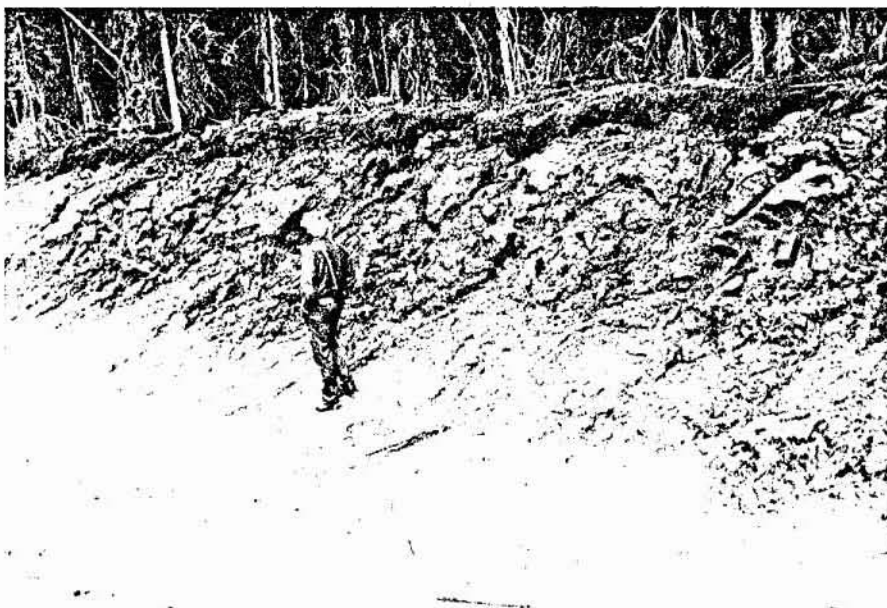
Figure 8. North end of above Site 24 (Mile 6.9). Road is descending north flank of ridge, and colluvial cover above bedrock has thickened. August 1, 1975.

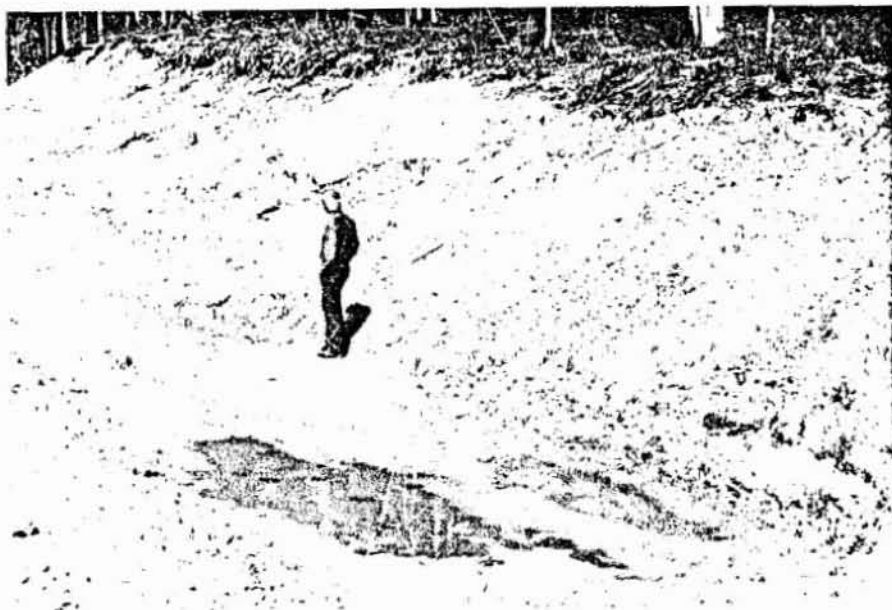
Figure 10. Road cut through colluvium-filled swale at Mile 13.8 (Site 29). August 1, 1975.

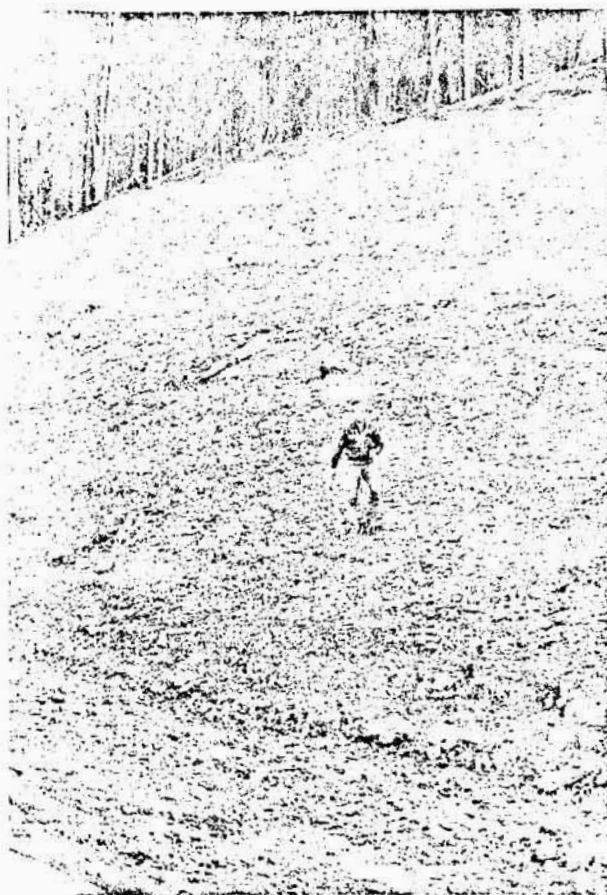
| Site No. | Mileage | Description |
|---|---|---|
| 30 | 15.4 & 15.8 | Cuts about 15 m deep expose shattered granitic rock with thin soil cap (Fig. 11). Very little loess above bedrock in this area, and slopes appear relatively well drained and stable. |

Figure 11 (left). Road cut through shattered bedrock at Mile 15.4 (Site 30). June 24, 1975.

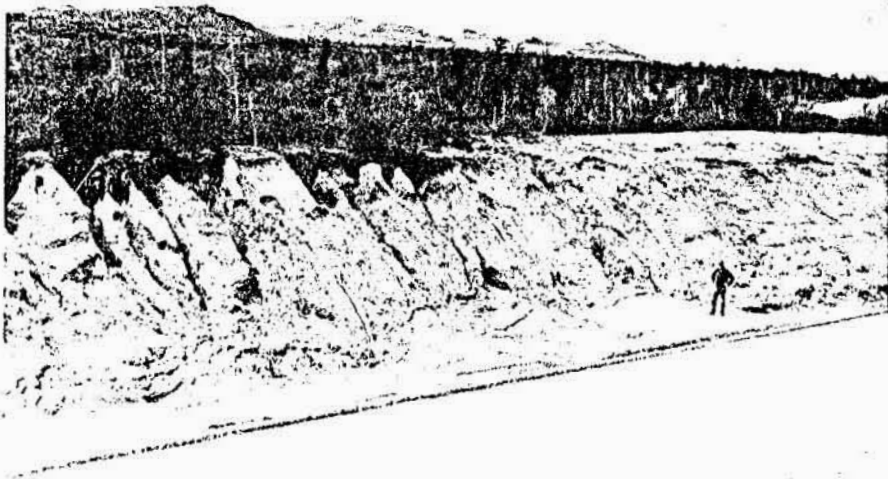
| Site No. | Mileage | Description |
|---|---|---|
| *46 | 54.8-55.4 | Road cuts 3-5 m high expose grus above granitic rock. Overlying thin soils thicken into colluvial aprons on ridge flanks. Local gullyng on June 24 (Fig. 13); continued gullyng, seepages, and alluviation of roadside ditches on August 1 (Figs. 14 and 15). |

Figure 13. Road cut into grus near Old Man Camp (Site 46). June 24, 1975.

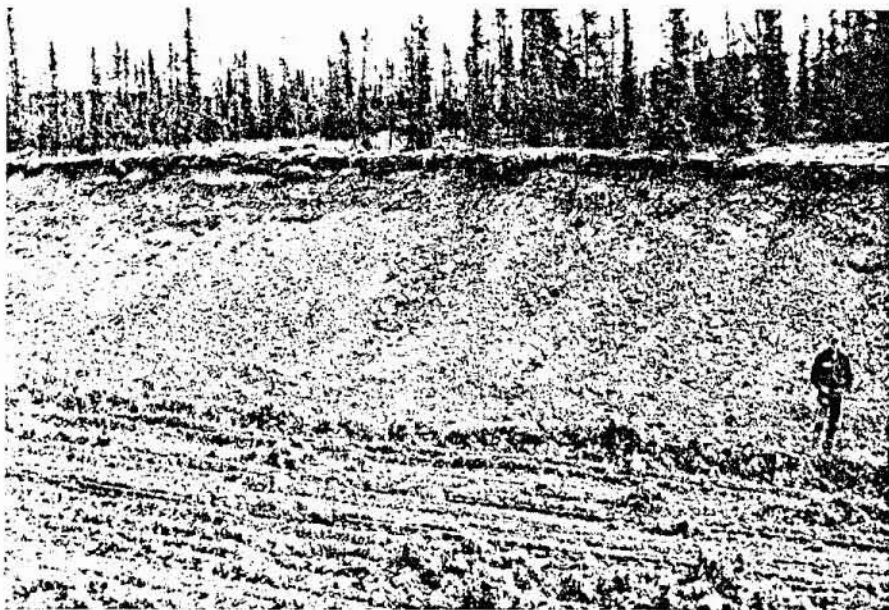
| Site No. | Mileage | Description |
|---|---|---|
| *58 | 87.0 | Cut 5 m deep into alluvial terrace exposes gravel with thin cap of sand and sod (Fig. 17). Floor of roadside ditch consists of moist sand, gravel, and grey clayey silt churned together by heavy construction machinery. The terrace gravel probably was deposited over Pleistocene lake beds. Ditch was still wet, soft, and muddy on August 1, and had been widened to about 15 m by removal of borrow material. Road shoulder was actively sloughing into ditch (Fig. 18). |

Figure 17. Alluvial gravel in road cut near Jim River (Site 58). June 24, 1975.

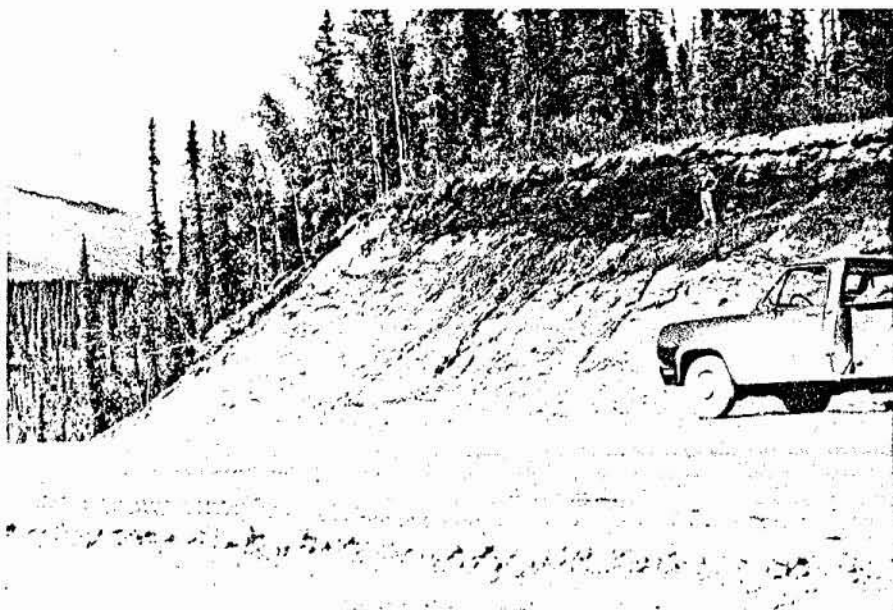
| Site No. | Mileage | Description |
|---|---|---|
| *68 | 114.9 | Cuts to about 10 m deep at edge of highest terrace along Middle Fork of Koyukuk River expose alluvial sand and gravel below peaty surface cap, which thickens to 2 m and becomes ice-rich in a depression fill near north |

| Site No. | Mileage | Description |
|---|---|---|
| | | end of eastern road cut (Fig. 19). Peat was wet and thaw on June 24; dry and stable on August 1. |

Figure 19. Peaty depression fill in alluvial terrace along Middle Fork of Koyukuk River (Site 68). June 24, 1975.

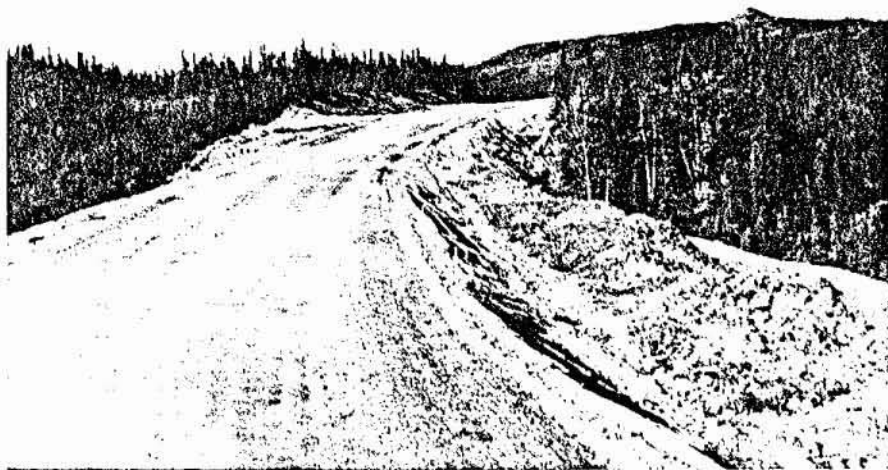
| Site No. | Mileage | Description |
|---|---|---|
| *71 | 117.0 | Road ascends from floodplain to surface of drift sheet (Fig. 20). Sandy alluvium underlies 5-8 m of glacial drift, which consists of till west of road and ice-marginal stream gravel to east. Till forms a ridge which probably is end moraine; gravel occupies channel-like depression which later filled with colluvium and organic matter. Ditch along east side of roadway had eroded deeply into the fine-grained channel fill on June 24, causing extensive siltation at base of grade (Figs. 21 and 22).<br><br>This problem area was largely stabilized on July 31. Gully incisions had been filled with coarse gravel, with grass growing in places. Debris fan at base of grade no longer was receiving sediments; road cuts and ditches were dry and stable (Fig. 23). However, local piping along ditch suggests that erosion still is taking place beneath coarse gravel fill (Fig. 24).<br><br>Air photo coverage of haul road is complete beyond this point. |

Figure 20. Haul road ascending moraine front in Middle Fork Valley (Site 71). June 24, 1975.

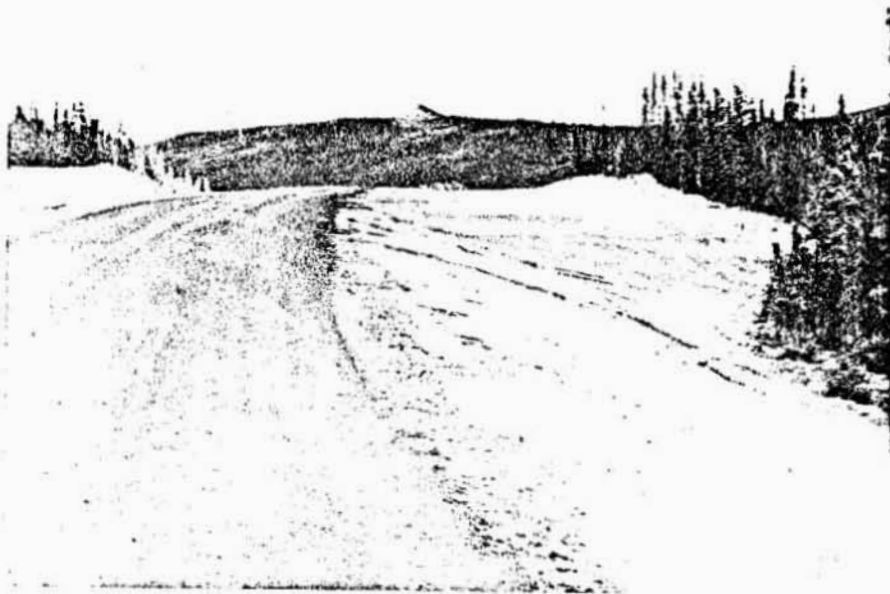
Figure 23. Site 71 on July 31, 1975.

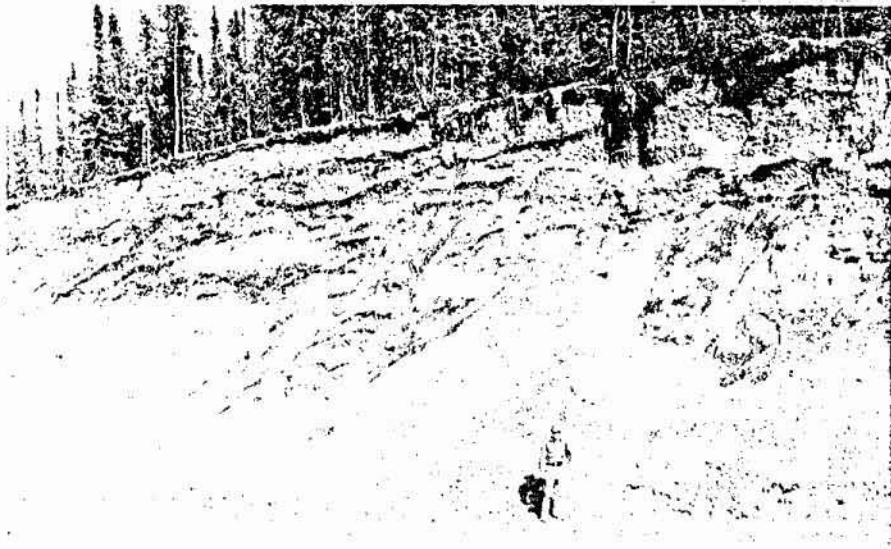
| Site No. | Mileage | Description |
|---|---|---|
| 72 | 117.2 | Road cut 12-15 m high exposes probable fan deposits (Fig. 25). Clasts poorly bedded and sorted, but most are angular, of local lithology, and range from pebbles to very small boulders. No striated or faceted clasts evident. Cut dry and stable, with only slight raveling. |

Figure 25. Fan gravel exposed at Site 72. June 24, 1974.

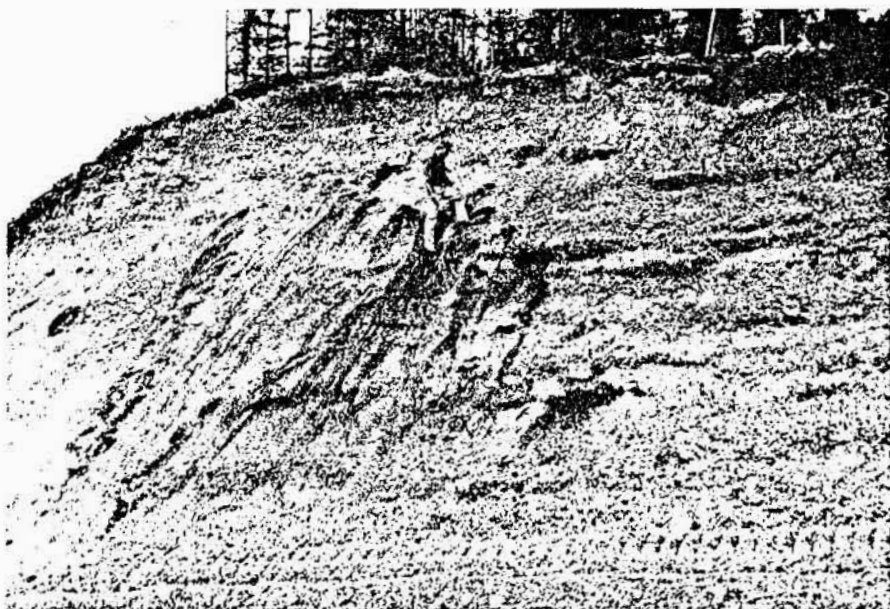
Figure 27. Terrace gravel at Site 79. June 25, 1975.

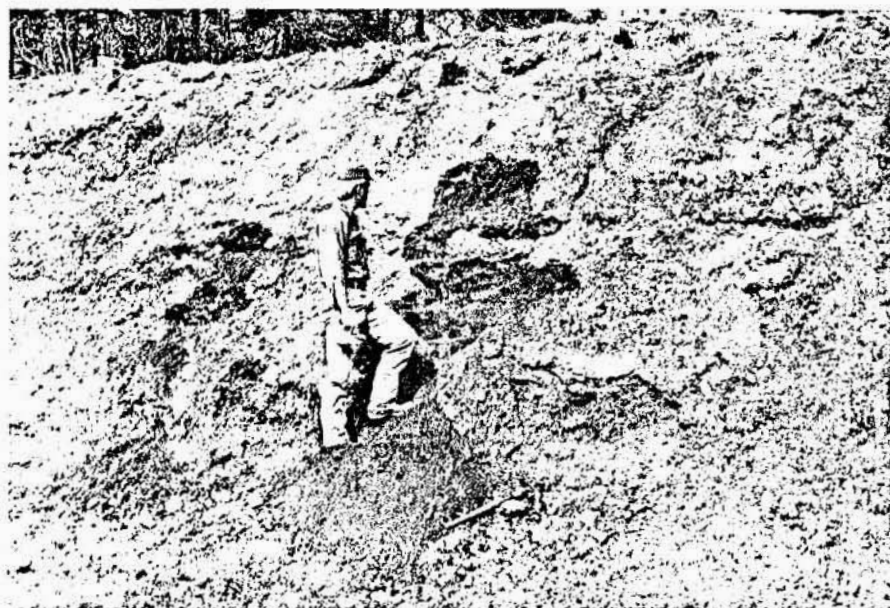
Figure 28. Buried Histosol in diamicton at Site 82. June 25, 1975.

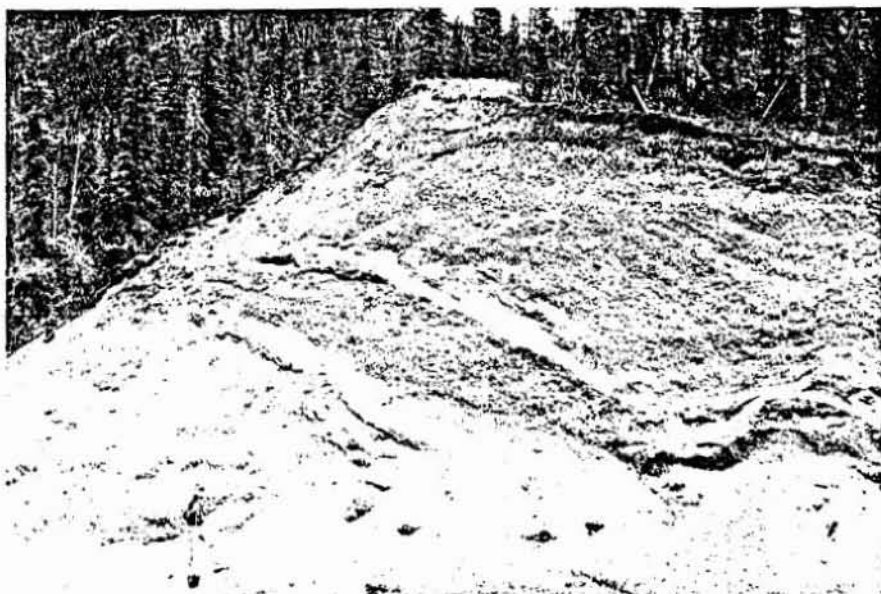
Figure 31. Ice-contact gravel at Site 84. Note steeply dipping foreset beds. June 25, 1975.

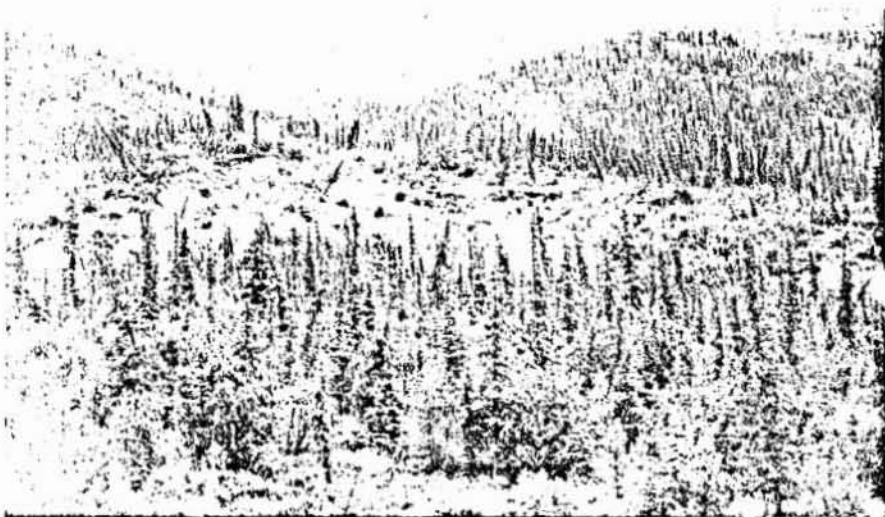
Figure 36. Front of probably active rock glacier close to haul road at Site 107. June 25, 1975.

| Site No. | Mileage | Description |
|---|---|---|
| *107 | 170.1-<br>171.0 | Possible solifluction slope flanks road to east. Inactive rock glacier lies east of road at Mile 170.5, and unvegetated front of possibly active rock glacier stands close to road at Mile 171.0 (Fig. 36). |

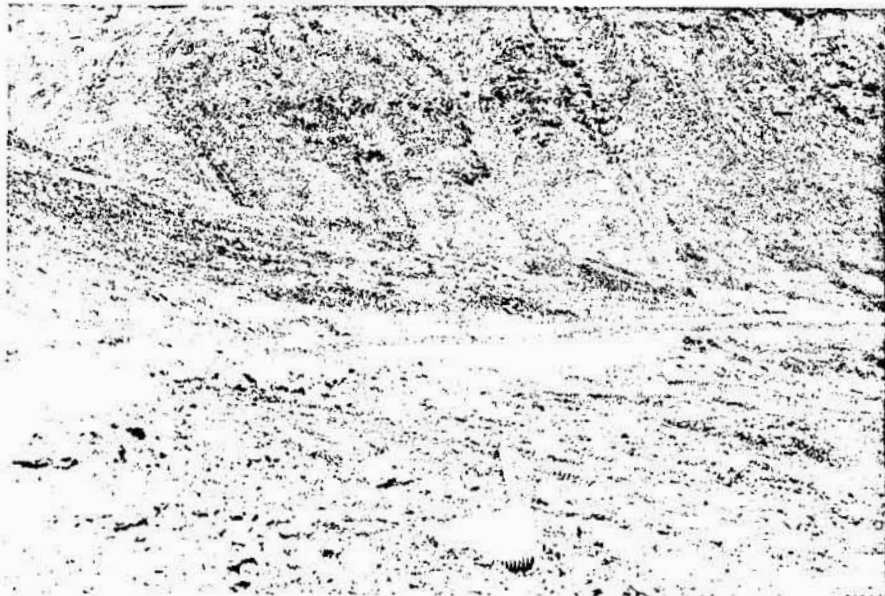
| Site No. | Mileage | Description |
|---|---|---|
| 126 | 199.0 | Road crosses inactive rock glacier (Fig. 43). |

Figure 43. Inactive rock glacier crossed by haul road at north end of Atigun Pass (Site 126). June 25, 1975.

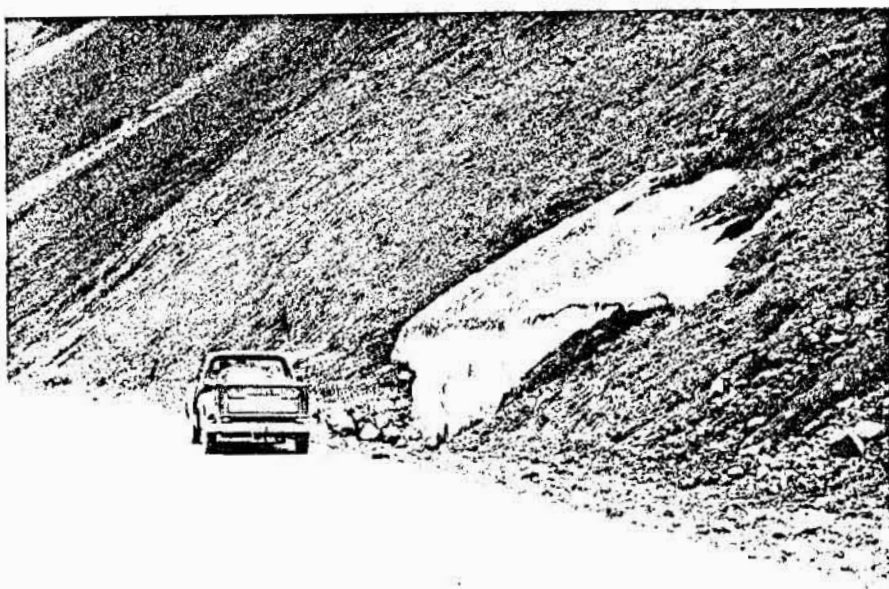
| Site No. | Mileage | Description |
|---|---|---|
| *129 | 199.7-199.9 | Persisting snowbanks along southeast side of road on June 25 (Fig. 46). |

Figure 46. Persisting snowbank at road margin on north flank of Atigun Pass (Site 129). June 25, 1975.

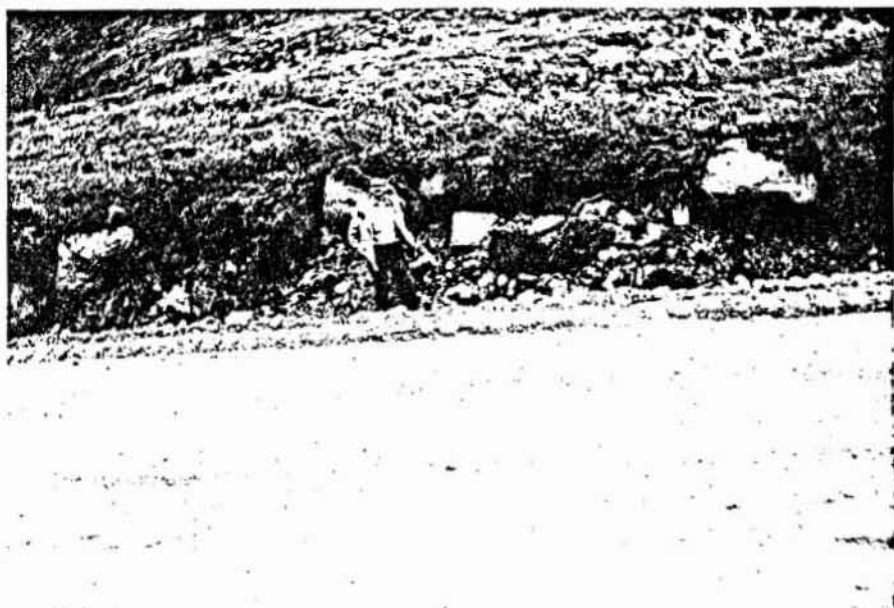
| Site No. | Mileage | Description |
|---|---|---|
| *139 | 214.4 | Steep alpine fan with prominent levees and channel intersects haul road (Fig. 53). Boulders with diameters of 1 m or more have been carried by flows of debris or slush rather than by running water. |

Figure 53. Cut into alpine fan intersected by road at Site 139. June 25, 1975.

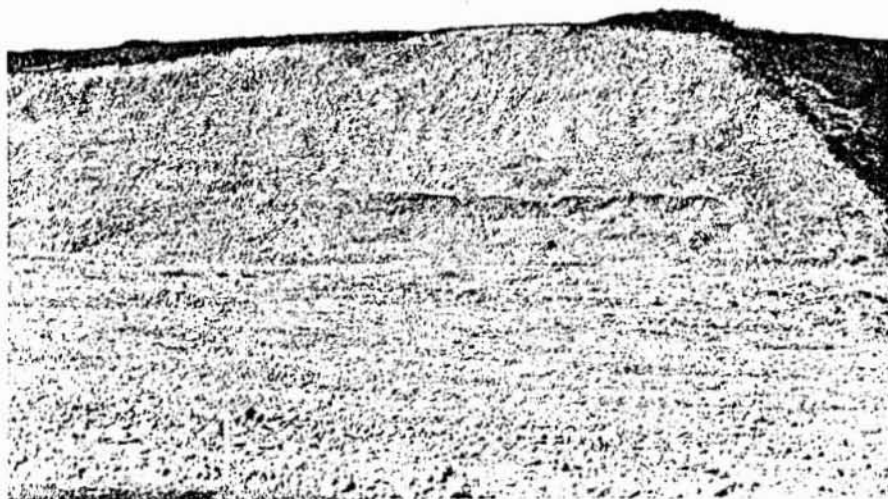
| Site No. | Mileage | Description |
|---|---|---|
| 156 | 264.7 | Begin descent to flood plain of Sagavanirktok River. Cut along west side of road exposes 7 m of grey outwash gravel (rounded stones up to cobble size in a sandy matrix) beneath 40 cm of frost-churned stony silt (Fig. 55). |

Figure 55. Road cut into gravel of Itkillik Glaciation (Site 156). July 7, 1975.

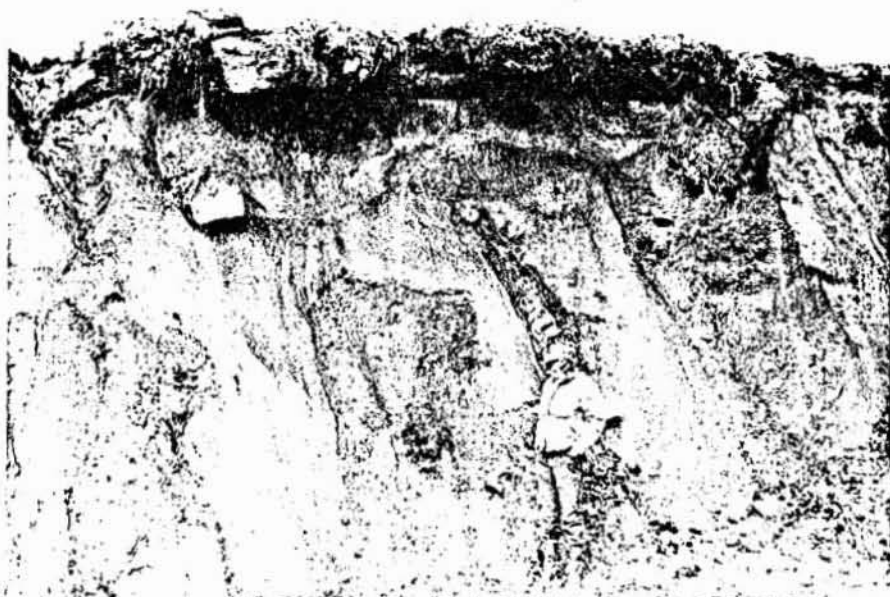
| Site No. | Mileage | Description |
|---|---|---|
| *162 | 280.9 | Road leaves flood plain of Sagavanirktok River and ascends about 50 m up steep grade to upland surface underlain by bedrock and glacial deposits (Fig. 56). In 1974, road cuts exposed muck and peat with ice wedges and other massive ground ice above a lens of till resting on bedrock (Fig. 57). By July 1975, massive ground ice no longer was visible in road cuts, but continued melting was causing slope retreat by slump and flowage (Fig. 58). Liquefied muck and till were discharging down both roadside ditches into basins behind dikes built at the base of the grade (Fig. 56). |

Figure 57. Western road cut at Site 162 shortly after excavation. June 30, 1974.

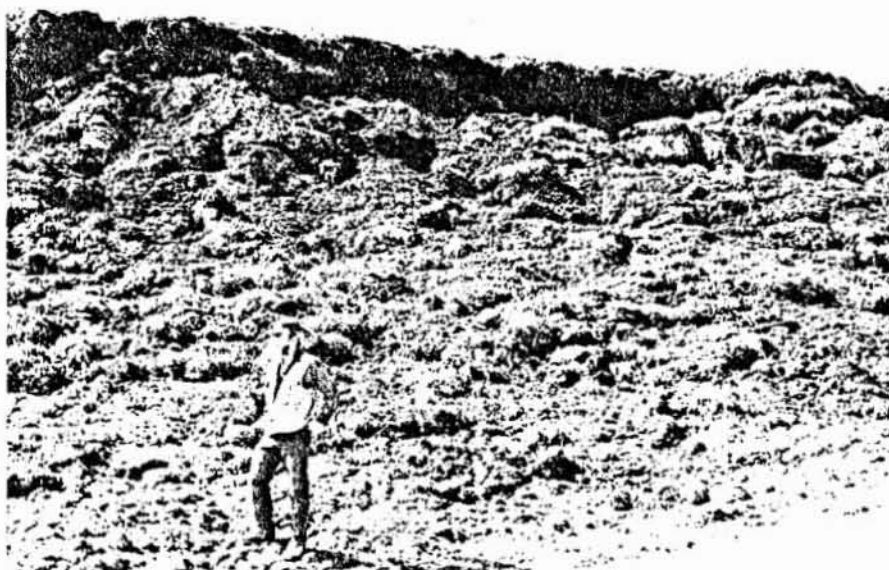
Figure 58, Western road cut at Site 162 one year later. July 7, 1975.
