THE ALASKA EARTHQUAKE, MARCH 27, 1964—  
EFFECTS ON COMMUNITIES

# Effects of the Earthquake Of March 27, 1964 At Anchorage, Alaska

*A description and analysis of the damage resulting from seismic vibration, ground cracks, and especially landslides in Alaska's largest city*

GEOLOGICAL SURVEY PROFESSIONAL PAPER 542-A

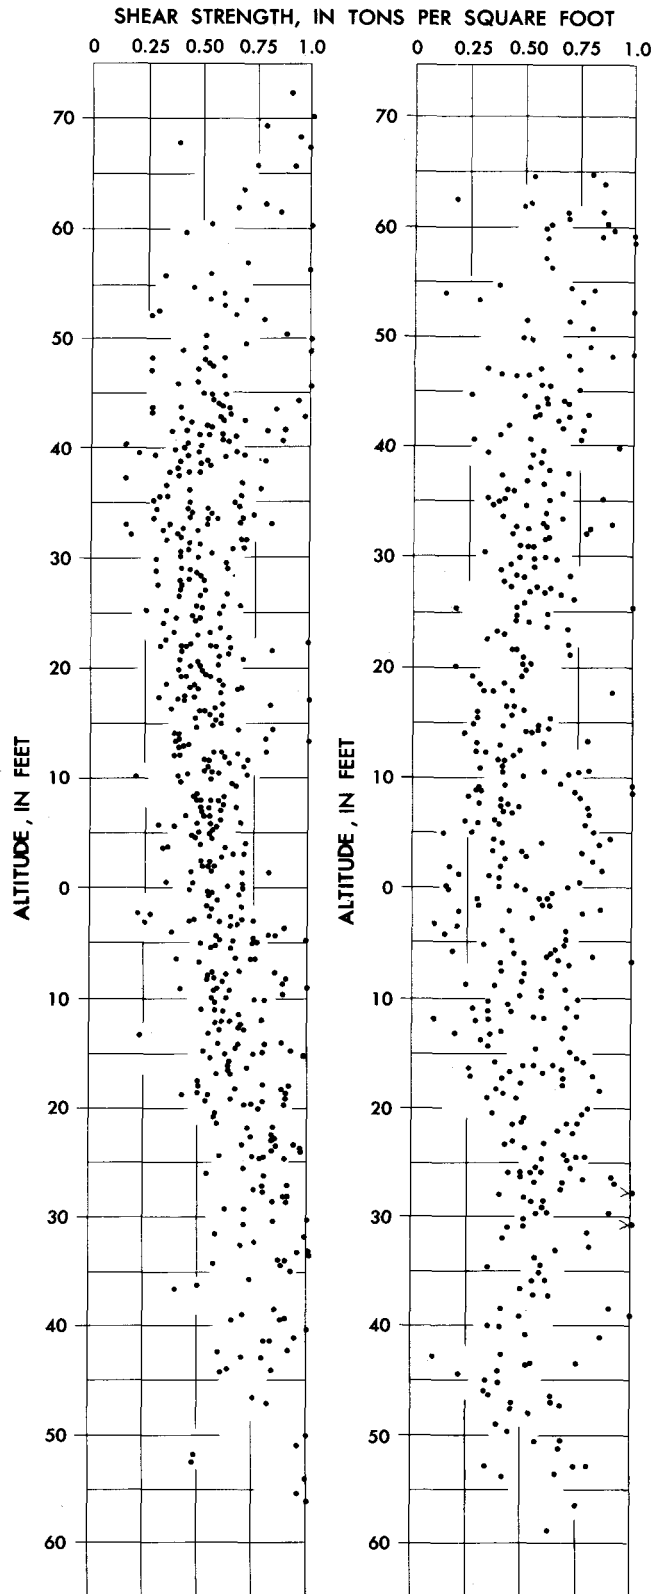
Shear strength was measured in torsional-vane-shear tests, undrained triaxial tests, consolidated-undrained triaxial tests, and consolidated-drained triaxial tests; strain, stress, volume change, and pore-water pressure were recorded throughout the tests (Shannon and Wilson, Inc., 1964, p. 28). The results of vane-shear tests for the Fourth Avenue and Turnagain Heights slide areas are shown in figure 8. Triaxial tests performed on the clay generally correlated well with the vane-shear tests within the ranges of strengths at which failure was prevalent. Tests correlated well in the range 0.4 to 0.5 tsf (tons per square foot), but for clays of higher strength, the triaxial tests generally yielded somewhat higher values than the vane tests. Most of the samples of clay from critical depths in the landslides had initial shear strengths between 0.2 and 0.7 tsf, and in this range the ratio of torsional-vane-shear-test results to triaxial-compression-test results is generally between 0.7 and 1.5 (Shannon and Wilson, Inc., 1964, p. B8). This ratio indicates a fairly good correlation between test methods. In any event, the vane-shear-test results shown by the graphs of figure 8 clearly demonstrate the generally lower shear strength of the clay at intermediate depths as compared with shallower and deeper layers.

8.—Summary of torsional-vane-shear strengths of selected borings, Bootlegger Cove Clay, from Fourth Avenue slide area (left) and Turnagain Heights slide area (right). Simplified from Shannon and Wilson, Inc. (1964, pl. B15).

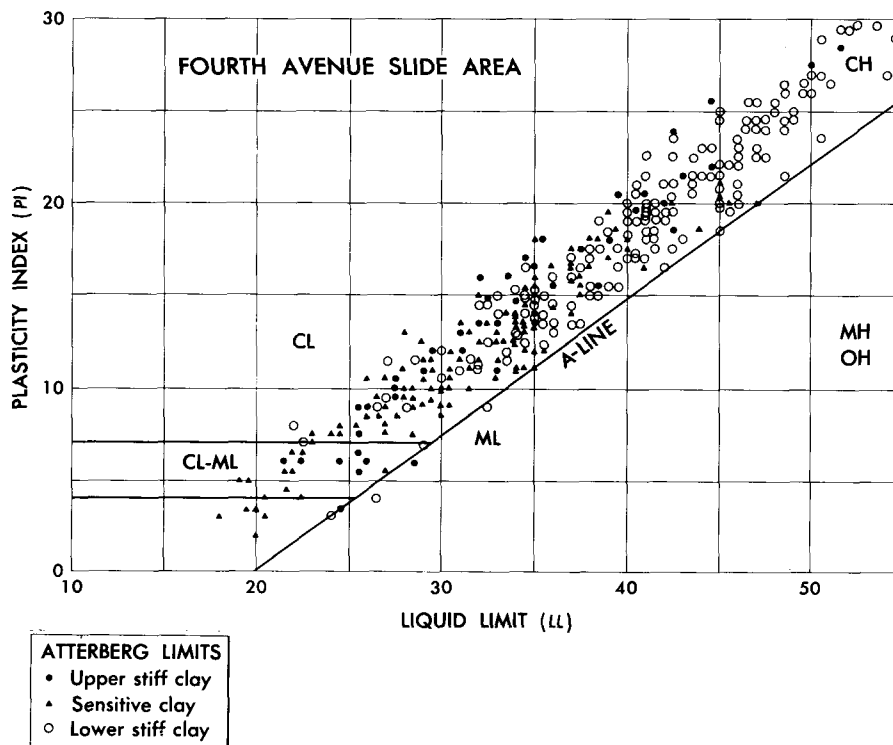
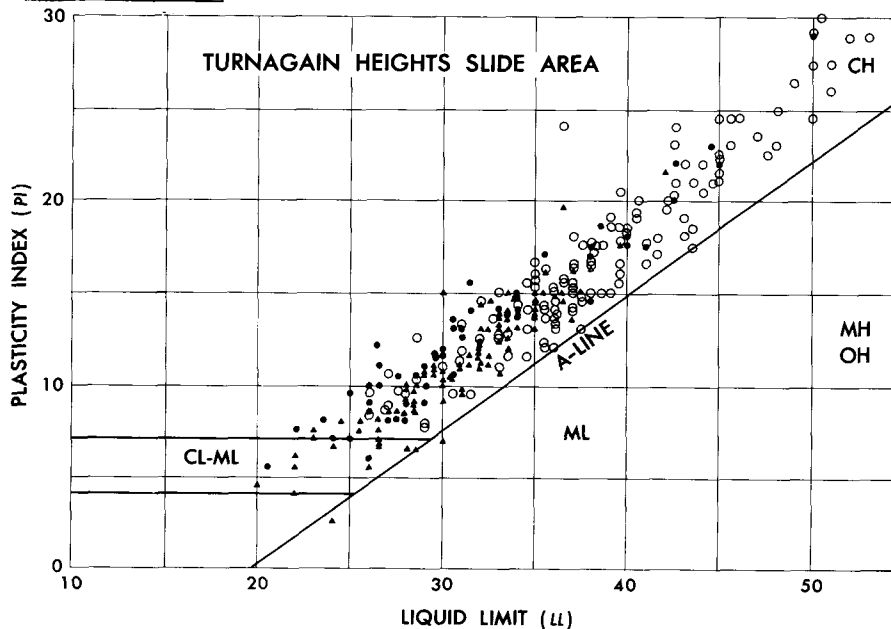
9.—Plasticity charts from selected borings, Bootlegger Cove Clay, Fourth Avenue and Turnagain Heights slide area. Reprinted from Shannon and Wilson, Inc. (1964, pl. B16). CL, inorganic clay of low to medium plasticity; ML, inorganic silts and very fine sand; CH, inorganic clay of high plasticity; MH, inorganic silt; OH, organic clay.

Shannon and Wilson, Inc. (1964). These charts show generally higher plasticity indices and liquid limits for the lower stiff clay than for the upper stiff clay or the sen-

bution curves (fig. 10). Nearly all points plotted on the plasticity charts lie above the "A" line—the line which separates soils of high cohesion and low permeability above from soils of low cohesion and high permeability below (Casagrande, 1947, p. 801).

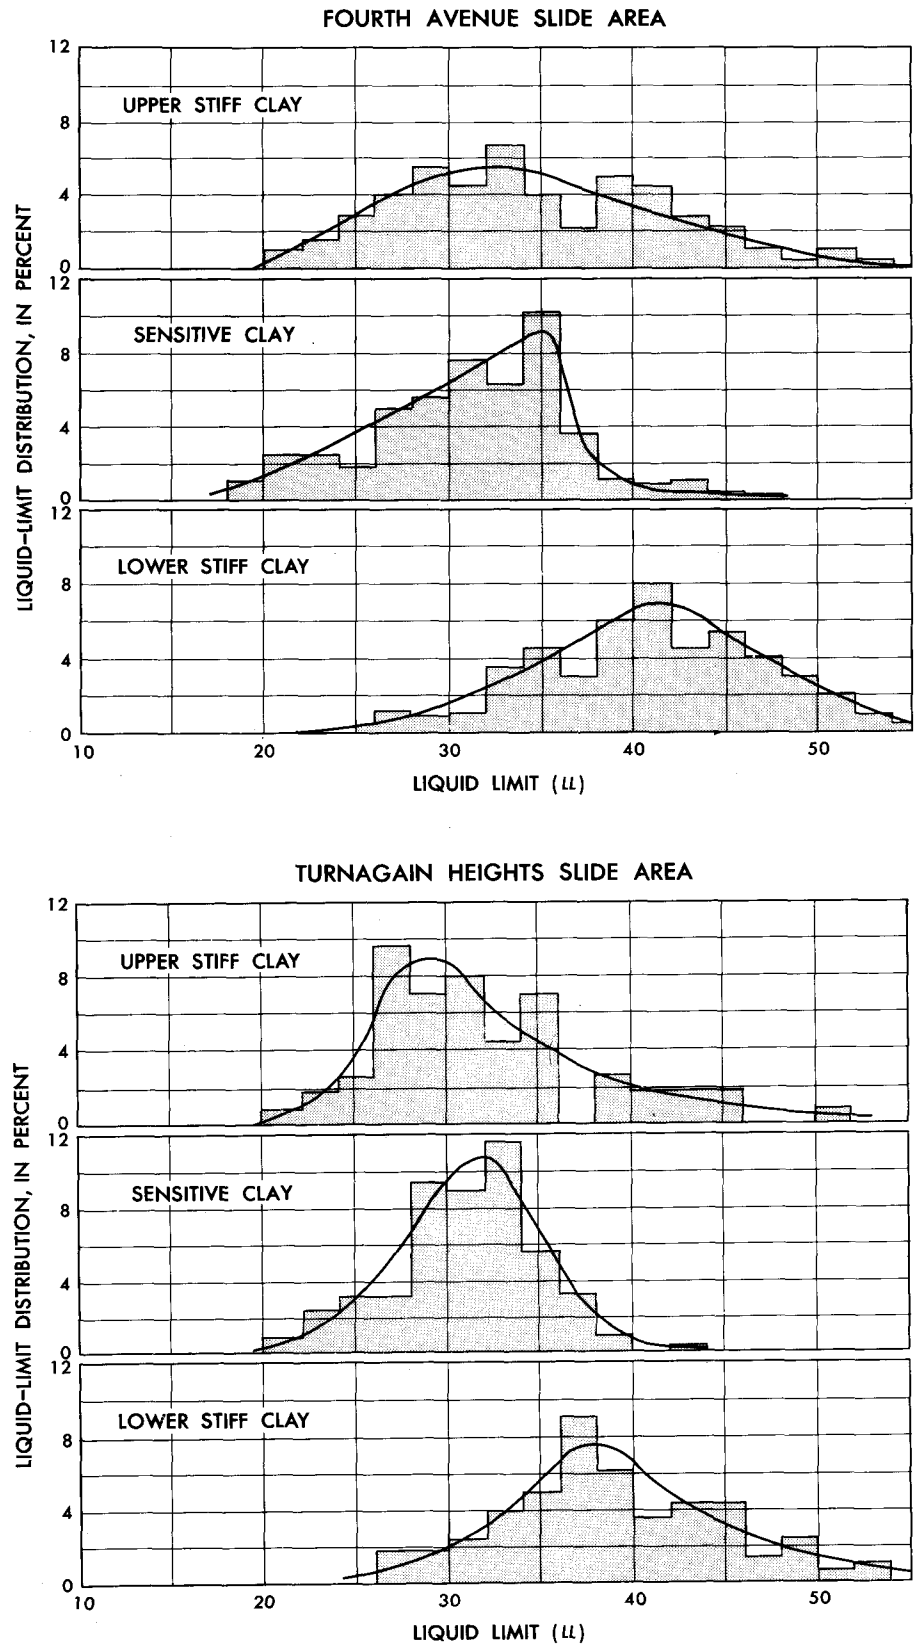
The statistical liquid-limit distribution curves (fig. 10) show the distinctions between the three zones of the Bootlegger Cove Clay in the Fourth Avenue and Turnagain Heights areas. These curves bring out the differences between the upper stiff zone and the sensitive zone, and also the higher liquid limit of the lower stiff zone. The statistical relationship of sensitivity to liquid limit is shown by figure 11. In general, about 80 percent of the soil samples tested had liquid limits within the range of 22 to 48 percent, regardless of their vertical position in the formation. About 80 percent of the liquid limits of the sensitive clay range from 22 to 38 percent, and about 80 percent from the lower stiff clay range from 32 to 50 percent. As sensitivity increases, the upper limit of the liquid limit decreases. Most clay samples of sensitivities greater than 10 had liquid limits in the range of 20 to 40 percent, and no sensitive-clay sample had a liquid limit above 45 percent. For sensitivities greater than 40, the range of liquid limits was only 22 to 28 percent (Shannon and Wilson, Inc., 1964, p. B11). Several samples analyzed had a natural-water content greater than their liquid limits.

10.—Statistical liquid-limit distribution curves from selected borings, Bootlegger Cove Clay. Reprinted from Shannon and Wilson, Inc. (1964, pl. B16).

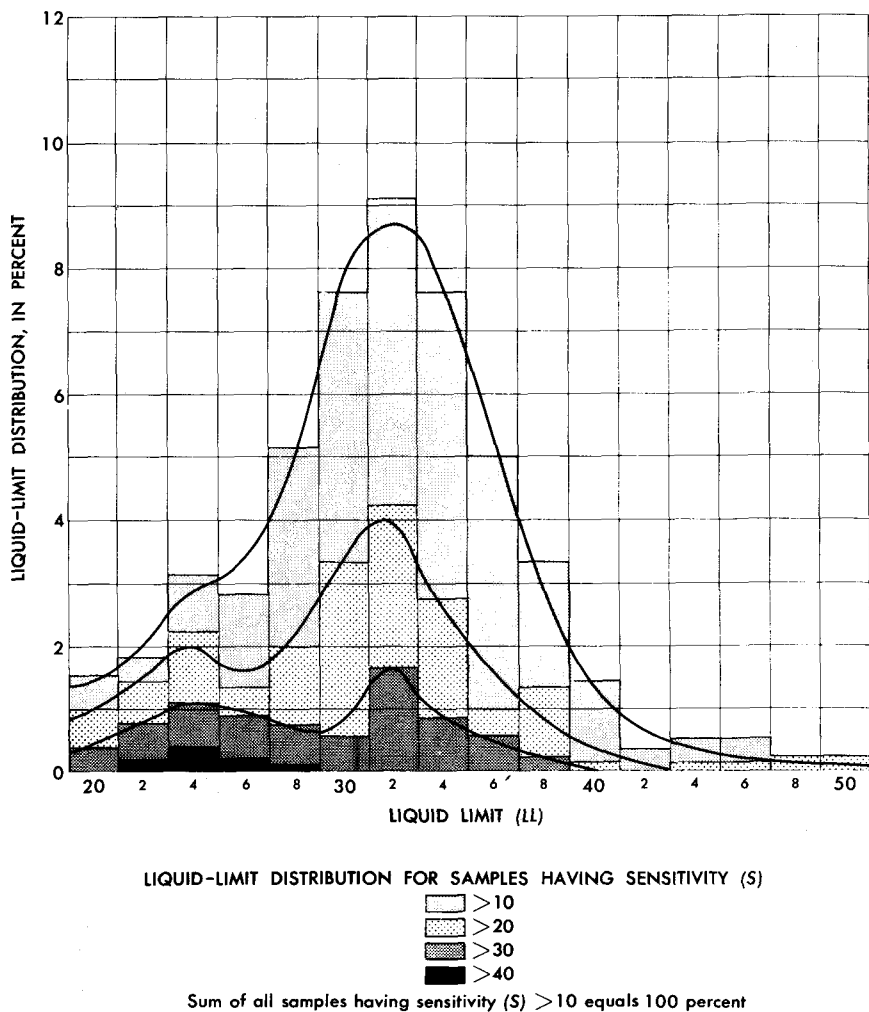
11.—Liquid-limit sensitivity distribution curves, Bootlegger Cove Clay. Reprinted from Shannon and Wilson, Inc. (1965, pl. B17).

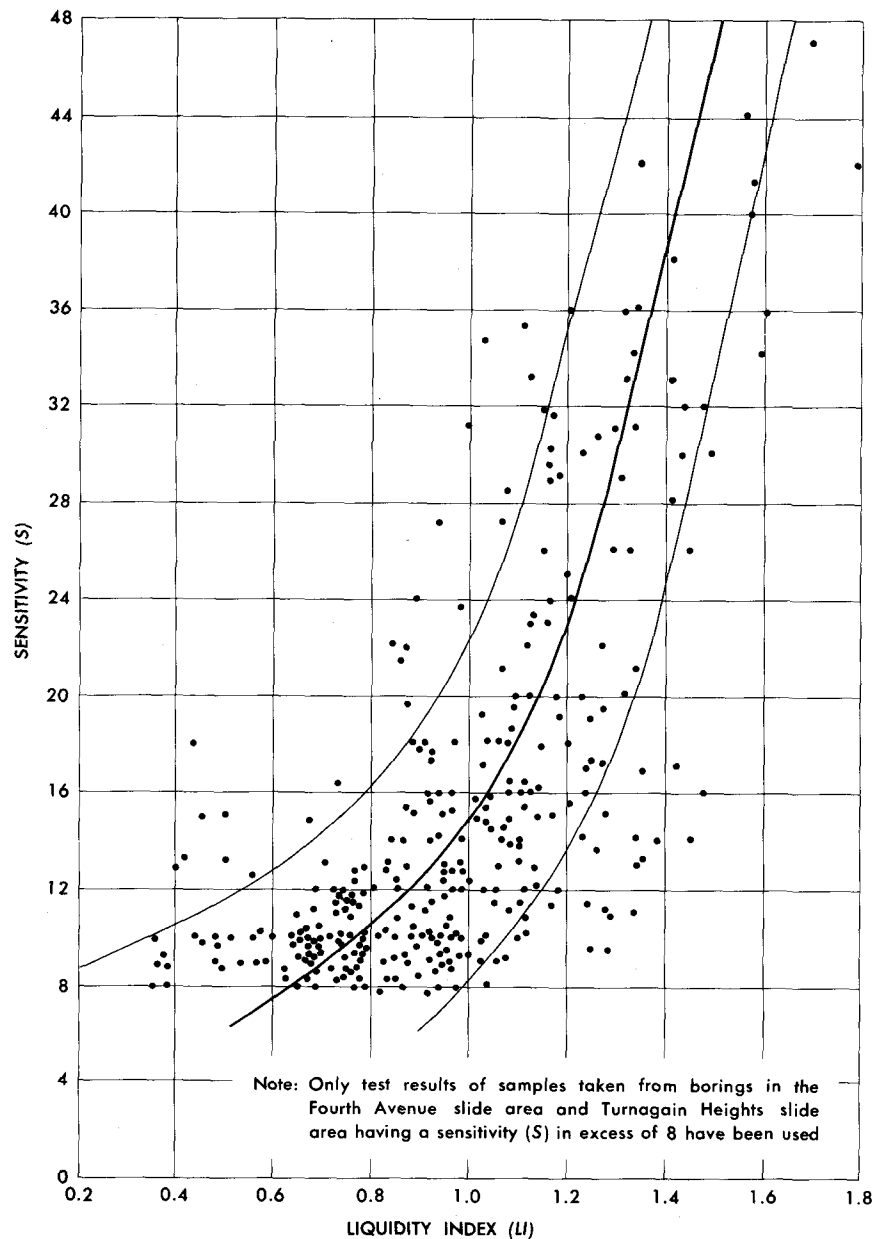
the liquid limit minus the plastic limit; that is  $(W_n - PL)/(LL - PL)$ . For the Bootlegger Cove Clay, it was found that in most soils having a water-plasticity ratio greater than 1.0 the liquid limit ranged from 20 to 40 percent, and in soils having a water-plasticity ratio greater than 2.0 the liquid limit lay in the range 19 to 27 percent. A direct correlation also was found between sensitivity and the water-plasticity ratio (Shannon and Wilson, Inc., 1964, p. B11, pl. B17; see fig. 12, next page). Thus in the Bootlegger Cove Clay a high water-plasticity ratio is related to low shear strength, high

sensitivity, and high susceptibility to failure.

12.—Relation between sensitivity and liquidity index (water-plasticity ratio), Bootlegger Cove Clay. Reprinted from Shannon and Wilson, Inc. (1964, pl. B17).

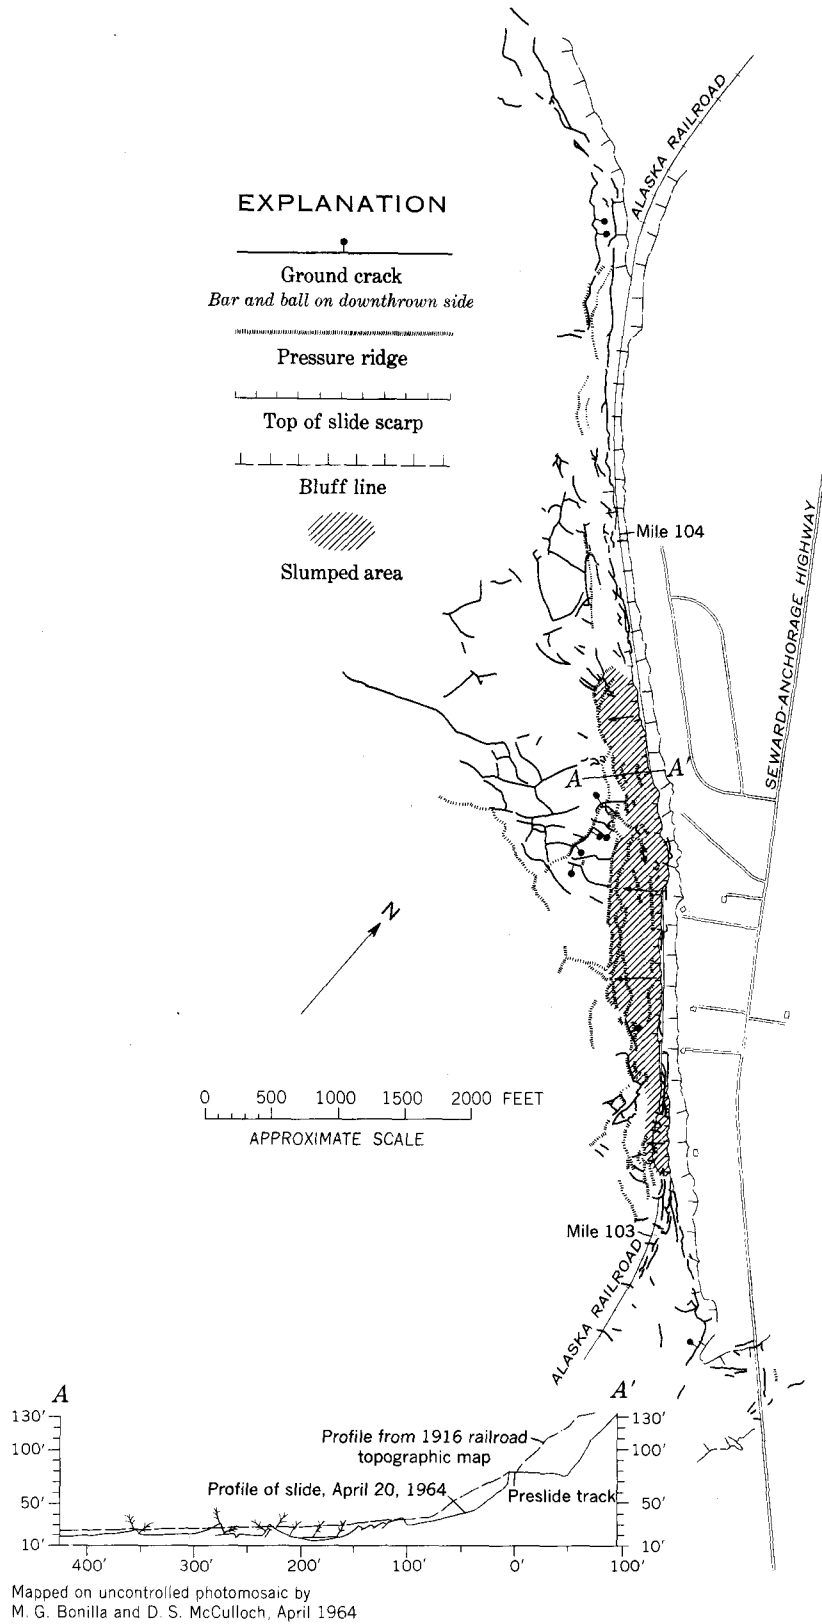
17.—Map and profile of Potter Hill landslide area near Anchorage, Alaska.

sisted of elongate fragmented slump blocks rotated backward and broken into many pieces toward the base of the slope. In places at the toe, they turned into earth and mudflows derived partly from the intertidal silt of Turnagain Arm and partly, perhaps, from the clay-silt-sand sequence in the lower part of the bluff.

The mechanics of sliding has been investigated by D. S. McCulloch and M. G. Bonilla (written commun., 1964). They concluded that sliding was initiated by failure and flowage of material from the base of the slope. Higher parts of the slope slumped and disintegrated as a consequence. Flowage may have occurred in the modern estuarine silt at the base

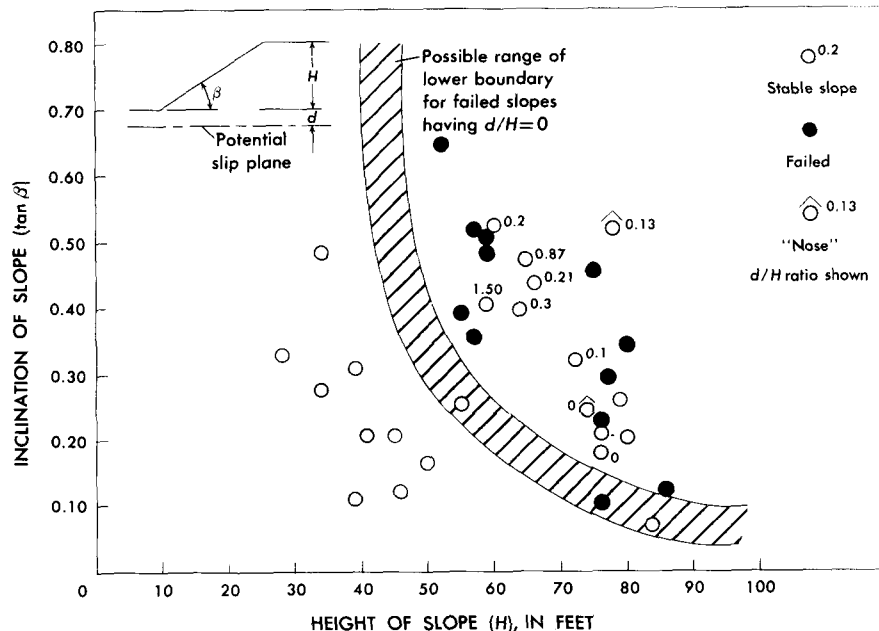
23.—Slope stability chart. Reprinted from Shannon and Wilson, Inc. (1964, pl. 7.1).

slope-to-height ratios within the same area of the chart as slopes that failed seems to point up the modifying influences of other factors such as soil-strength profile and water content. A low slope underlain by soil having a high water-plasticity ratio, for example, may be more susceptible to failure—may have a lower safety factor—than a high slope underlain by soil having a low water-plasticity ratio. In a unit of time, other factors being equal, a salient should drain and desiccate more rapidly than a recess; hence it should be more stable.

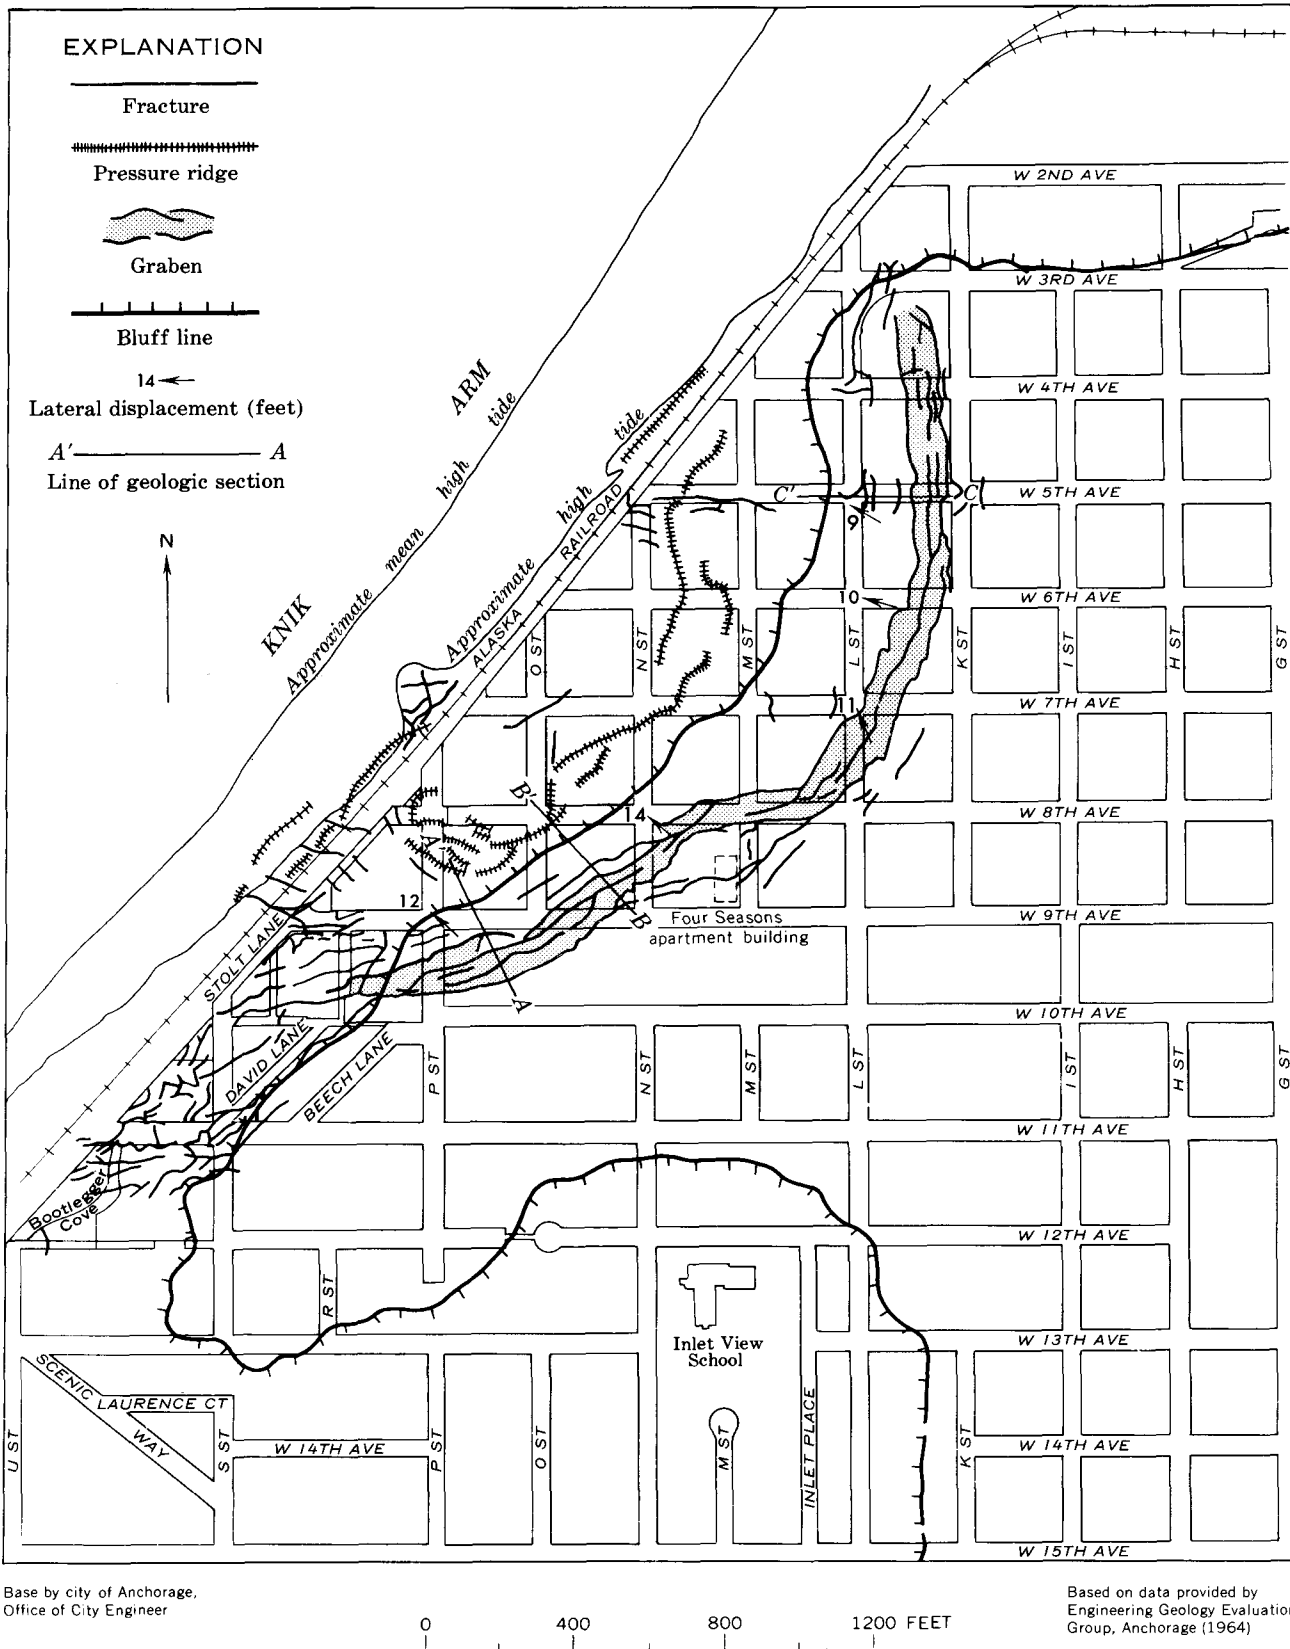
The graben itself formed a broad arc in plan, concave toward the slide block. It extended south from West Third Avenue between K and L Streets and curved westward to R Street between Ninth and Tenth Avenues. It was about 3,600 feet long and had a maximum width of about 250 feet; generally, its width was between 150 and 200 feet (fig. 30). Its depth—that is, the displacement of the down-dropped block—reached a maximum of about 10 feet; the displacement was greater south of Sixth Avenue than north. Overall, the graben looked like a dry canal or a streambed, and, when contrasted with the lack of damage on either side, it stirred considerable speculation in the minds of early viewers. One popular magazine account stated that it resulted from collapse of an old

27.—L Street slide area, Anchorage, Alaska. Geologic cross sections are shown in figure 30.
