THE ALASKA EARTHQUAKE, MARCH 27, 1964:
EFFECTS ON COMMUNITIES

Effects of the Earthquake
Of March 27, 1964
On the Communities of
Kodiak and Nearby Islands

By REUBEN KACHADOORIAN and GEORGE PLAFKER

GEOLOGICAL SURVEY PROFESSIONAL PAPER 542-F

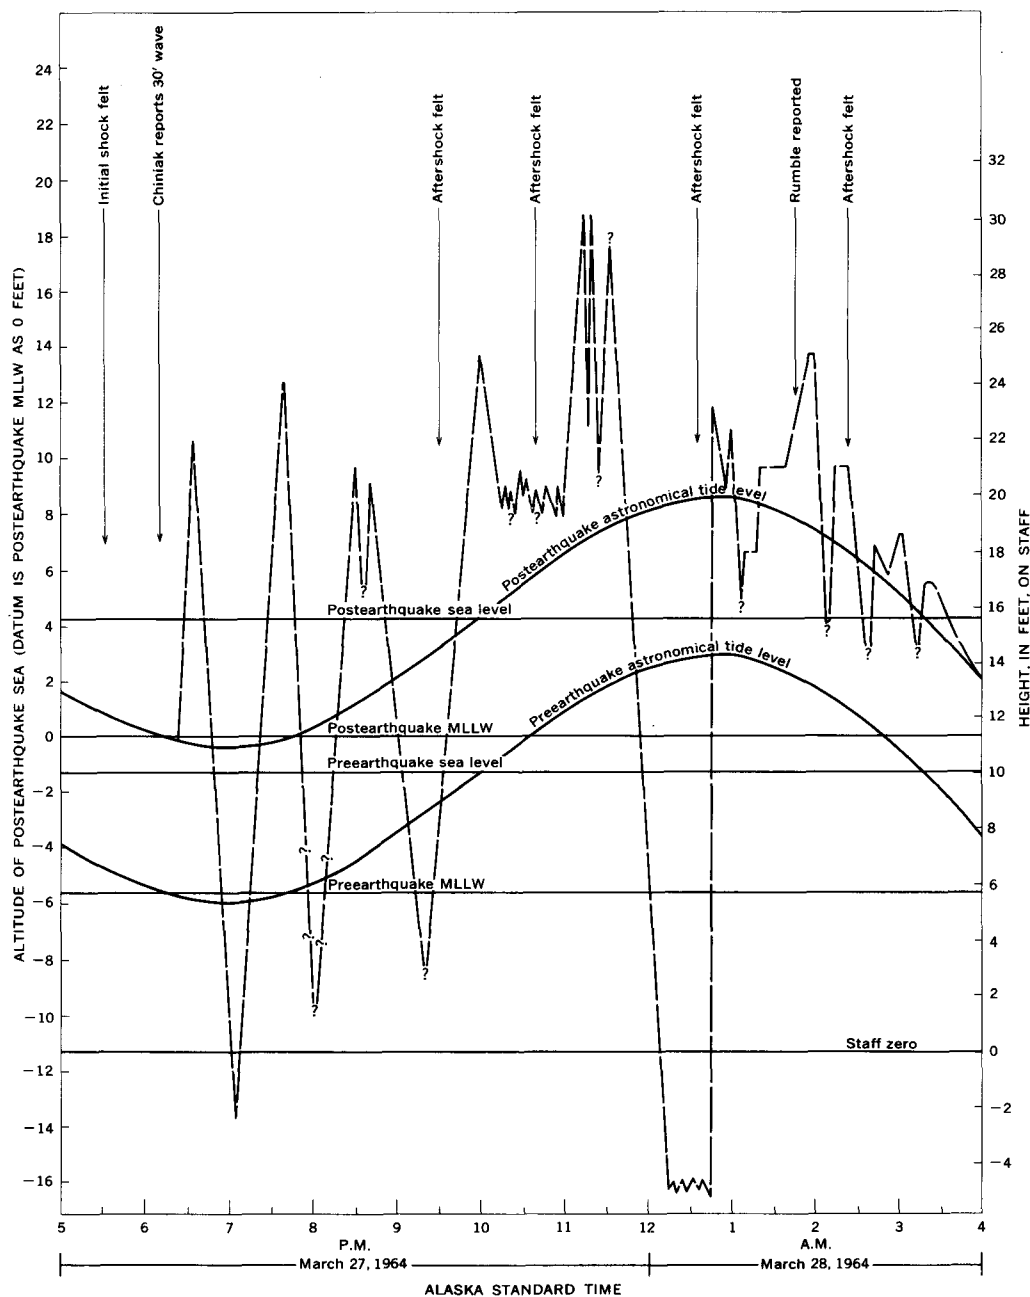
8.—Reconstructed marigram of seismic sea waves at Kodiak Naval Station.

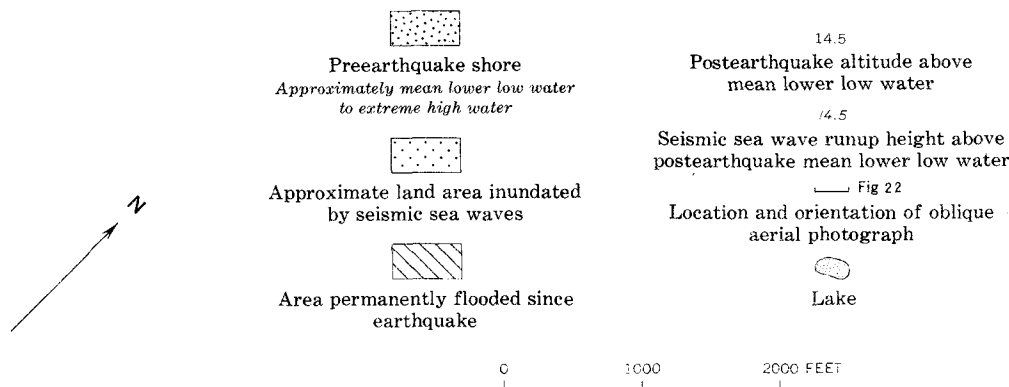
21.—Planimetric sketch map of Afognak showing approximate limits of inundation by seismic sea waves and the areas flooded by ponding behind barrier beaches.
