*A description and analysis of the geologic  
controls of earthquake damage to The Alaska  
Railroad, with emphasis on damage caused  
by the mobilization of unconsolidated  
sediments*

In the 1964 Alaska earthquake, the federally owned Alaska Railroad sustained damage of more than \$35 million: 54 percent of the cost for port facilities; 25 percent, roadbed and track; 9 percent, buildings and utilities; 7 percent, bridges and culverts; and 5 percent, landslide removal. Principal causes of damage were: (1) landslides, landslide-generated waves, and seismic sea waves that destroyed costly port facilities built on deltas; (2) regional tectonic subsidence that necessitated raising and armoring 22 miles of roadbed made susceptible to marine erosion; and (3), of greatest importance in terms of potential damage in seismically active areas, a general loss of strength experienced by wet water-laid unconsolidated granular sediments (silt to coarse gravel) that allowed embankments to settle and enabled sediments to undergo flowlike displacement toward topographic depressions, even in flat-lying areas. The term "landspreading" is proposed for the lateral displacement and distension of mobili

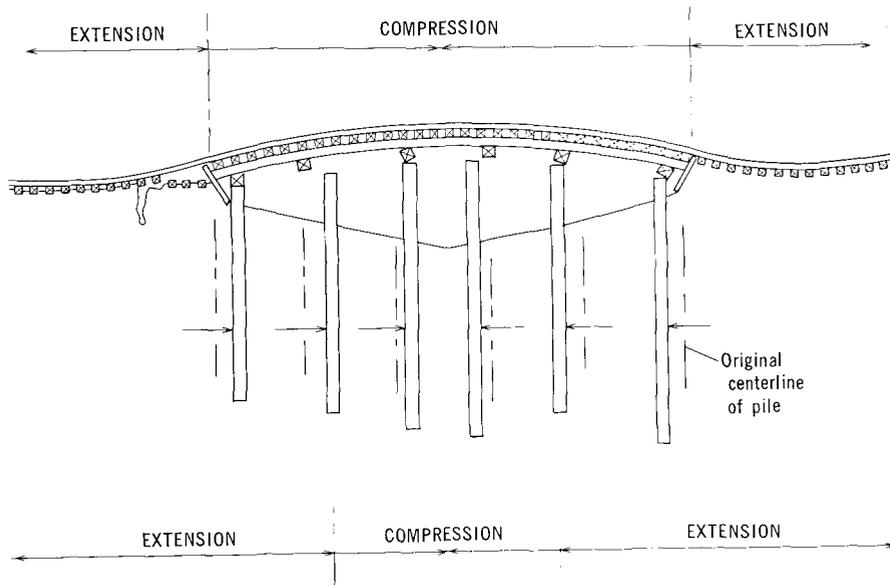
In nearly every damaged bridge, bents were shifted both horizontally and vertically, as shown diagrammatically in figure 5. Shifting occurred without vertical rotation; thus bents remained nearly vertical. Most horizontal displace-

Most displaced bents were torn free of the superstructure. Some pile caps remained attached to the piles and were pulled from the bolts that secured them to the stringers (fig. 5). Other pile caps remained secured to the stringers, but the piles pulled free of the drift pins that attach them to the pile cap and the sway braces were often split and detached from the caps. In other bridges, the pile caps were partially pulled from the stringers and the piles and were rotated between the shifting piles and the deck. Displacements of the bents probably very nearly reflect the movement of the foundation materials, because the connections between the piling and the superstructure appear to have offered little resistance to the horizontal displacement of the piles. If the connections at the tops of the bents had held, their bases would have rotated streamward, as were the bases of some of the piers

5.—Typical displacement of bridge piles. Most piles were crowded toward the center of the stream. The distance between piles increased at the bridge ends and decreased toward the bridge center. Piles in the center usually stood higher than at the ends.

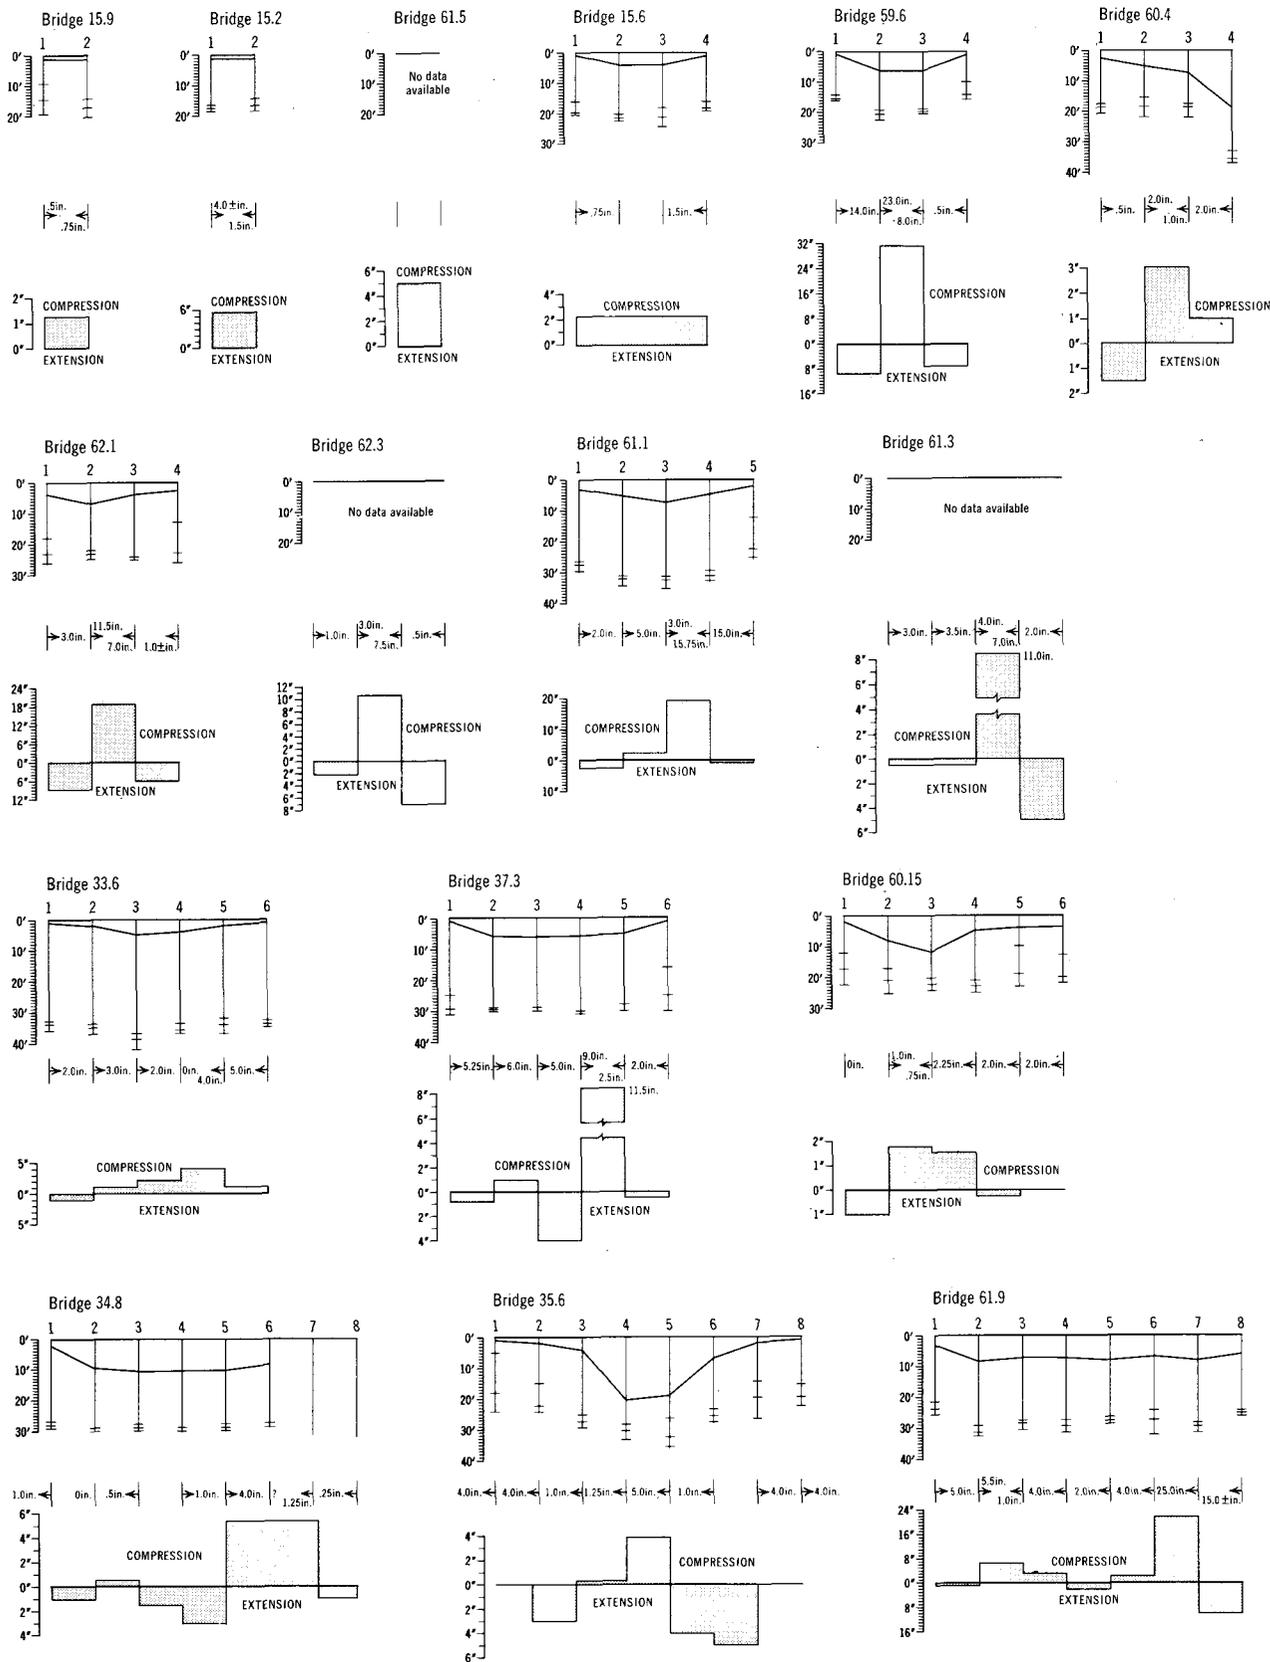
Relative horizontal displacements between bents, as determined by measuring offsets between the pre- and postearthquake position of the bents on the stringers, are plotted as bar graphs on figures 7 and 8. Distances between bents increased, remained unchanged, or decreased. The displacements are shown on the graphs in terms of the interpreted behavior of the foundation material as extension, no change, or compression.

7.—Pile penetration length and relative horizontal displacement of bents of one- to seven-span open wood trestle bridges. The horizontal displacements are shown in terms of interpreted behavior of the foundation material: Extension, distance between bents increased; no change; and compression, distance between bents decreased. The shallowest, average, and greatest depths of penetration in each bent are indicated by horizontal lines.

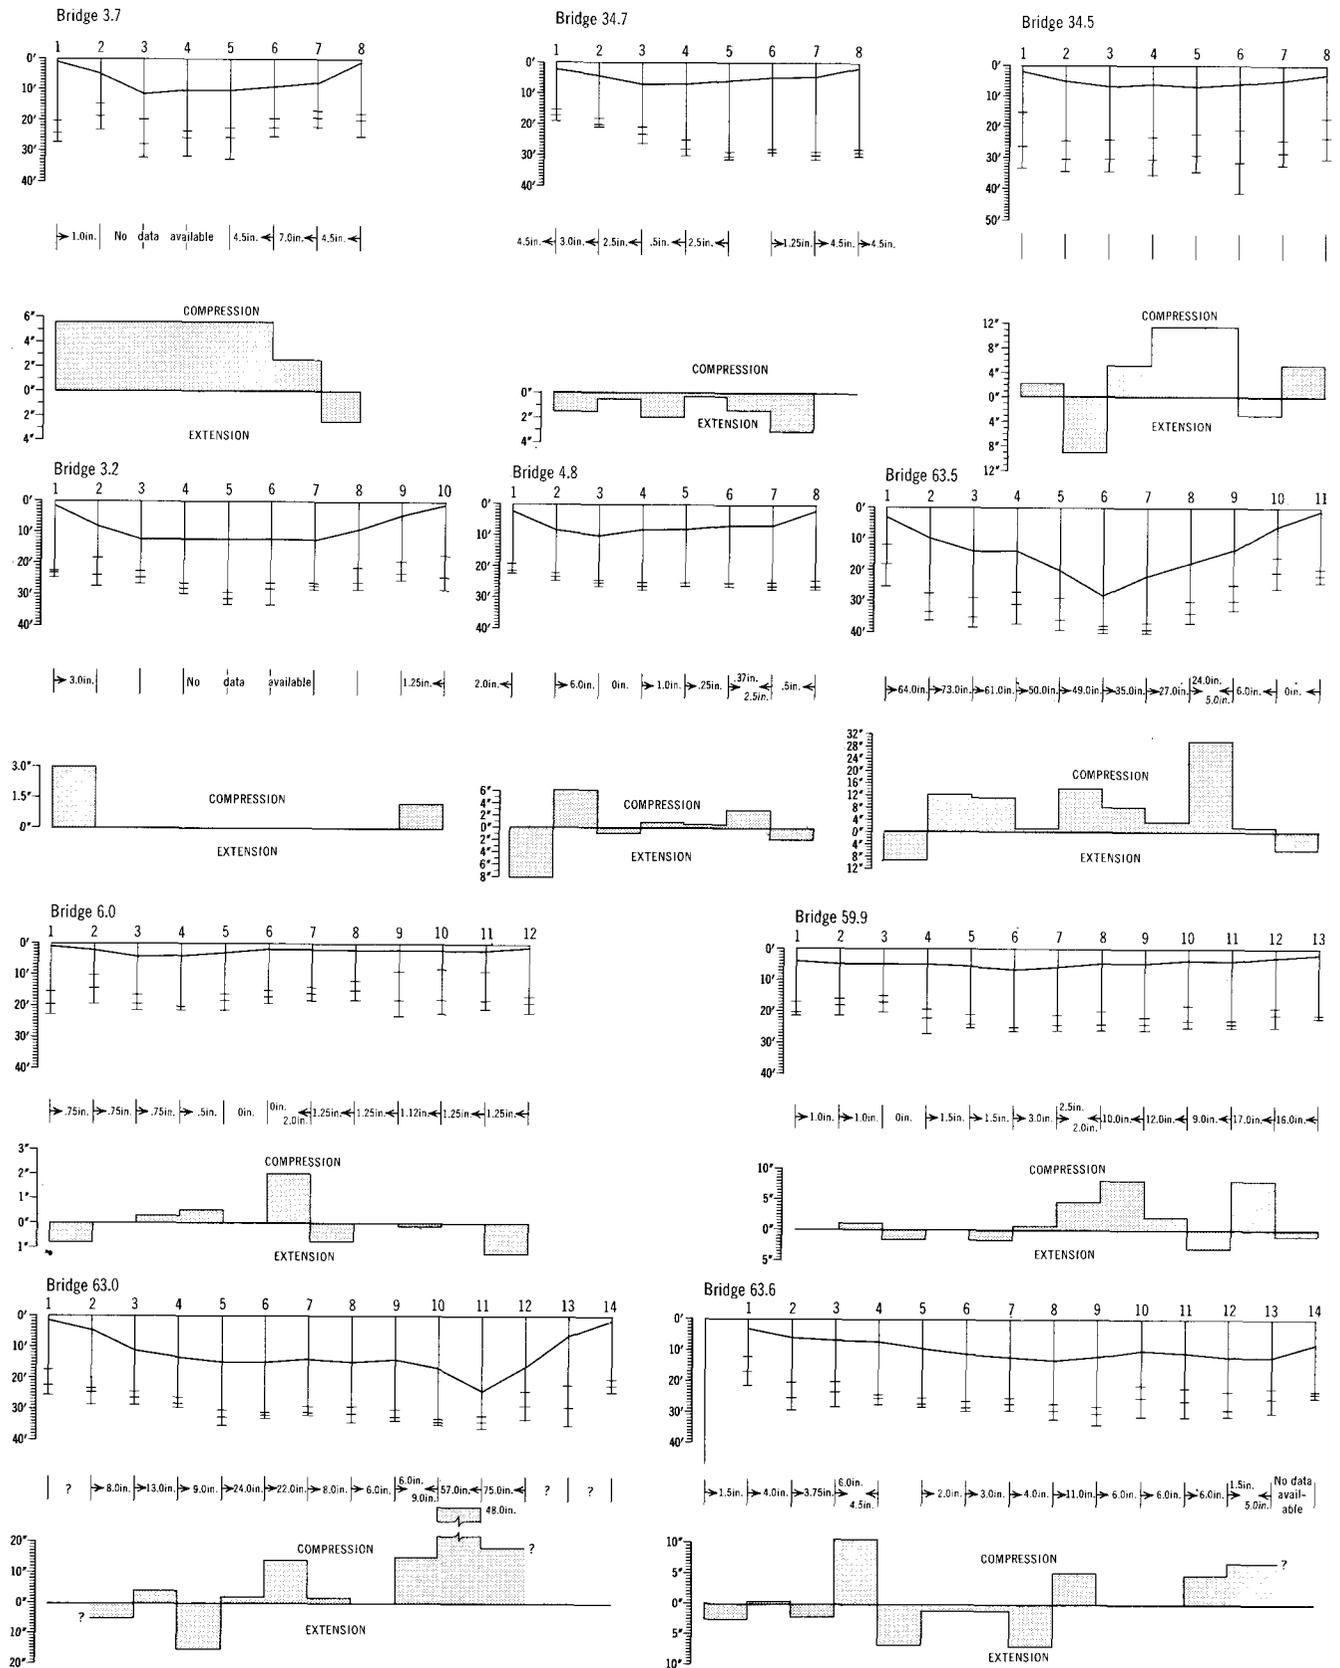
8.—Pile penetration length and relative horizontal displacement of bents of seven- to 14-span open wood trestle bridges. The horizontal displacements are shown in terms of interpreted behavior of the foundation material: Extension, distance between bents increased; no change; and compression, distance between bents decreased. The shallowest, average, and greatest depths of penetration in each bent are indicated by horizontal lines.

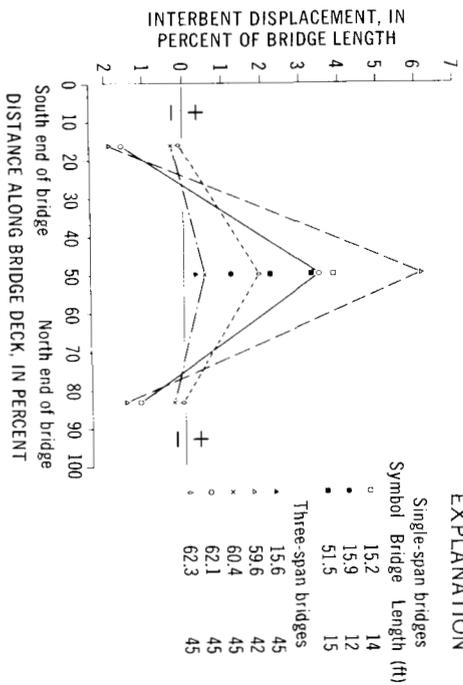
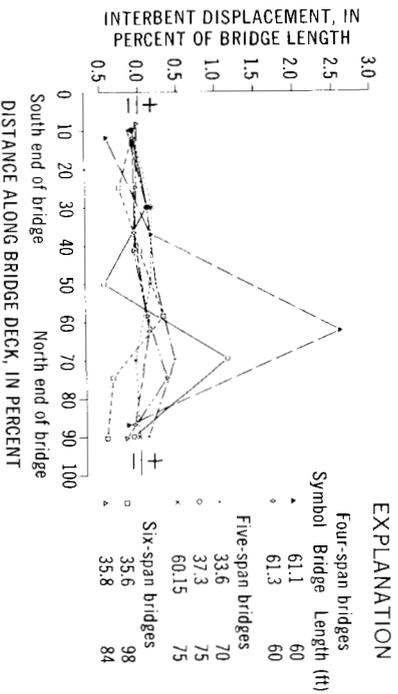
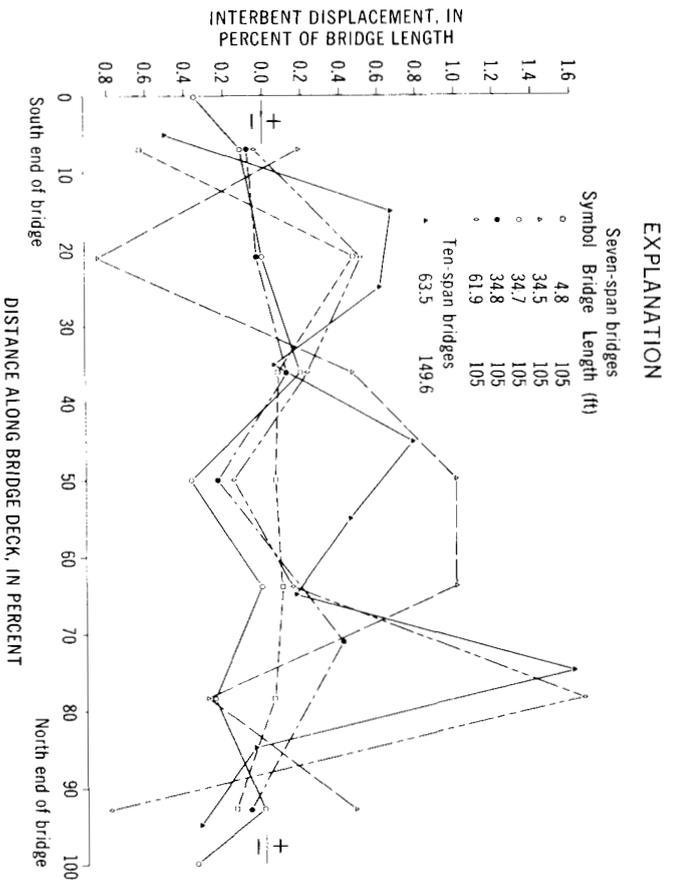
9.—Relative horizontal displacements between bents of open wood trestle bridges plotted as the percentage of the bridge length. Horizontal compression of foundation materials indicated by +, horizontal extension by —.

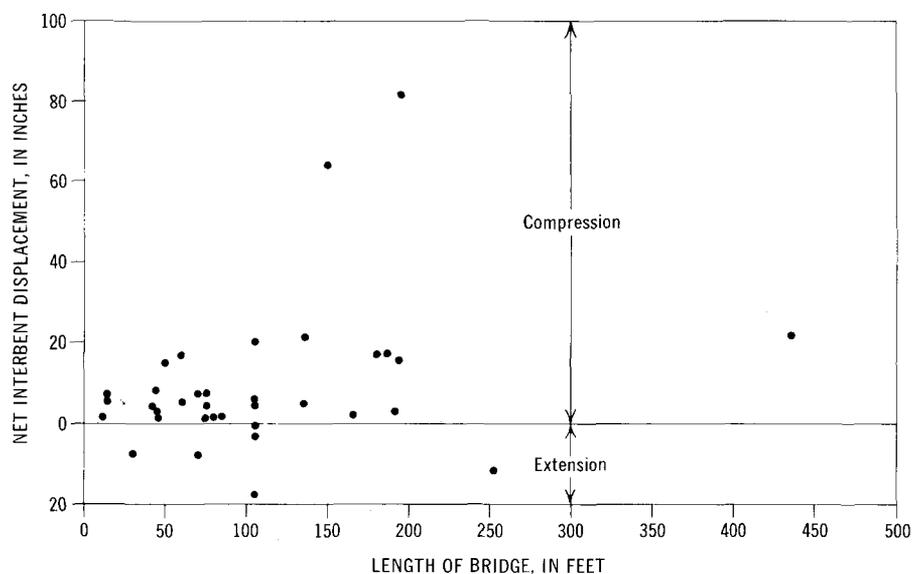
10.—Net horizontal compression or extension of bents, compared with the lengths of bridges.

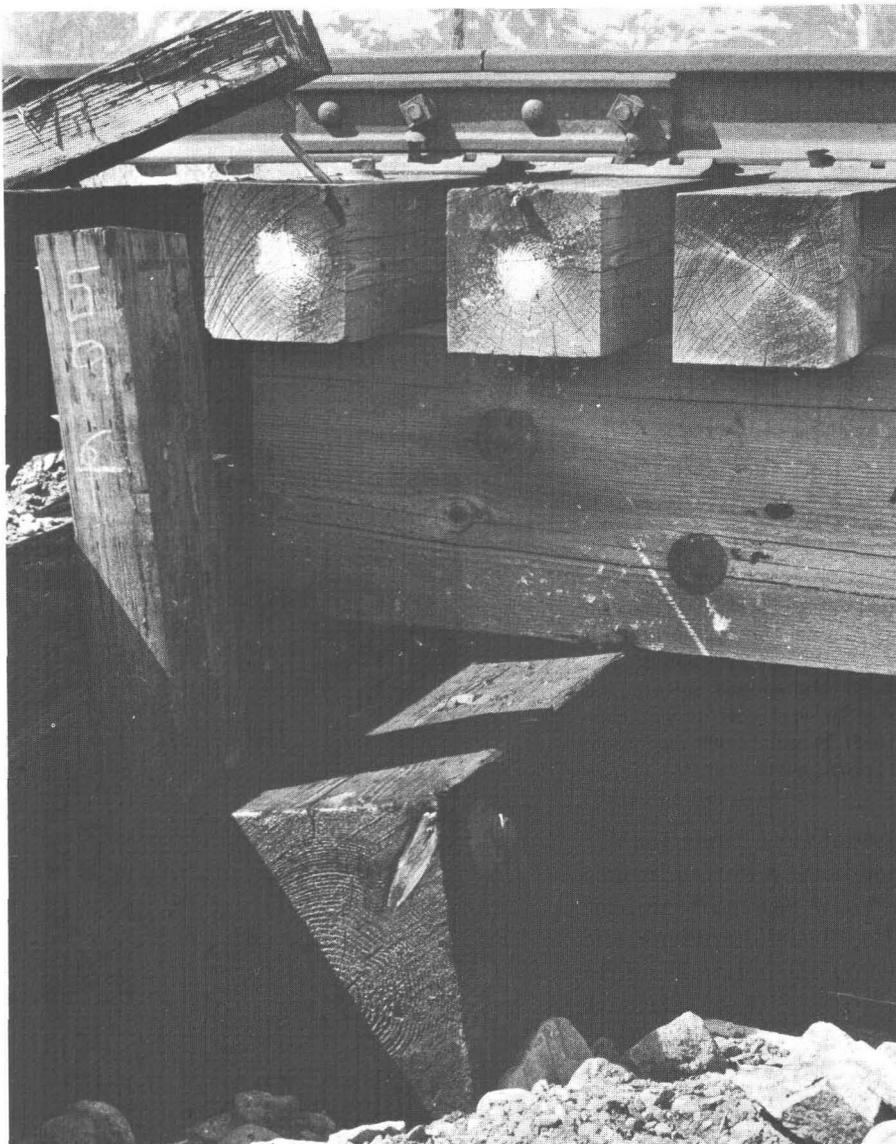
11.—Stringers jammed into the bulkhead planking as the result of a decrease in distance of  $14\frac{1}{2}$  inches between streambanks at bridge 59.6.

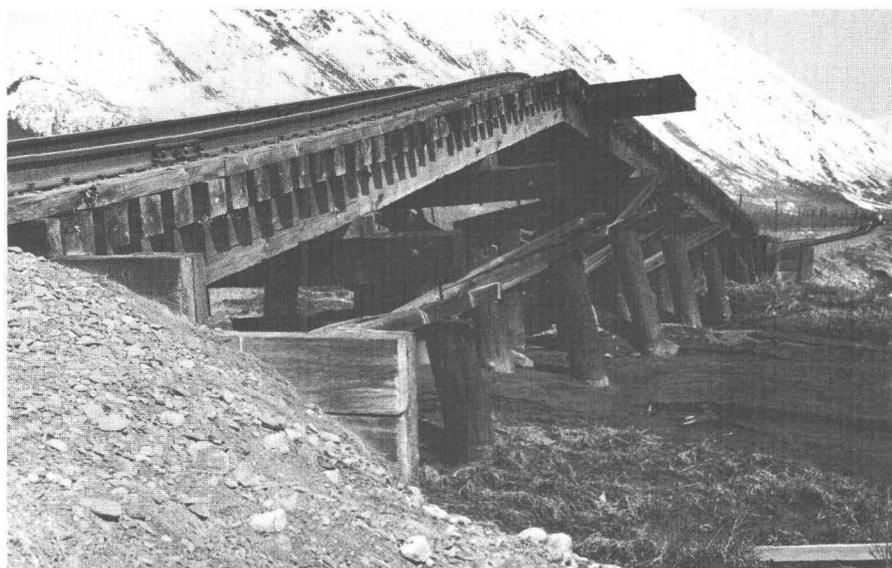
companied by an upward displacement on the floors of the streams, indicate that the foundation materials underwent a kind of flowage in which there was rearrangement of the materials at the intergranular level. Sand ejected from cracks on stream floors (figs. 13, 17) indicates that excess water pressures developed within the sediments. These observations suggest that the foundation materials may have undergone liquefaction. Liquefaction is known to occur during earthquakes (Seed, 1967) and results when ground motion compacts saturated granular sediments. If the water in the sediments cannot escape, or escapes only slowly, the grains of the sediment become reordered in such a way as to increase the load on the interstitial water. As the pressure of the confined water increases, the sediment starts to liquefy and lose strength; when the water pressure is equal to the load of the overlying materials, the sediment will have become completely liquefied and will have no strength.

13.—Bridge 34.5 jackknifed upward by compression at the bulkheads. Note the mounds of fine-grained sediments ejected with ground water through cracks in the stream floor.

The 105-foot open wood trestle bridge at mile 34.5 was compressed so severely (2.2 ft) that the stringers jackknifed up off the piles and broke in the center of the span (figs. 13, 95). The piles were shifted toward the stream channel, and sand that had been ejected with ground water from cracks in the streambed covered the bed to a depth of several inches. Details of damage to this bridge are given on page D51.

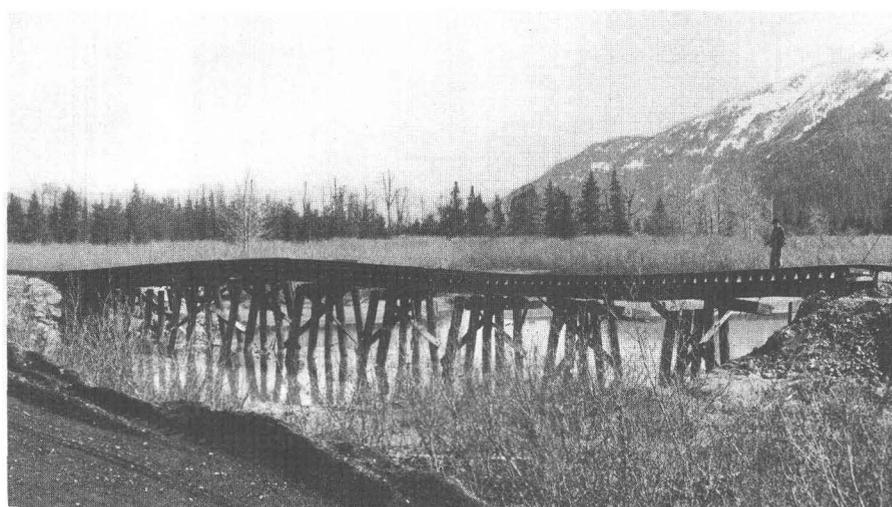
bulkhead and onto the approach fill which left the superstructure unsupported to the place where the sagging stringers again found bearing on the piling (fig. 14).

14.—Streambank closure of 64 inches drove the deck of bridge 63.5 through the south bulkhead up onto the top of the embankment. The tops of the piles beneath the deck describe an upward arch, and the deck sagged at the right until it encountered the piles. Photograph by The Alaska Railroad.

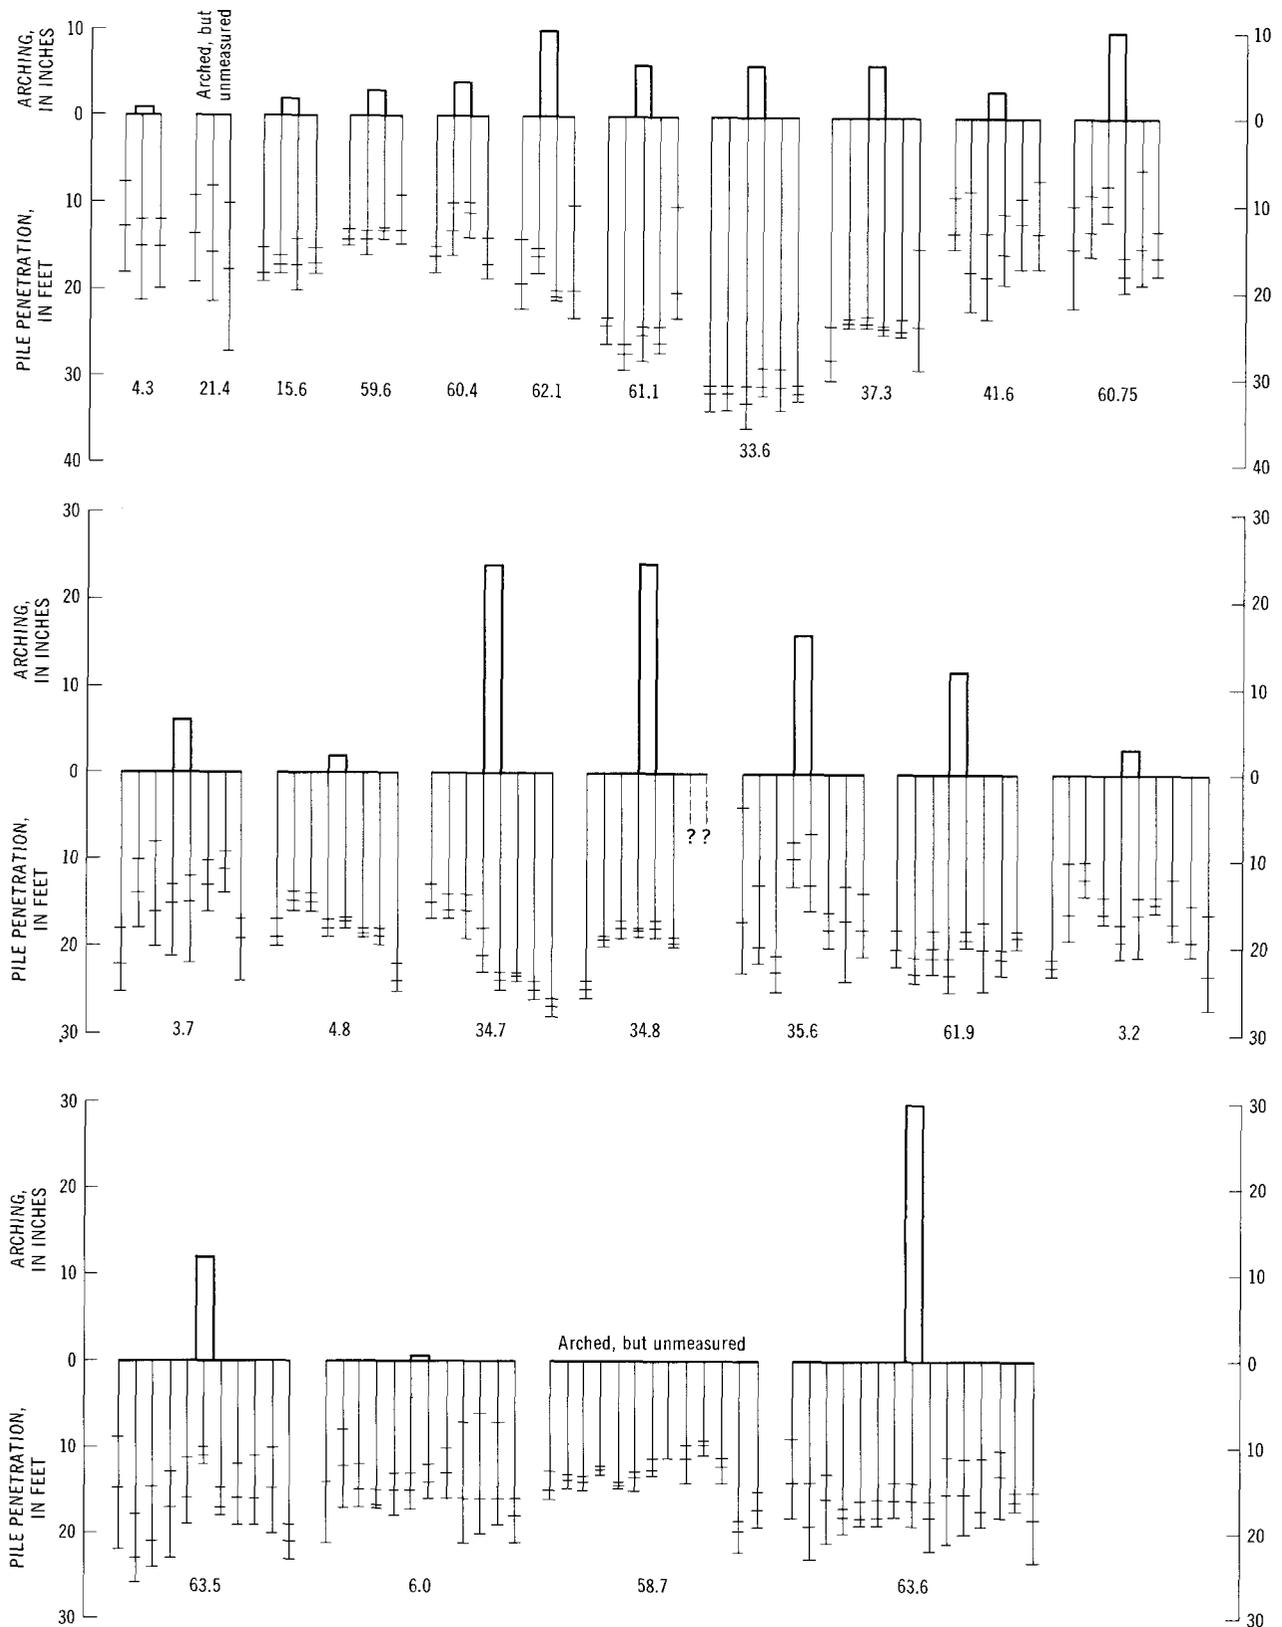
15.—Arching of decks and pile penetration in open wood trestles. The shallowest, average, and greatest depth of penetration in each bent are indicated by horizontal lines. Arching always occurred in the stream centers, regardless of the distribution of the pile penetration.

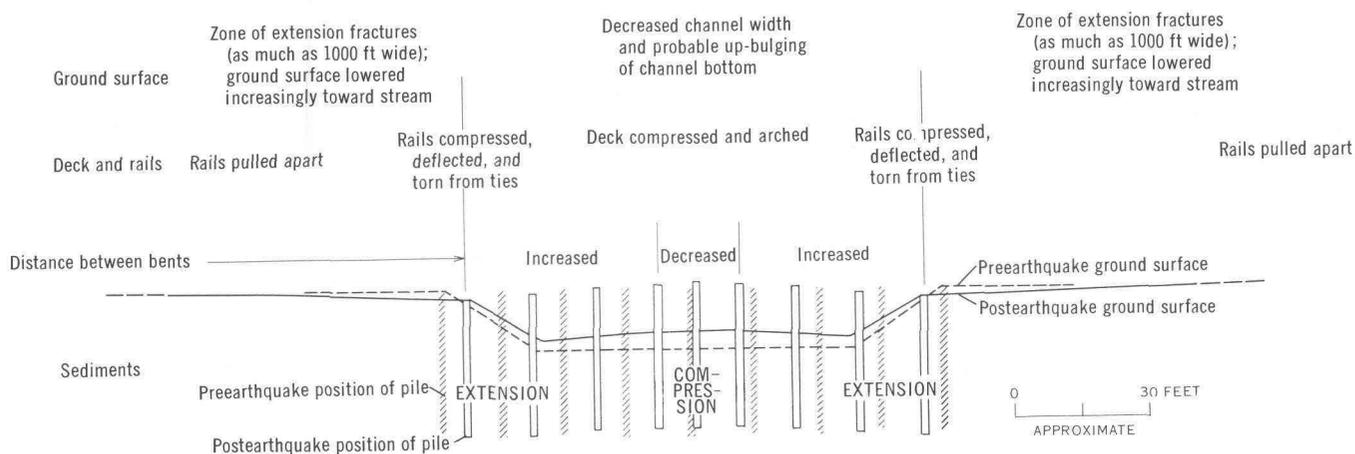
16.—Generalized diagram of a typical compressed open wood trestle. Piles were displaced toward the stream and upward in the stream center. The fact that interbent distances increased at the ends of the bridge and decreased under the middle shows that the sediments were extended at the edges and compressed at the center of the stream channel. Extension, continuing back from the streambanks, formed fractures in the ground and embankments and pulled rails apart.

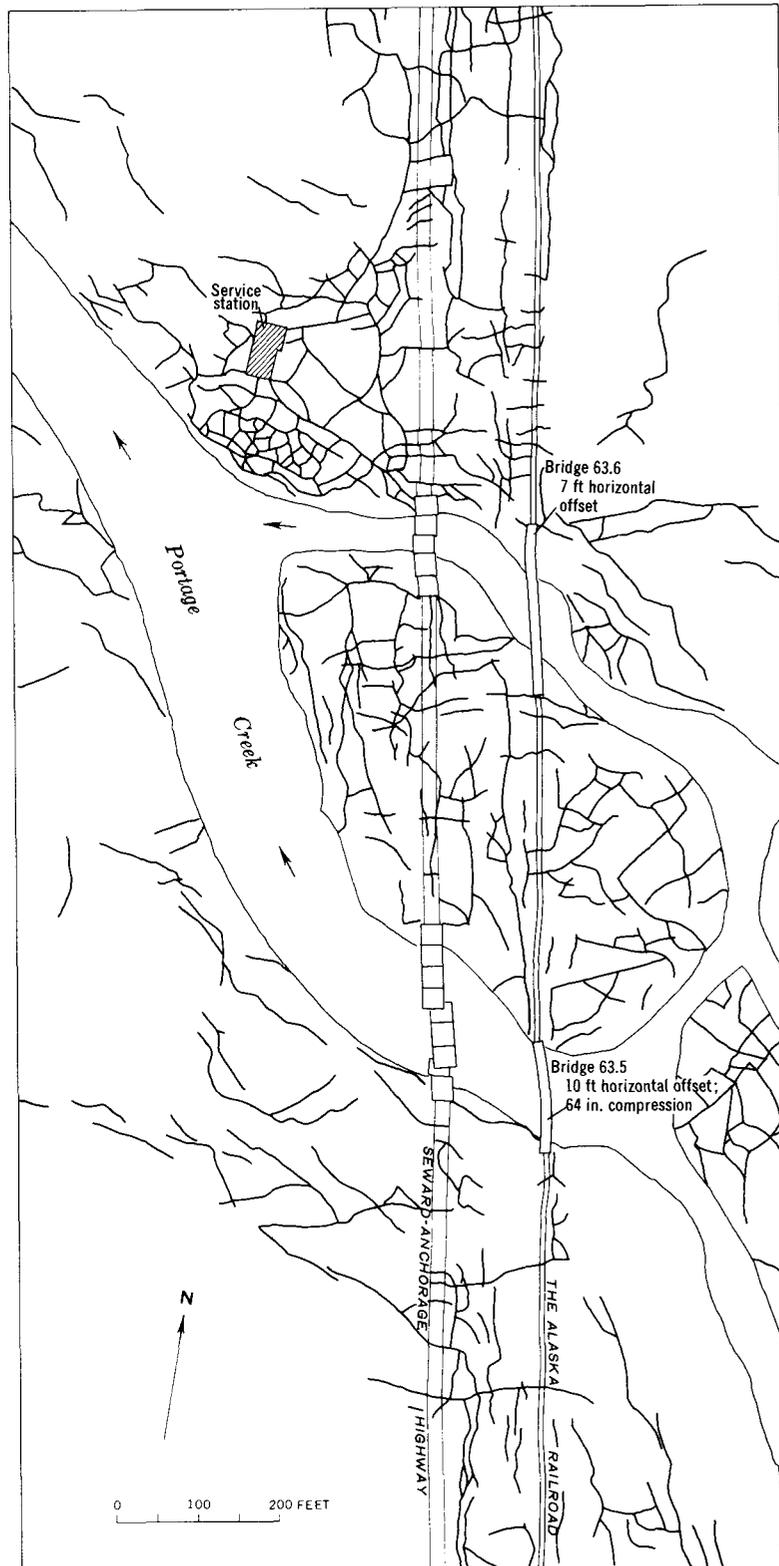
19.—Ground cracks at Portage Creek, as mapped from aerial photographs. Note the open network of fractures south of the service station, on the island, and on the point of land southeast of the island; note also that the tension fractures are generally perpendicular to the highway and railroad embankments.

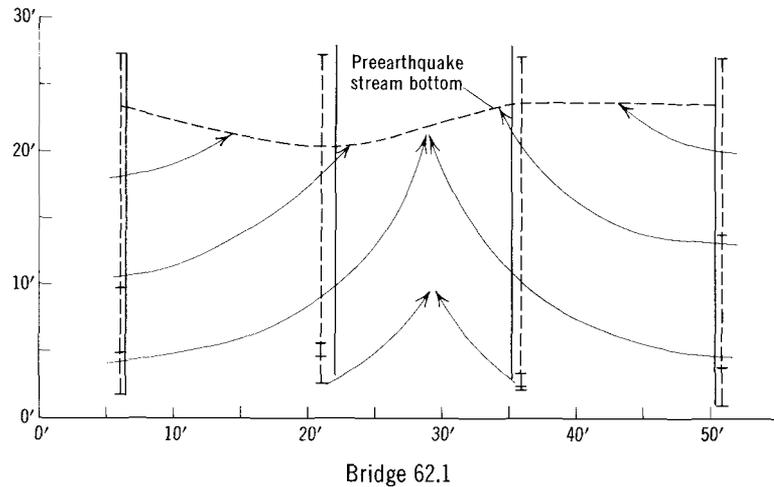
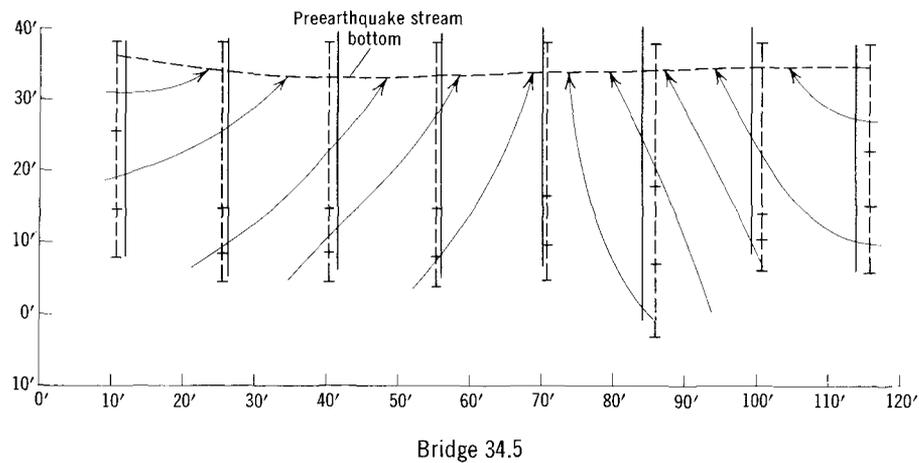
20.—Sediment movement suggested by displacement of bents in two arched bridges, based on the assumptions given in the text. The preearthquake bent positions are indicated by dashed lines, on which the shallowest, average, and deepest pile penetration lengths are indicated by horizontal lines.

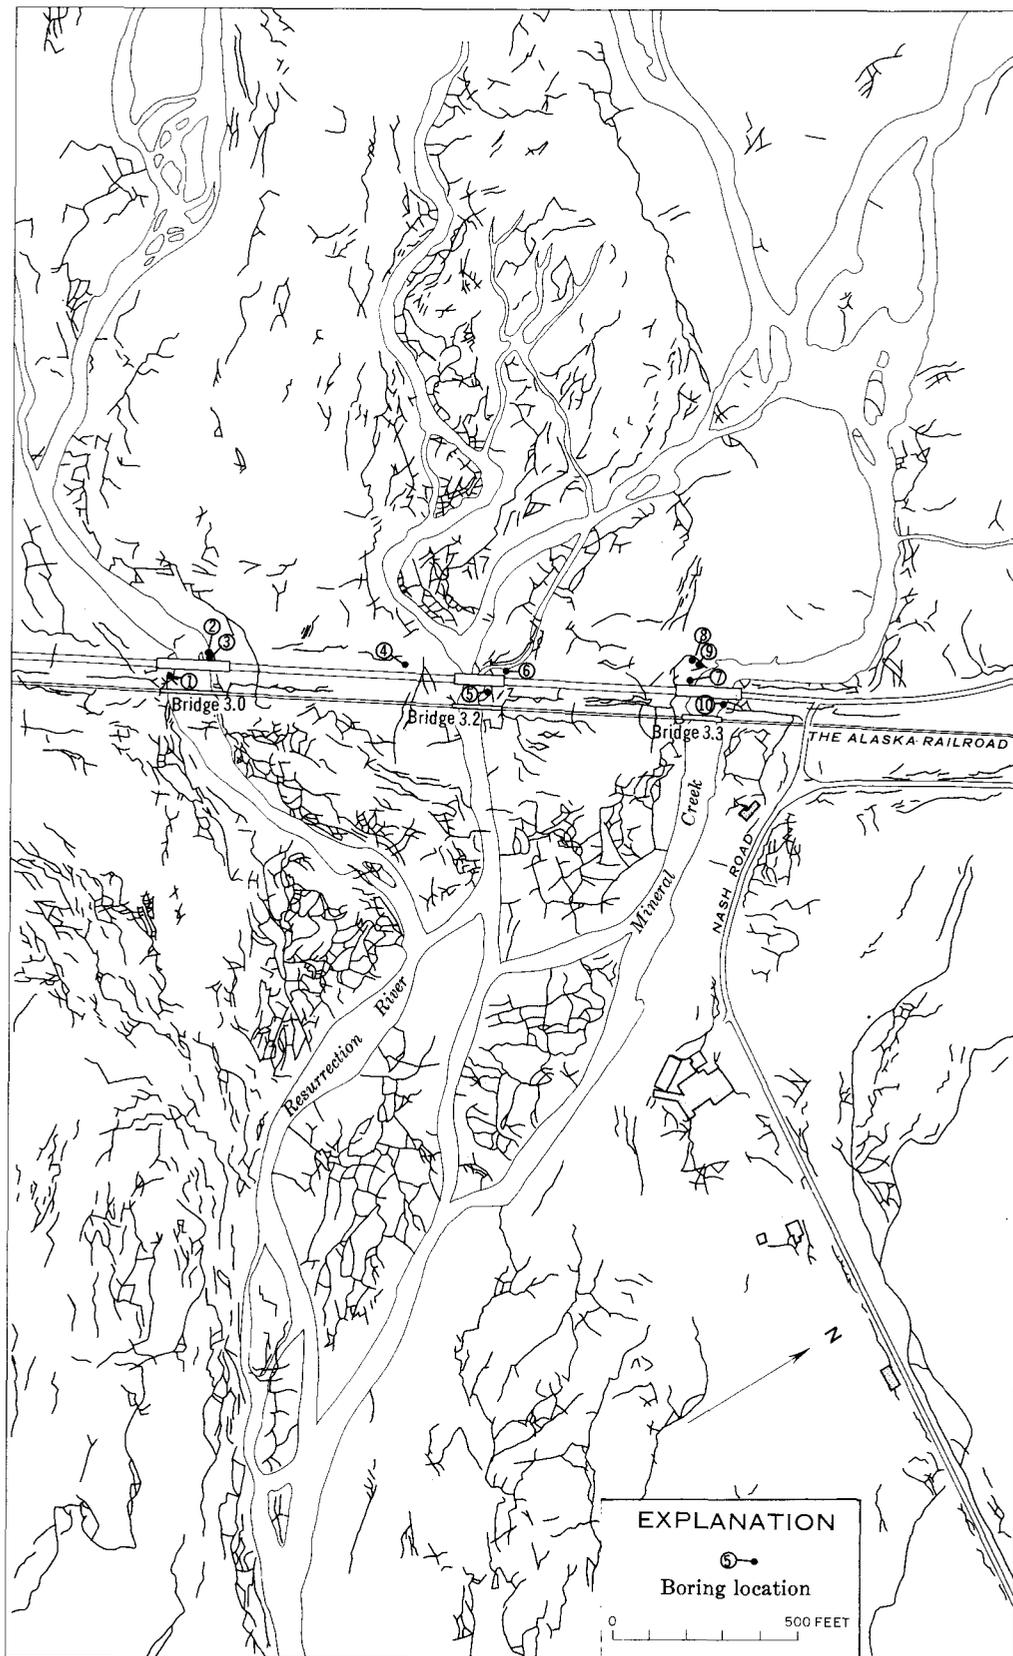
Three railroad and three adjacent highway bridges that cross the flood plain shared by Resurrection River and Mineral Creek just north of Seward were severely damaged. All three railroad bridges had to be replaced with entirely new structures. The low-relief flood-plain surface was severely fractured. Fracturing (figs. 27, 28) was accompanied by the ejection of a considerable amount of water.

27.—Ground cracking on the flood plains of Resurrection River and Mineral Creek. Numbers indicate borings, the logs of which are given on figures 29, 31, and 32. Cracks were mapped from aerial photographs taken by Air Photo Tech, Anchorage.

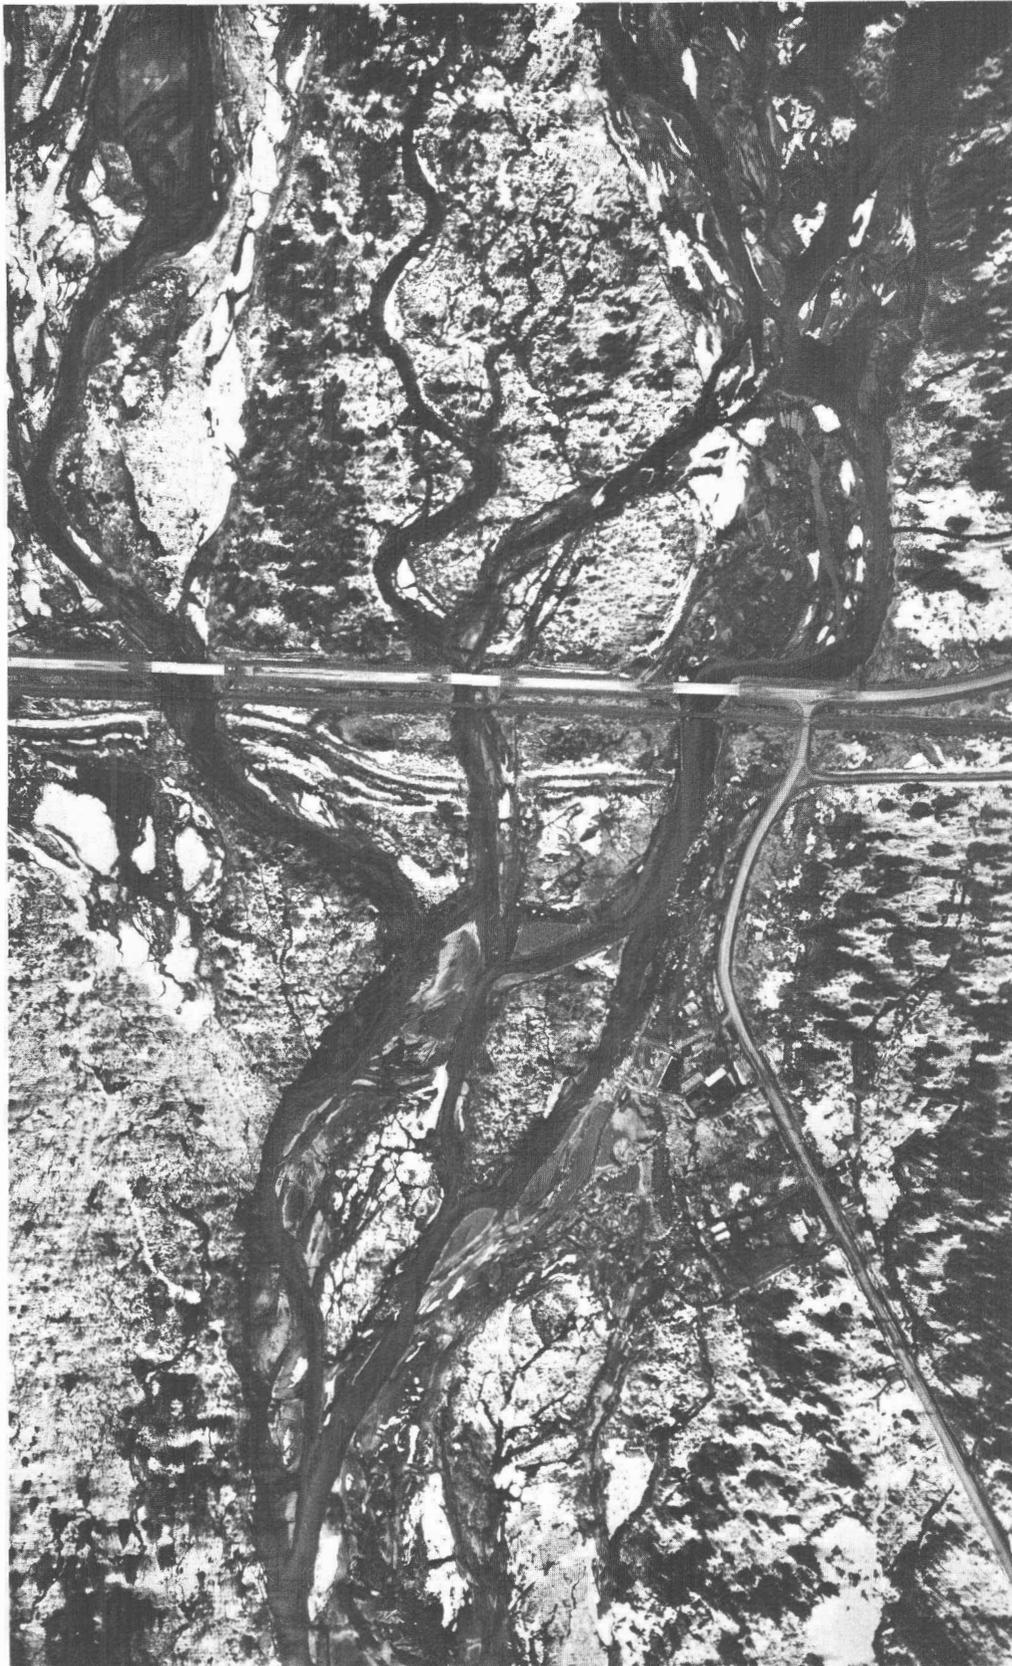
28.—Aerial photograph of area mapped on figure 27 of Resurrection River and Mineral Creek flood plains. Photograph by Air Photo Tech, Anchorage.

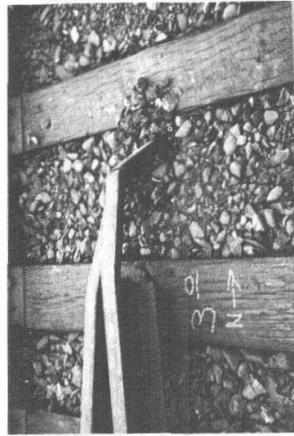
Central rail on bridge driven back into approach fill

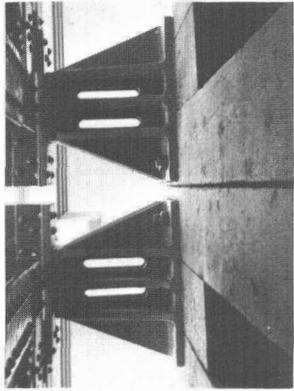
Fixed bridge shoes on upstream side of the central pier were not displaced

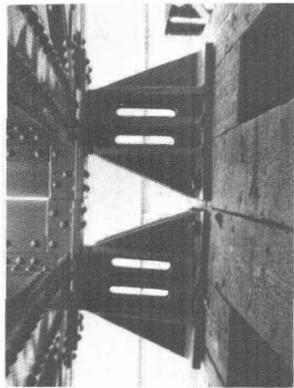
Fixed bridge shoes on the downstream side of the central pier were pried upward at their outward edges as the spans above were driven together

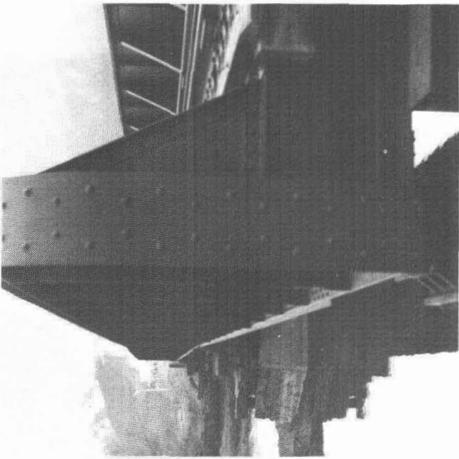
In addition to moving streamward, the outer piers shifted 8 inches downstream of the central pier, and the bulkheads and approach fills were carried 4 to 5 inches more; the central pier was thus left 12 to 13 inches upstream of the approaches. As shown in figure 29, the downstream edges of the steel girders were jammed together, and the metal shoes were rocked inward, their bases lifting ¾ and 1¾ inches off the cribbing. On the upstream side of the same pier the girders were pulled 3-3/16 inches apart. The compression of the steel spans at the downstream edge of this central pier may have exerted some downward force, for the top of the pier was tilted about 2 inches in the downstream direction.

View south showing ends of bridge displaced downstream relative to its center

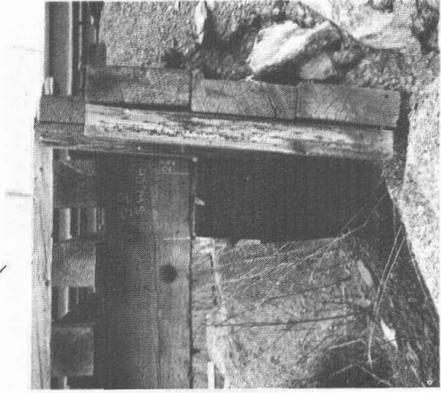
Deck stringers driven 2½ inches into the bulkhead. Rails pulled free at ties on the embankment. Bulkhead rotated back into the fill and guard timber driven over top at the bulkhead

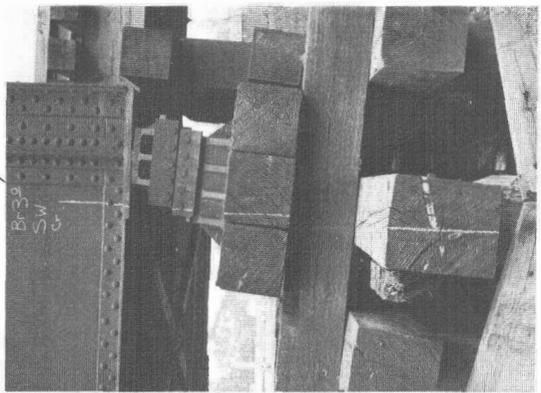
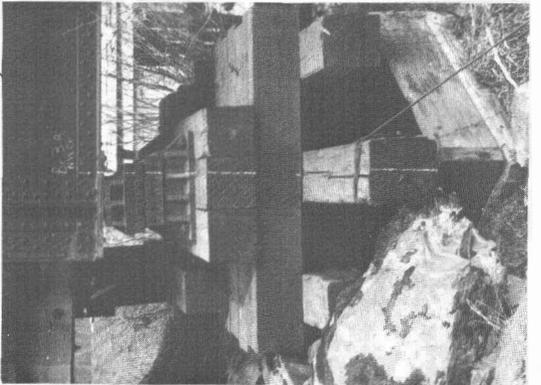
Piles at the bulkheads and piers were shifted streamward. All moved with no detected vertical rotation. The horizontal displacements ranged from 1½ to 11 inches; there was extension of the valley bottom sediments at the stream edges and compression in the center (fig. 29). The centers of the piers, originally under the bridge shoes, were displaced as shown by vertical chalk lines drawn up from the centerline of the central row of piles (fig. 29). As the piers shifted, rockers on the bridge shoes were driven to their extreme positions, and with continued movement of the piers, the cribbing was rotated, which placed more weight on the outside row of piles in each pier. The redistribution of the weight may have caused the vertical movements that occurred in piles under the piers. The tops of the piles in each row stood successively higher toward the streams. Despite the greater heights streamward, the cribbing was cantilevered off most

of the streamward row of piles. In the south pier, only three of the nine piles in the row were bearing; the rest ranged from three quarters of an inch to 6 inches below the cribbing. In the north pier all the streamward piles stood an inch or so below the cribbing. The transfer of the load to the outside piling and the decrease in skin friction which must have occurred during the movement of the sediments probably caused the outer row of piles to be driven downward into the sediments. Because these piers are closely spaced and depend primarily on skin friction for most of their bearing capacity, it also seems likely that downward movement of the overloaded piles may have produced a negative skin friction which pulled the unloaded streamward row of piles downward.

Piles shifted streamward, rotating the cribbing. Vertical chalk lines drawn upward from the pile cap at the pier center show the amount of horizontal displacement at the bridge shoes. Note that the nested rollers are driven into their extreme positions. Wooden stringers were driven 4 inches and 5½ inches into the central steel spans (shown by crowded ties in upper left of left photograph)

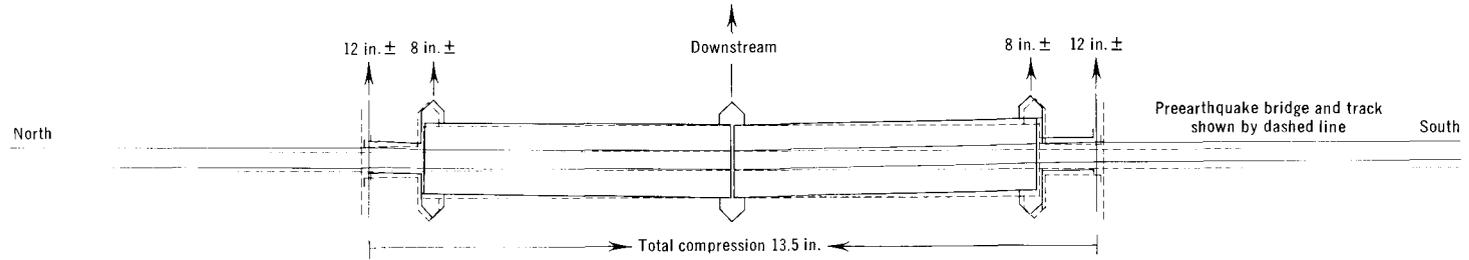
29.—Bridge 3.0; construction, damage, and subsurface information. Subsurface data projected to rail line at proper altitude.

Bridge 3.0 crosses the southern branch of Resurrection River and is 187 feet long (fig. 29). Its two 13.5-foot open wood-trestle end spans bear on a seven-pile bent at the bulkheads and a cribbing on pile-supported piers that carry two 80-foot through steel girders. The central pier rests on four rows of nine piles, and the outer piers have three rows of nine piles. Compression at the deck level totaled 13½ inches. The steel deck beams were driven 4 and 5½ inches into the ends of the wood stringers, and the wood stringers were driven 1.5 and 2.5 inches into the bulkheads. Compression was accompanied by endways pounding (shown by pebble dents between the last tie and fillers on the north bulkhead).

Preearthquake bridge (dashed line) was compressed longitudinally and its ends carried in the downstream direction, while its center pier remained upstream

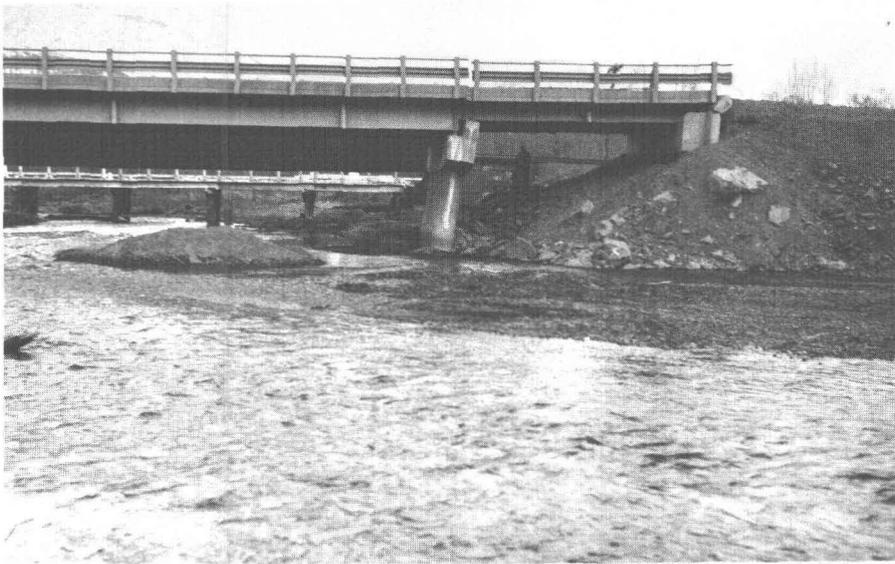
For comparison, the adjacent highway bridge is shown in figure 30. Deck level compression drove the steel into the abutment, breaking the back wall. The abutment and pier were shifted streamward. The top of the pier was prevented

30.—Looking southeast toward highway bridge (No. 596) at Resurrection River. Streamward movement of the foundation materials compressed the deck, breaking the abutment backwall, and carried the abutments and bases of the piers toward the channel. Being restrained at the top, the pier was broken at the ground line. Similar damage occurred at the other end of the bridge.

from moving laterally by the deep central steel span, but its base was carried streamward, rotating the pier and cracking it at the waterline. Damage to this bridge was typical of the adjacent highway bridges—in all of which the abutments were rammed by the steel, and the piers were broken and shifted streamward at their bases.

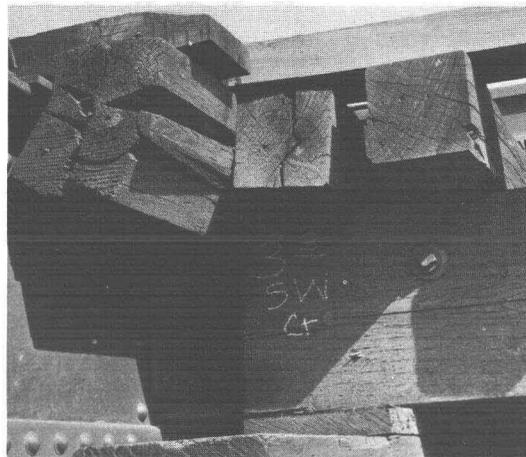
Ties crushed and crowded as wood stringers were driven into the steel central span; stringers driven 2 inches into the steel at left and 4 inches below
