*A description and analysis of the geologic  
controls of earthquake damage to The Alaska  
Railroad, with emphasis on damage caused  
by the mobilization of unconsolidated  
sediments*

In the 1964 Alaska earthquake, the federally owned Alaska Railroad sustained damage of more than \$35 million: 54 percent of the cost for port facilities; 25 percent, roadbed and track; 9 percent, buildings and utilities; 7 percent, bridges and culverts; and 5 percent, landslide removal. Principal causes of damage were: (1) landslides, landslide-generated waves, and seismic sea waves that destroyed costly port facilities built on deltas; (2) regional tectonic subsidence that necessitated raising and armoring 22 miles of roadbed made susceptible to marine erosion; and (3), of greatest importance in terms of potential damage in seismically active areas, a general loss of strength experienced by wet water-laid unconsolidated granular sediments (silt to coarse gravel) that allowed embankments to settle and enabled sediments to undergo flowlike displacement toward topographic depressions, even in flat-lying areas. The term "landspreading" is proposed for the lateral displacement and distension of mobili

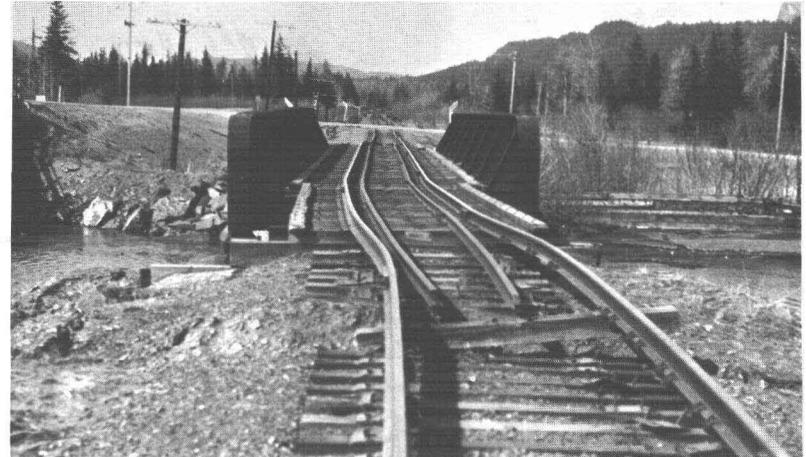
View north over bridge, showing end spans and embankments offset downstream (right) from highway fill located at left

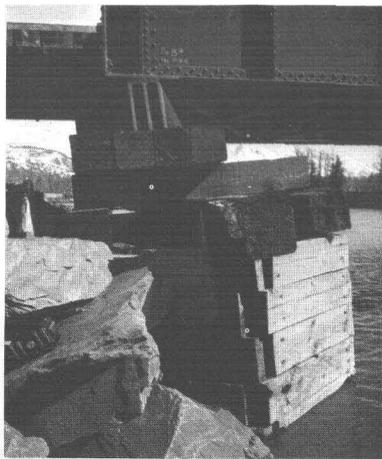
As the pier piles shifted streamward, the nested rollers in the south bridge bearings were driven to their extreme positions, and the northern fixed bearings were rotated, their streamward edges lifting up off the cribbing about  $\frac{3}{4}$  of an inch. Rotation of the cribbing streamward at its base increased the weight on the outer row of piles. As at bridge 3.0, the outer row of piles were all bearing on the cribbing, most of the central piles were bearing, and the cribbing was cantilevered an inch or more above the inner rows of piles.

Piles shifted streamward in the piers, rotating the cribbing and driving the nested rollers in the bridge shoe (at right) to its extreme position

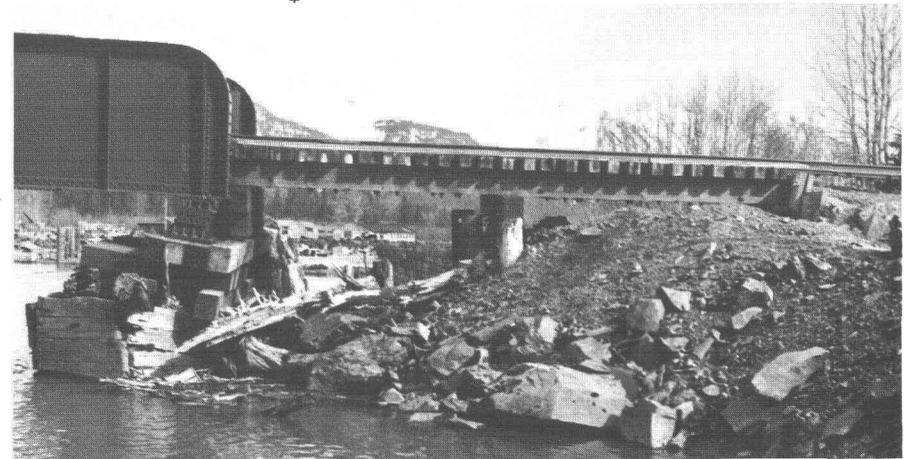
32.—Bridge 3.3; construction, damage, and subsurface information. Subsurface data projected to rail line at proper altitude.

Mineral Creek bridge, at mile 3.3, has a total length of 136 feet and is built with an 80-foot central steel through girder and two 14-foot pile-supported open wood trestles at each end (fig. 32). The damage to this bridge was very much like the damage to the similar bridge at mile 3.0. Compression, totaling about 19 inches developed at the deck level, driving stringers into bulkheads and into the central steel spans. At the north bulkhead the stringers were

Streambanks moved closer together, driving wood stringers into the central span and about 1 foot past the bulkhead piles. The bulkhead was rotated and driven into the fill, and the guard timber was shoved over the top of the bulkhead. The rails were pulled free of the ties on the approach fill. The piles between the wood spans were shifted 22 inches to the left of the pile cap. Light-colored pile in foreground from older bridge

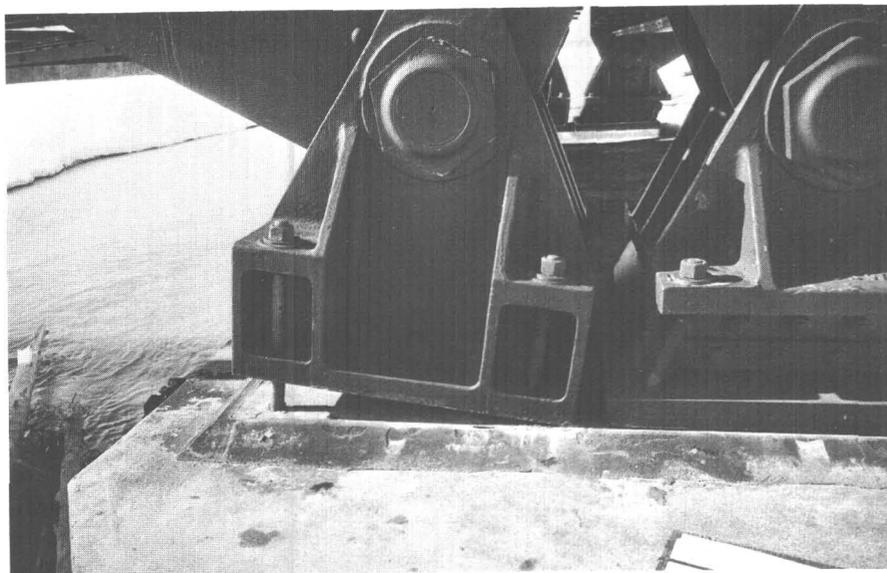
34.—Fixed end bearing lifted from pier at north end of sixth span of bridge 14.5. Anchor bolt pulled free of concrete. In adjacent expansion bearing, nested rollers were driven to the extreme position.

der move generally toward the river. Maximum displacement was 5.5 inches. Piers shifted without tipping, and, if the piling was not bent, sediments to depths in excess of 45 to 55 feet must have been involved in the displacement. There was neither upward movement nor settling of the piers, and no noticeable upstream or downstream displacement. Rollers on expansion bearings of piers 5 and 6 were driven to their extreme positions. Fixed bearings were shifted, and on the north end of the sixth span, where compression was maximum, the edge of the bearing was rocked upward off the pier (fig. 34). Anchor bolts were bent and stretched but none were sheared. No boring data are available for this bridge.

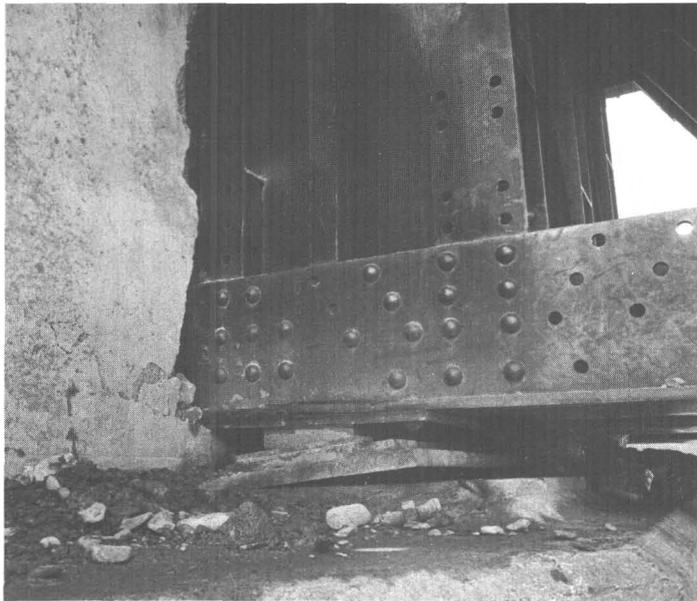
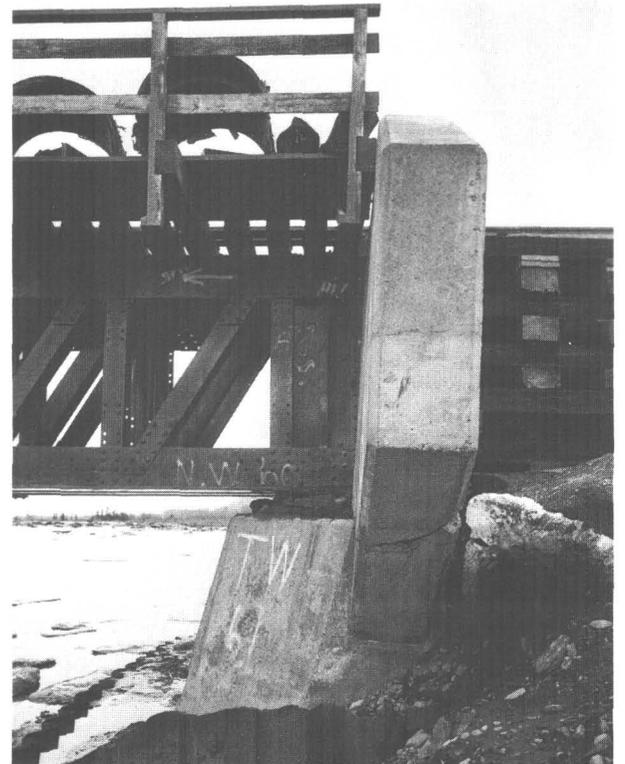
37.—Damage to Twentymile River bridge. Left: Concrete abutment broken away after earthquake to relieve pressure on spans. Note tilted bearing shoe and missing sheared-off anchor bolt. Right: North abutment backwall broken by thrust of steel deck.

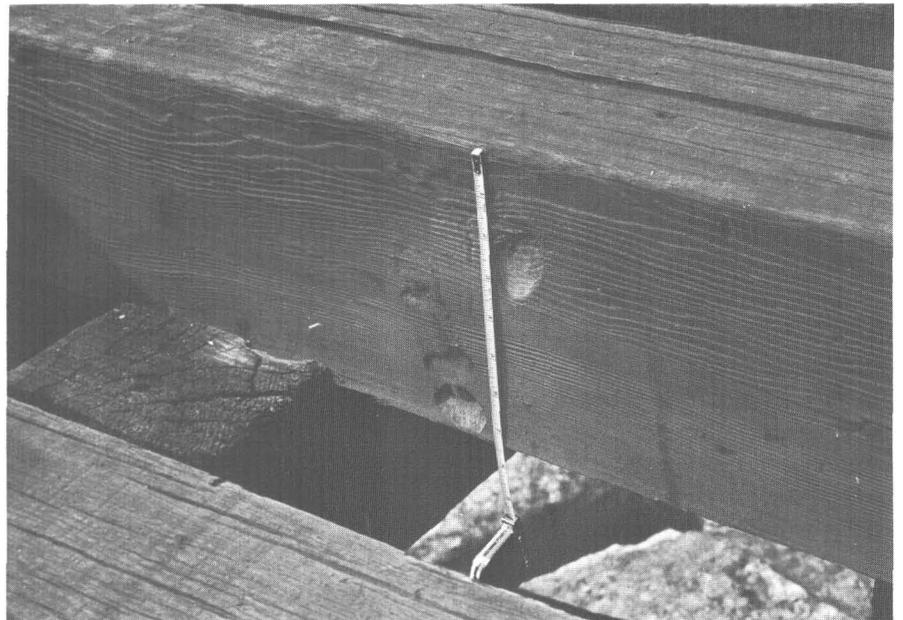
40.—Multiple dents on the end tie of a bridge deck made by a pebble that was caught as it fell between the filler (foreground) and tie during endways compression.

Using 0.07 to 0.09 seconds for the free-fall times making the assumption that the pounding was harmonic, a pounding rate can be estimated. If one assumes a wide range for the part of the compression-relaxation cycle during which the pebble was in free fall, the real rate should lie between the extremes. Assuming that the free-fall time was from  $1/5$  to  $1/2$  the cycle, the pounding rate should lie between 2.22 to 7.14 cycles per second. Clearly the assumptions make these figures questionable; furthermore they represent data from only one bridge. However, their magnitude suggests that this transient horizontal displacement is produced by considerably higher frequency ground displacements than those of observed surface waves, where periods are in the range of several seconds. (See, for example, Coulter and Magliacchio, 1966, p. C10.)

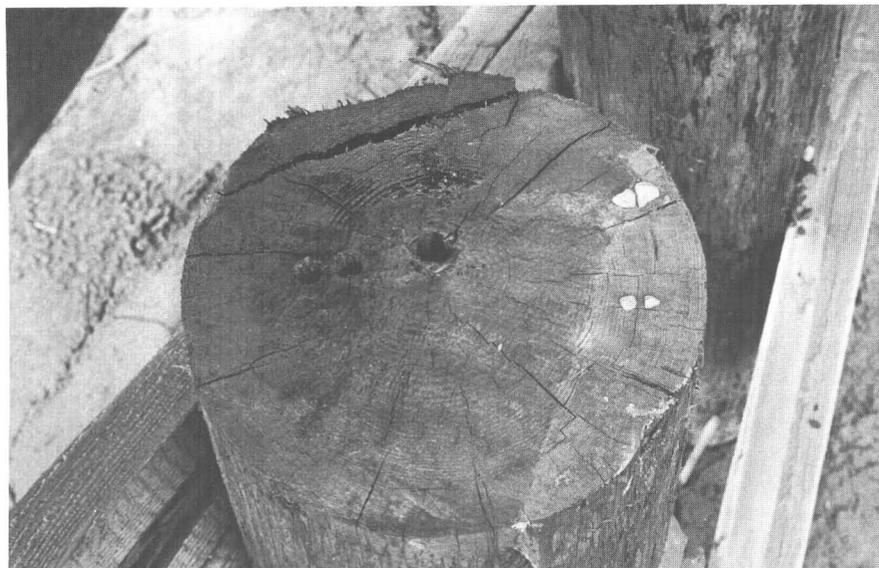
Although pebble dents provide a means of estimating the pounding rate, they do not distinguish horizontal motion of the ground from horizontal motion of the bridge. Further, they do not give an indication of the forces involved. However, both the sense of horizontal ground motion and a minimum estimate of the forces involved in the transient horizontal displacement can be determined from the damage to a 105-foot-long open wood trestle at mile 34.5 on Hunter Flats (see p. D114). The deck of this bridge was alternately arched upward off the piles by compression, and dropped down onto the piles during relaxation. Impact holes in the pile tops, made by the drift pins that normally connect the pile caps to the piles, record from two to four compressive episodes, and there may have been more (fig. 41).

41.—Two impact holes made by a drift pin in the pile cap as the deck of the bridge was alternately raised and lowered onto the piles (see also figs. 13, 95). Stream channel is to the right.

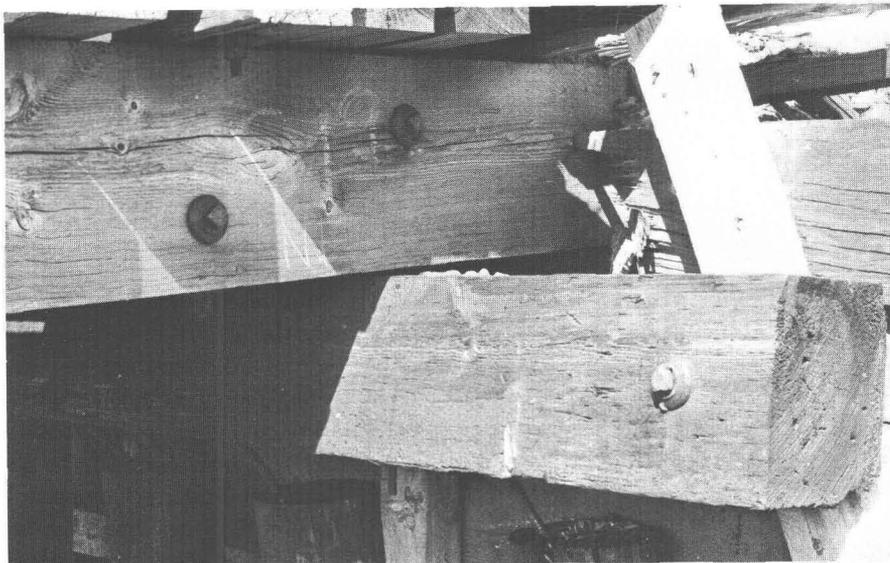
44.—Unbattered stringers of bridge 61.9 driven through the south bulkhead planks.

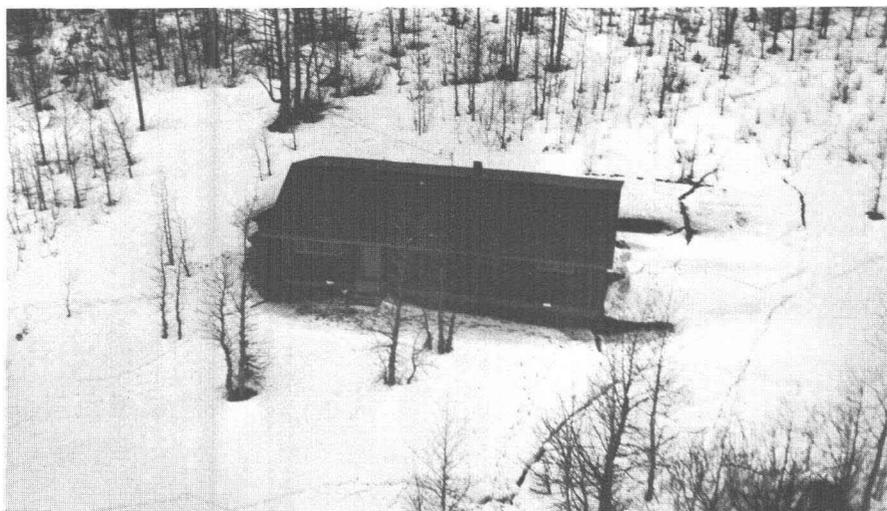
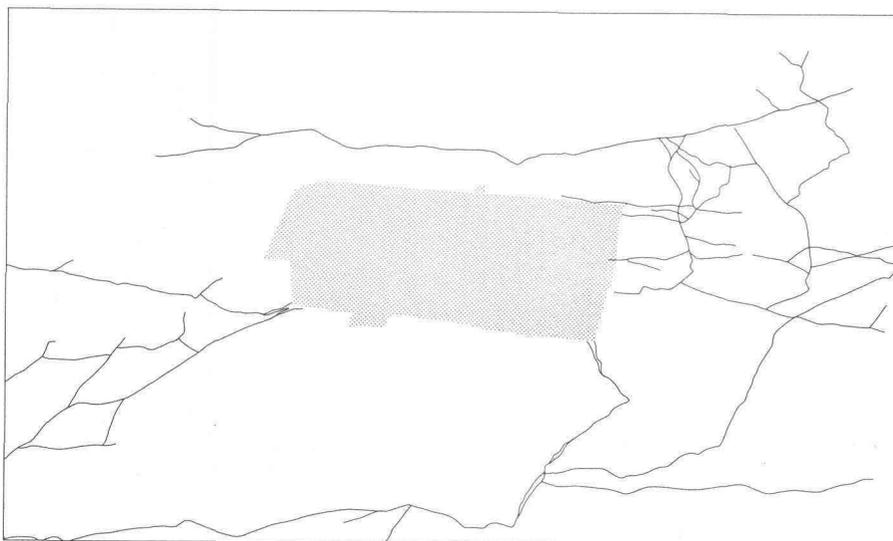
Miller (in Lemke, 1967, fig. 15) of the cracking on Jap Creek fan just north of Seward (see p. D98). On this map, 14 houses are shown to have been intersected by 46 cracks, 36 of which extend diagonally from the corners of the buildings. Lemke noted that such cracks were common but gave no explanation of their occurrence.

If, as suggested above, the surface materials were put in tension by lateral displacement of the underlying sediments, any sharp external angle in a hole through the frozen plate of surface sediments would concentrate the strain, and should be the site of a fracture. Once a fracture has been formed, the amount of force necessary to propagate the crack is reduced, because the sides of the fracture act as lever arms and increase the stress at the point of rupture; Inglis (1913) has shown that the stress at the apex of a crack in a plate is proportional to the square root of the length of the crack and inversely proportional to the radius of curvature of the angle at the apex of the crack. Because these cracks are initiated at weak

47.—Photograph and sketch of ground cracks localized at the corners of the U.S. Forest Service crew house on Portage Creek flood plain. Cracks broke the foundation and the building was moved to a new foundation. Photograph by Arthur Kennedy, U.S. Forest Service, Anchorage.

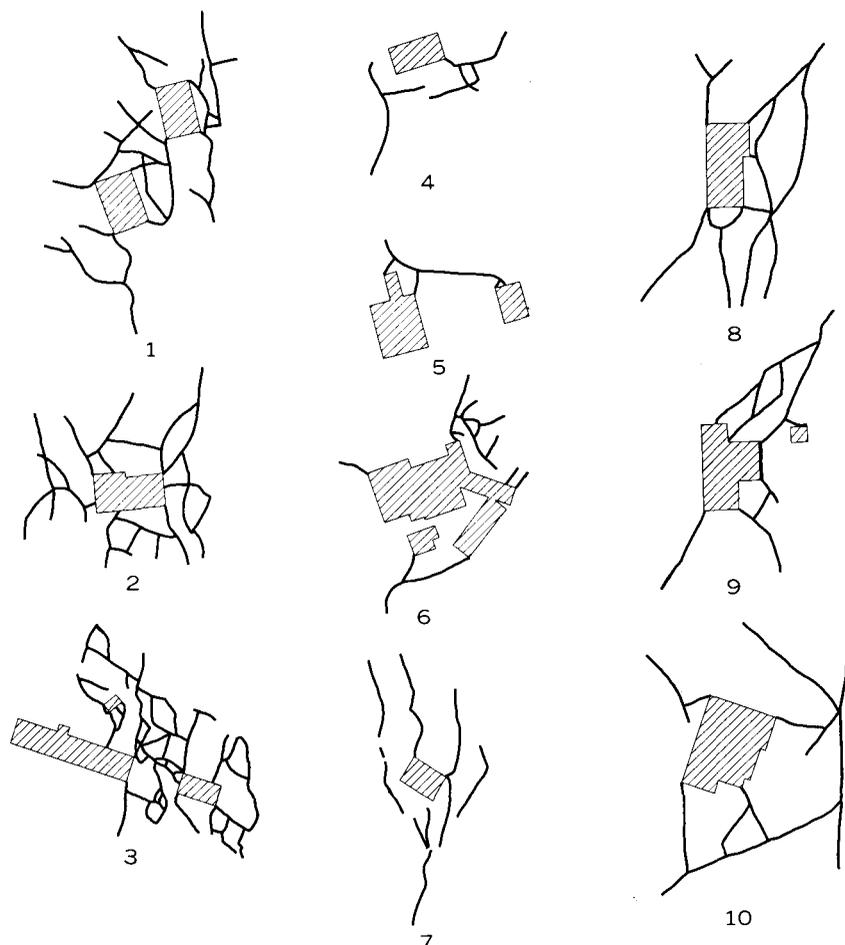
Similar cracks, located at the corners of houses, were common behind the scarps of the big block-glide slides in the Anchorage area (see, for example, Shannon and Wilson, Inc., 1964a, pl. 8.2). This stress in the surface appears to

48.—Ground cracks localized at the corners of houses on flood plains (1, 2, 4-6), on deltas (3, 7), and on alluvial fans (8-10). All houses oriented with the principal direction of landspreading to the right. Houses 1 and 2 on Portage Creek flood plain; 3, Lowell Creek delta; 4-6, Resurrection River flood plain; 7, Rocky Creek delta; 8-10 on Jap Creek fan (after Lemke, 1967, fig. 15).

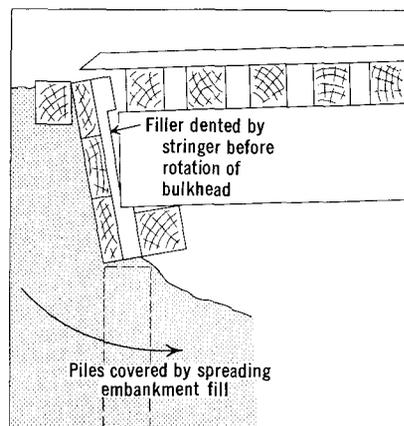
There is some evidence for failure by shear distributed throughout the fill, as shown by spreading of embankments at bridge bulkheads. Commonly, bulkhead fillers, rammed and compressed for the full stringer depth in the early part of the shaking when the bulkhead was vertical, were later rotated, their bases being pushed streamward by the spreading fill during the continued shaking (fig. 52). At several bridges the spread-

52.—A bulkhead filler that was rammed and dented by the stringer while it was still vertical. With continued shaking the base of the embankment fill spread over the bulkhead piles and the bulkhead was rotated.

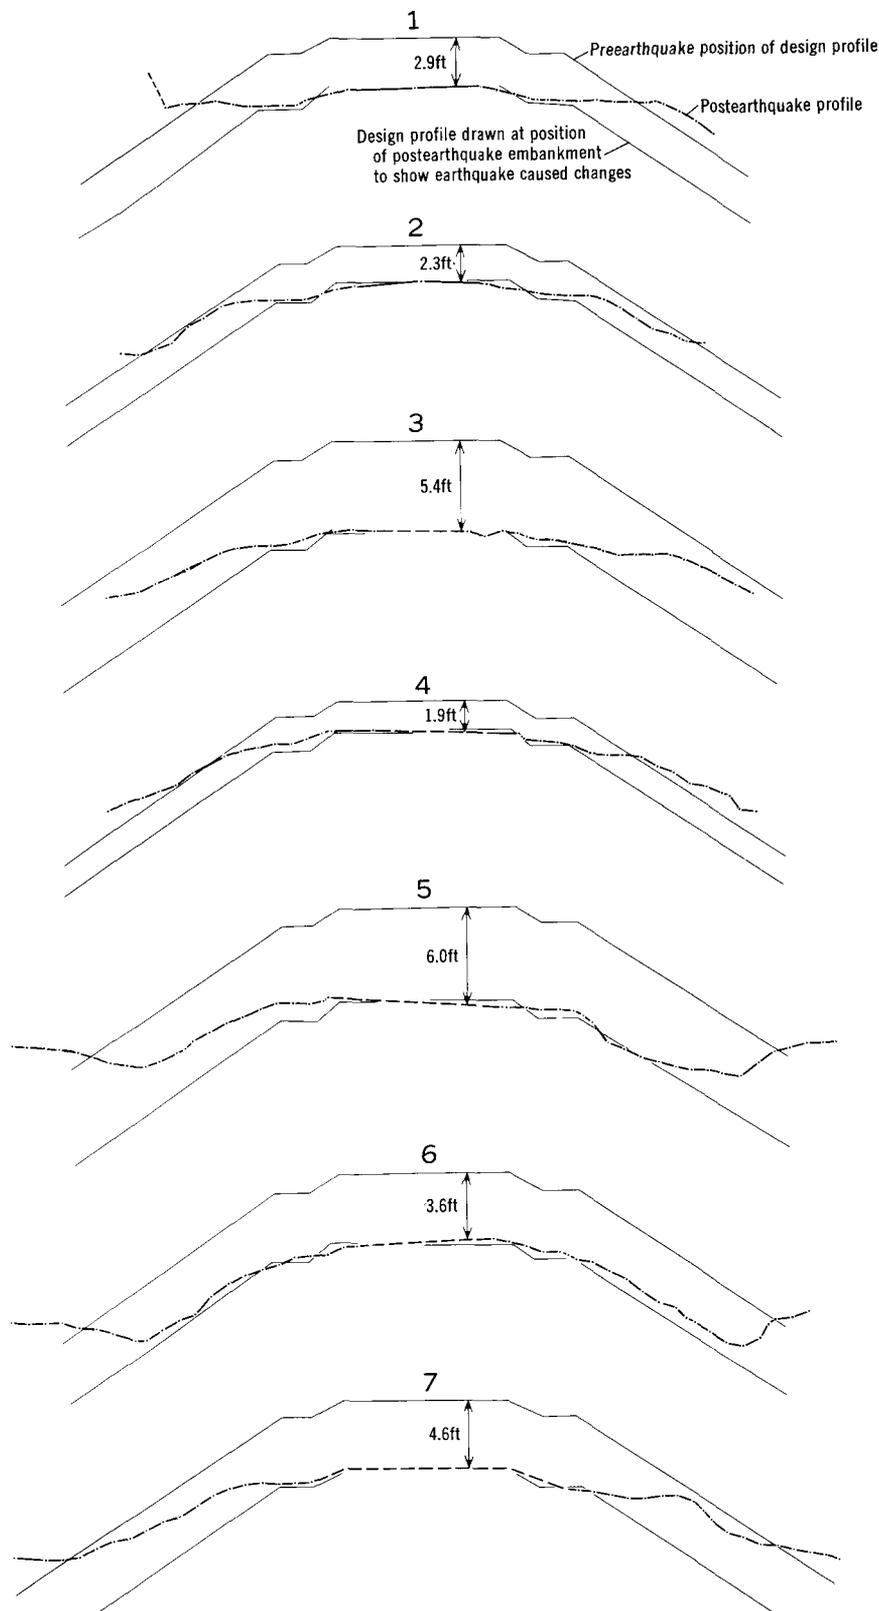
53.—Transverse profiles of settled railroad embankments in the Portage area measured by M. G. Bonilla and R. Kachadoorian. Each profile is compared with the design profile at the original and postearthquake height of the embankment. Profiles are located on figure 114.

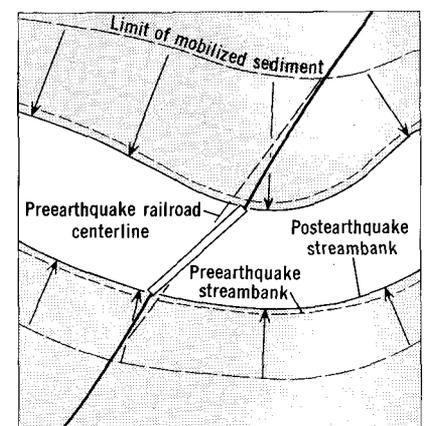
The most damaging passive failures of the embankments were at stream crossings, where landspreading was greatest. Because displacement was generally toward the stream valleys, embankments that approached valleys obliquely were offset horizontally in opposite directions on opposite sides of the streams (fig. 55) and the bridges were skewed horizontally. Horizontal offsets between embankment centerlines on opposite sides of stream channels measured at 27 bridges ranged from several inches to 10 feet (table 1). Twenty-one of these bridges are shown in figure 56; the offsetting of each bridge is described in pages D98–D157. As can be seen in figure 56, offsetting generally occurred as the result of movement toward the stream channels, but it also was produced by movement toward depressions

55.—Bridge skewed by streamward movement of sediments. Landspreading toward stream moved the banks closer together, and railroad grades that crossed streams at acute angles were carried sidewise in opposite directions on opposite sides of the stream, skewing the bridges.

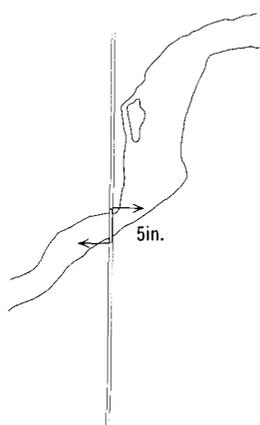
Bridge 4.8

56.—Bridges that were skewed horizontally by landspreading toward stream channels or topographically low areas. All figures oriented with increasing mileage from bottom to top.

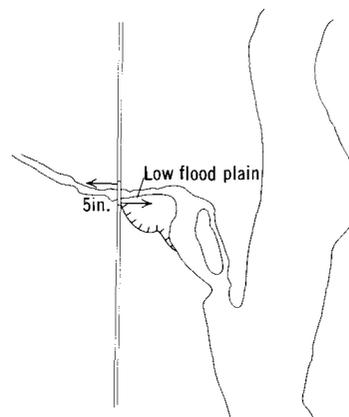
Bridge 33.6

(often wet) beside the embankments (bridges 33.6, 34.8, 37.0, 61.5). In one bridge (62.3), displacement was in the opposite sense, possibly because of local displacement of the high, narrow embankments of this bridge on the low active flood plain. In three large bridges (3.0, 3.2, and 3.3), the bridge ends and adjacent embankments were displaced laterally in the same directions parallel to the contours, offsetting them from the centers of the spans (figs. 29, 31, 32).

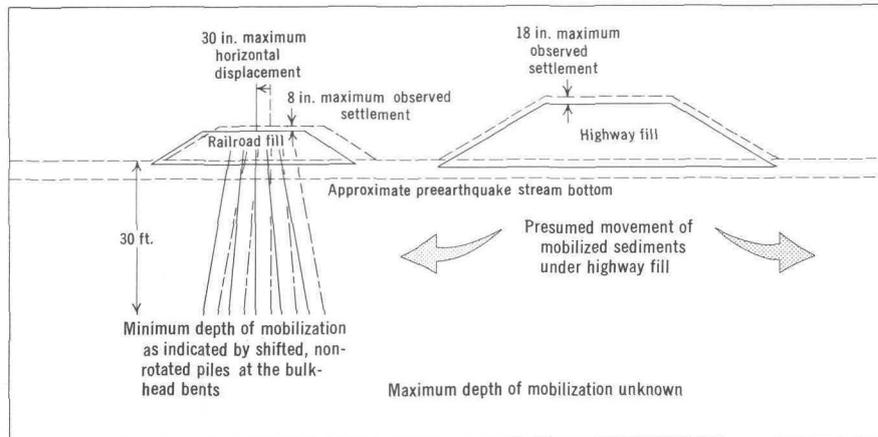
The absence of tilting in the displaced bridge piles driven largely through fill (bridges 3.0, 3.3) or the underlying sediments (bridges 3.0, 3.2) demonstrates that lateral shifting was not restricted to the fill, but that the fill was carried passively as the underlying material shifted. The minimal lateral displacement of the bridge centers suggests that movement parallel to the contours resulted from some force on the interstream areas. On the interstream areas the railroad lies adjacent to a large highway fill (fig. 27). Both the highway and railroad fills settled, and as shown by the extensive ground fracturing, expulsion of ground water, and streamward displacement of the foundation materials, the sediments were extensively mobilized by the shaking. The sinking of the large highway fill probably produced an outward flow of foundation materials that carried the adjacent railroad fill sidewise (fig. 57). This outward flow is also suggested by the fact that where the highway swings away from the railroad just north of bridge 3.3, the railroad fill was not displaced laterally (fig. 58). In the middle ground of this same figure, a lateral kink can be seen where the rails crossed a small road (Nash

57.—Cross section of the railroad and highway fills at Resurrection River (fig. 27). Sediments displaced laterally beneath the sinking highway fill displaced the railroad fill and ends of bridges a maximum of 30 inches laterally, parallel to the contours. The lack of tilting in the bridge piling indicates that the depth of lateral displacement probably exceeded the pile depths. Dashed lines indicate preearthquake positions of embankments and piles.

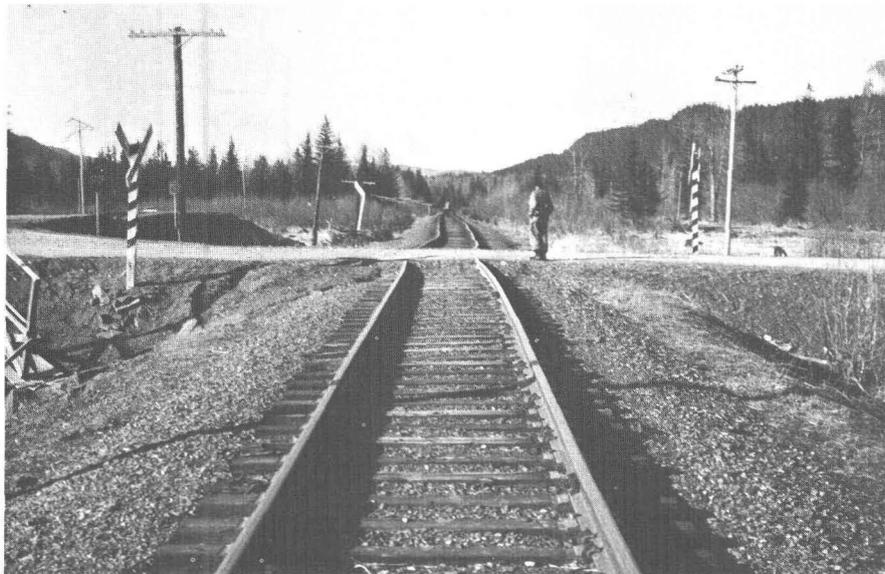
Road, fig. 27). This road fill, lying at right angles to the railroad fill, appears to have resisted the lateral displacement, possibly because of its resistance to longitudinal compression.

58.—Sinking of large highway fill (at left) displaced adjacent sediments that carried the railroad embankment to the right and kinked the rails at smaller road fill (Nash Road, mile 3.4 figs. 27, 28) that was unaffected by the displacement, possibly because of its resistance to longitudinal compression. Lateral displacement decreased where the highway turns away from the railroad.

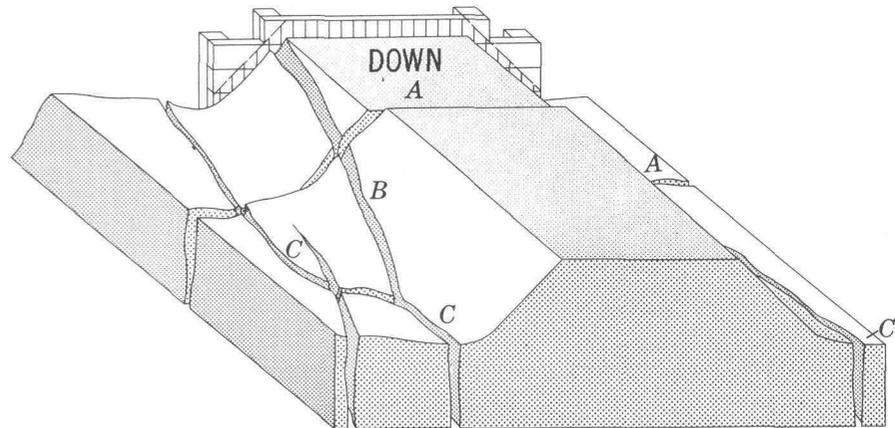
59.—Typical fractures at a bridge approach. A block of fill was lowered at the bulkhead and along a fracture (A) running perpendicular to the embankment. Fractures (B) formed on both sides of the embankment and ran diagonally back from the upper edge of the fill and joined fractures (C) that were approximately parallel to the fill in the adjacent ground.

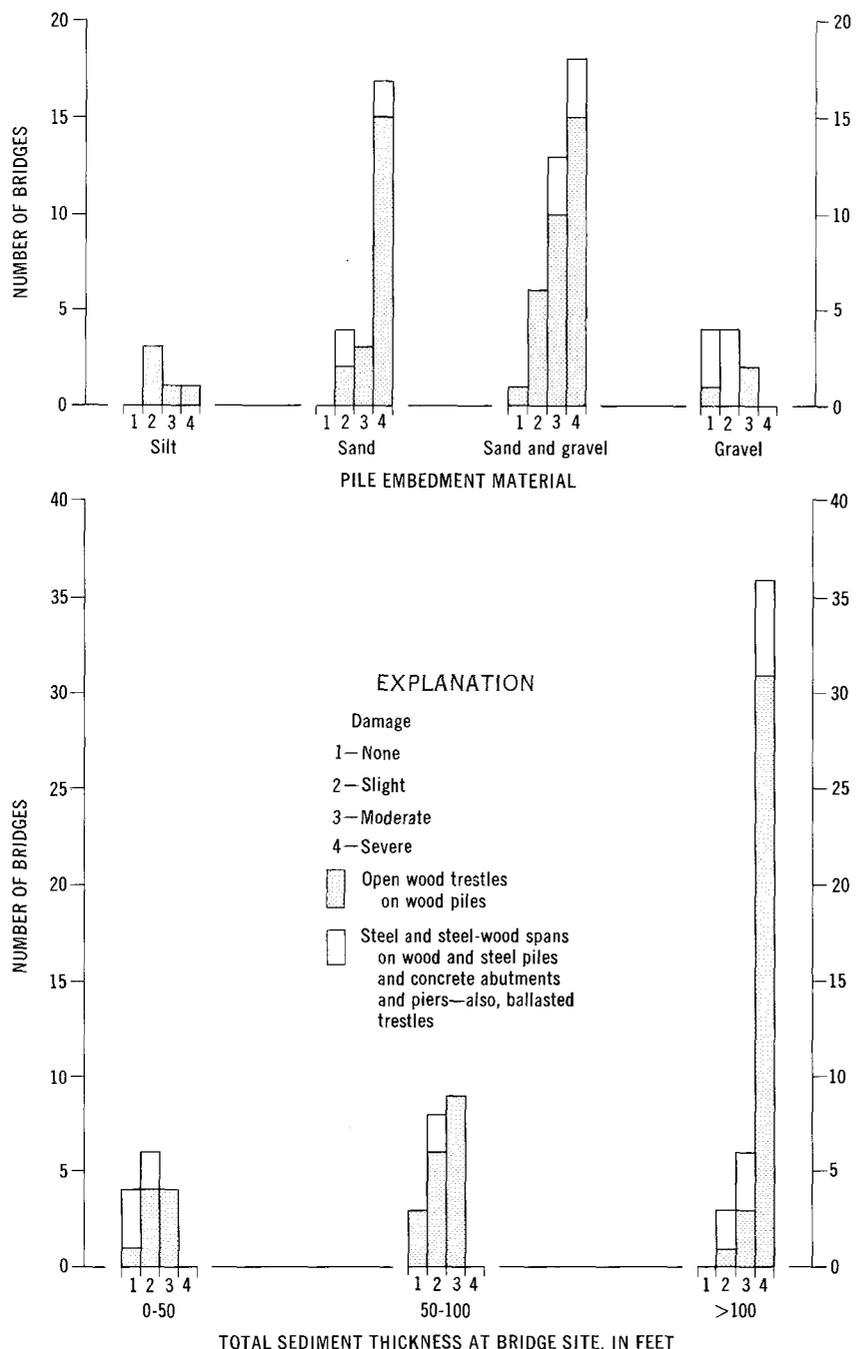
All steel and wood pile-supported abutments and piers beneath steel spans were displaced streamward. Anchor bolts on steel spans were commonly sheared, and steel spans jammed together, damaging span bearings. Streamward displacement of wood pile bents occurred in those with open wood trestle approach spans (146.4, 148.3). Three of the bridges were severely damaged (147.1, 147.5, 148.3) and the remaining two were moderately damaged. The *N* values at the tips of the piles of these damaged bridges are compared with those of four severely damaged open wood trestles in the Portage area in figure 64. (Damage to the Portage bridges is described in section 12b p. D128, and pile displacements are shown on figs. 7, 8). Each bridge is indicated by a horizontal line that crosses

61.—The degree of damage to bridges compared with the grain size of the material in which the piles were embedded and the total thickness of all unconsolidated sediments at the bridge sites. As shown in table 3 and 4, the severity of the damage appears to be related most directly to the total sediment thickness.

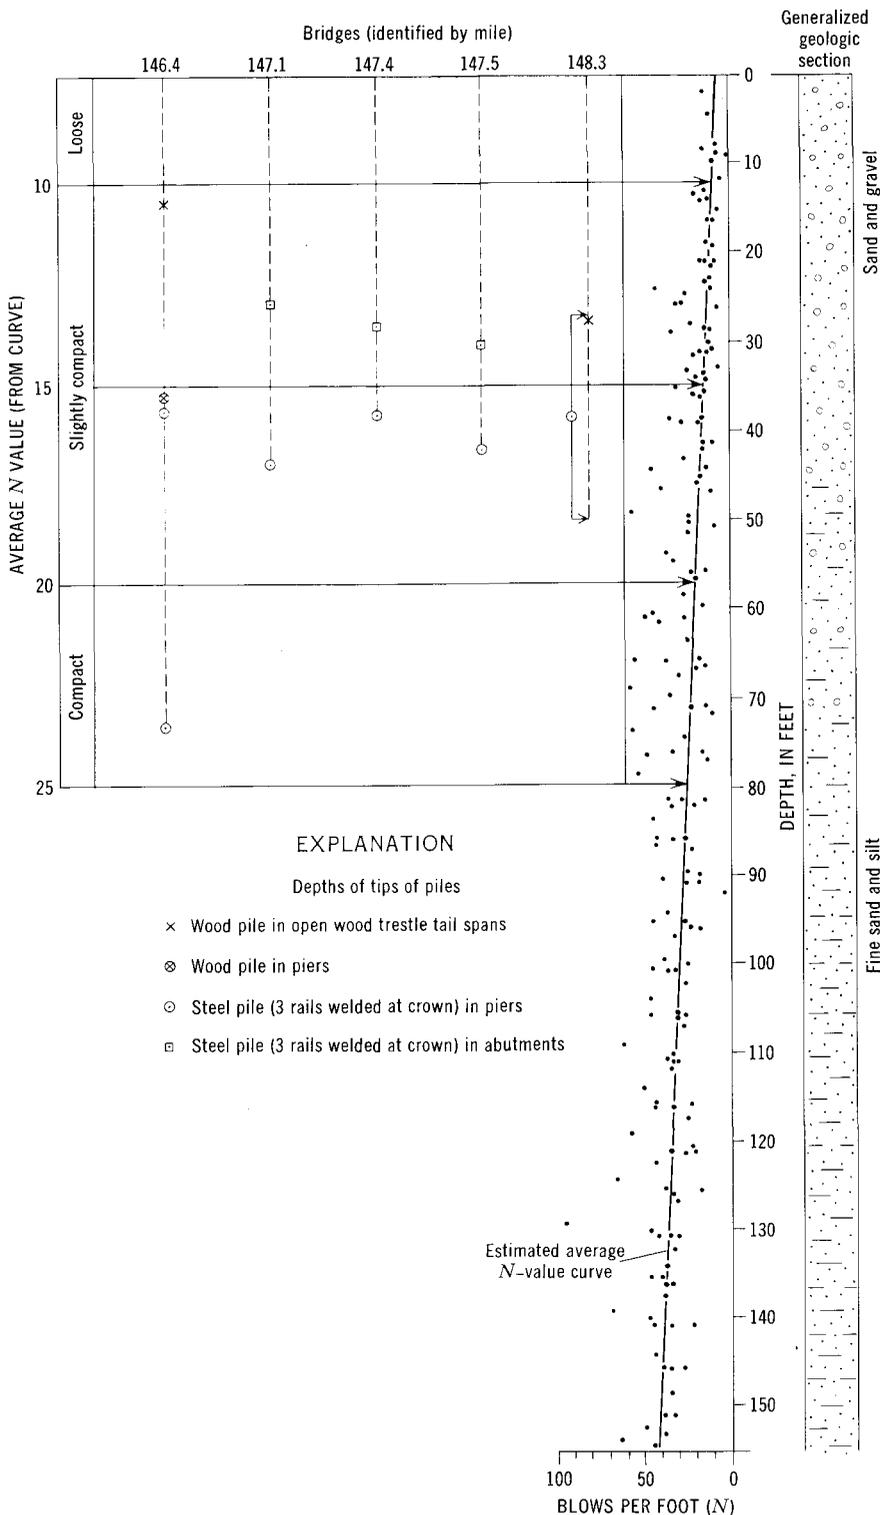
63.—Standard penetrometer values ( $N$ , blows per ft), an estimated average  $N$ -value curve for 22 borings across Knik and Matanuska River floodplains, and a generalized geologic section based on 24 borings. The average penetrometer values are compared with the tips of piles in five bridges located on plate 1. Six of the deeper borings are located on plate 1 and their logs are shown in figure 137. Data supplied by the Alaska Department of Highways.

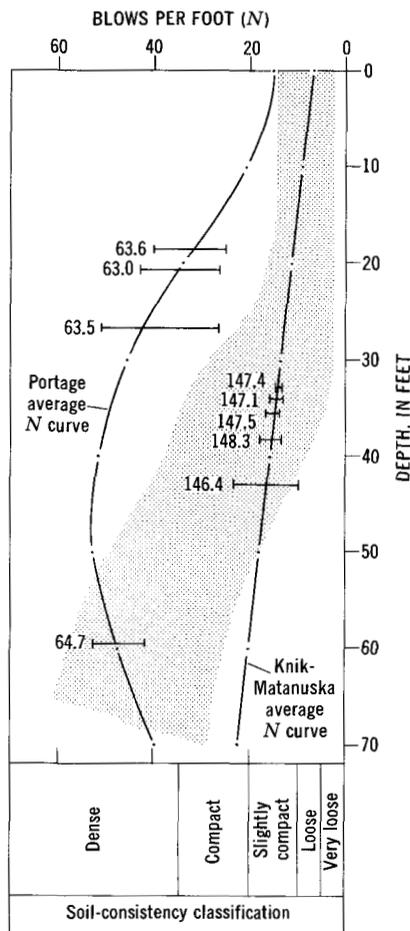
The considerable range in the density of the sediments associated with displaced foundations of these damaged bridges is shown in figure 64; those at Portage lie within the compact to dense range, and those at Knik-Matanuska crossings within the slightly compact to compact range. The more severe damage to bridges in denser sediments at Portage probably is due to the fact that Portage is considerably closer to the area of high strain release (fig. 2). Thus, in these two areas in which the sediments are relatively thick, the large difference in density of the foundation material appears to have had less effect on the degree of damage than the severity of the ground motion.

64.—Range of  $N$ -values (horizontal line) at tips of shallowest and deepest piles in damaged bridges in Portage and Knik-Matanuska areas, plotted on their respective average penetration resistance curves. Bridges in less dense sediments, far from the area of strain release at Knik-Matanuska area, were less severely damaged than those in denser sediments, nearer the area of greater strain release at Portage. The shaded area is the range of penetrometer values in sediments under severely damaged pile-supported structures in the 1964 Niigata earthquake in Japan (Seed and Idress, 1967).

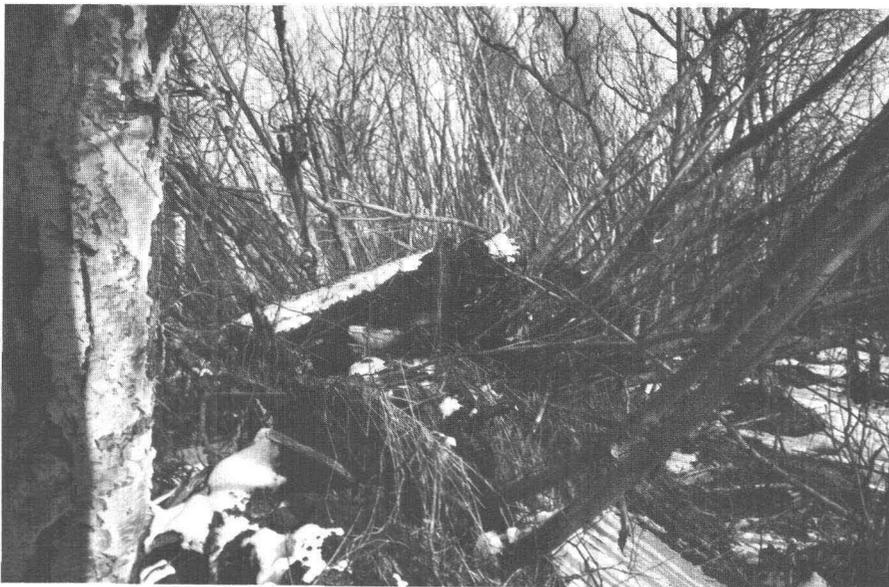
66.—Entirely detached block of frozen soil and uprooted trees that was thrust up over the adjacent tree-covered ground in a pressure ridge at the toe of Potter Hill slide.

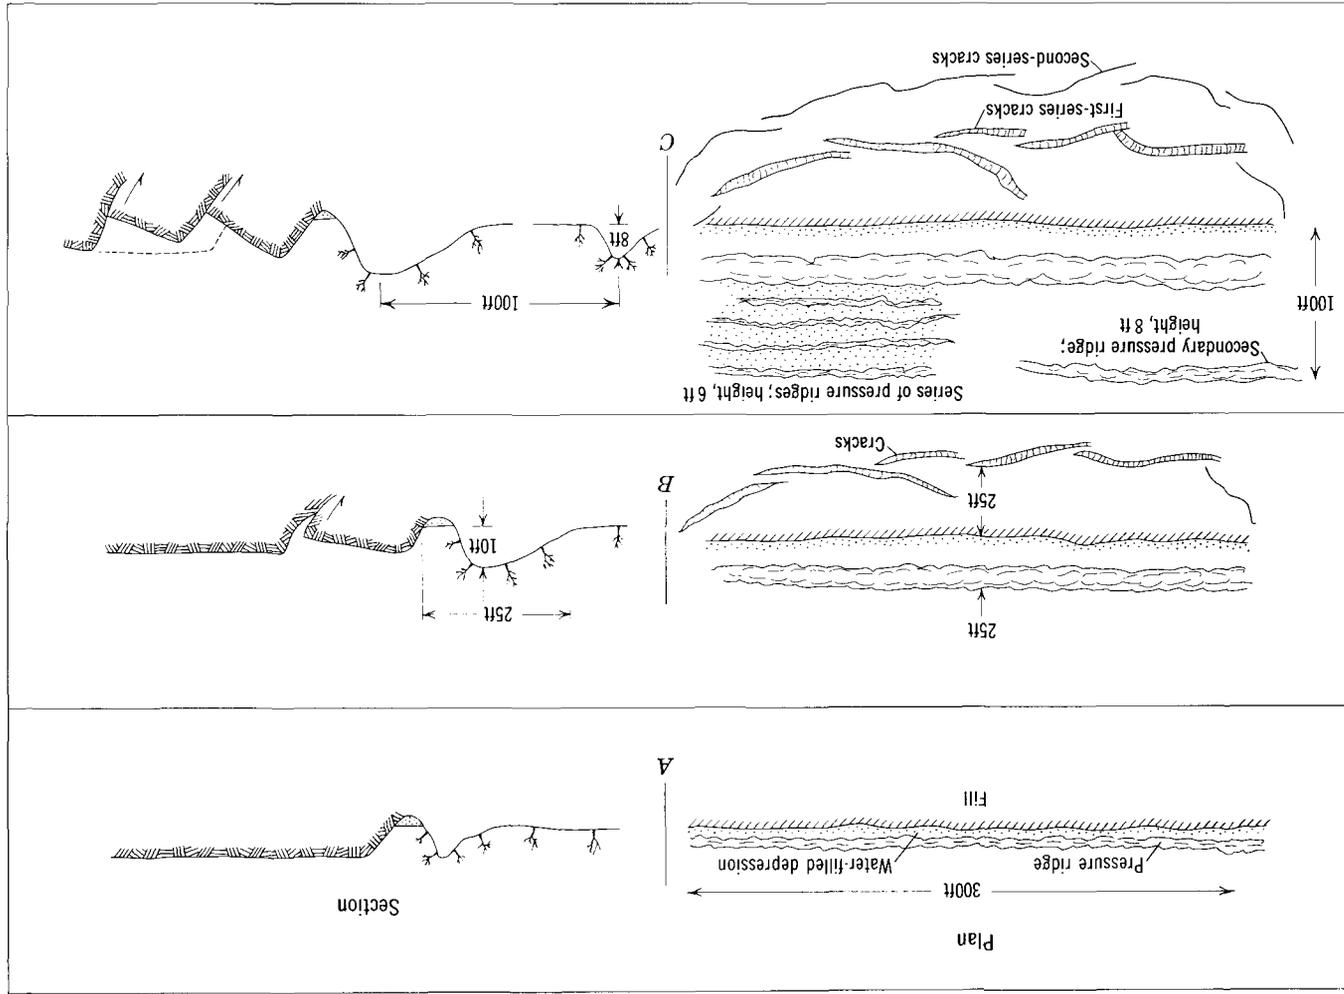
67.—Field sketches of successive failures that occurred in a spoil area and adjacent tidal flat at the toe of Potter Hill slides during reconstruction. Sketches redrawn from Dan K. Conger, Clair A. Hill and Associates.

Opposite Railroad Survey Stations 2886 to 2889, a section of the fill approximately 25 ft. by 300 feet, dropped suddenly and started moving out. A short time later cracks appeared about 25 feet further back and a new section was seen to be subsiding and moving toward the tundra [fig. 67B].

A characteristic rotation of the blocks of earth was noted, having minor subsidence of the forward edge, with the rear edges continuing to subside during the periods of forward motion. The surface of the first section dipped 45° from horizontal, reaching a maximum settlement of 10 feet. The second section attained a dip of about 30° and experienced somewhat less settlement.

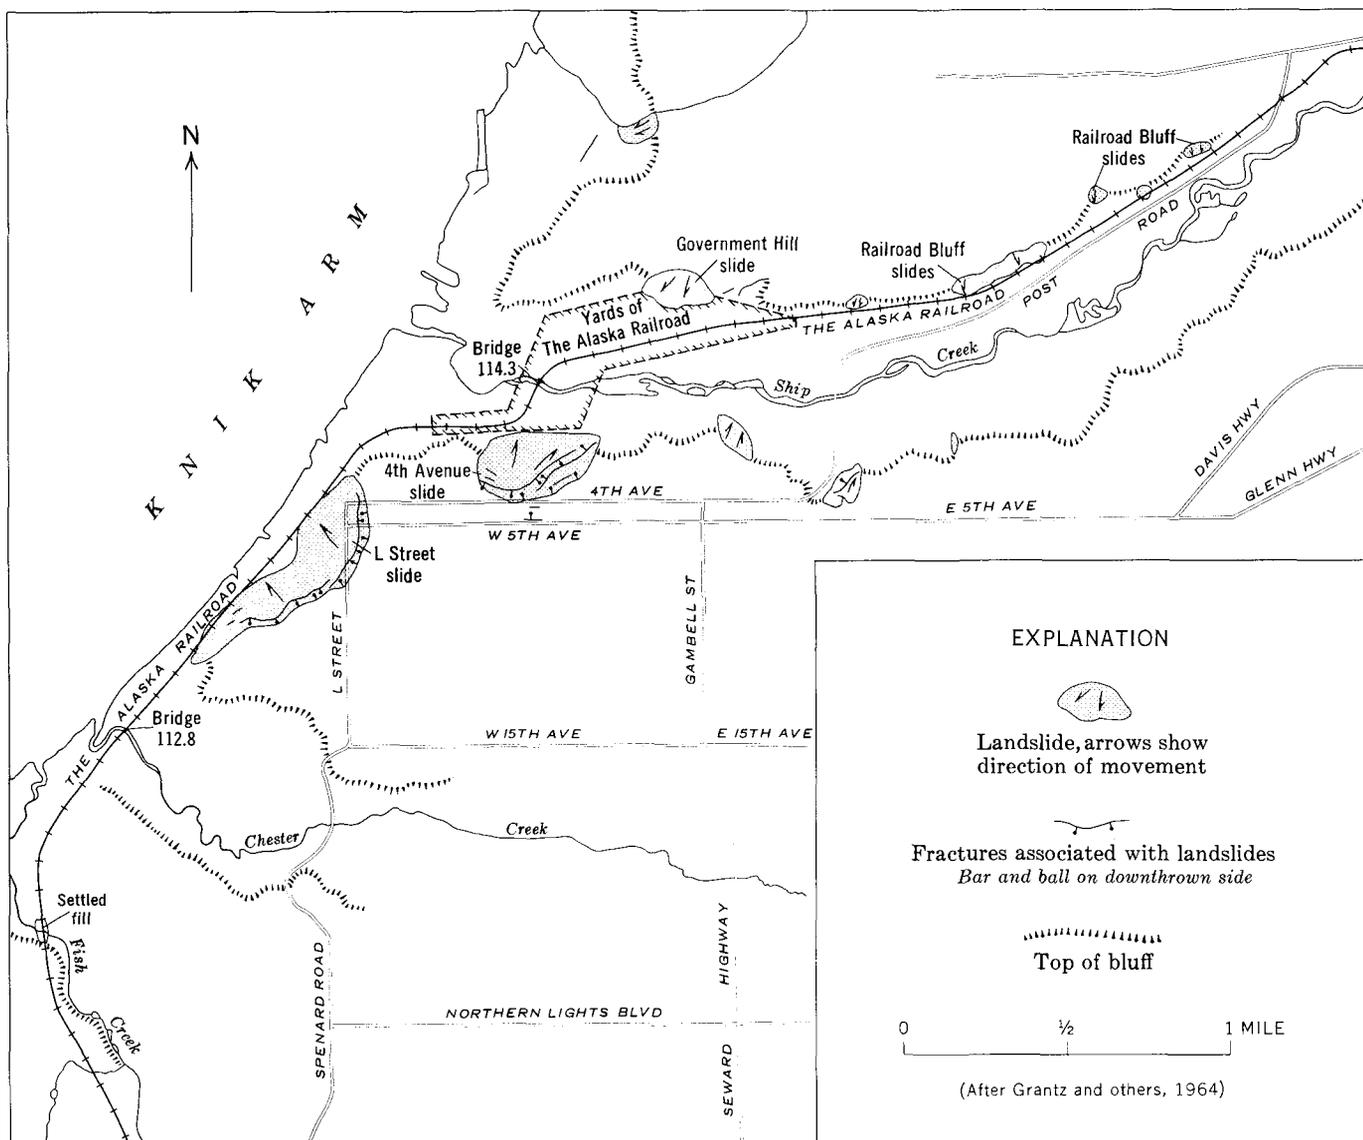
Landslides that occurred along the edges of the high bluffs beside Knik Arm and the valley of Ship Creek (fig. 68) have been described in detail by Shannon and Wilson, Inc. (1964a) and by Hansen (1965). The L Street slide, the Fourth Avenue slide, the Government Hill slide, and some of the slides along Railroad Bluff damaged tracks, buildings, buried utilities, and rolling stock of the railroad (see Section 15, p. D143). Ship Creek valley probably has a long history of landsliding. A 1914 topographic map made by the Alaska Engineering Commission (fig. 69) shows landforms that are clearly landslides along the bluffs surrounding the railyards. Although Miller and Dobrovolsky (1959) recognized old landslides

68.—Distribution of landslides in the Anchorage area and settled fill on Fish Creek (after Grantz and others, 1964).

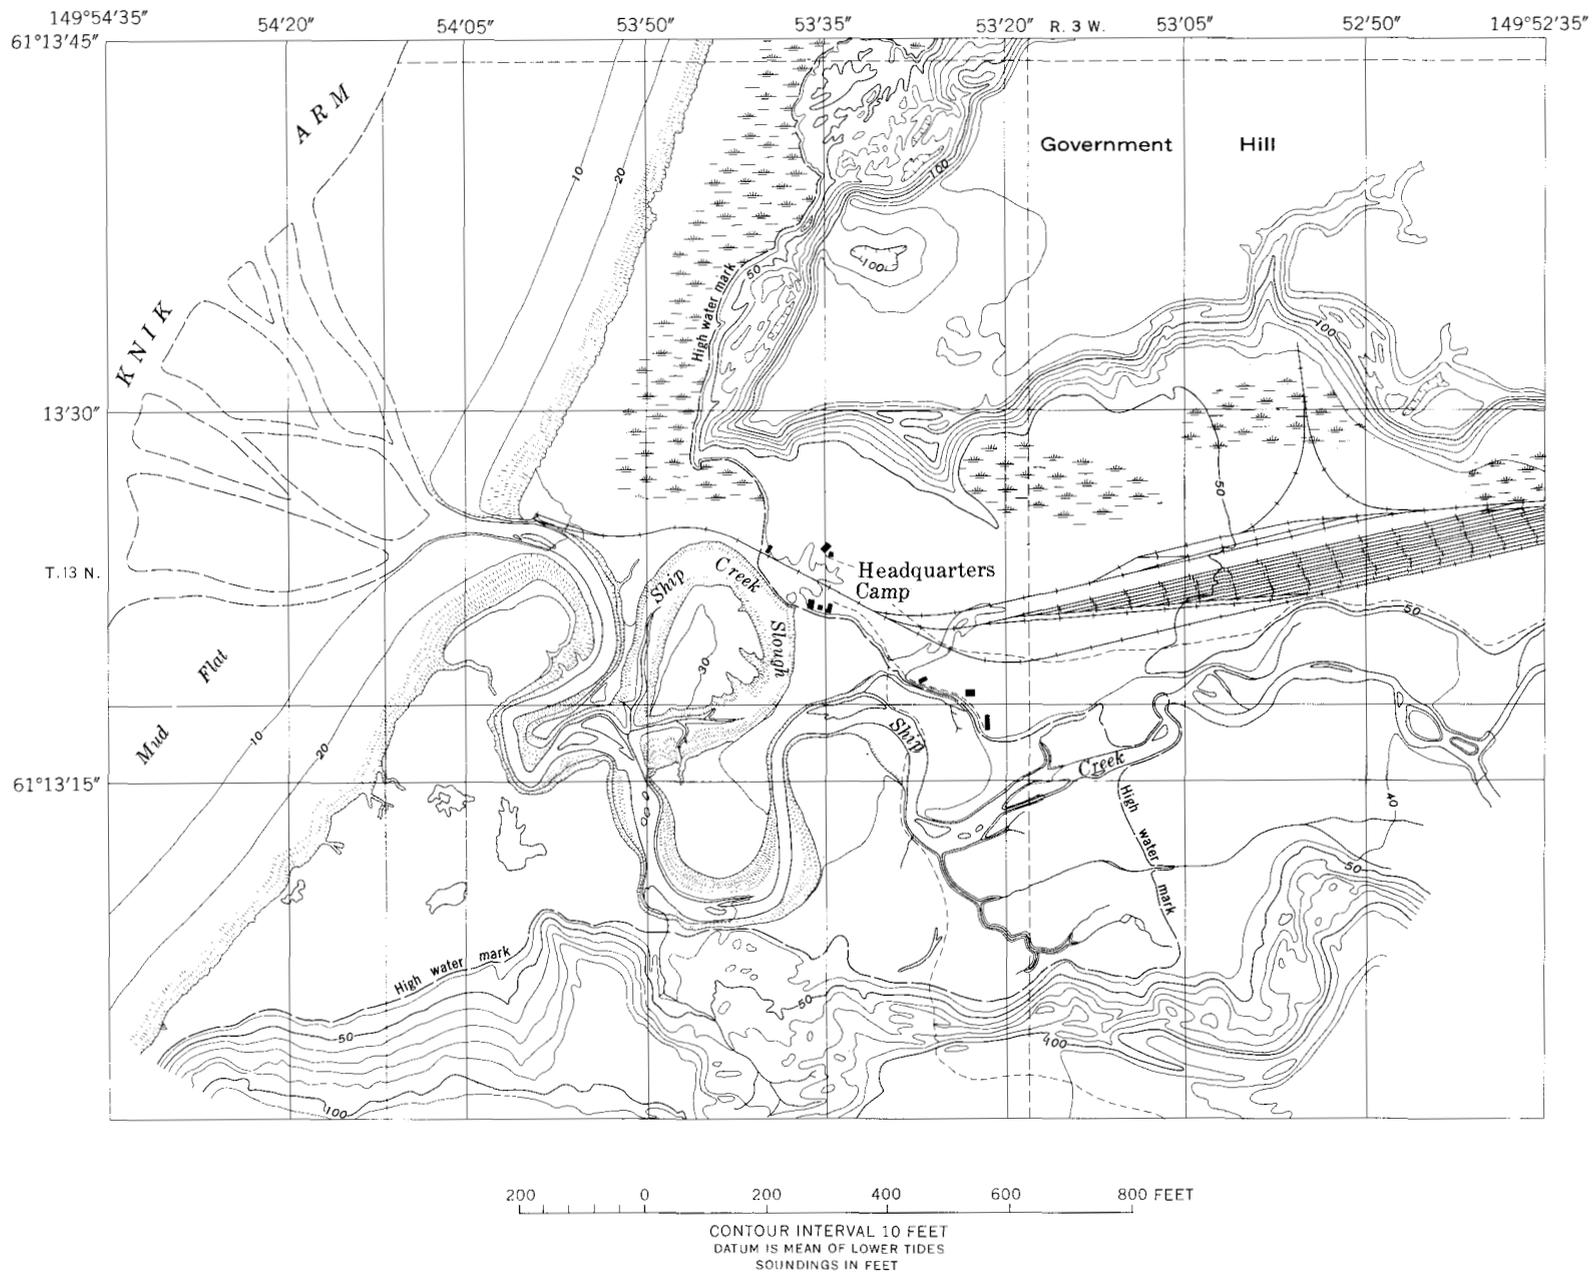
69.—Alaska Engineering Commission 1914 topographic map of Ship Creek valley, Anchorage. The landforms indicate two distinct slides backed by elongate grabens. These slides are on the west side of Government Hill, on either side of a topographic depression interpreted as being an ice-kettle hole. Two slides are also discernible on the south side of Government Hill, the easternmost in the position of the 1964 slide. On the south side of the creek, jumbled side-slope topography suggests extensive sliding from the area of the 1964 Fourth Avenue slide eastward for a distance of approximately 2,600 feet.

The topography shown on the 1914 map clearly confirms this conclusion. It also indicates that there was a flowing stream with several tributaries in the slide area. Although the topographer indicated small gullies up the face of the bluff, the fact that this is the only stream that he drew suggests that it was of some consequence. As drawn, the tributary pattern shows that the stream was largely fed from springs located in the slide mass and in the scarp at its head.
