*A description and analysis of the geologic  
controls of earthquake damage to The Alaska  
Railroad, with emphasis on damage caused  
by the mobilization of unconsolidated  
sediments*

In the 1964 Alaska earthquake, the federally owned Alaska Railroad sustained damage of more than \$35 million: 54 percent of the cost for port facilities; 25 percent, roadbed and track; 9 percent, buildings and utilities; 7 percent, bridges and culverts; and 5 percent, landslide removal. Principal causes of damage were: (1) landslides, landslide-generated waves, and seismic sea waves that destroyed costly port facilities built on deltas; (2) regional tectonic subsidence that necessitated raising and armoring 22 miles of roadbed made susceptible to marine erosion; and (3), of greatest importance in terms of potential damage in seismically active areas, a general loss of strength experienced by wet water-laid unconsolidated granular sediments (silt to coarse gravel) that allowed embankments to settle and enabled sediments to undergo flowlike displacement toward topographic depressions, even in flat-lying areas. The term "landspreading" is proposed for the lateral displacement and distension of mobili

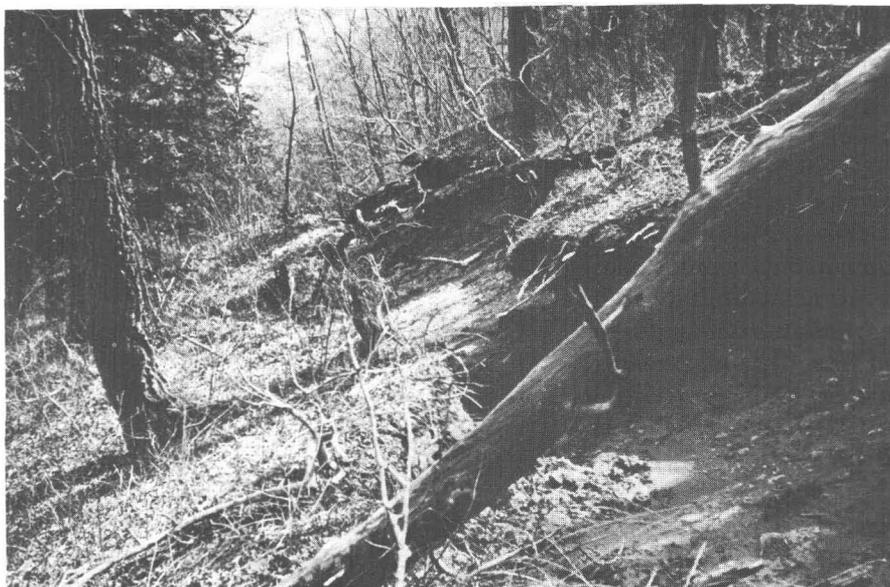
Sliding occurred on the very steep 40° to 45° face of a 150-foot-high bluff cut in outwash sand and gravel. The area affected by the

slide was about 700 feet wide and extended to about 100 feet above the bluff base; thus, about 21,000 cubic yards of material were involved. As far as could be determined, the only material in the slide was an approximately 6-foot-thick layer of silty sand that had been blown from the adjacent valley floor onto the face of the bluff. The eolian material was tied together by the root mat of conifers, some deciduous trees, and low shrubs; it may have been frozen at the time of the earthquake. Several large pieces of this root mat tore free and skidded downslope. The movement occurred at the contact with the underlying outwash sand and gravel, and at no place was the sand and gravel seen to be involved in the slide (fig. 70). It is not known if water played any role in the sliding. Some water was seen in the jumbled slide debris at the base of the slope, but none was found above where the outwash was laid bare on the skid surface. Similar slides in which windblown sand was dis-

70.—Root mat development in windblown silty sand that became detached and skidded downslope along its contact with glacial outwash sand and gravel at mile 16.5 on the Sutton branch line.

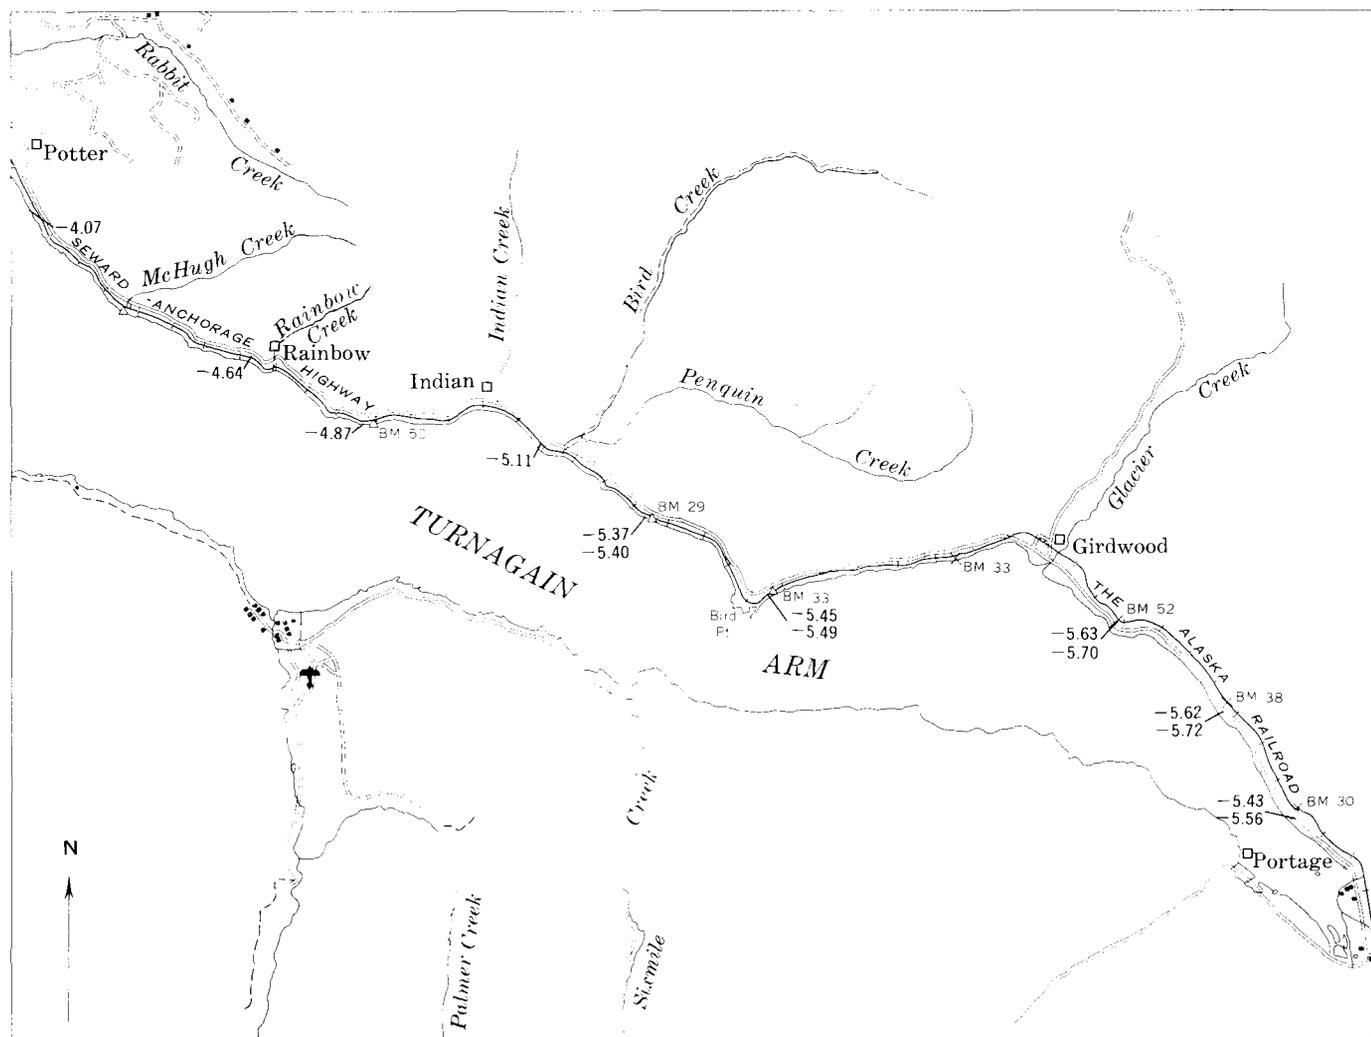
72.—The amount of lowering of bench marks on bedrock due to tectonic subsidence along Turnagain Arm, as determined by two U.S. Coast and Geodetic Survey level lines (Wood, 1966, p. 124). Single and top elevations were measured on a survey along the highway; bottom elevations east of Bird Creek were measured on a survey along the railroad.

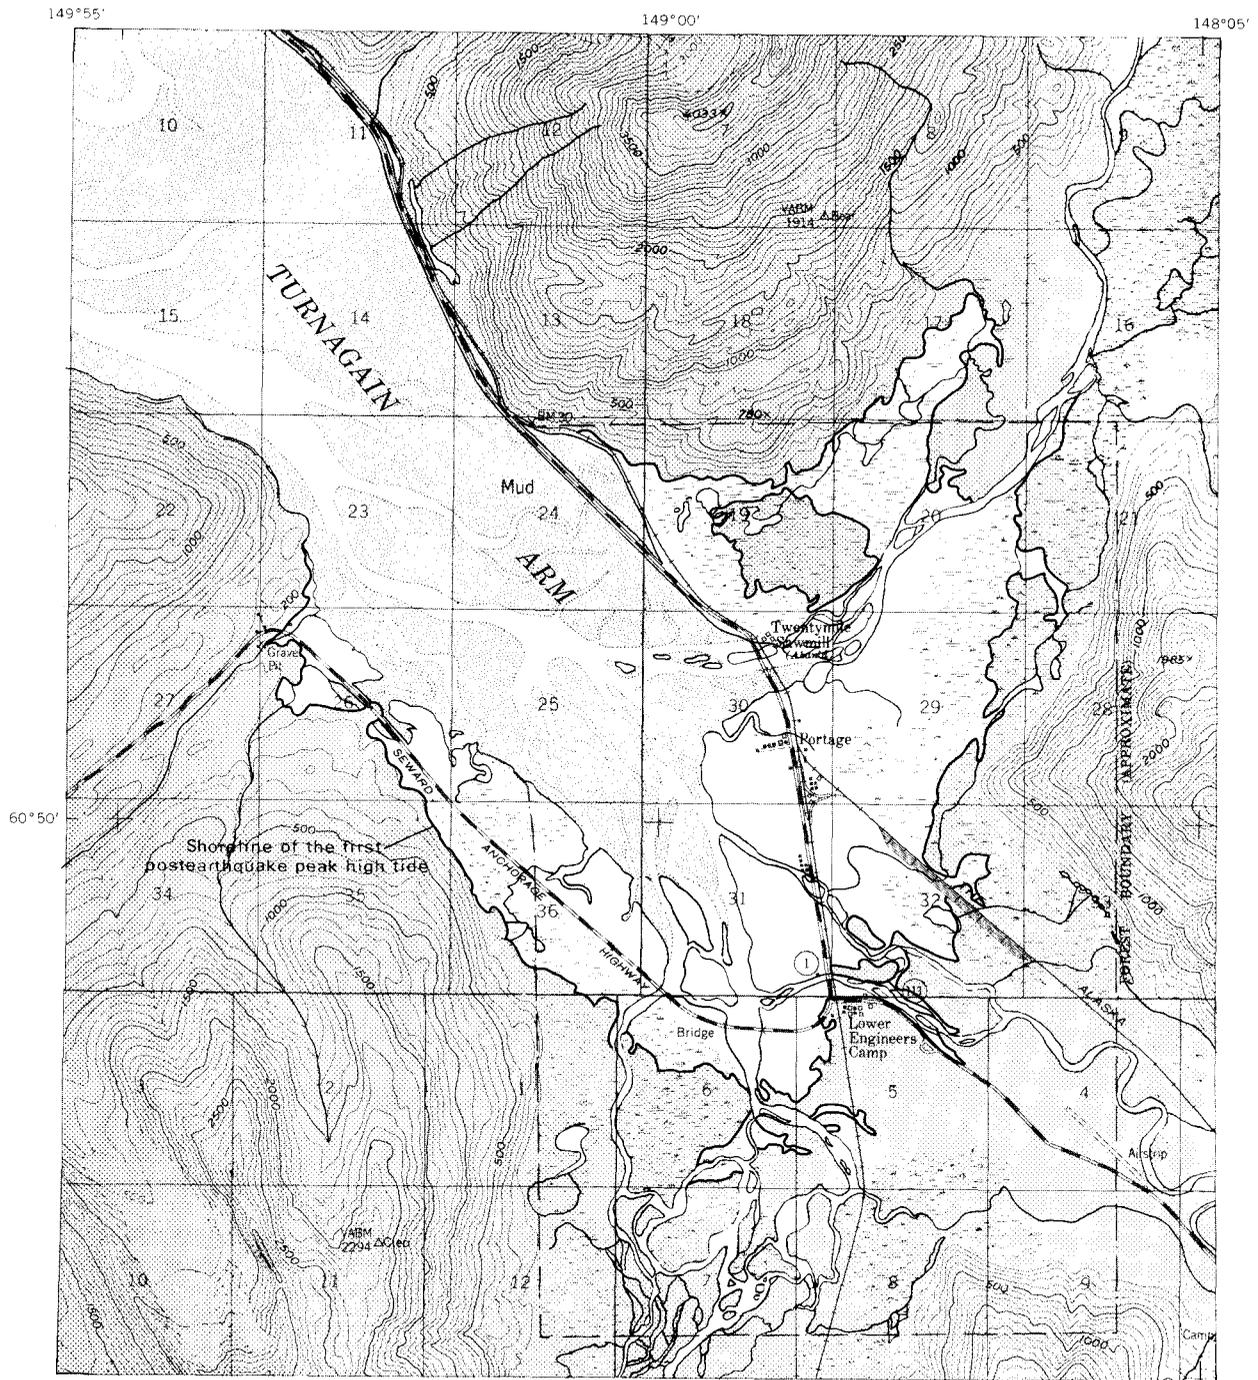
73.—Shorelines of the preearthquake mean high water and the first postearthquake peak high tides in the Portage area. The postearthquake high-tide limit is drawn from photographs by Air Photo Tech, Inc., Anchorage.

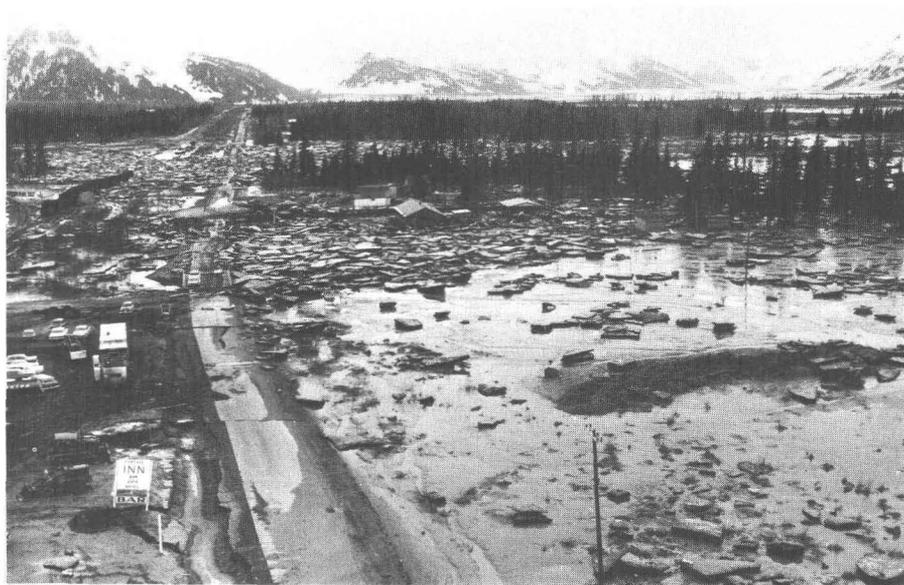
74.—View south over Portage after the postearthquake high tide had left ice blocks strewn over the townsite and a small house stranded on the railroad embankment (at left).

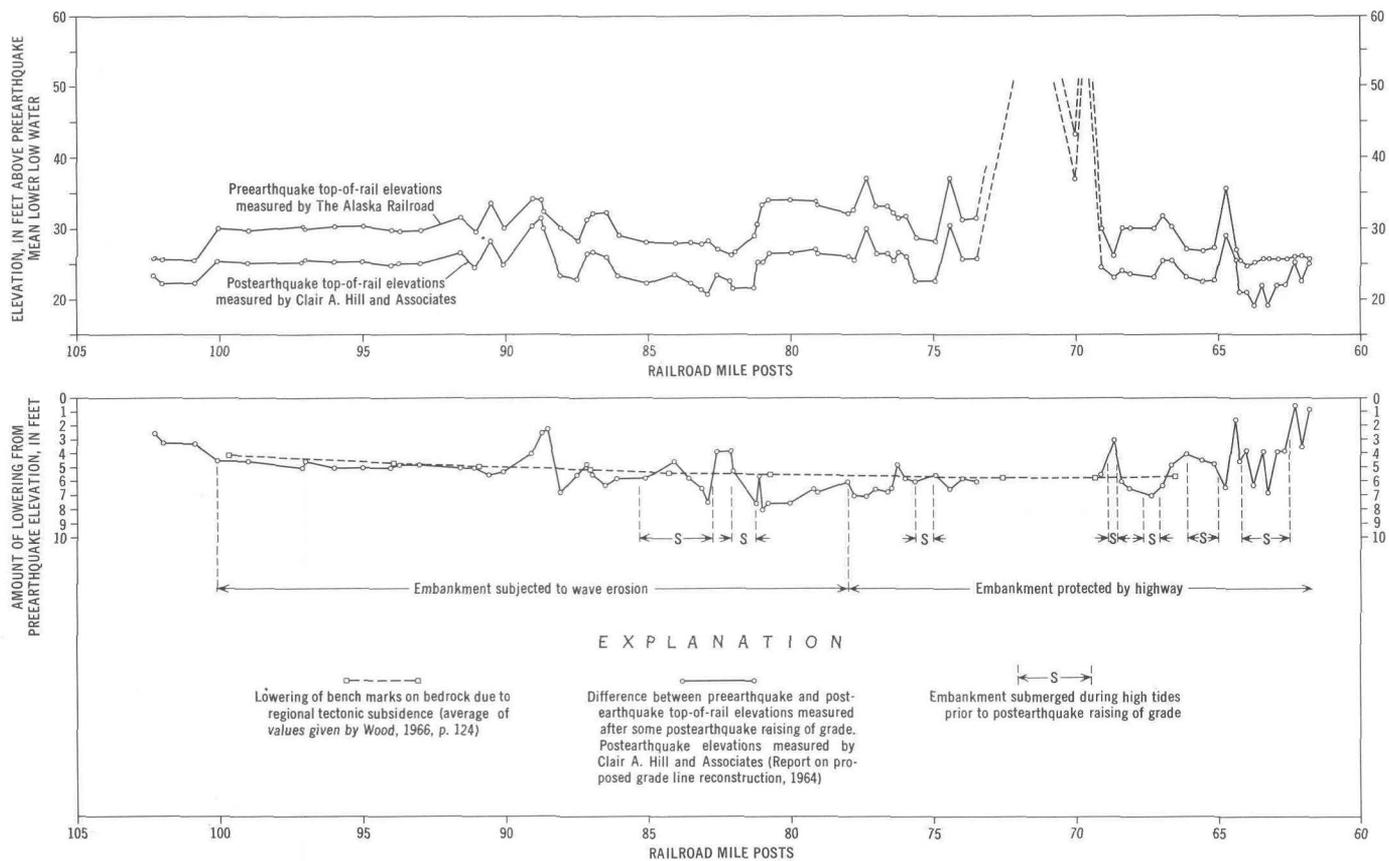
ments, which themselves also underwent some unknown and variable amount of compaction, combined with the regional tectonic subsidence to lower the railroad grade (fig. 75). Adding the 5.49 feet of regional subsidence to local lowering due to compaction and settling in the Portage area generally lowered the grade about 8.5 to 9.5 feet; local dips were as much as 11.5 feet. The amount and distribution of lowering northwest of Portage, where repairs were made before the line was surveyed, are not so well known. The pre- and

postearthquake top-of-rail profiles are compared in figure 75, and the total lowering of the grade is compared with the regional subsidence shown by lowering of bench marks on bedrock. Where apparent lowering was less than regional subsidence, the line had been regraded prior to the surveying; lowering in excess of regional subsidence was due to local settling and compaction. There may be errors in the survey, for at mile 80.77, where the grade and bench mark are both on bedrock, lowering exceeded regional subsidence.

75.—A comparison of the as-built top-of-rail profile and the postearthquake top-of-rail profile from mile 62 to mile 102.5 along Turnagain Arm, and a comparison of the lowering of the rail line and bench marks on bedrock.

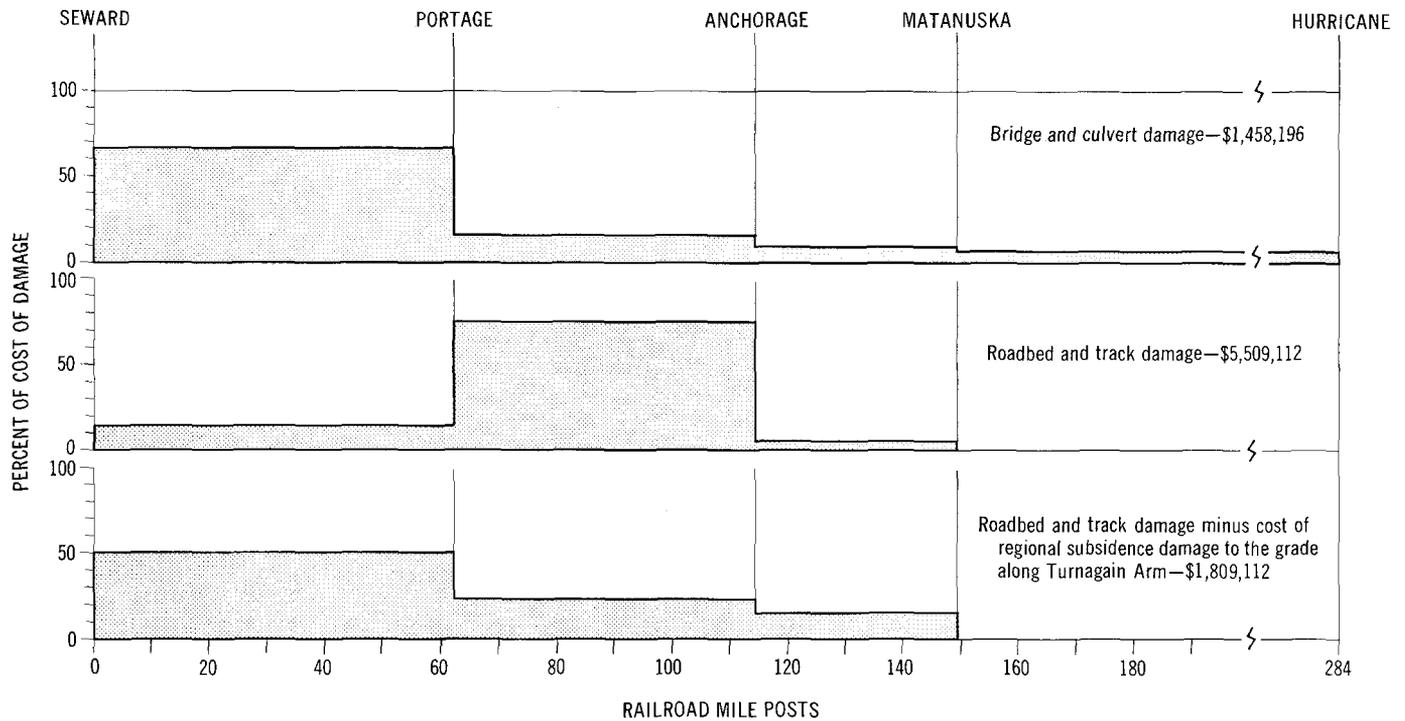
Regional subsidence played the greatest role in controlling the cost of roadbed and track damage—75 percent of all such damage occurred in the section along Turnagain Arm. Again, nearly all such damage (95 percent) lay south of Anchorage, and, where not caused by regional subsidence, it was due to the mobilization of foundation materials and their

attendant loss of bearing strength, surface cracking, and horizontal displacements. The lowermost graph (fig. 77) is an attempt to show the distribution of roadbed and track damage due solely to mobilization of foundation materials by eliminating that part of the cost resulting from regional subsidence of the roadbed along Turnagain Arm. In this graph the cost of armoring the grade with rock riprap and three-quarters of the cost of raising this 35-mile section of roadbed between 3 and 5 feet (total \$3,700,000) have been removed. One-quarter of the cost of raising the grade has been maintained to allow for local settling. With this estimated adjustment, the distribution of roadbed and track damage resembles that of bridges and culverts, and reflects the geologic control and the distribution of the seismic energy.

77.—Geographic distribution of the cost of the damage to bridges and culverts (top graph) and to roadbed and track (middle graph). Bridge and culvert damage increased to the south, toward the area of maximum strain release, but the cost of roadbed and track damage was greatest in the area of subsidence along Turnagain Arm. Eliminating costs due to regional subsidence (lower graph) shows that the roadbed and track damage also increased to the south, toward the area of maximum strain release.

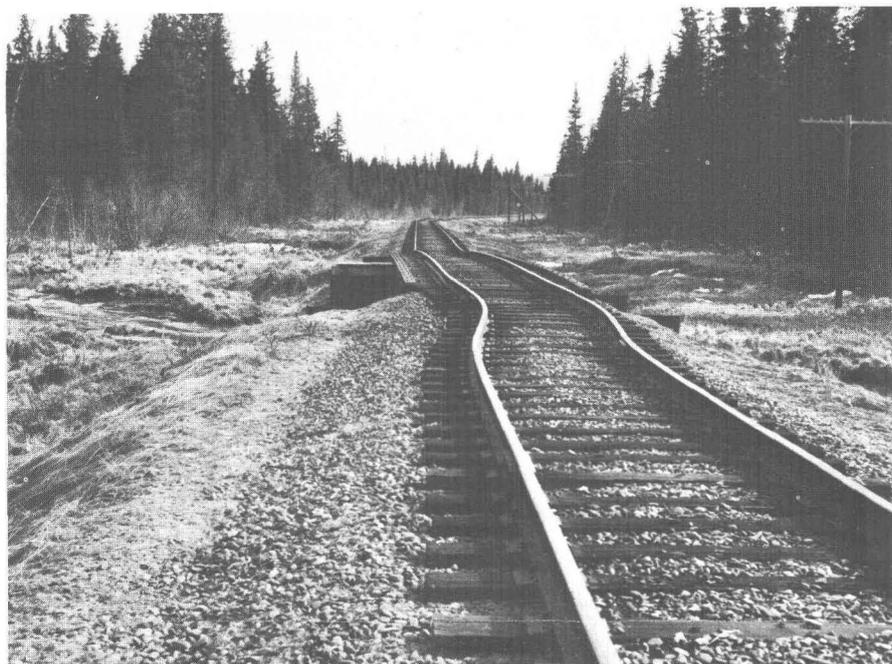
Bridge 15.6, a 45-foot open wood trestle, was also compressed, but only  $1\frac{3}{4}$  inches; its piles shifted streamward and the embankments were lowered slightly with respect to the bridge. As at bridge 15.2, long segments of the approaches were displaced horizontally. As shown in figure 56, the bridge crosses the creek obliquely. About 1,200 feet of the northern approach, to just beyond bridge 15.9,

was shifted westward toward the stream channel that approximately parallels the embankment (fig. 83). About 600 feet of the southern approach was displaced eastward toward a channel that lies between the rail line and the channel shown in figure 56. The straightness of the rails on the displaced segments north and south of the bridge indicates that the displacement was relatively uniform over the long segments. The resulting horizontal offset at the bridge was 20 inches.

83.—Bridge 15.6, a 45-foot wood trestle on the inactive floodplain of Snow River, showing long, horizontally offset embankments. A, View north; B, view south.

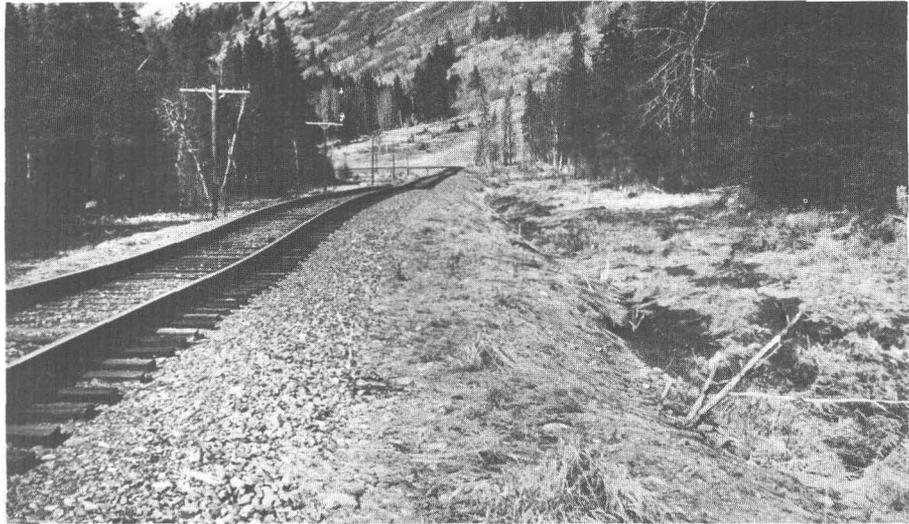
84.—Mounds of sand and gravel ejected with ground water coincident with local dips in the embankment (foreground and middle ground).

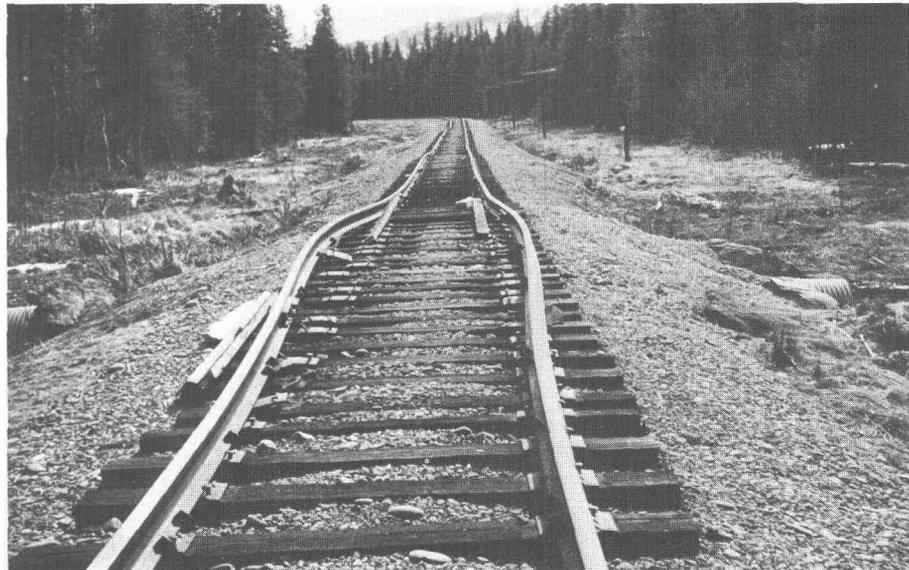
85.—Rails compressed and deflected where sediments moved toward a small ditch under the embankment and crushed a culvert (visible on both sides of tracks).

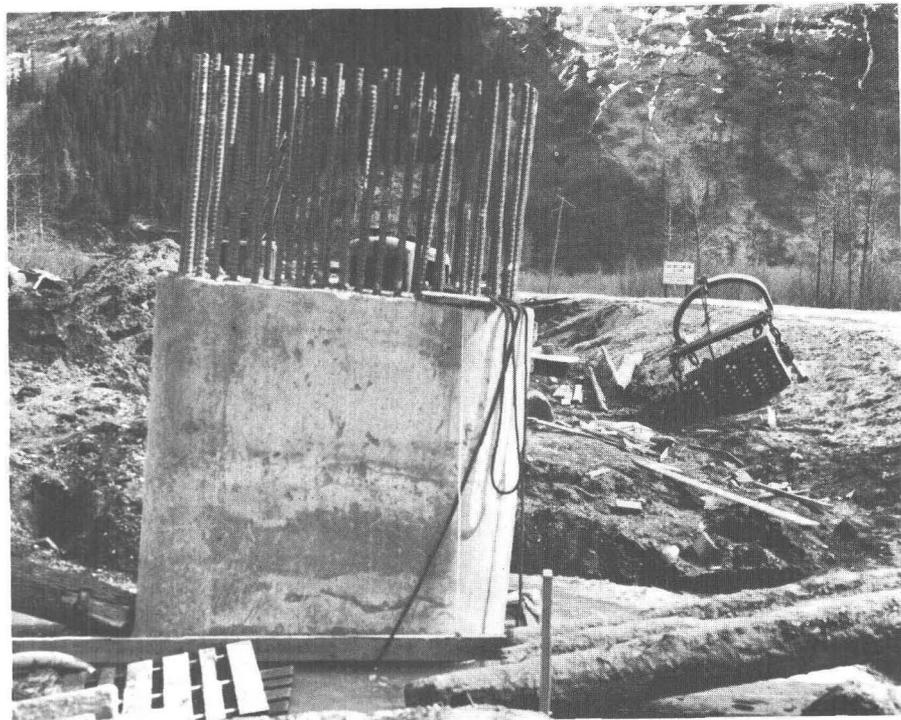
88.—A highway bridge pier on deeply driven steel piling at Snow River delta that was under construction at the time of the earthquake. Movement of the delta sediments toward Kenai Lake, to the left, from beneath the highway fill that settled approximately 4 feet carried the pier about 10 feet from its original position (Kachadoorian, 1968) and carried the base of the pier farther than its top; the white plumbline on the pier indicates a tilt of about 5°.

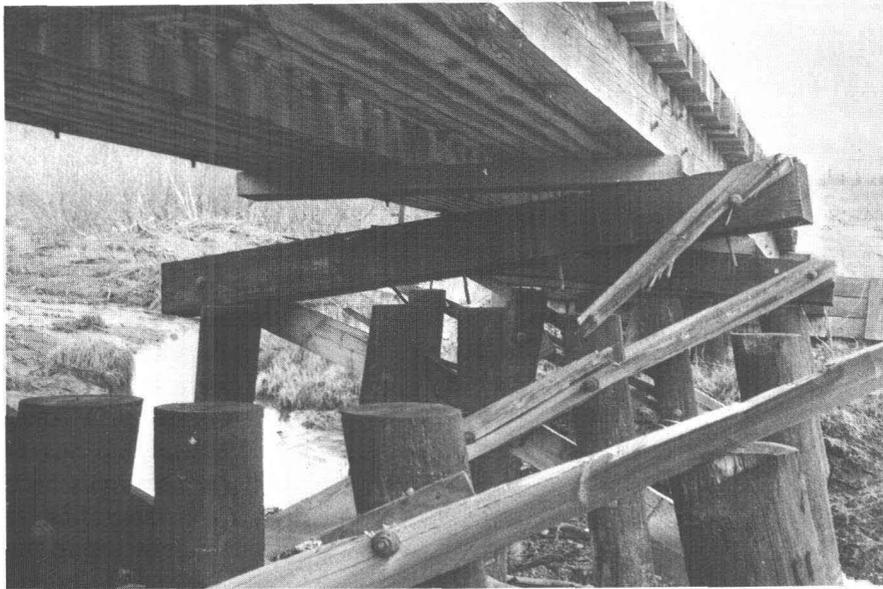
95.—Caps pulled from bents and broken sway braces on the underside of the jack-knifed deck of bridge 34.5.

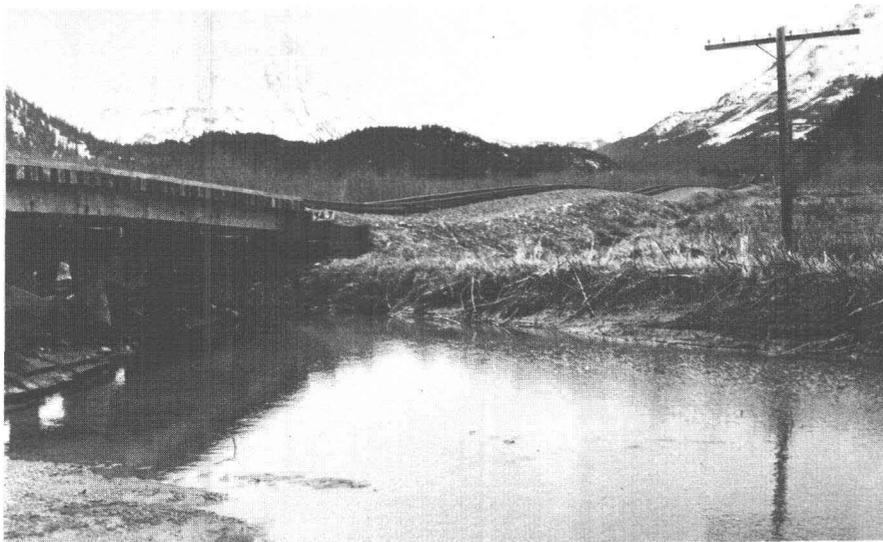
96.—Local settling of the railroad embankment between bridges 34.7 (foreground) and 34.5 on Hunter Flats.

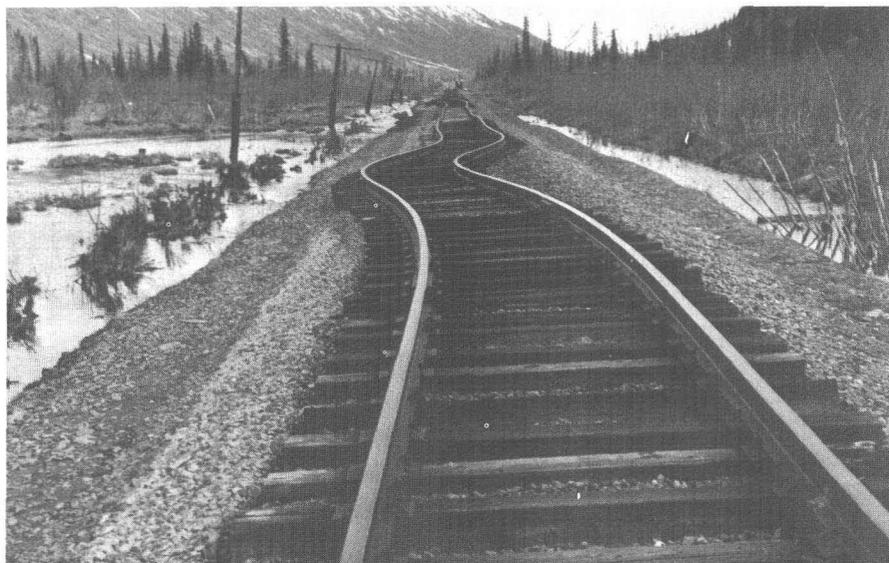
98.—Lateral kinks in the tracks, at mile 35 on Hunter Flats, which may have resulted from longitudinal compression of the embankment.

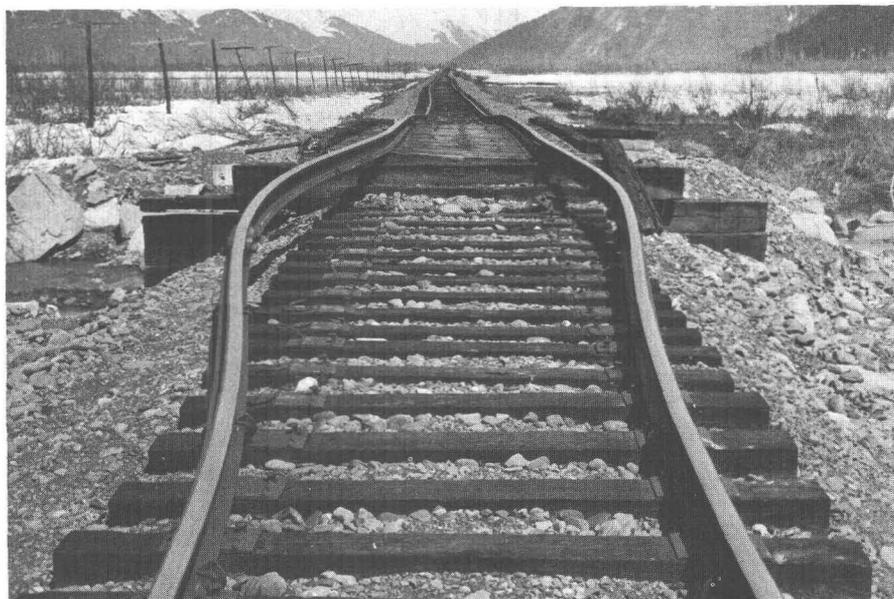
104.—View north over bridge 59.6, showing the lowering of the embankment relative to the bridge, compressive bowing of the rails, skewing of the deck, and horizontal displacement of the embankment toward the low ground to the left of the roadbed. The ties were frozen in the ballast, and the rails pulled free of the fish plates.

fill and the south end of the deck the rails bowed inward, and the west rail was torn free of the ties. On the north approach and northern end of the deck both rails bowed outward and both were torn free of the ties.

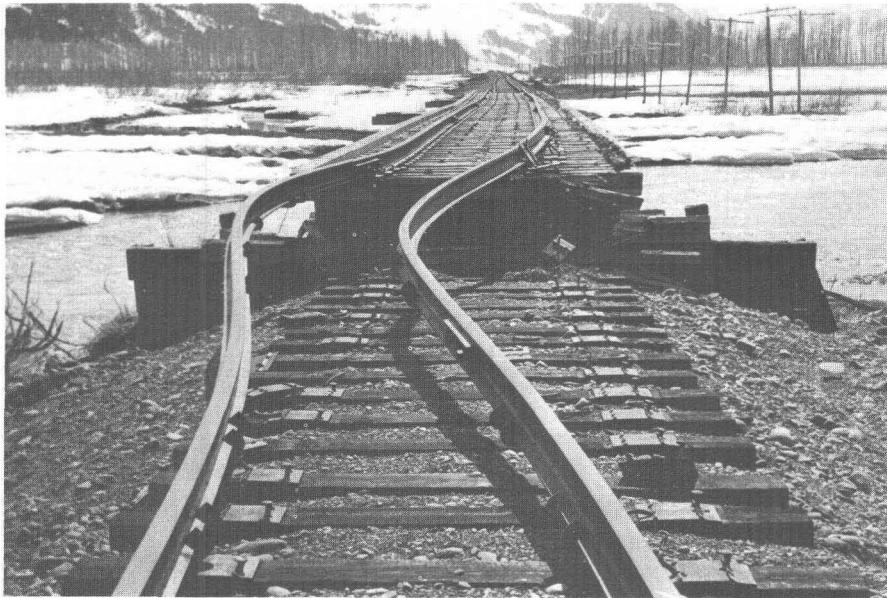
106.—View north over bridge 59.9 on Skookum Creek flood plain. It shows the lowered embankments, rails buckled by compression, and horizontal displacement of the embankment that produced a skew of about 3 feet in the bridge deck (see fig. 56).

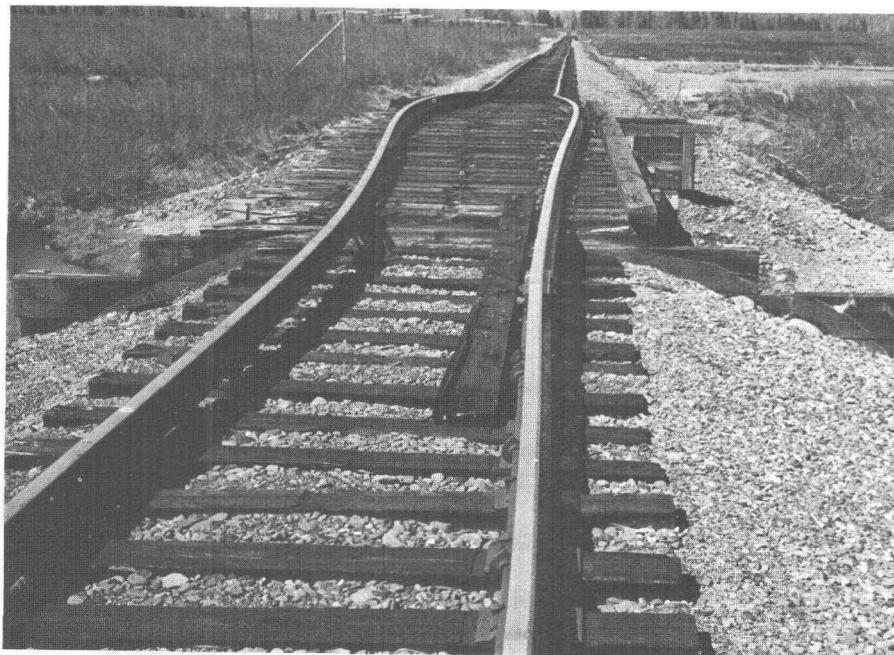
107.—View north over bridge 61.3 on the inactive flood plain of Placer River. The bridge was compressed and arched, and, as shown by the freshly exposed unweathered wood on the bulkhead, the embankment settled at the bulkheads. Approximately 200 feet of the embankment north of the bridge shifted to the left.

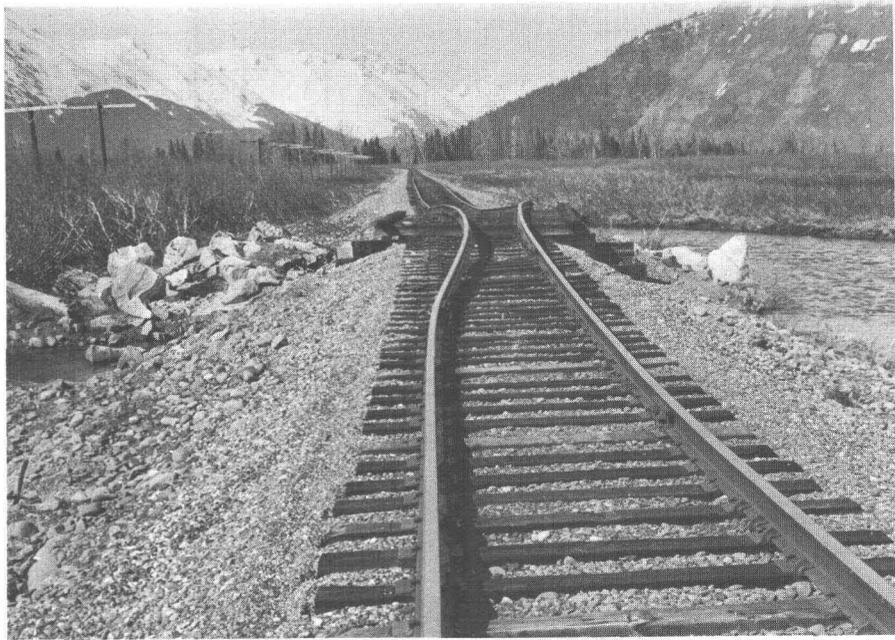
108.—View north over bridge 61.5 on the inactive flood plain of Portage Creek. The bridge was compressed and arched, and the rails pulled free of the fish plates. The north approach shifted to the right toward a small slough, and the south embankment shifted toward the topographically lower active flood plain of the adjacent creek, skewing the bridge 18 inches horizontally (see fig. 56).

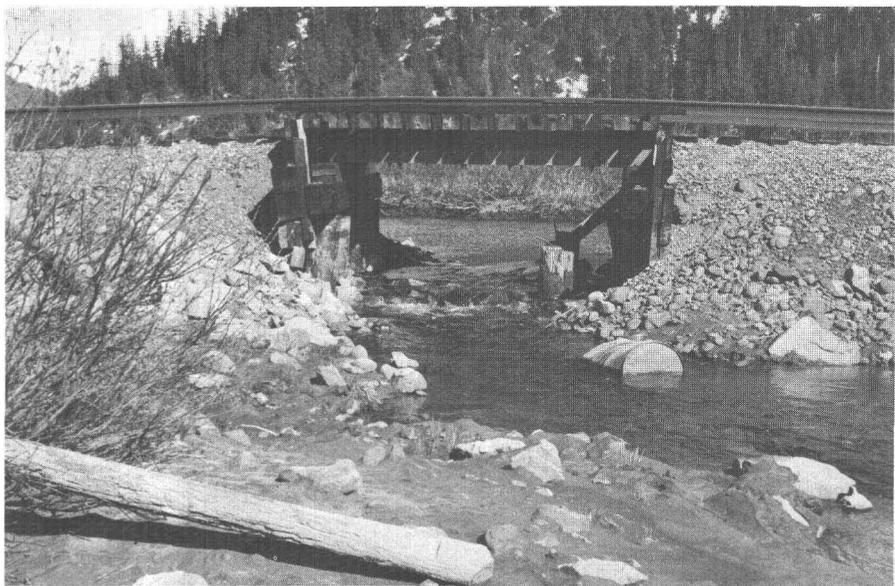
109.—View east at bridge 61.5 showing that the embankments were lowered relative to the bridge deck but had risen slightly toward the bridge.

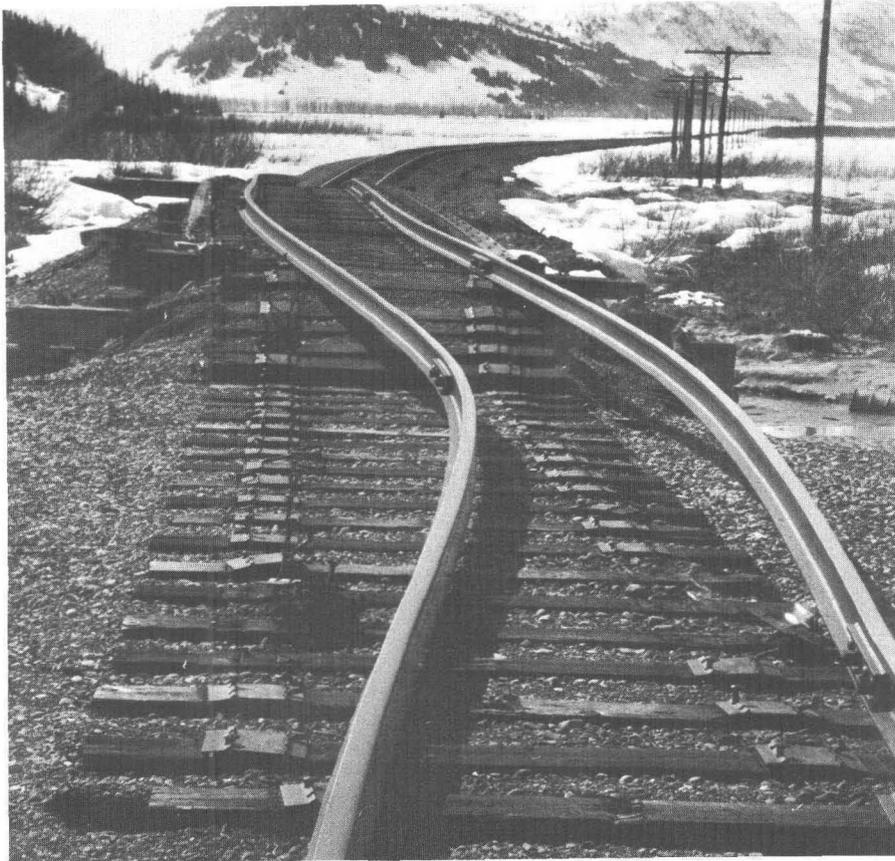
Bridge 61.9, a 103.8-foot eight-bent open wood trestle built on a curve, was compressed approximately 20 inches. The stringers crushed fillers on the south bulkhead and smashed through the north bulkhead planks. As noted in the discussion of transient horizontal displacements in bridges (p. D52-D53), the deck of this bridge may have developed a high horizontal acceleration. Penetration into and through the bulkheads released most of the compression on the stringers, but the rails, being restricted endways, reacted to the compression by horizontal deflection. On the south end of the deck, 40 feet of both rails bowed to the west a maximum of about 2 feet. The deflecting rails carried with them the alternate ties that were not secured to the bridge stringers and tore these ties free of the eastern guardrail to which they were lag screwed. Rails pulled free of the ties and bowed a maximum of 5 feet to the west over a distance of about 45 feet (fig. 110).

110.—Bridge 61.9 from the south, showing the lowering of the fills and the buckled compressed rails pulled free of the ties.

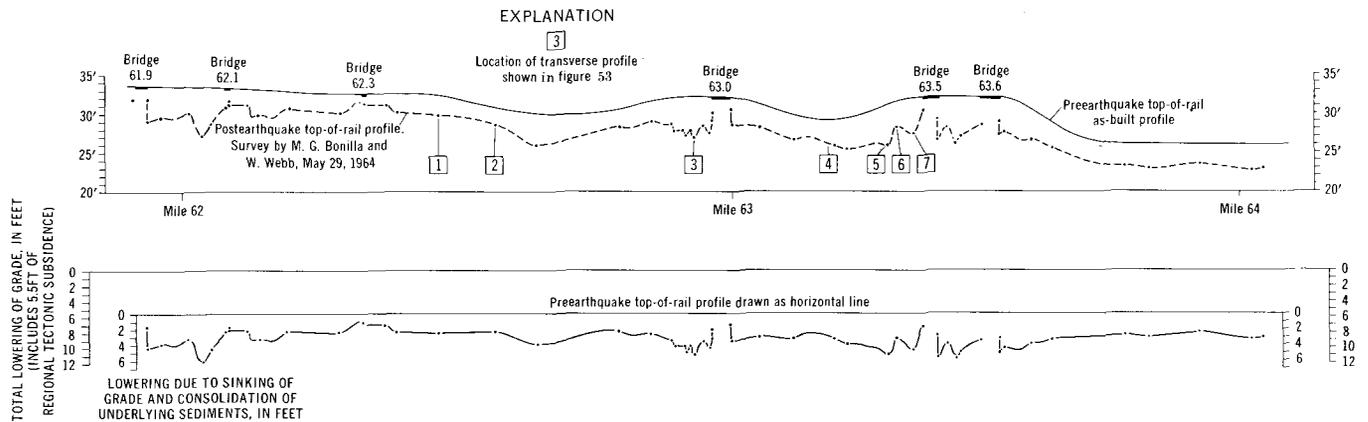
North from bridge 61.9 the embankment was generally lowered about 3 feet where it crosses the combined flood plains of Portage Creek and Twentymile River. The height of the postearthquake embankment is compared with the preearthquake embankment in figure 114, in which the heights of both are referred to the nearest bedrock bench mark (Q 12, U.S. Coast and Geod. Survey, 1929, at mile 66.5). Although there was ground cracking accompanied by the discharge of sediment-laden ground water along much of the embankment (pl. 3), the fact that local sags appeared to be related to larger discharges of sediment suggests that these sags resulted

114.—A comparison of the pre- and postearthquake top-of-rail profiles in the Portage area, neglecting the lowering due to tectonic subsidence, and a plot of the lowering as compared to the preearthquake position and the additional  $5.49 \pm$  feet of tectonic subsidence of the nearest bedrock bench mark (see fig. 72). Numbers indicate the stations at which transverse profiles were measured (see fig. 53).

The embankment on both sides of the bridge was lowered, 8 inches at the south bulkhead and about 2 feet at the north bulkhead beyond the few feet of embankment bulldozed up by the deck. The entire embankment north of the bridge was lowered, about 3 feet near the bridge and generally but irregularly increasing to about 5 feet at the next bridge at mile 63.4 (fig. 114).

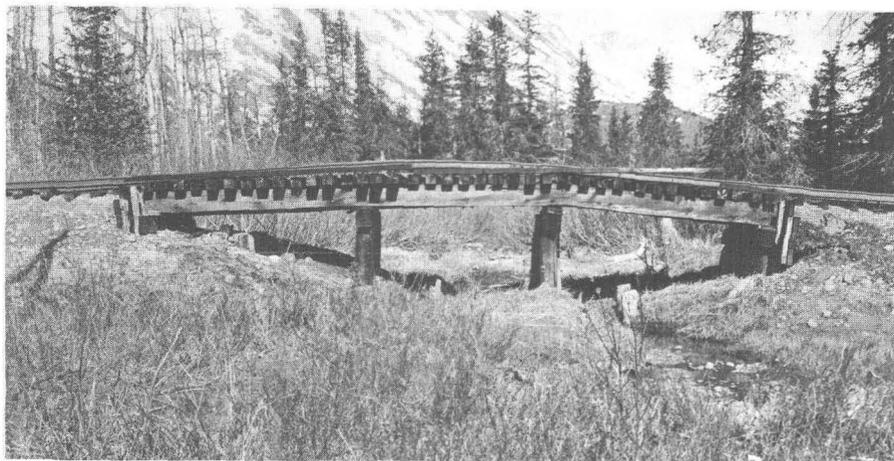
115.—Approach fills bulldozed against the bulkheads of bridge 62.1. Central bents were displaced horizontally without rotation, but the bulkhead bent was rotated as its base was carried farther toward the channel than its top. This sort of rotation was very uncommon.

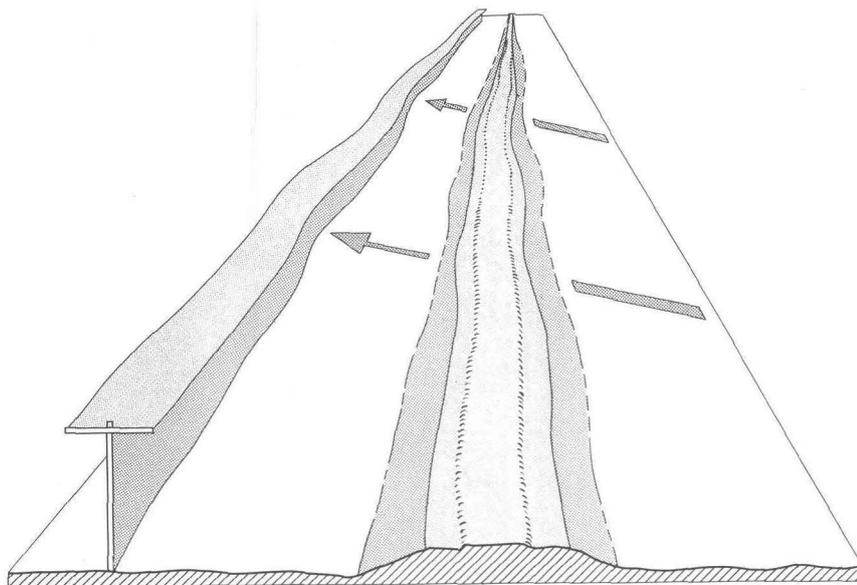
shows both the embankment and the adjacent pole line as drawn from a low-altitude aerial photograph that includes the embankment from just north of the buried structure to the Union Oil Co. tanks at about mile 62.8. The congruent sinuosity developed by both suggests that the lateral displacement resulted from horizontal shifting of the valley floor sediments beneath both the embankment and the pole line. As can be seen on plate 3, there was considerable ground cracking along the southern third of the embankment shown in figure 117. The pattern of the ground cracks and the numerous tension fractures that cross the embankment suggest an east-west spreading of unconsolidated materials beneath the flood-plain surface. The rails responded to the tension in this zone by forming 2-foot-wide pull-aparts, in the left rail 710 feet, and in the right rail 770 feet, north of the bridge (fig. 118). Actual movement of the valley floor sediment was predominantly to the east toward the major channel and the low area in which a small meandering stream flows.

117.—Congruent lateral displacement of the roadbed and pole line north of bridge 62.3 (drawn from fig. 116) showing that the roadbed and pole line were carried passively as the underlying flood-plain sediments moved laterally.

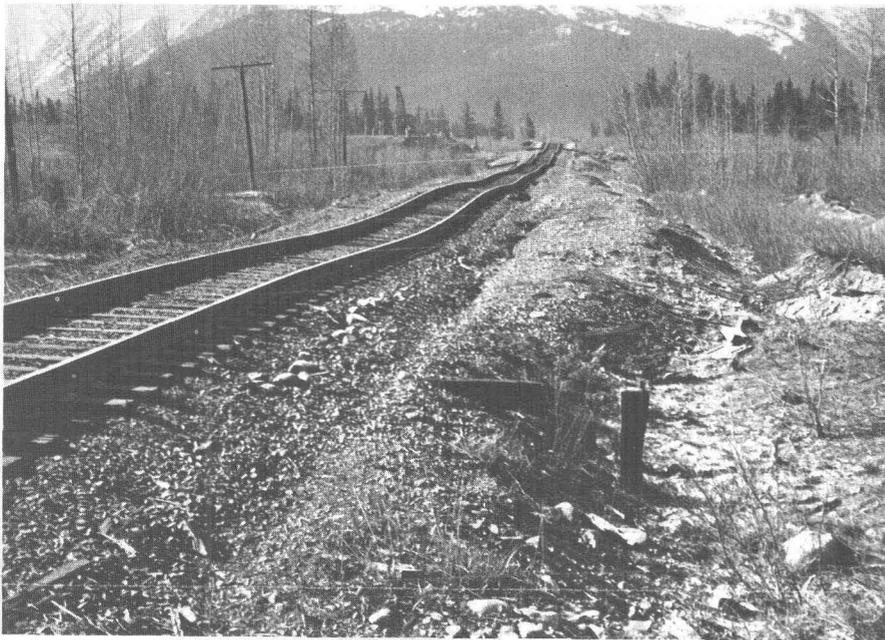
120.—Irregular settlement of the railroad embankment between the highway grade crossing at mile 62.9 and bridge 63.0 (see pl. 3).

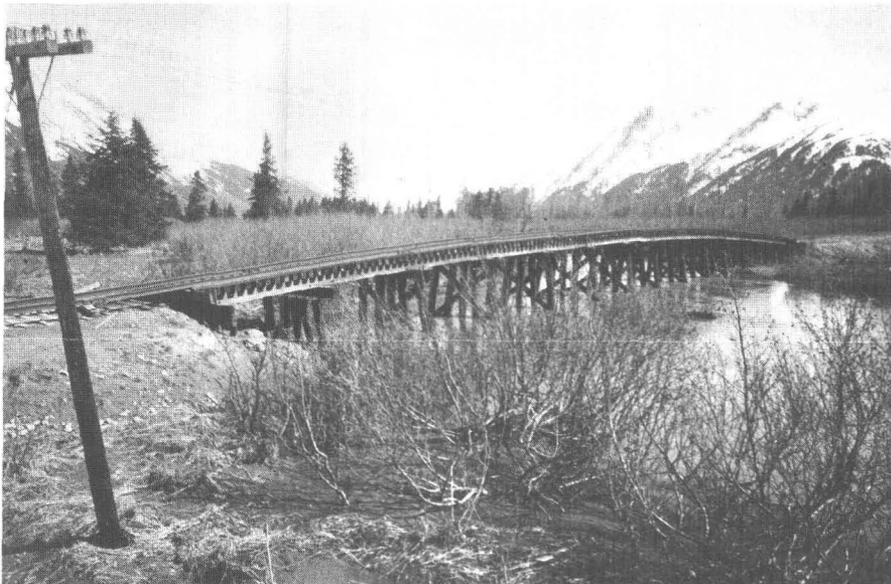
121.—A 2.6-foot arch in the deck of bridge 63.6 over Portage Creek. The deck was only slightly compressed, but was offset horizontally approximately 7 feet (see figs. 19, 56).

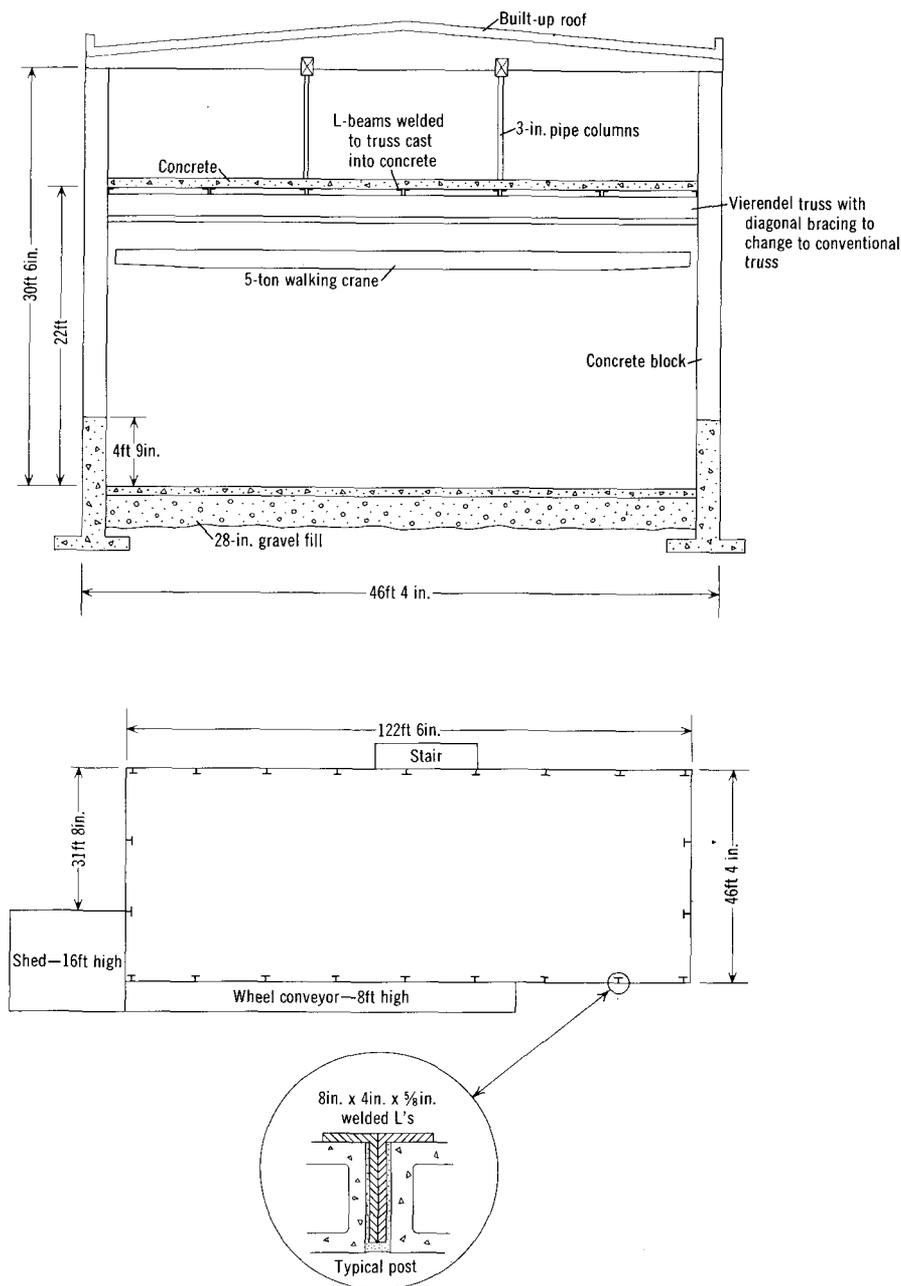
severely damaged that it had to be razed (fig. 127). The building, constructed during the Second World War when material was scarce, was built largely of salvaged materials. The steel frame consisted of columns of two welded L's cast into a high perimeter foundation wall (fig. 128). The columns were welded to modified Vierendeel trusses at the second

128.—Construction of the Wheel Shop-Mechanical Offices building.

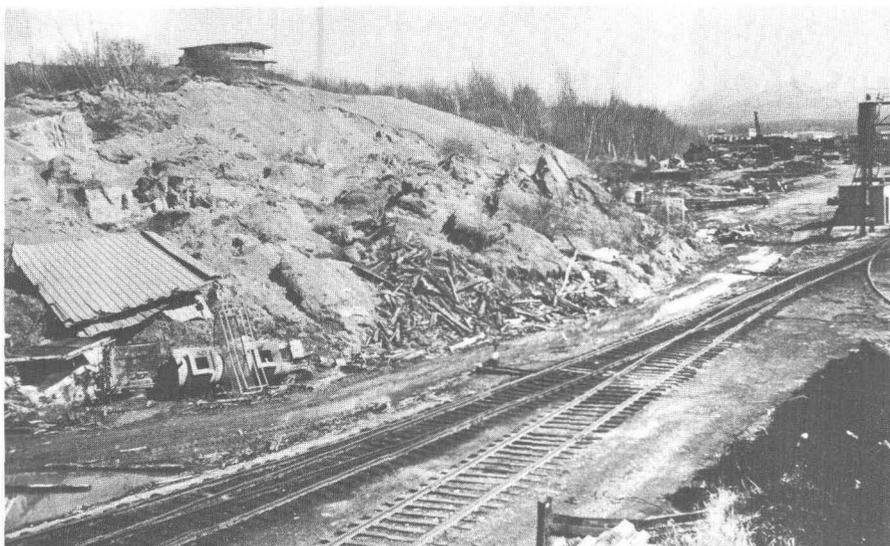
A steel-framed metal-sheathed Butler building (No. 5, fig. 126) used for on-track equipment storage was overrun by an earth flow that occurred at the toe of the Government Hill slide (fig. 135).

Some yard equipment and rolling stock were destroyed or damaged as the flowing earth covered about 850 feet of track. This slide is described by Hansen (1965).

135.—The toe of Government Hill slide that overran an on-track storage building and some rolling stock on the north side of Ship Creek valley
