*A description and analysis of the geologic  
controls of earthquake damage to The Alaska  
Railroad, with emphasis on damage caused  
by the mobilization of unconsolidated  
sediments*

In the 1964 Alaska earthquake, the federally owned Alaska Railroad sustained damage of more than \$35 million: 54 percent of the cost for port facilities; 25 percent, roadbed and track; 9 percent, buildings and utilities; 7 percent, bridges and culverts; and 5 percent, landslide removal. Principal causes of damage were: (1) landslides, landslide-generated waves, and seismic sea waves that destroyed costly port facilities built on deltas; (2) regional tectonic subsidence that necessitated raising and armoring 22 miles of roadbed made susceptible to marine erosion; and (3), of greatest importance in terms of potential damage in seismically active areas, a general loss of strength experienced by wet water-laid unconsolidated granular sediments (silt to coarse gravel) that allowed embankments to settle and enabled sediments to undergo flowlike displacement toward topographic depressions, even in flat-lying areas. The term "landspreading" is proposed for the lateral displacement and distension of mobili

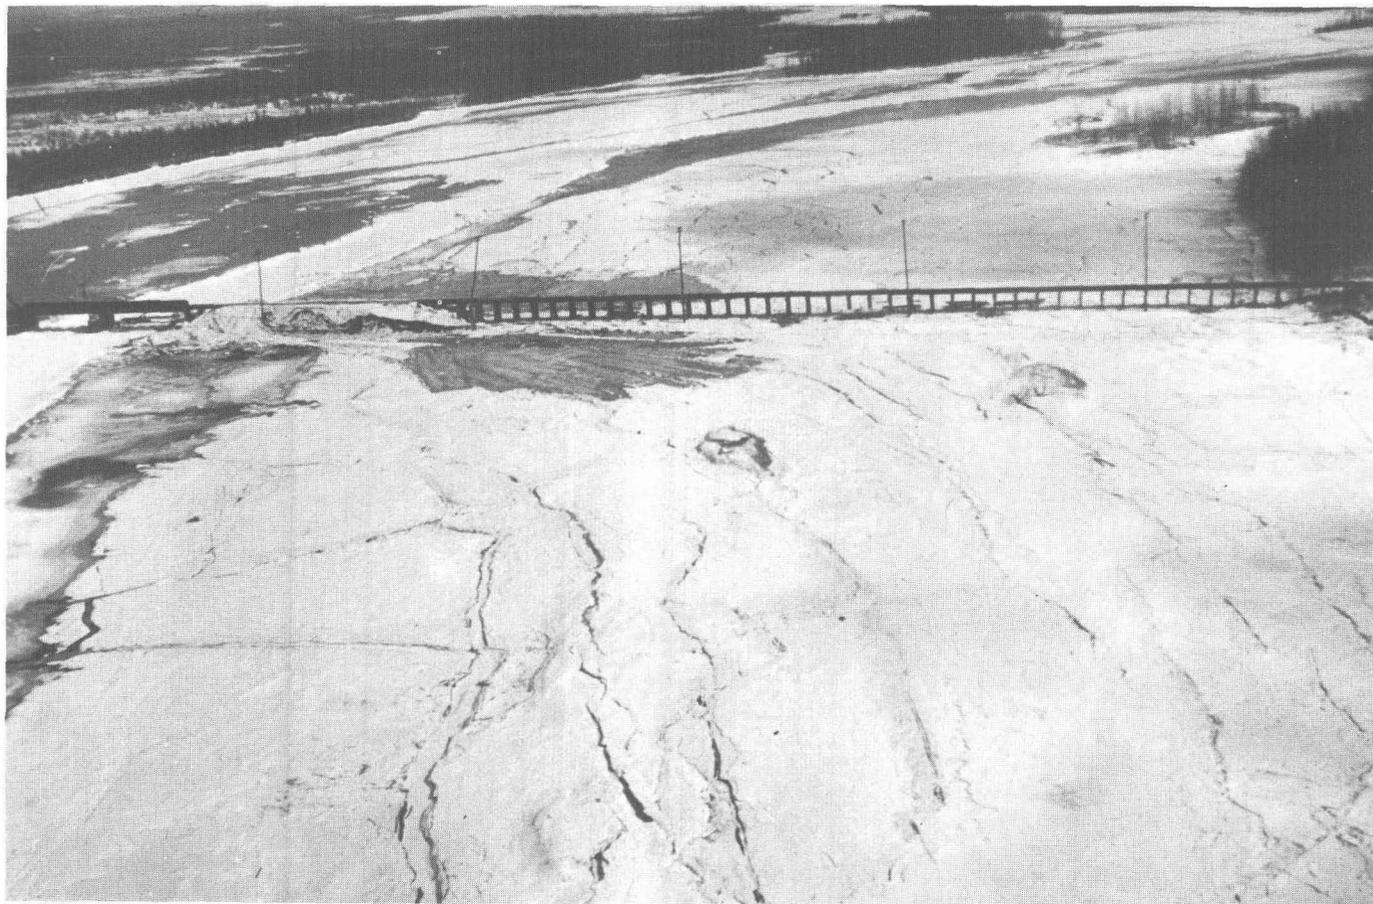
cracks. Figure 139, taken after channel deposits had been bulldozed to replace the destroyed bridge, shows that some of the cracks were several feet wide. Mr. Cannon also reports that the anchor bolts in the adjacent 70-foot through girders shown at the left of figure 140 were sheared.

139.—Cracks in the active flood-plain sediments at the south end of bridge 147.5 at Matanuska River. An earth fill has been bulldozed in to replace a section of trestle in which cracks sheared wood piles at the ground and offset the trestle.

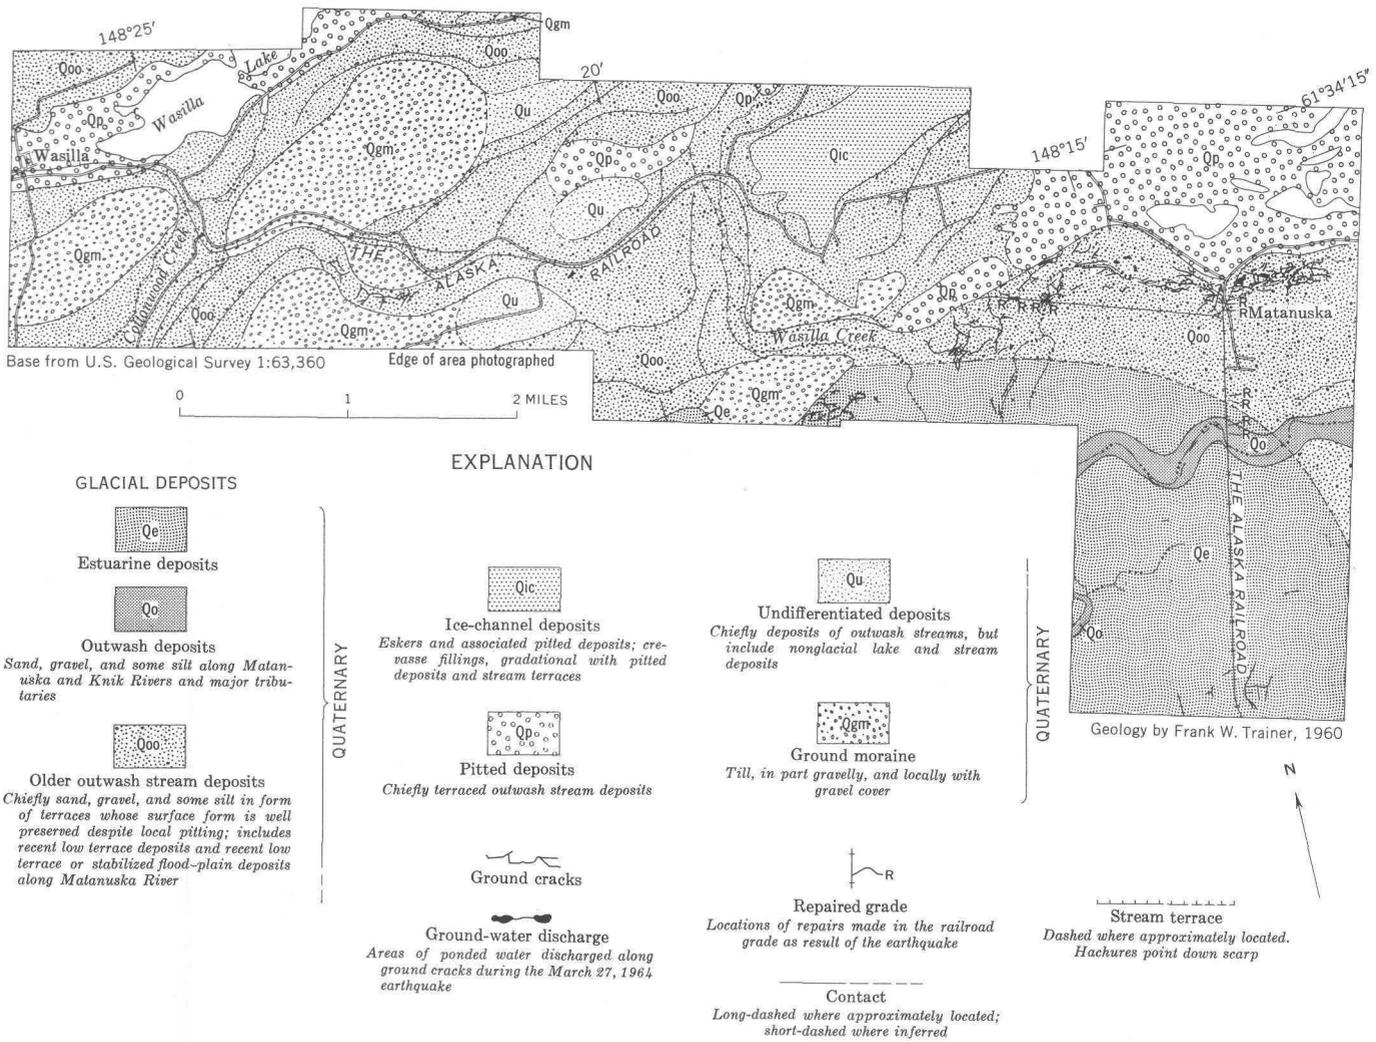
North of the Matanuska River the rail line leaves the highly fractured outwash and river-channel deposits and passes abruptly onto a nearly unfractured flat low-lying surface underlain by estuarine silt and clay (fig. 140). The estuarine deposits are relatively thick; Trainer (1960, p. 52) reports that a well drilled by The Alaska Railroad near Matanuska penetrated estuarine silt and clay to a total depth of 200 feet (175 ft below sea level) without reaching the base of the estuarine sediments. The estuarine sediments grade nearly imperceptibly into glacial-outwash

140.—Ground cracking in the area of Matanuska. Most cracks are in young stream deposits lying in old glacial-outwash channels, where the water table is at, or just below, the ground surface.

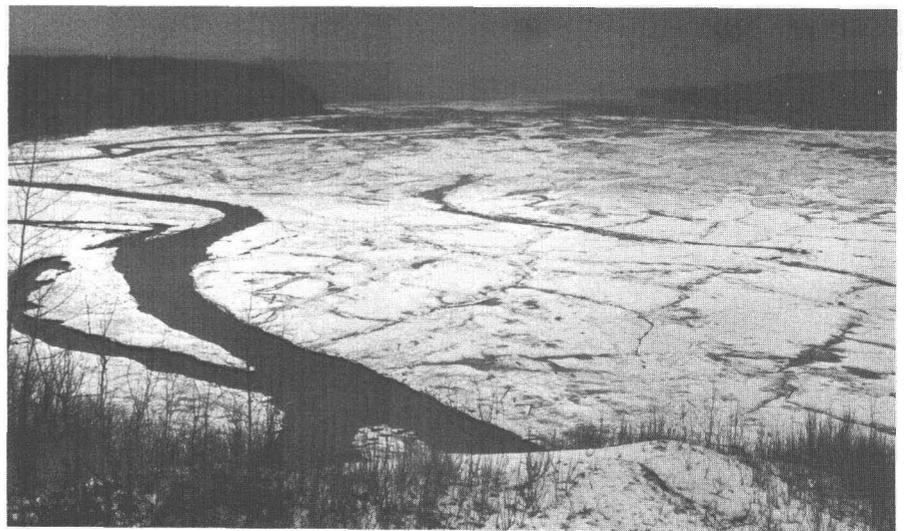
from the flood plain of the Matanuska River have accumulated on the outwash in a blanket that thickens to about 20 feet a mile or so north of Palmer (Trainer, 1961). Just beyond Palmer the rail line drops down across the steep river bluffs onto the flood plain of the Matanuska River and continues north on the flood plain at the toe of the bluffs to Sutton. The flood-plain sediments and the islands and low terraces composed of glacial outwash sand and gravel (Trainer, 1961) were as severely fractured here as at the mainline crossing to the southwest (fig. 141). The rail line is built at the

141.—Large and continuous ground cracks in low terraces of glacial outwash and flood-plain sediments in the Matanuska River valley.
