Public-data File 83-5

A BRIEF OUTLINE OF THE SEISMIC HAZARD
IN THE FAIRBANKS/NORTH POLE AREA

Dr. John N. Davies

March 1983

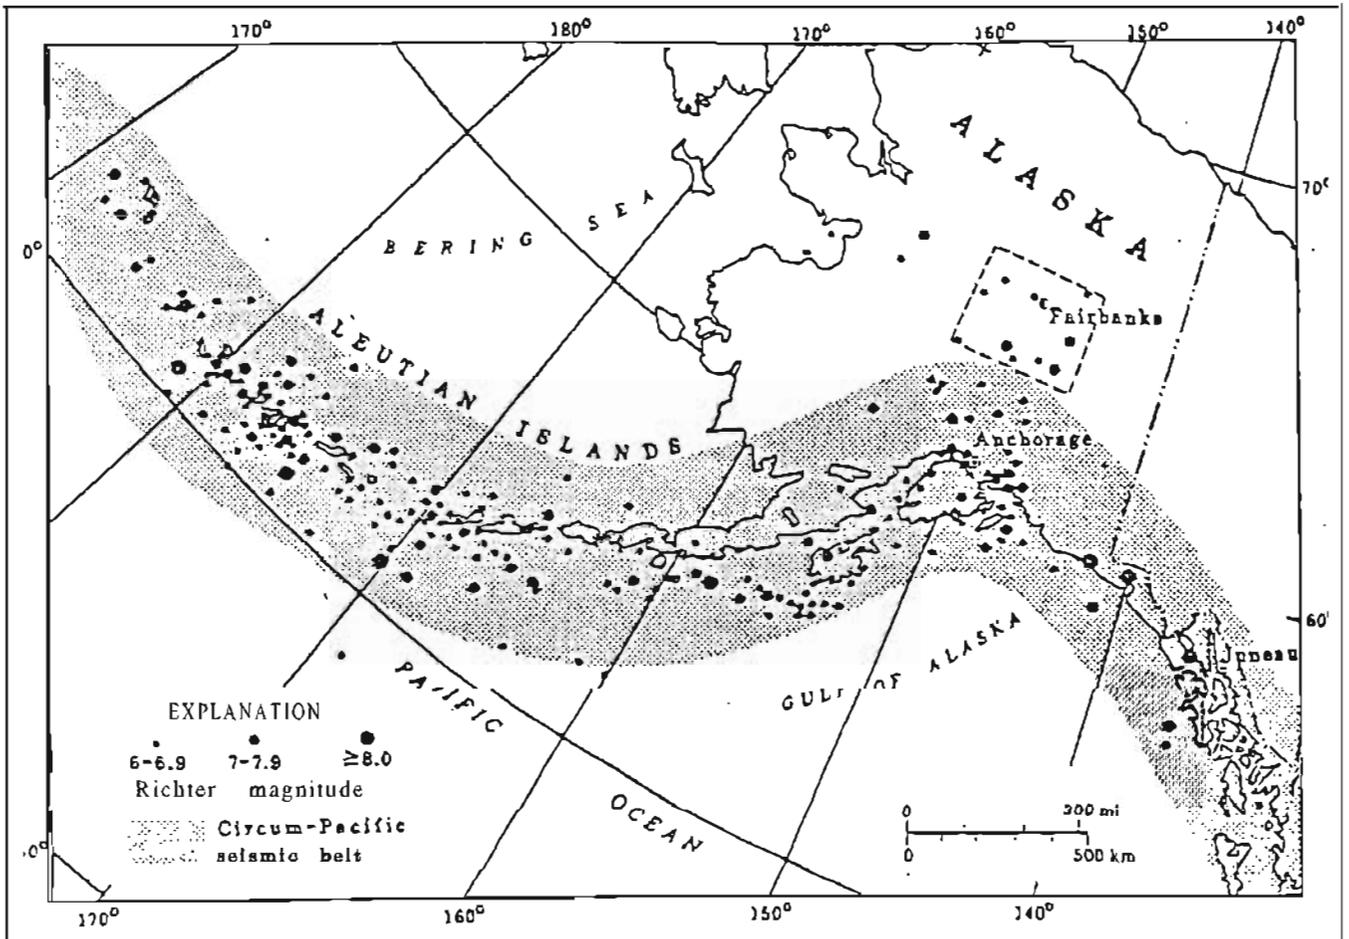
• Epicenters of earthquakes with Richter magnitudes 6.0 and larger in Alaska from 1699 to 1967. Shaded area represents the Circum-Pacific seismic belt in Alaska. The dashed rectangle encloses area shown in figure 81 (modified from Jordan and others, 1966).

Figure 1: Map showing the relationship of the Fairbanks area to the Circum-Pacific seismic belt. From Pewé (1982).

The proximity of Fairbanks to the Circum-Pacific seismic belt is shown in figure 1. The high level of seismic activity along the Aleutian Islands and the south coast of Alaska results from the collision of the Pacific Plate with Alaska. The floor of the Pacific Ocean is moving northwestward with respect to Alaska at about 6 cm/yr. This motion is taken up by the Pacific Plate being thrust under Alaska at an angle of about 45°. This underthrusting is illustrated in figure 2. The northernmost edge of the Pacific Plate, beneath central Alaska, is below the northern frontrange of the Alaska Range; under Healy, Gold King and perhaps Delta Junction for example. This means that at its closest point of approach the Pacific Plate is about 50 to 75 mi south of Fairbanks and some 100 mi below groundlevel. On the scale of the Pacific-Plate this is a very small distance, which means that we should expect the effect of the collision of the Pacific Plate with Alaska to be felt strongly in Fairbanks, and this is indeed the case.

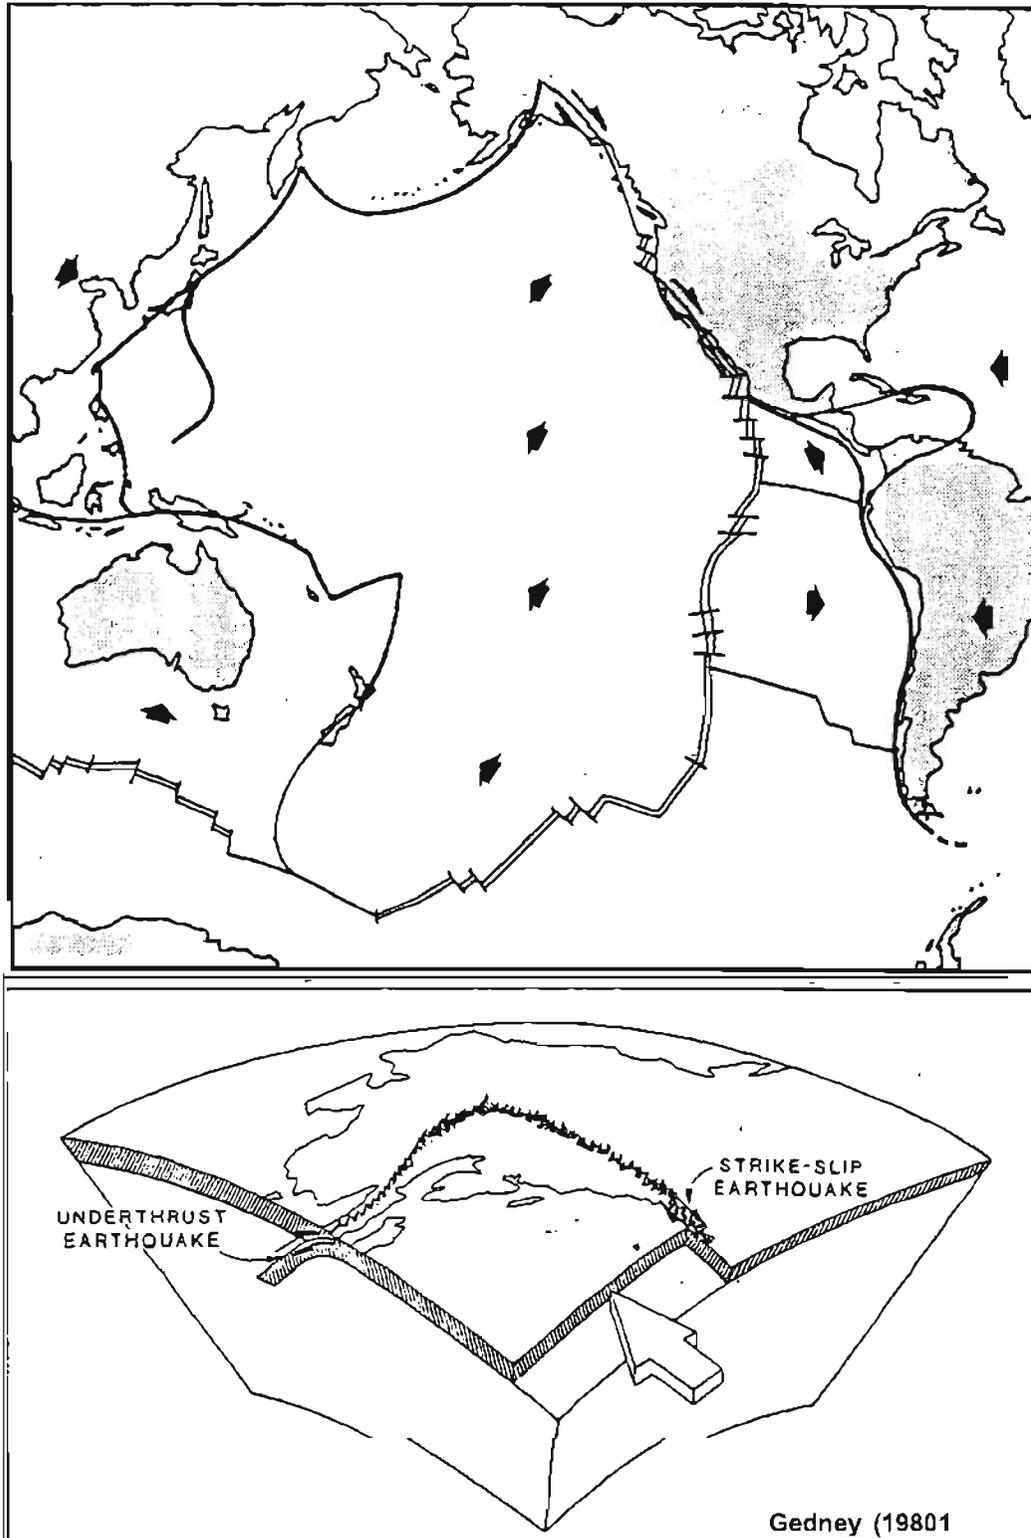
Figure 2: Schematic diagram of the boundary between the Pacific Plate and Alaska (top) and of the geometry of the underthrusting of the Pacific Plate beneath Alaska (bottom) From Gedney (1980).

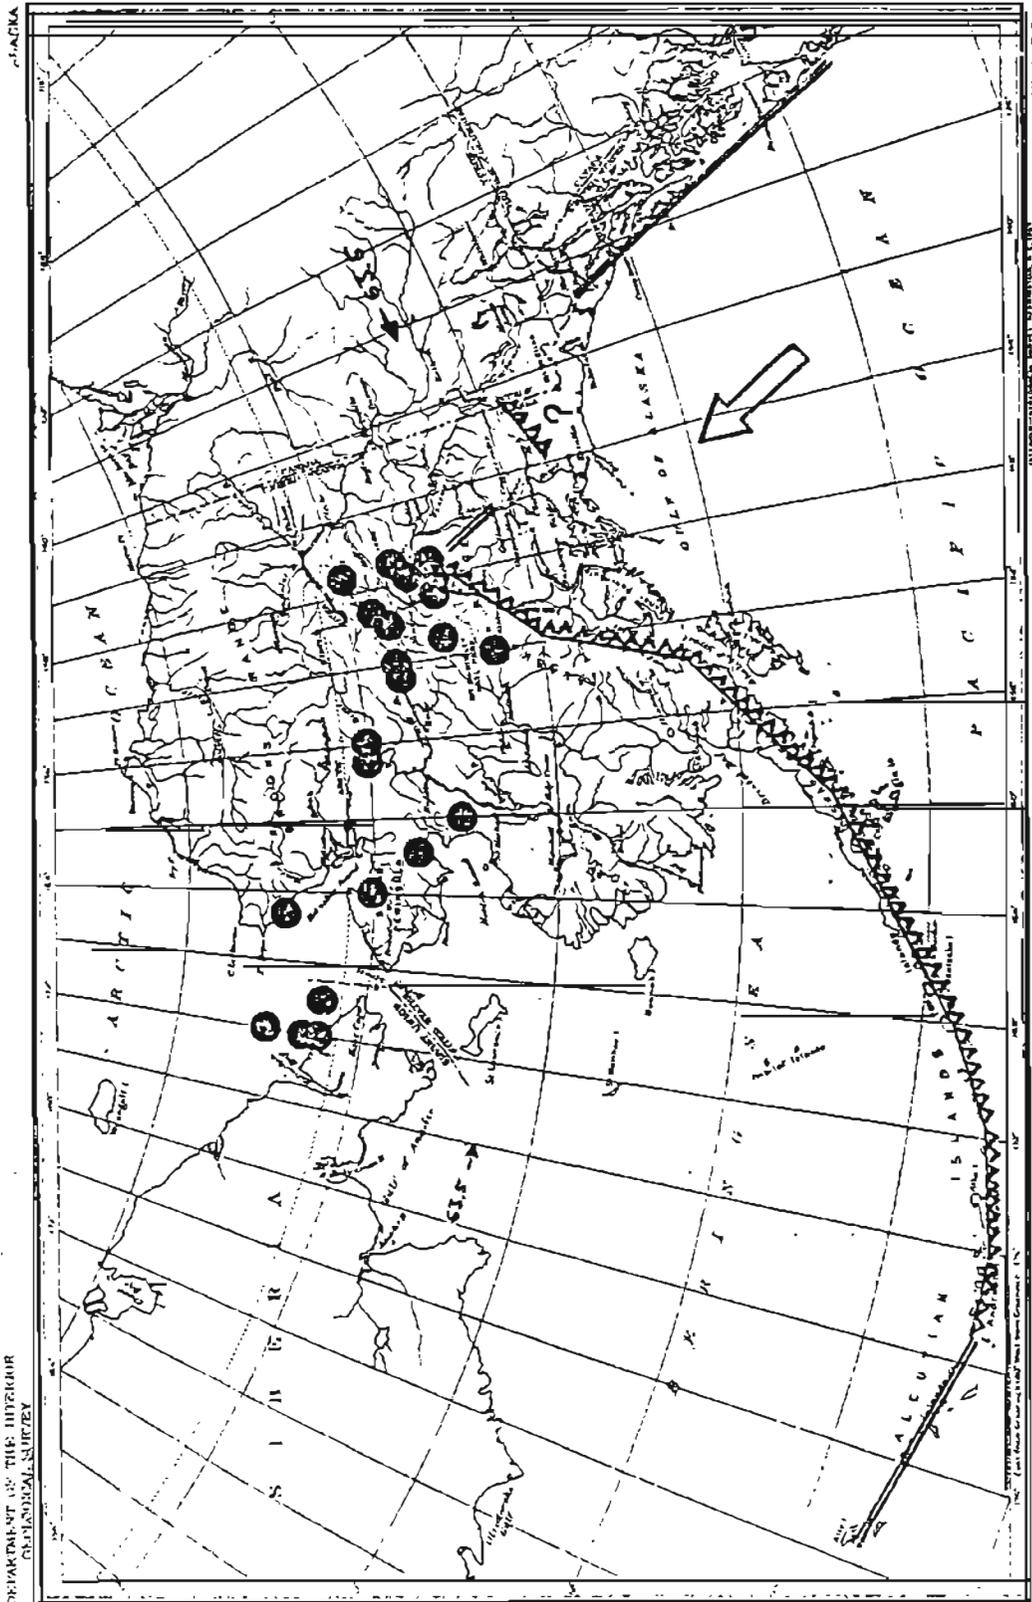
Figure 3: Map showing the locus of all shallow earthquakes of magnitude greater than 6.0 in Alaska north of 63.5°N in relation to the Pacific plate-Alaska boundary. The arrow indicates the direction of motion of the Pacific plate with respect to Alaska. From Davies (1983).

The effect of this collision is illustrated in figure 3, which shows the locations of all shallow (less than 30 mi deep) earthquakes of magnitude greater than 6.0 that have occurred in Alaska north of 63.5°N latitude. The epicenters of these earthquakes all lie in a band extending from Delta Junction through Kotzebue. Not shown in this figure is the fact that the larger events tend to occur closer to the east end of this band. The largest event was a magnitude 8 earthquake that occurred in 1904 (see appendix). Several other shocks in the greater Fairbanks area have had magnitudes of approximately 7½.

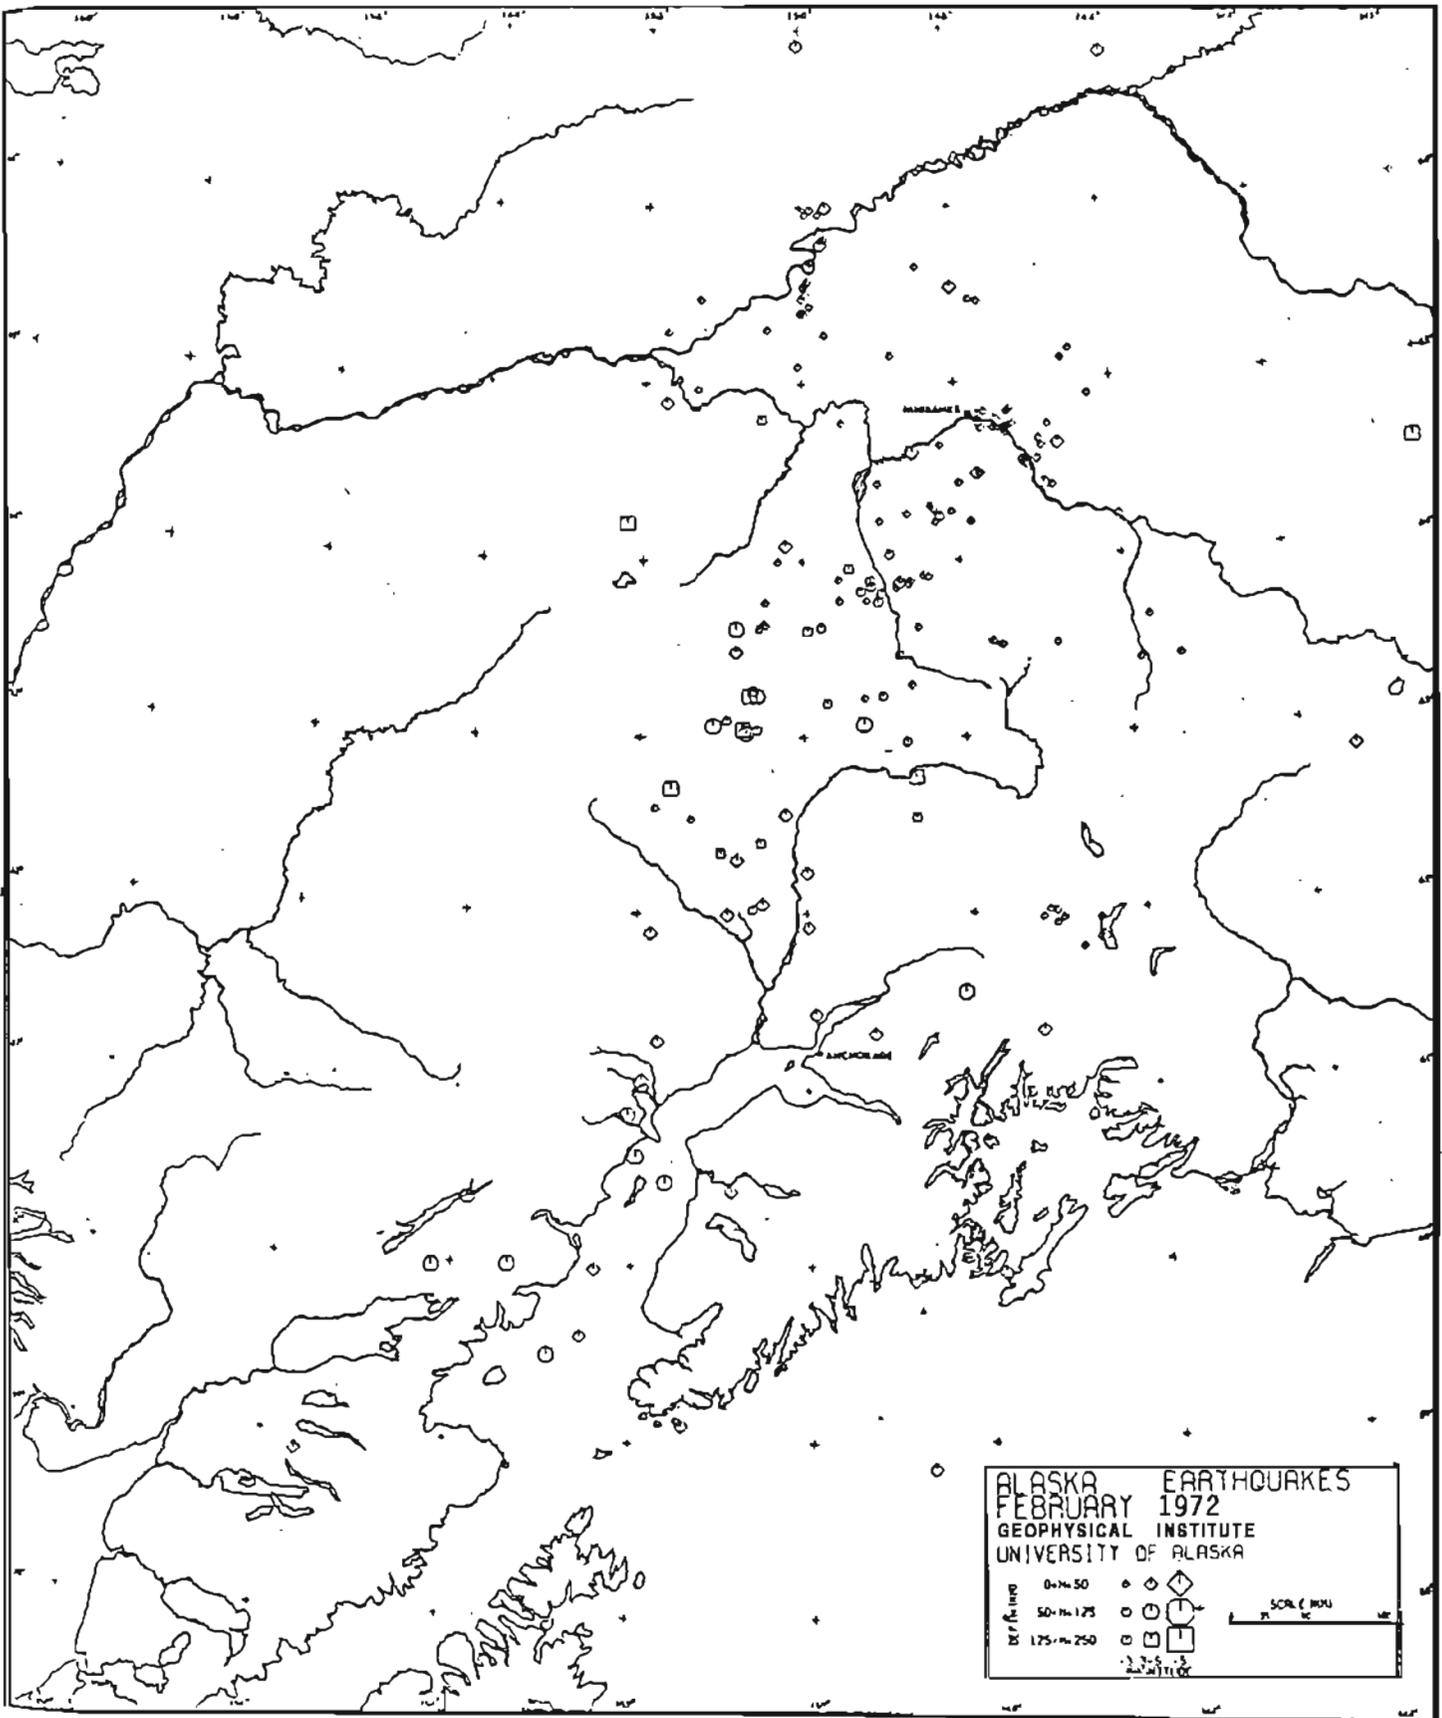
Figure 4a: Central Alaska earthquakes located by the University of Alaska Geophysical Institute for the month of February 1972. Note activity in Fairbanks area and absence of activity in the Yukon Flats north of Fairbanks. From VanWormer, Davies, and Gedney (1973).

February 1972 epicenter map.

The Badger Road area has been the source area for many small earthquakes ever since the 1967 Fairbanks earthquakes. **By** contrast, other areas are relatively quiet except for an occasional burst of activity. An example of this is the Yukon Flats area as shown in figures 4a, 4b and 4c. In each of these figures, which show central Alaskan earthquakes for the months of February, April and September, 1972 respectively, the Fairbanks area is seen to be quite active whereas the Yukon Flats area is quiet in February and September, only showing a brief burst of activity in April.

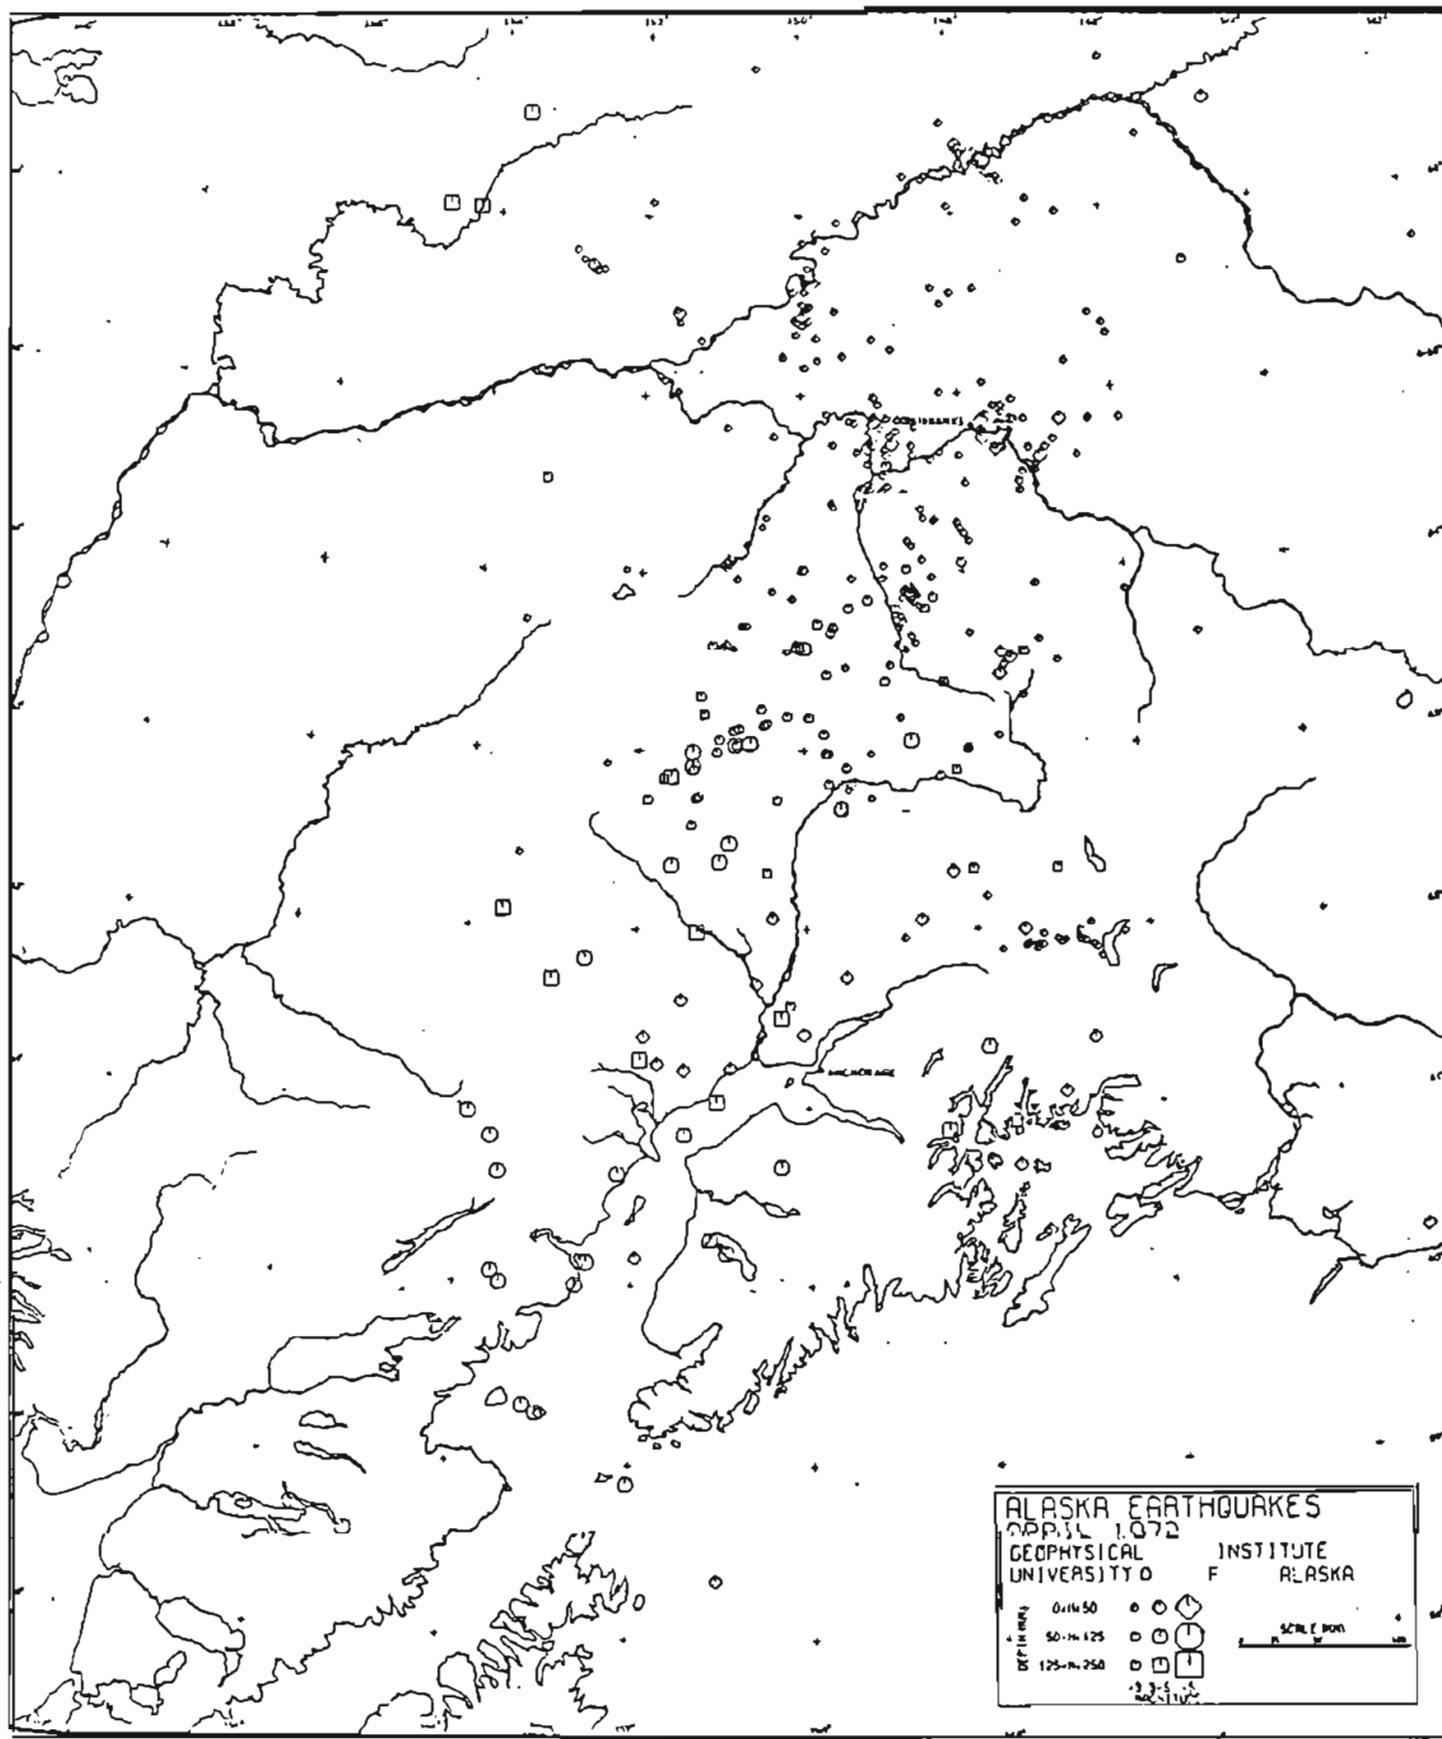
Figure 4b: Same as 4a, for the month of April, 1972. Note continuing activity in Fairbanks area and new activity in Yukon Flats. From VanWormer, Davies, and Gedney (1973).

April 1972 epicenter map. Note activity in Yukon Flats.

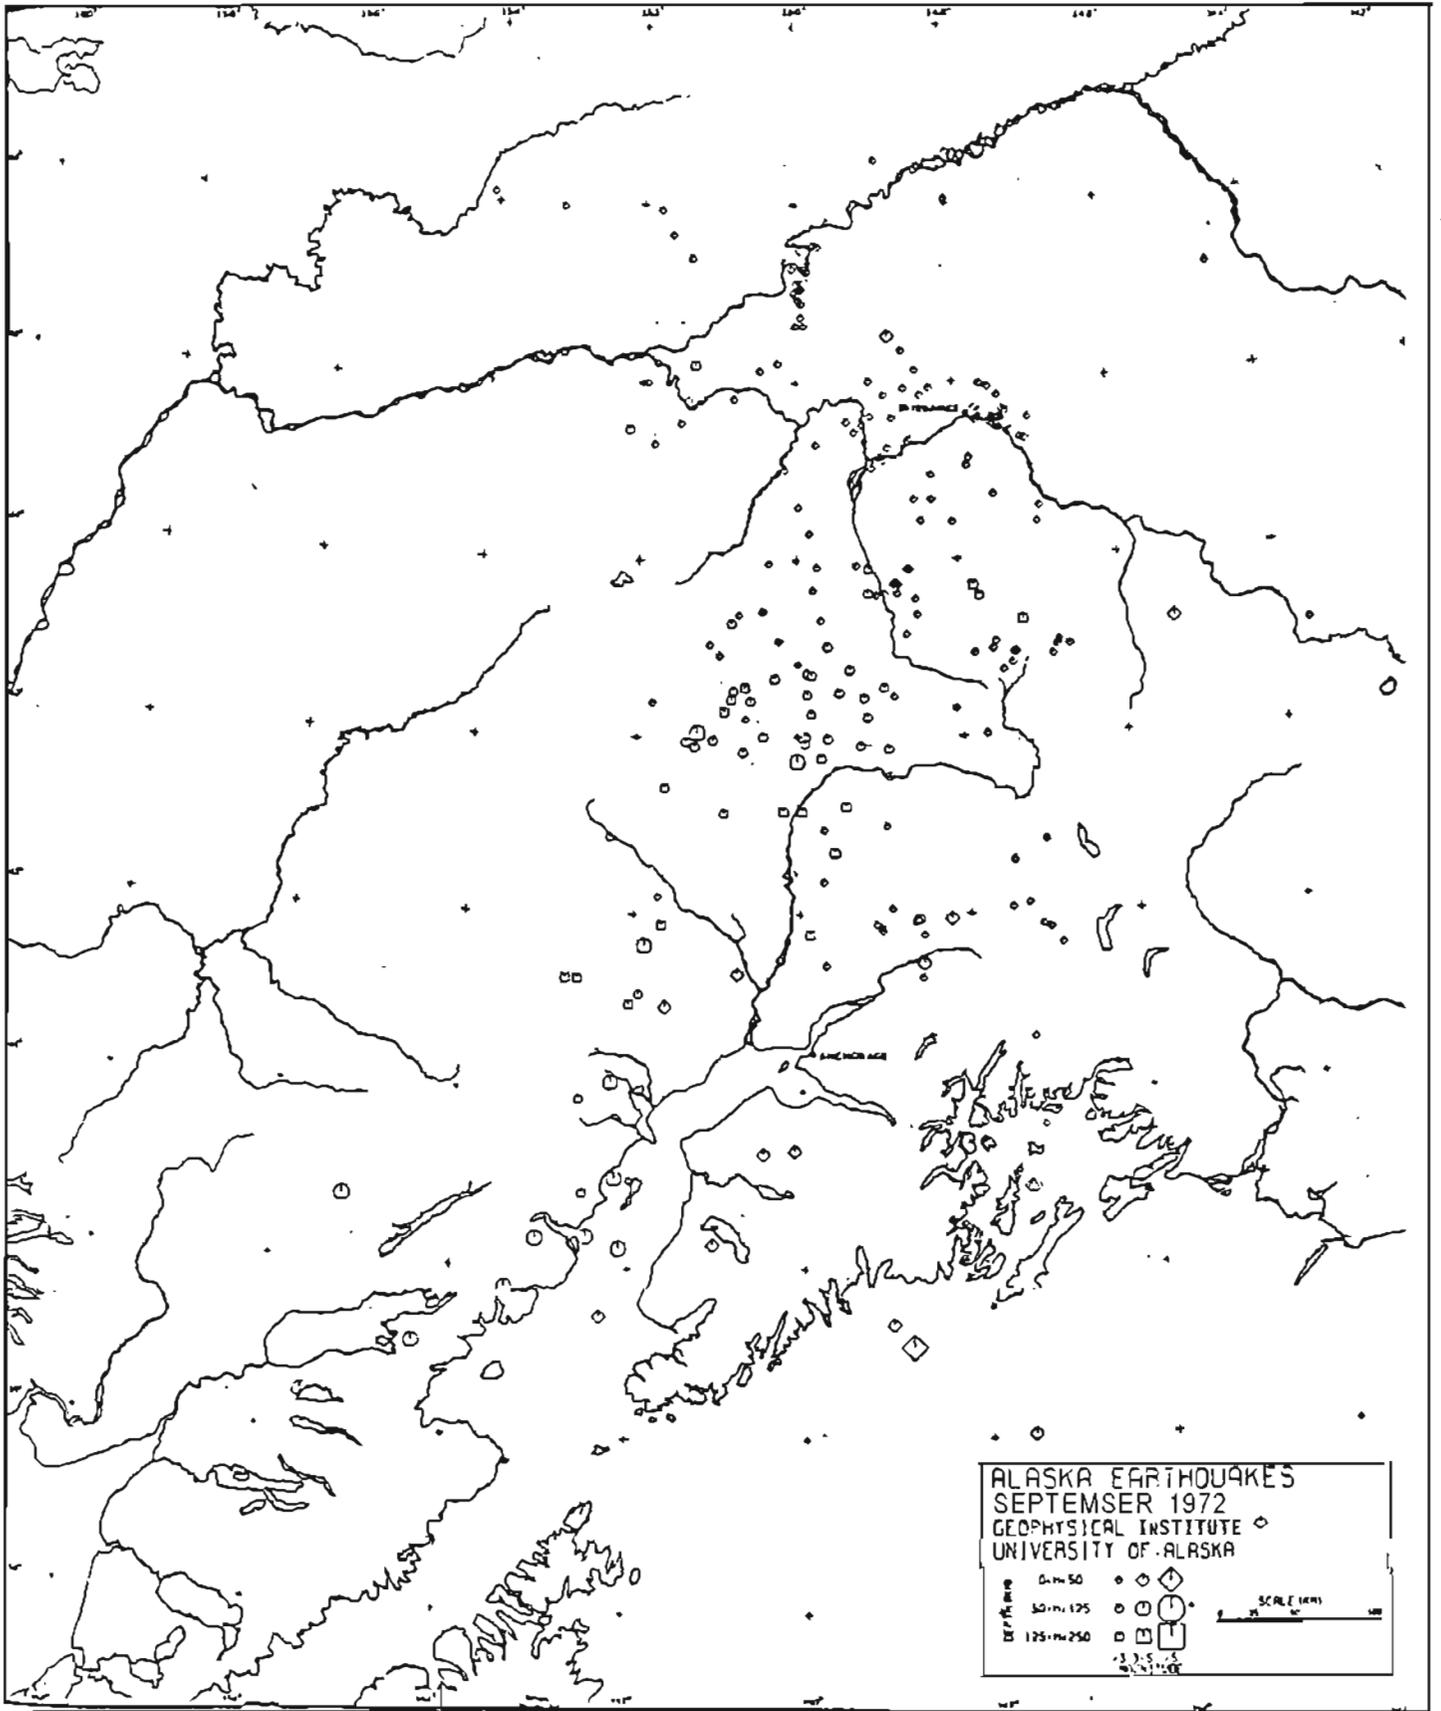
Figure 4c: Same as 4a, for the month of September, 1972. Note continuing activity in the Fairbanks area and cessation of activity in the Yukon Flats. From VanWormer, Davies, and Gedney (1973).

September 1972 epicenter map.

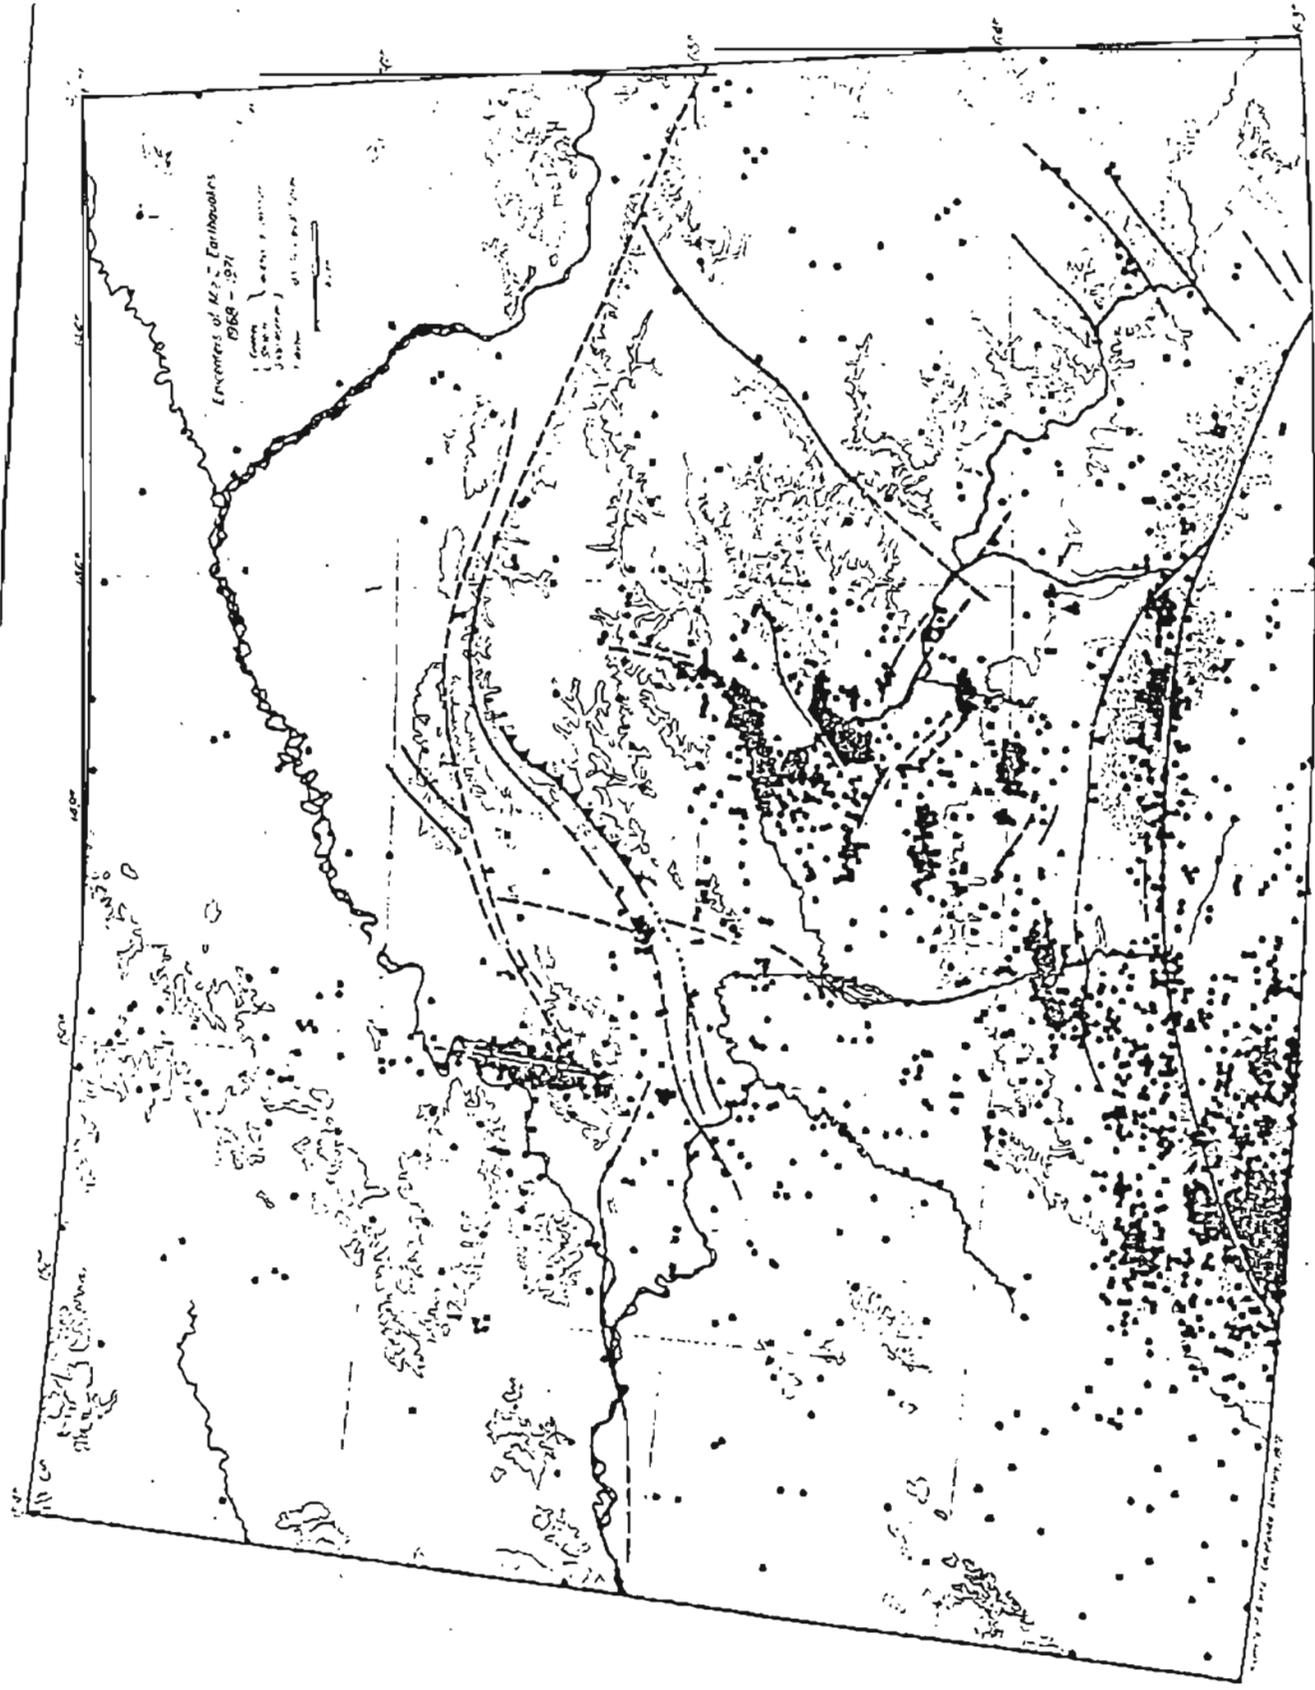
Figure 5: Correlation of epicenters with mapped faults. Note both ENE-WSW and NNW-SSE alignments of epicenters trending through the Fairbanks area. From Gedney and others (1972).

At least since the 1967 earthquakes in the Badger Road area, Fairbanks has been one of the most active seismic **zones** in the Interior of Alaska. Figure 5 shows that Fairbanks is located at the intersection of two trends of seismic activity, one extending about east-west and subparallel to the Chena River Valley, and the second, a somewhat more diffuse northwest-southeast trend following the Tanana River Valley between Fairbanks and Salcha.

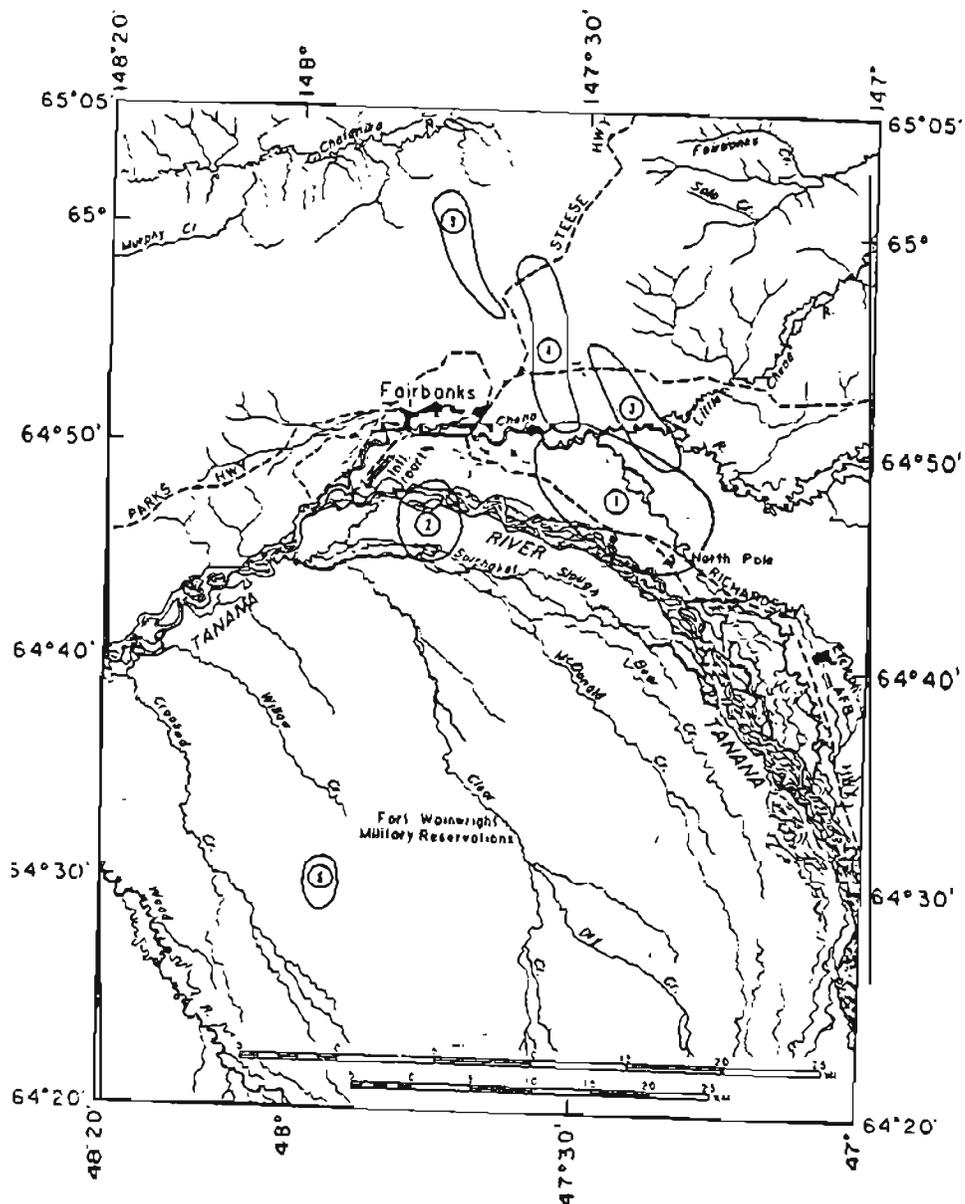
Shaded areas indicate locations of earthquake swarms referenced in text. Area labeled 1 is aftershock zone of June 1966 earthquakes. Area 2 is epicentral area of swarm which developed in late 1970, early 1971. Swarms in areas 3 and 4 developed in February 1977 and February 1979, respectively. Swarm in area 5 occurred in October 1981, and earthquakes in area 6, some of which are ^{uncollected} in Table 1, began on 30 December 1981.

Figure 6: Recent aftershock zones and areas of swarming in Fairbanks area, Note en echelon arrangement of zones 3, 4, and 5 and general NNW-SSE alignment of the group comprising zones 1, 3, 4, and 5. From Gedney and others (1982).

Since 1967 there have been four notable sequences of earthquakes in the Fairbanks area. These are shown in figure 6. The shaded area marked (1) corresponds to the aftershock zone of the 1967 earthquakes. Areas (2), (3), (4), and (5) mark the locations of earthquake sequences that occurred in 1970-71, 1977, 1979, and 1951, respectively. Typical depths for earthquakes in these zones range from 10 to 20 km. Areas (3), (4), and (5)

delimit an interesting, en echelon pattern that appears to extend the Badger Road zone along a northwesterly extension of the above mentioned Tanana River trend. Area (2) might represent a westerly extension of the Chena River trend. Again, note that no faults have been mapped in these areas (figure 7). The depths of these events are consistent with their occurrences on some sort of buried structure or fault. Critical questions in this regard are "How long are these buried structures.", "Is there one long fault, all of which could break in a single, large earthquake?" or "Are there several smaller structures each of which might generate a maximum earthquake of only magnitude six?"

What does all of this mean for the Badger Road area? There are two major unknowns which make it difficult to be more specific in the assessment of the hazard for a particular site near the Badger Road aftershock area, zone (1) in figure 6. The first is that we do not know the nature of the structure(s) on which the Fairbanks earthquakes are occurring. The second is that even if we could specify with certainty the level of acceleration to be expected for bedrock sites in this area, we would also need to know some details of the soil types and thicknesses at the site in question. For simple residential structures these questions need not be addressed exhaustively, but for more important structures, as fire stations, hospitals, large buildings, power plants, etc., these questions are critically important.

(1) Sites within 10 km of the Badger Road seismic zone, area (1) on figure 6, should be considered to be in UBC seismic zone 4 for purposes of private dwellings and other non-engineered structures.

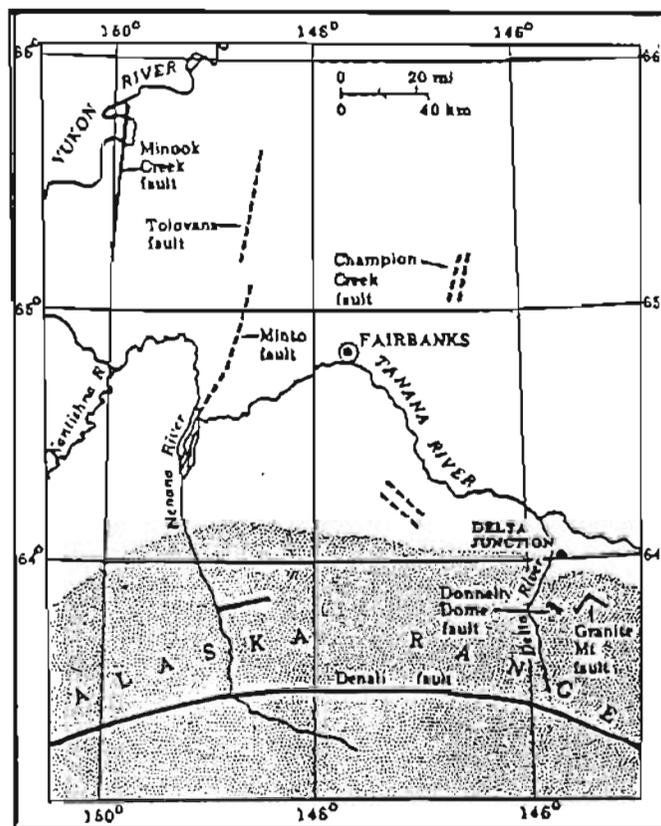
Active faults in central Alaska (Brogan and others, 1975; Gedney and others, 1972; Holmes and Pewé, 1965; Hudson and others, 1977; and Pewé and Holmes, 1964).

Figure 7: Mapped faults in the Fairbanks area. Note that even though there are many earthquakes near Fairbanks, there are no mapped faults. From Pewé (1982).

While it is likely that these two river valleys are structurally controlled, no faults have been mapped along their trends and the nature of the structural contacts or faults along which the earthquakes are occurring remains unknown (see figure 7).

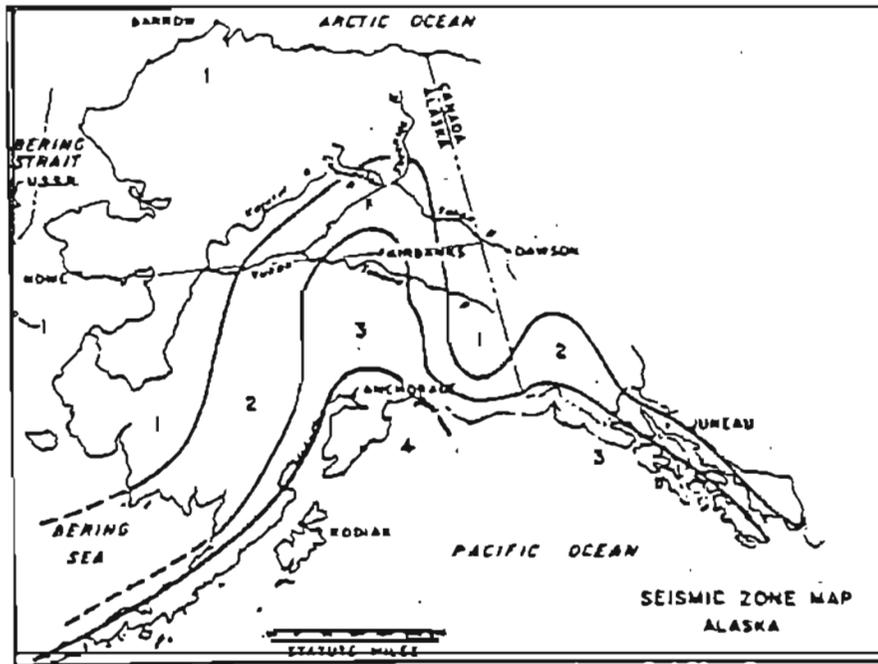
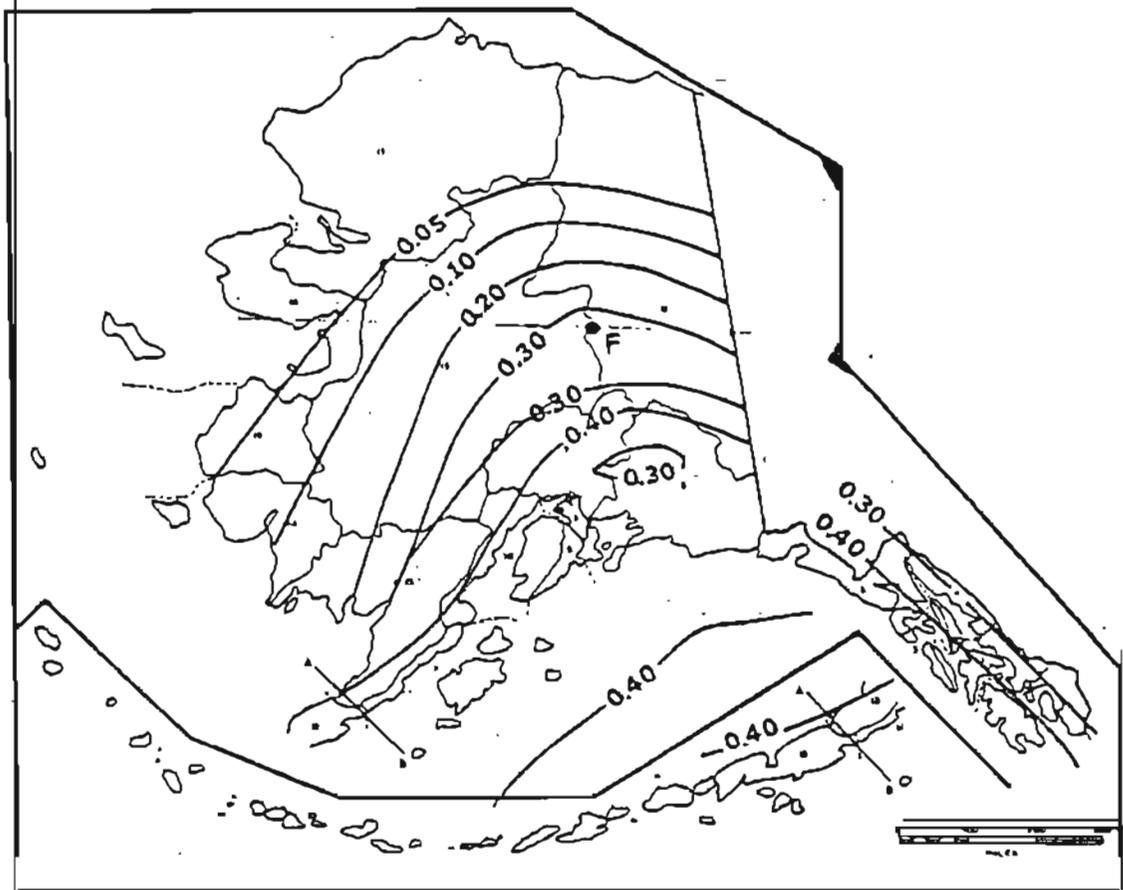
Figure 8: Uniform Building Code Seismic Zonation map for Alaska (top). Note that Fairbanks lies in zone 3. Applied Technology Council contour map of effective peak acceleration to be used for design purposes (bottom). For Fairbanks a value of slightly more than 0.3 g would be appropriate.

That the general earthquake hazard in the Fairbanks area is relatively high can be deduced from the foregoing descriptions of previous seismic activity. The level of the hazard has been assessed in a general way by the seismic zonation map for Alaska adopted by the Uniform Building Code (see figure 8, top). On this map Fairbanks is shown to be in zone 3, the penultimate ranking on a scale which ranges from 0 (negligible hazard) to 4 (highest level of hazard). A similar general picture of the hazard is given by the map shown in the bottom of figure 8. This map, published by the Applied Technology Council (ATC 3-06, 1978), depicts contours of the maximum level of peak accelerations expected across Alaska. Again, it can be seen that Fairbanks is in a zone where the expected level of strong ground motion during earthquakes is among the highest in the state (indeed, in the world).

A reasonably conservative assumption, in light of the seismic activity of the Badger Road seismic zone, is that it does represent a buried fault capable of generating a magnitude 7.5 earthquake every 400 or 500 yr.; this would translate into design peak accelerations a little higher than those given by the map in the bottom of figure 8 and the assignment of the immediate Badger Road area to seismic zone 4 instead of zone 3 as specified by the UBC map shown in the top of figure 8.

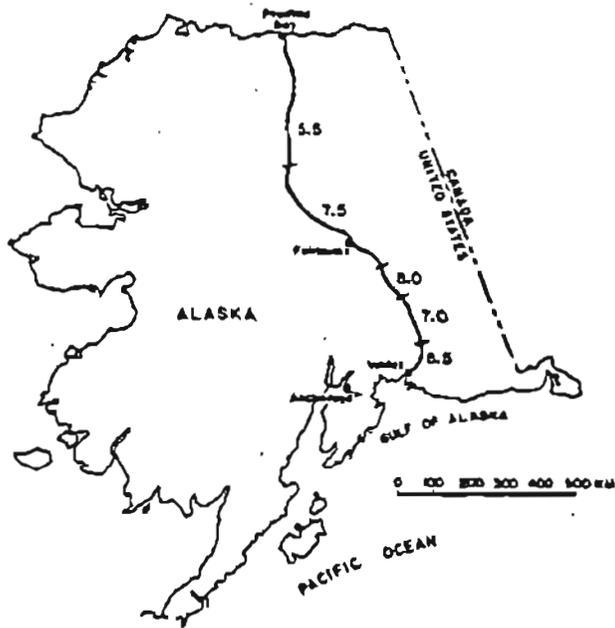
Map of proposed route of Trans-Alaska oil pipeline showing seismic zonation and magnitude of design.
