A BRIEF OUTLINE OF THE SEISMIC HAZARD  
IN THE FAIRBANKS/NORTH POLE AREA

Dr. John N. Davies

Alaska Division of  
Geological and Geophysical Surveys

March 1983

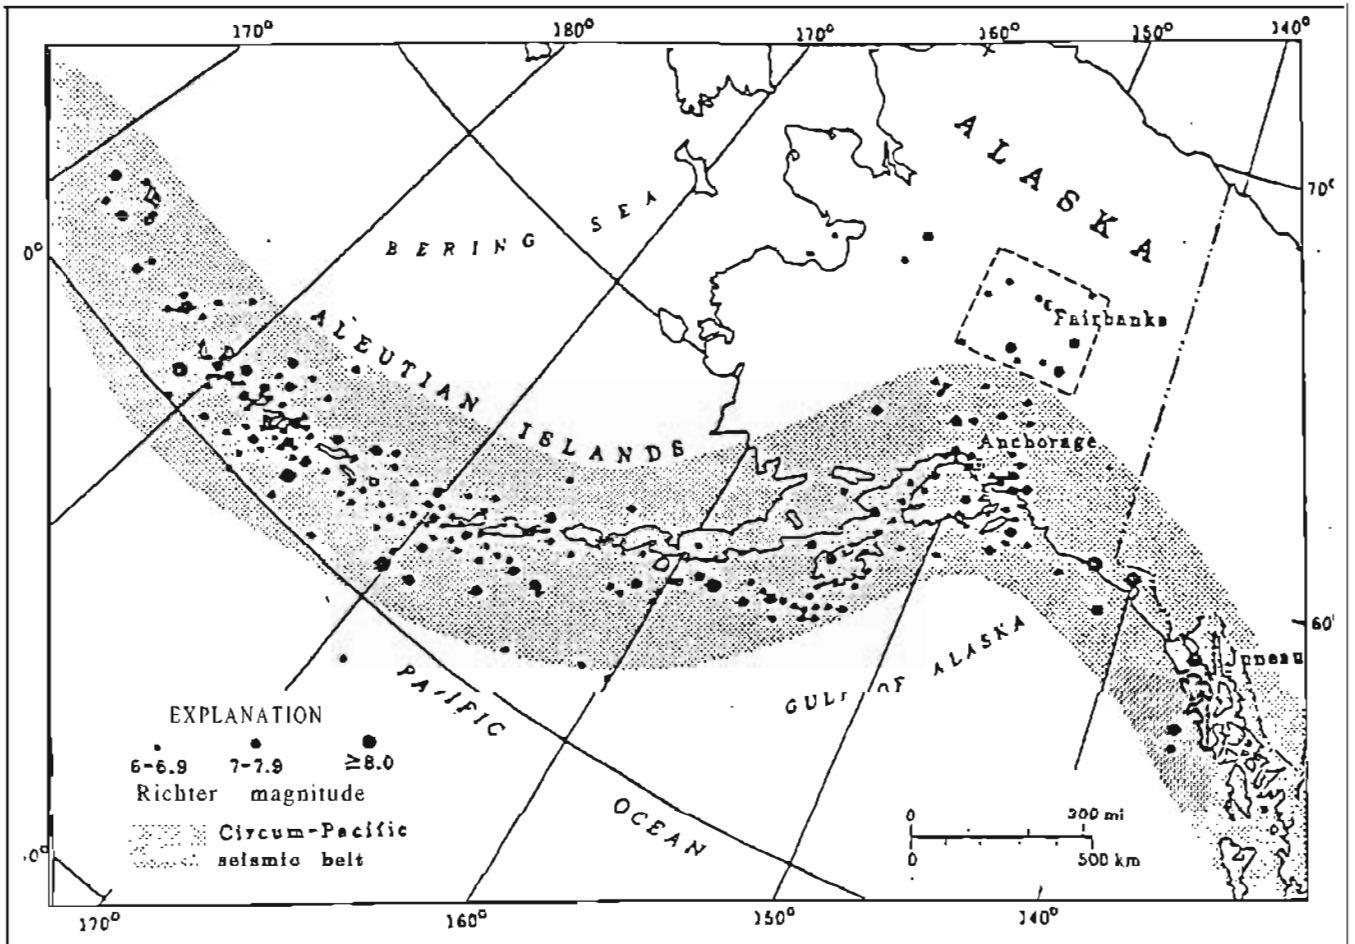
• Epicenters of earthquakes with Richter magnitudes 6.0 and larger in Alaska from 1699 to 1967. Shaded area represents the Circum-Pacific seismic belt in Alaska. The dashed rectangle encloses area shown in figure 81 (modified from Jordan and others, 1966).

Figure 1: Map showing the relationship of the Fairbanks area to the Circum-Pacific seismic belt. From Pewé (1982).

The proximity of Fairbanks to the Circum-Pacific seismic belt is shown in figure 1. The high level of seismic activity along the Aleutian Islands and the south coast of Alaska results from the collision of the Pacific Plate with Alaska. The floor of the Pacific Ocean is moving northwestward with respect to Alaska at about 6 cm/yr. This motion is taken up by the Pacific Plate being thrust under Alaska at an angle of about 45°. This underthrusting is illustrated in figure 2. The northernmost edge of the Pacific Plate, beneath central Alaska, is below the northern fringe of the Alaska Range; under Healy, Gold King and perhaps Delta Junction for example. This means that at its closest point of approach the Pacific Plate is about 50 to 75 mi south of Fairbanks and some 100 mi below groundlevel. On the scale of the Pacific-Plate this is a very small distance, which means that we should expect the effect of the collision of the Pacific Plate with Alaska to be felt strongly in Fairbanks, and this is indeed the case.

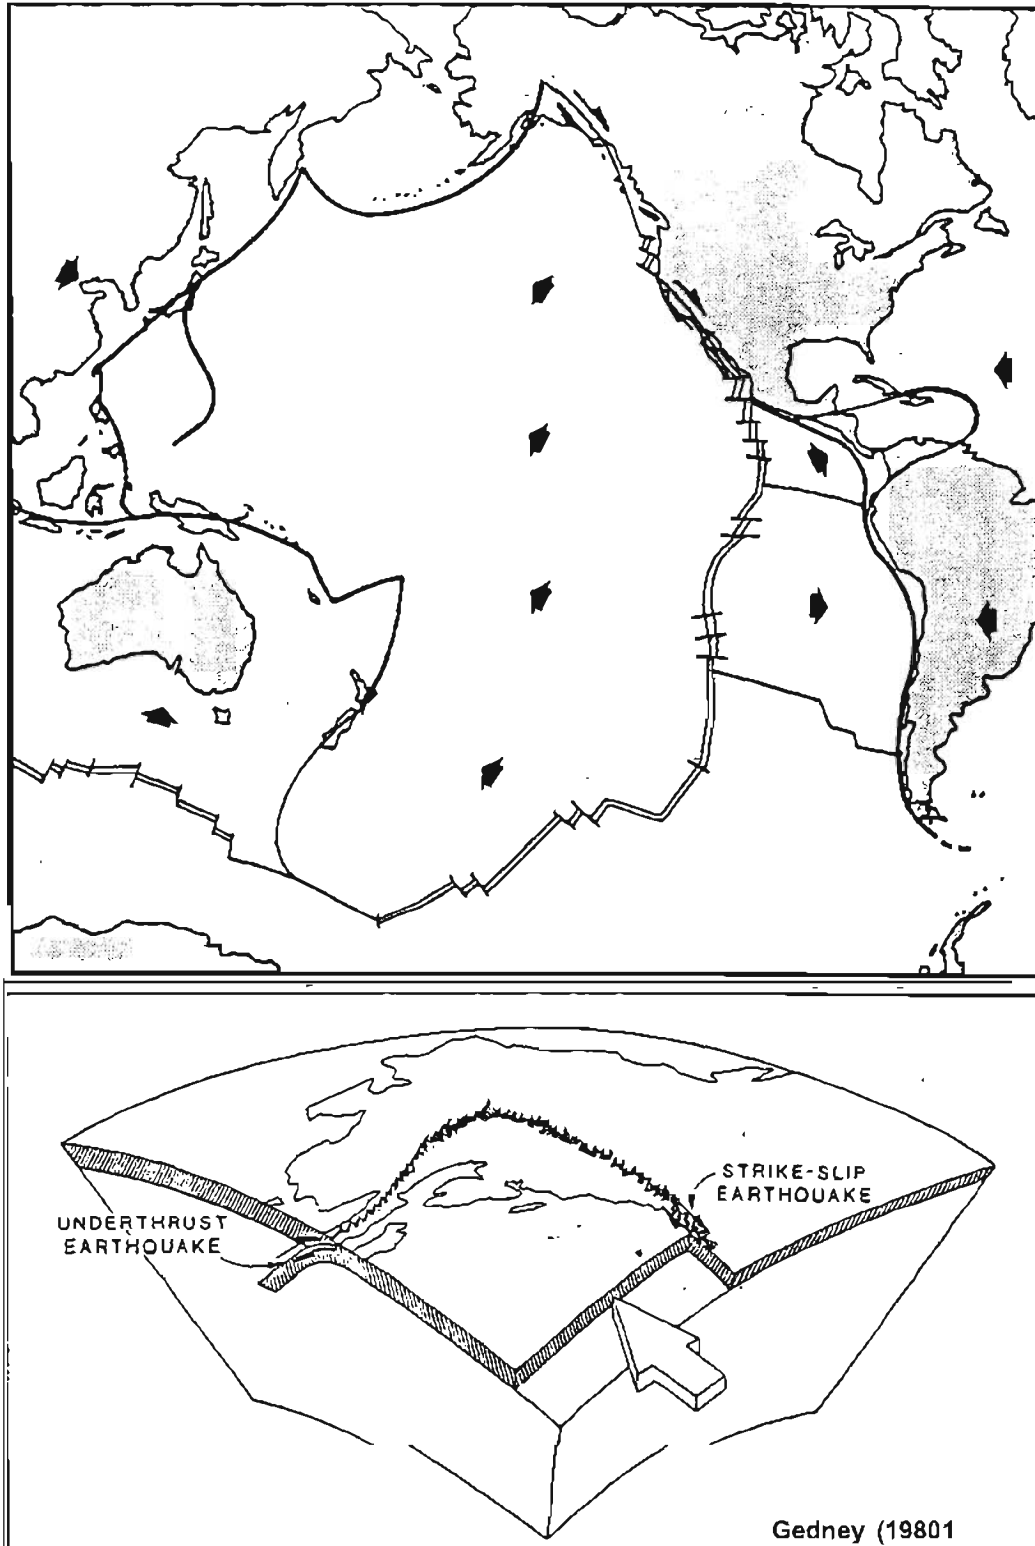
Figure 2: Schematic diagram of the boundary between the Pacific Plate and Alaska (top) and of the geometry of the underthrusting of the Pacific Plate beneath Alaska (bottom) From Gedney (1980).

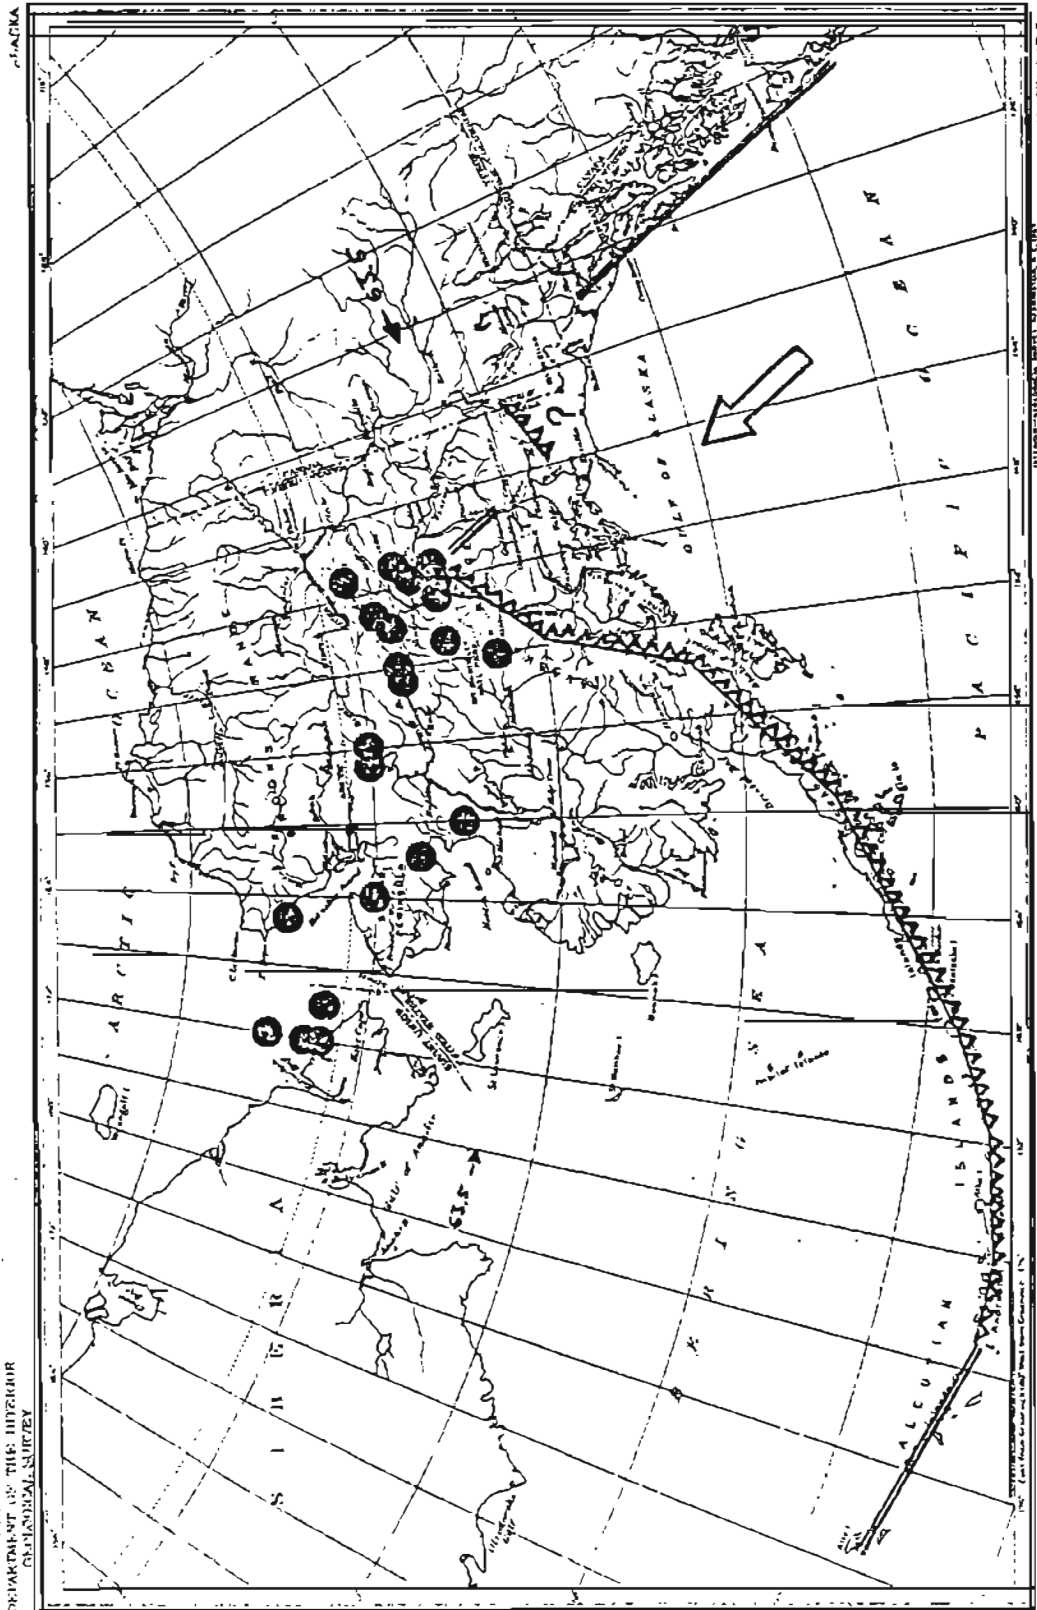
Figure 3: Map showing the locus of all shallow earthquakes of magnitude greater than 6.0 in Alaska north of 63.5°N in relation to the Pacific plate-Alaska boundary. The arrow indicates the direction of motion of the Pacific plate with respect to Alaska. From Davies (1983).

The effect of this collision is illustrated in figure 3, which shows the locations of all shallow (less than 30 mi deep) earthquakes of magnitude greater than 6.0 that have occurred in Alaska north of 63.5°N latitude. The epicenters of these earthquakes all lie in a band extending from Delta Junction through Kotzebue. Not shown in this figure is the fact that the larger events tend to occur closer to the east end of this band. The largest event was a magnitude 8 earthquake that occurred in 1904 (see appendix). Several other shocks in the greater Fairbanks area have had magnitudes of approximately 7½.

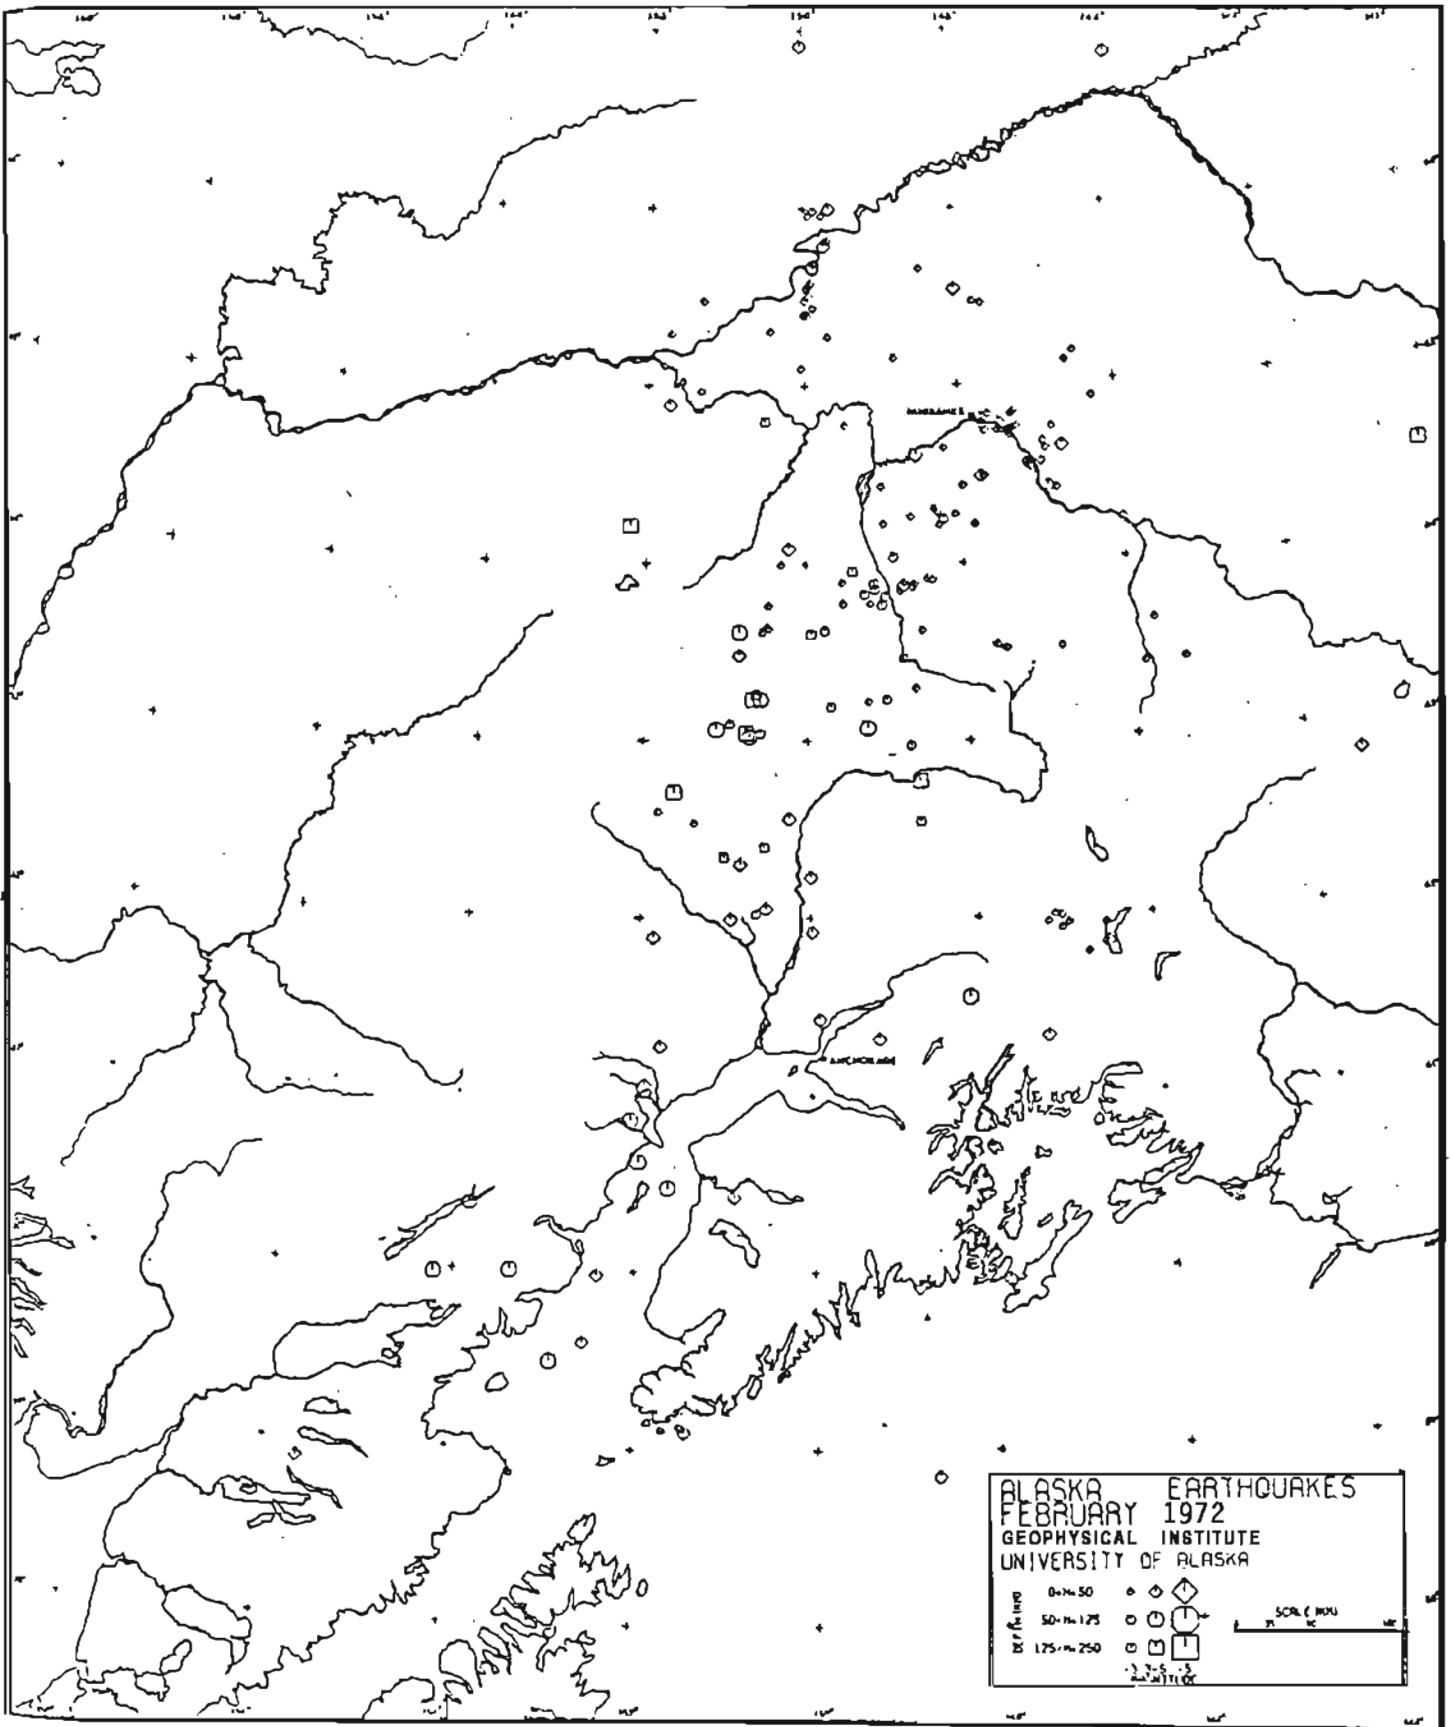
Figure 4a: Central Alaska earthquakes located by the University of Alaska Geophysical Institute for the month of February 1972. Note activity in Fairbanks area and absence of activity in the Yukon Flats north of Fairbanks. From VanWormer, Davies, and Gedney (1973).

February 1972 epicenter map.

The Badger Road area has been the source area for many small earthquakes ever since the 1967 Fairbanks earthquakes. **By** contrast, other areas are relatively quiet except for an occasional burst of activity. An example of this is the Yukon Flats area as shown in figures 4a, 4b and 4c. In each of these figures, which show central Alaskan earthquakes for the months of February, April and September, 1972 respectively, the Fairbanks area is seen to be quite active whereas the Yukon Flats area is quiet in February and September, only showing a brief burst of activity in April.

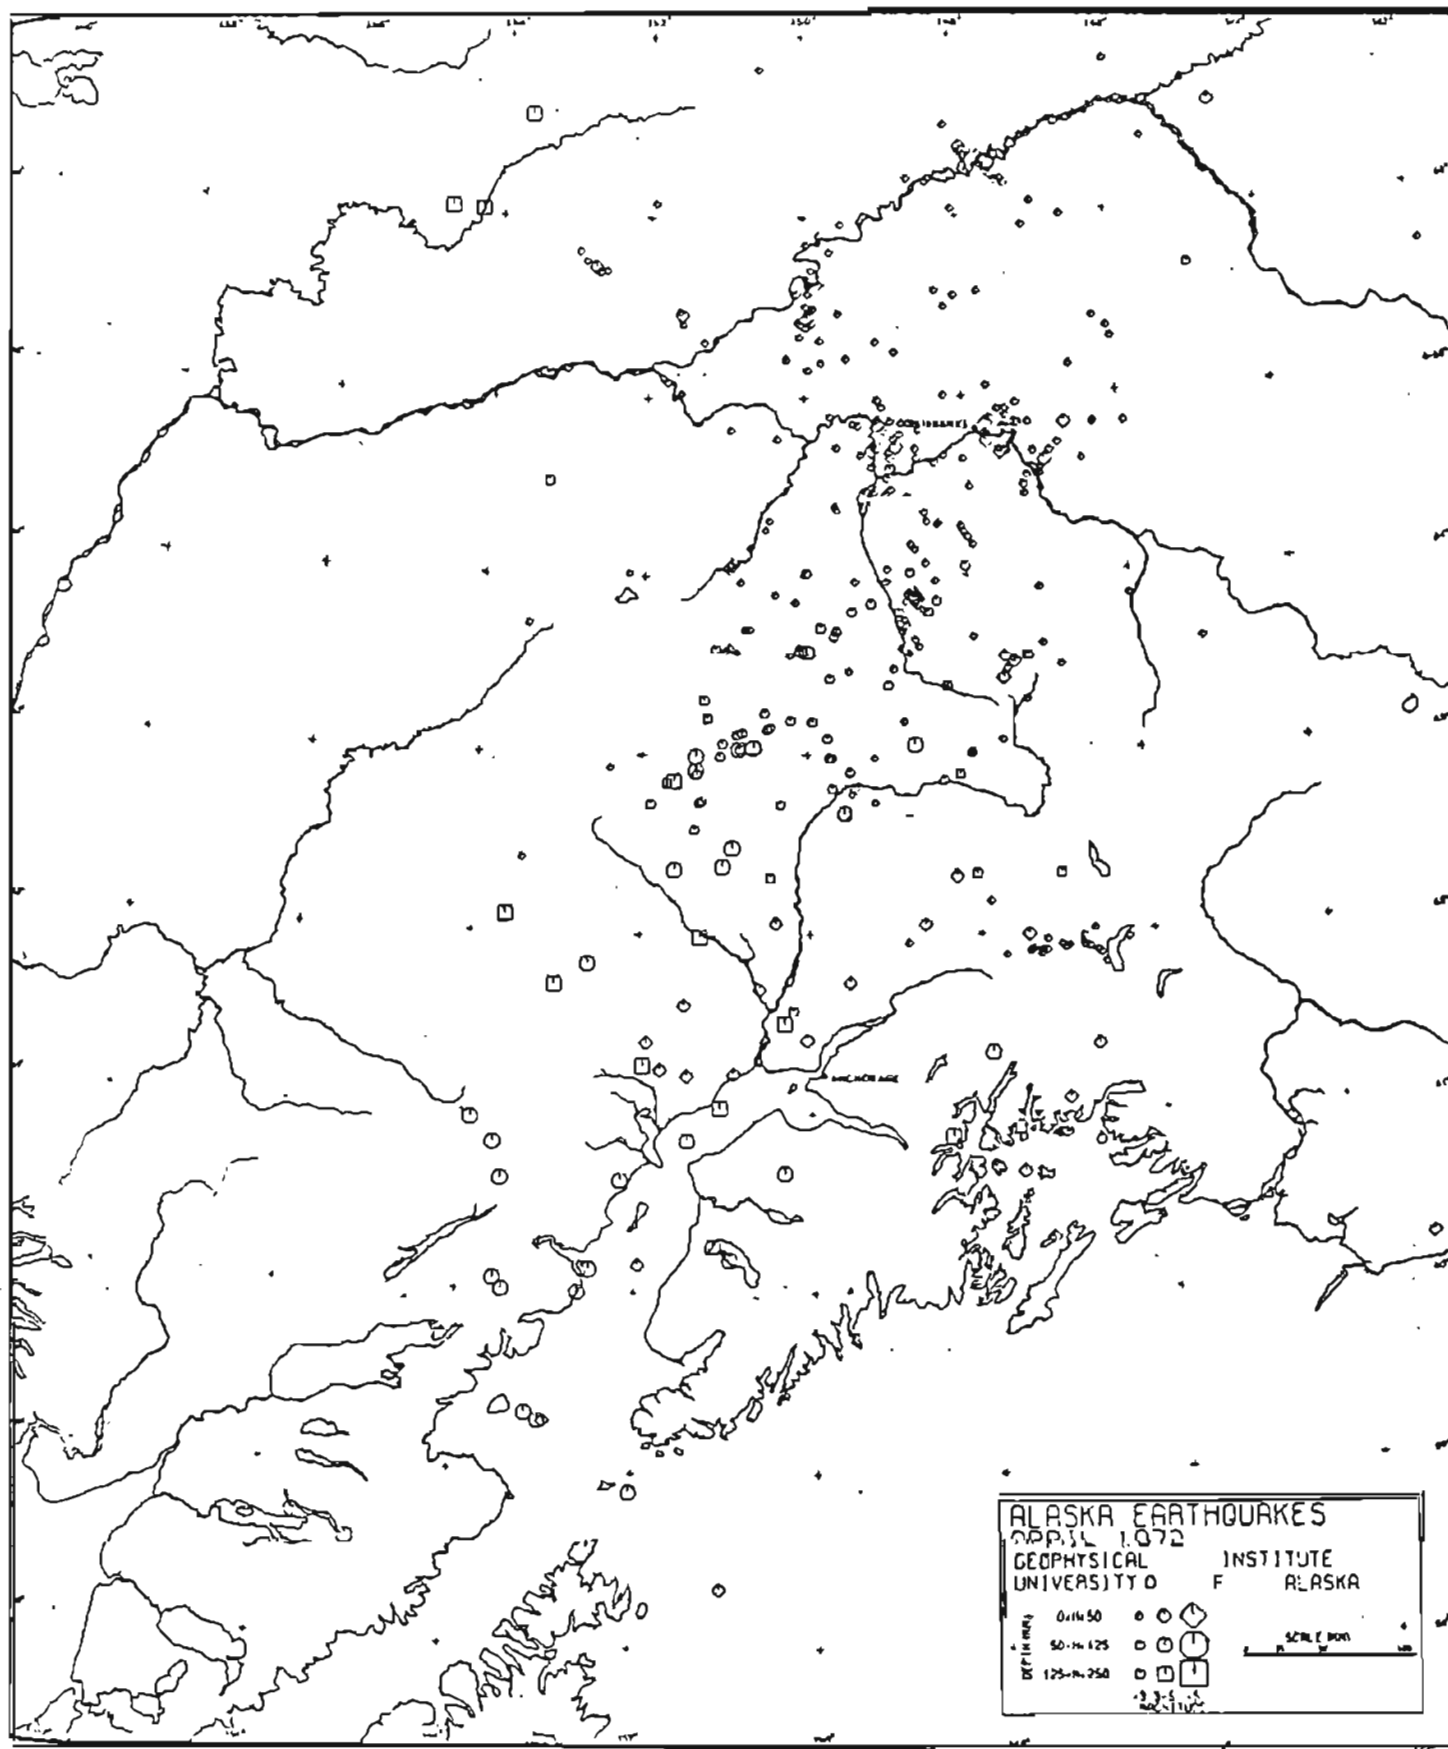
Figure 4b: Same as 4a, for the month of April, 1972. Note continuing activity in Fairbanks area and new activity in Yukon Flats. From VanWormer, Davies, and Gedney (1973).

April 1972 epicenter map. Note activity in Yukon Flats.

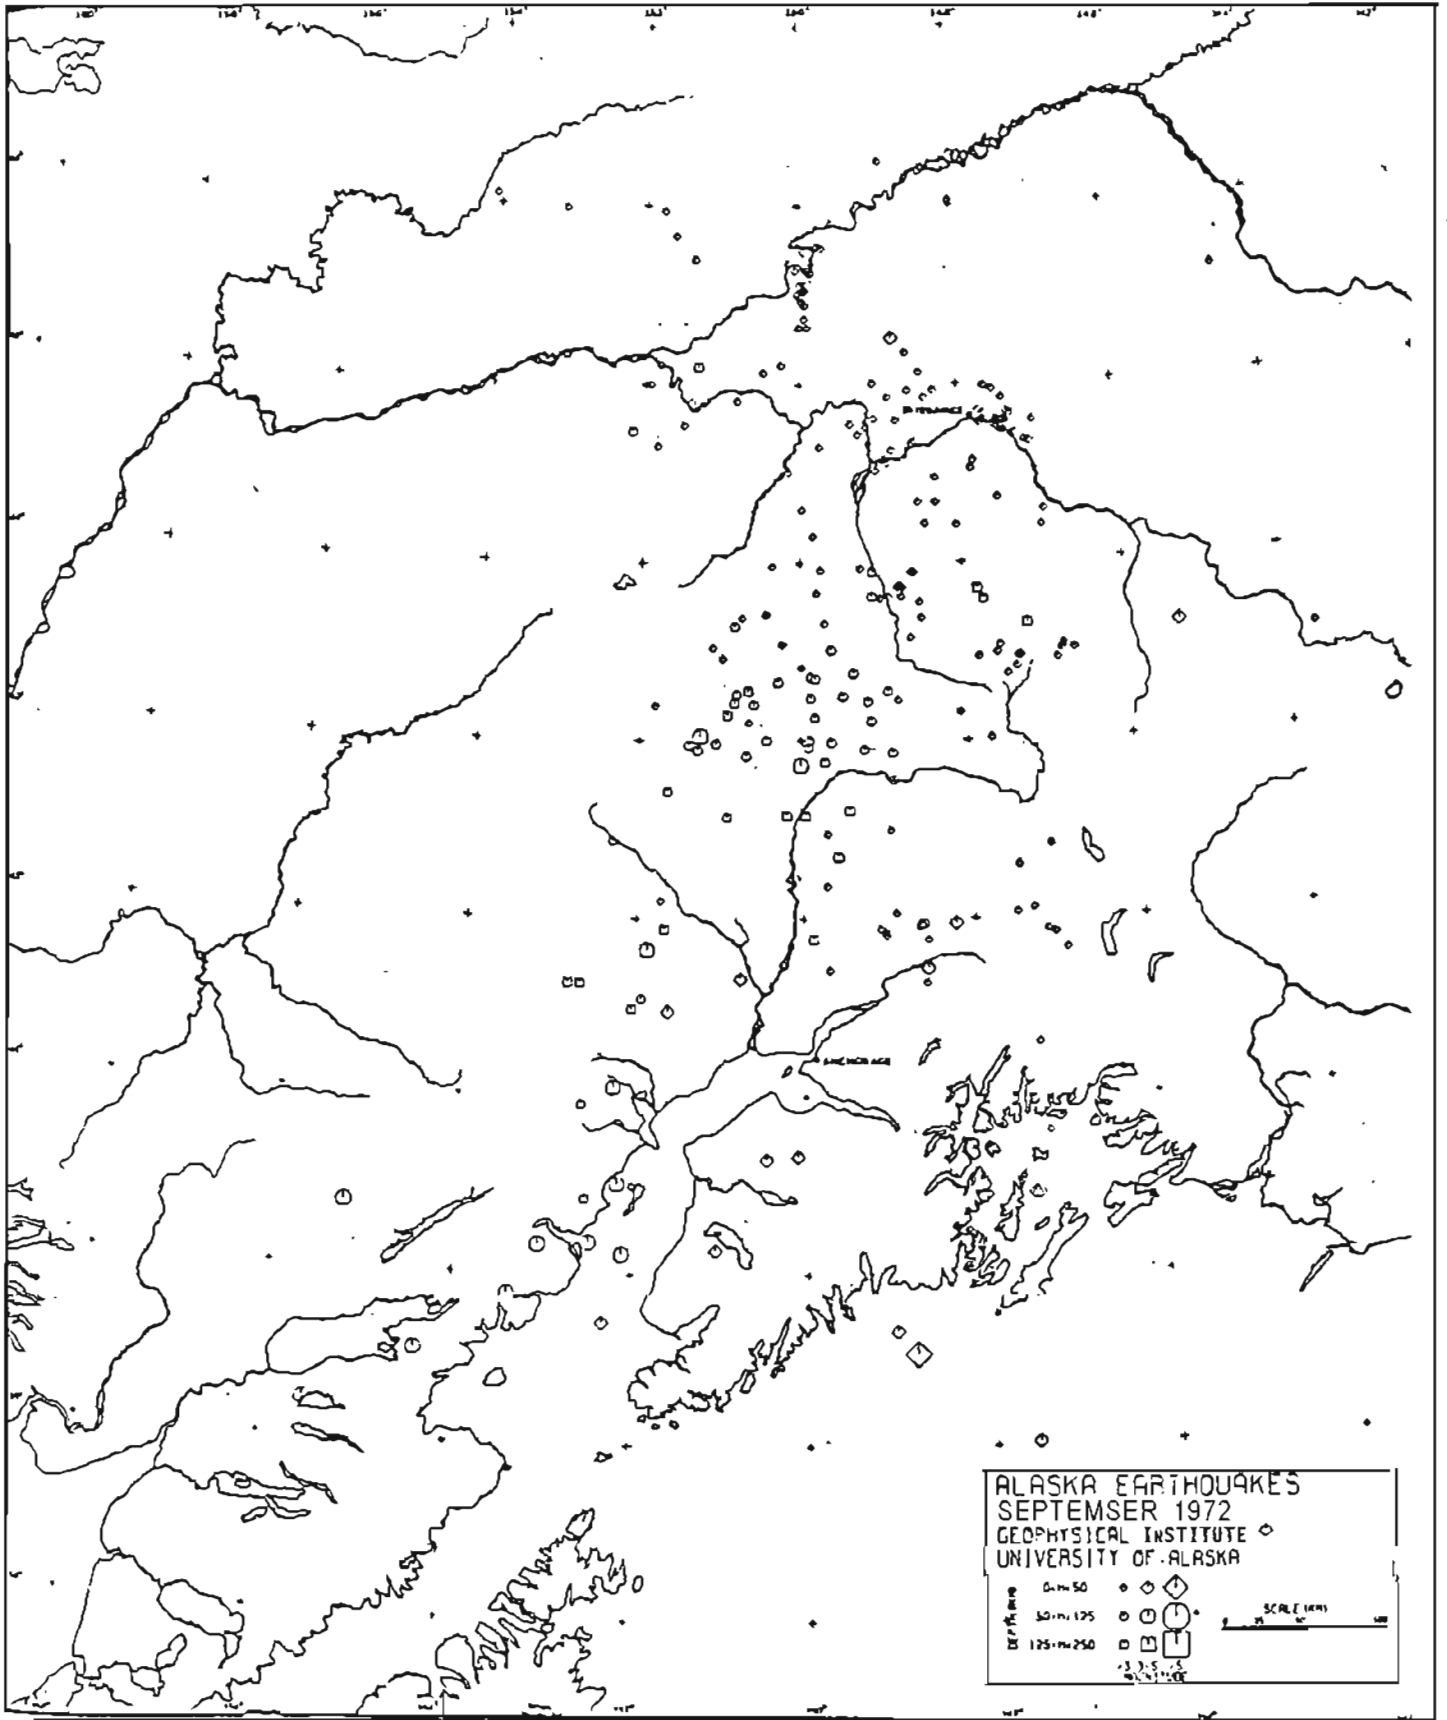
Figure 4c: Same as 4a, for the month of September, 1972. Note continuing activity in the Fairbanks area and cessation of activity in the Yukon Flats. From VanWormer, Davies, and Gedney (1973).

September 1972 epicenter map.

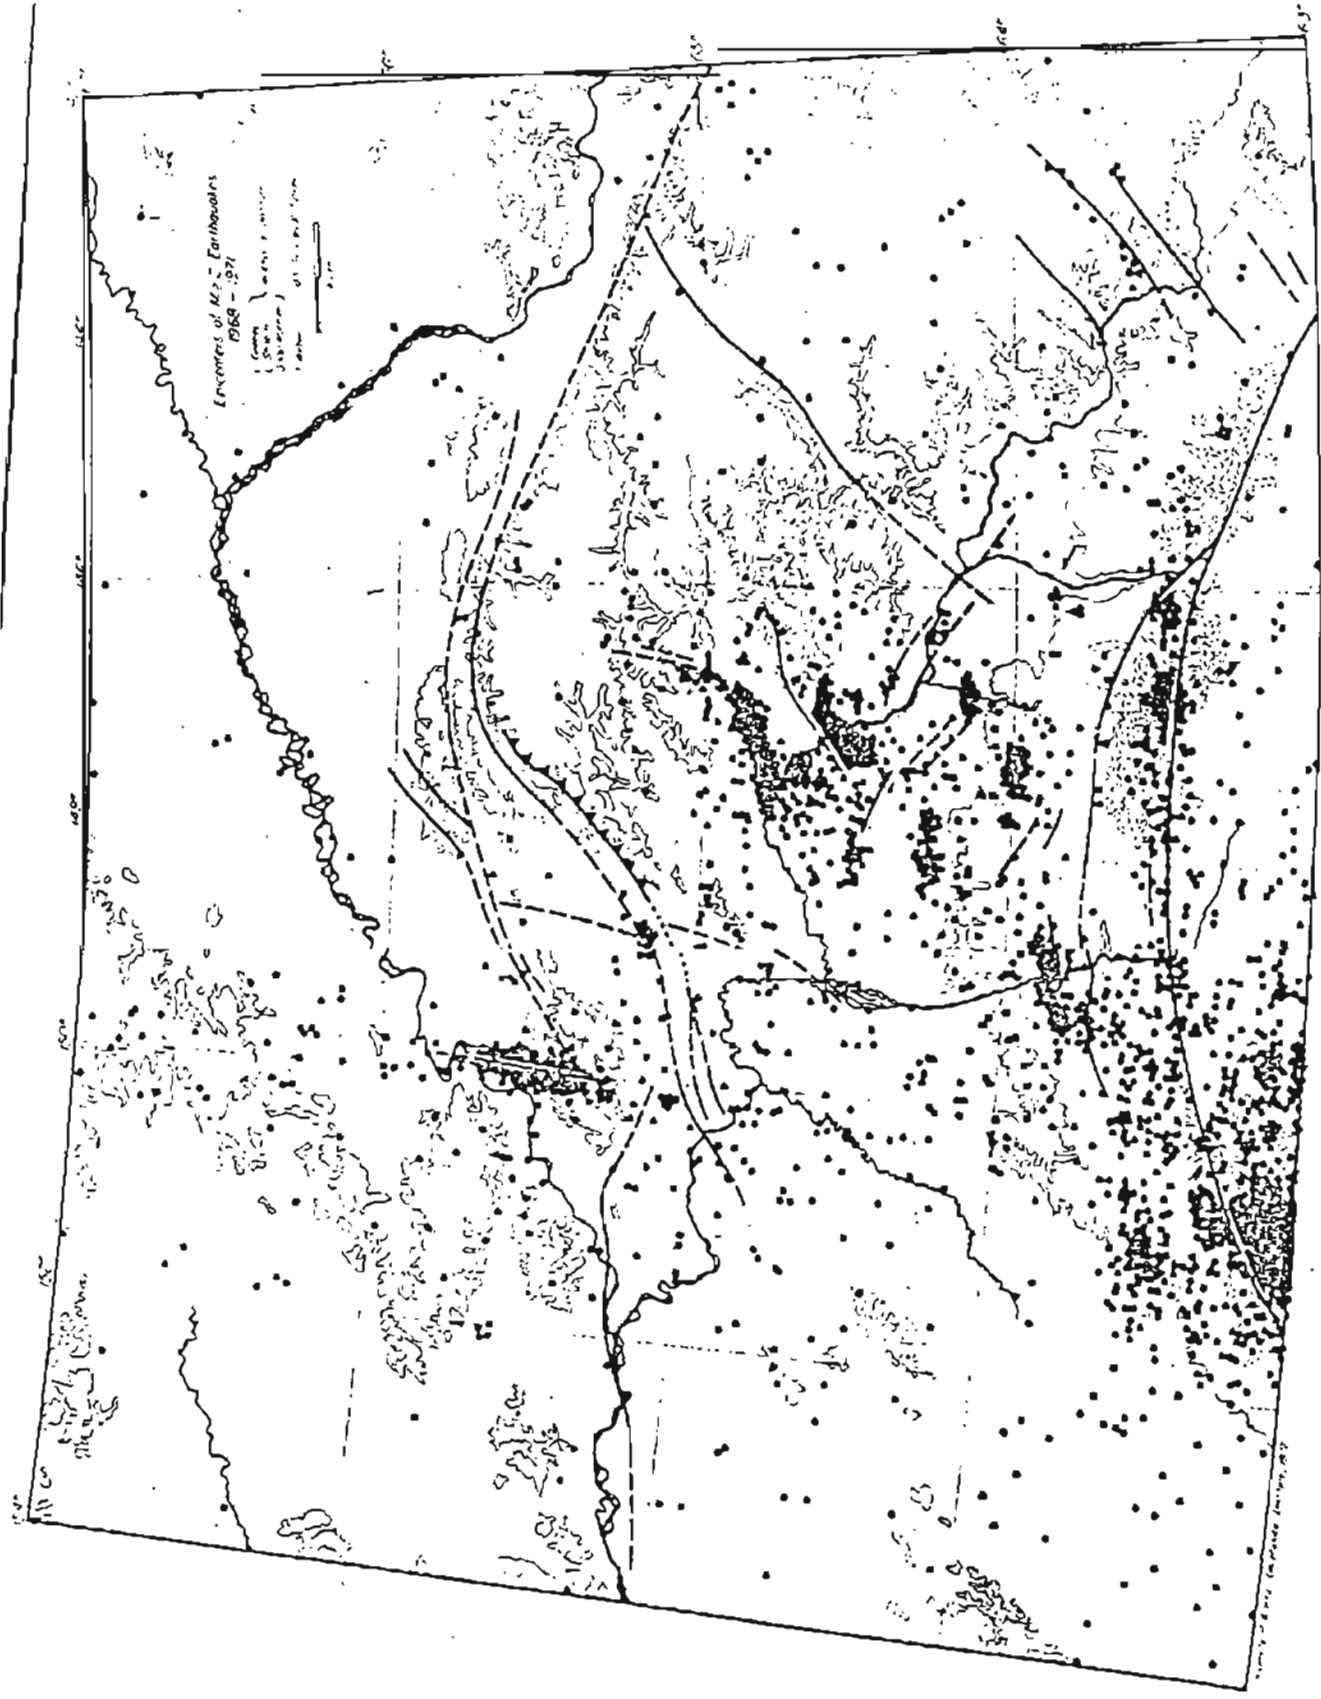
Figure 5: Correlation of epicenters with mapped faults. Note both ENE-WSW and NNW-SSE alignments of epicenters trending through the Fairbanks area. From Gedney and others (1972).

At least since the 1967 earthquakes in the Badger Road area, Fairbanks has been one of the most active seismic **zones** in the Interior of Alaska. Figure 5 shows that Fairbanks is located at the intersection of two trends of seismic activity, one extending about east-west and subparallel to the Chena River Valley, and the second, a somewhat more diffuse northwest-southeast trend following the Tanana River Valley between Fairbanks and Salcha.

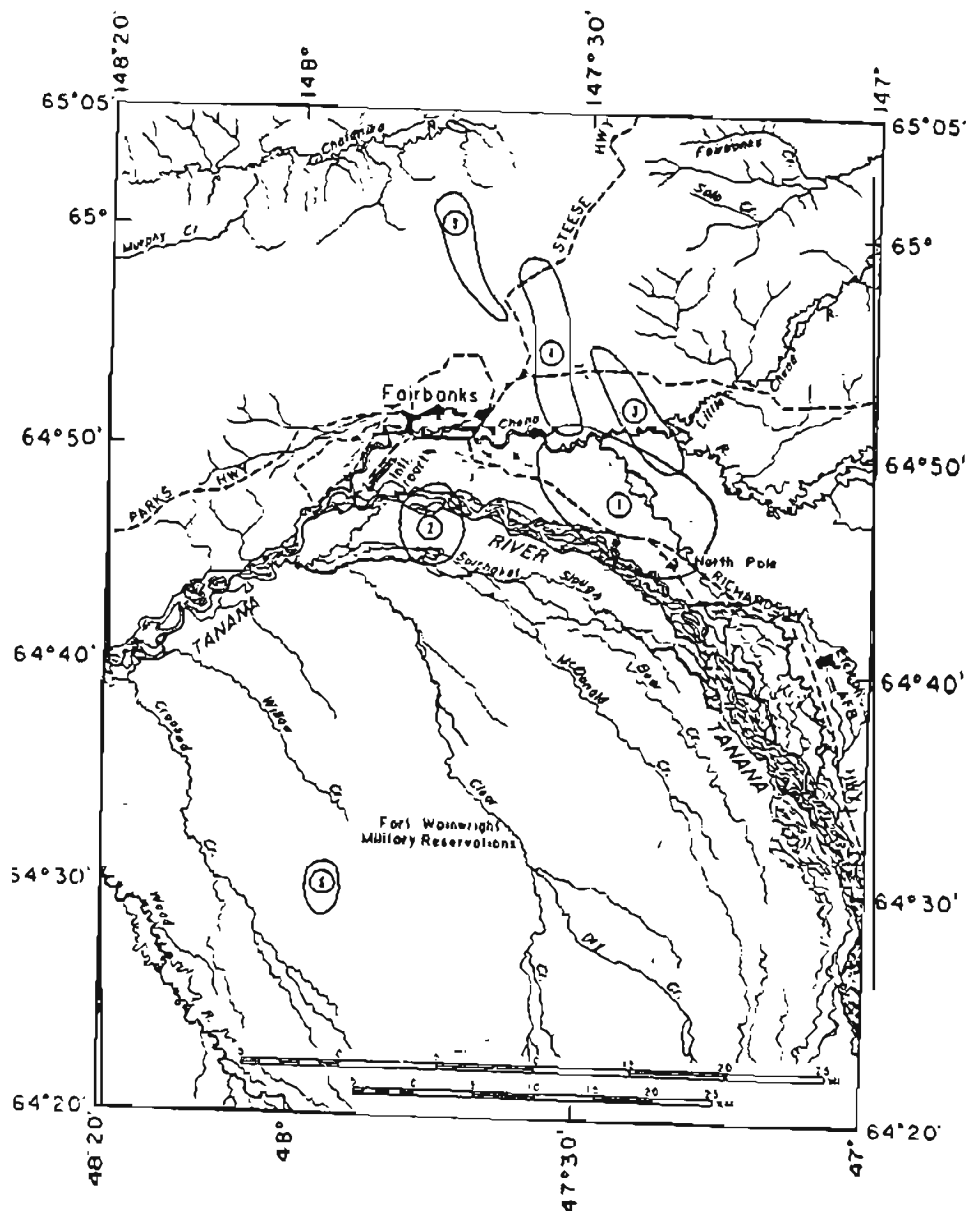
Shaded areas indicate locations of earthquake swarms referenced in text. Area labeled 1 is aftershock zone of June 1966 earthquakes. Area 2 is epicentral area of swarm which developed in late 1970, early 1971. Swarms in areas 3 and 4 developed in February 1977 and February 1979, respectively. Swarm in area 5 occurred in October 1981, and earthquakes in area 6, some of which are <sup>uncollected</sup> in Table 1, began on 30 December 1981.

Figure 6: Recent aftershock zones and areas of swarming in Fairbanks area, Note en echelon arrangement of zones 3, 4, and 5 and general NNW-SSE alignment of the group comprising zones 1, 3, 4, and 5. From Gedney and others (1982).

Since 1967 there have been four notable sequences of earthquakes in the Fairbanks area. These are shown in figure 6. The shaded area marked (1) corresponds to the aftershock zone of the 1967 earthquakes. Areas (2), (3), (4), and (5) mark the locations of earthquake sequences that occurred in 1970-71, 1977, 1979, and 1951, respectively. Typical depths for earthquakes in these zones range from 10 to 20 km. Areas (3), (4), and (5)

delimit an interesting, en echelon pattern that appears to extend the Badger Road zone along a northwesterly extension of the above mentioned Tanana River trend. Area (2) might represent a westerly extension of the Chena River trend. Again, note that no faults have been mapped in these areas (figure 7). The depths of these events are consistent with their occurrences on some sort of buried structure or fault. Critical questions in this regard are "How long are these buried structures.", "Is there one long fault, all of which could break in a single, large earthquake?" or "Are there several smaller structures each of which might generate a maximum earthquake of only magnitude six?"

What does all of this mean for the Badger Road area? There are two major unknowns which make it difficult to be more specific in the assessment of the hazard for a particular site near the Badger Road aftershock area, zone (1) in figure 6. The first is that we do not know the nature of the structure(s) on which the Fairbanks earthquakes are occurring. The second is that even if we could specify with certainty the level of acceleration to be expected for bedrock sites in this area, we would also need to know some details of the soil types and thicknesses at the site in question. For simple residential structures these questions need not be addressed exhaustively, but for more important structures, as fire stations, hospitals, large buildings, power plants, etc., these questions are critically important.

(1) Sites within 10 km of the Badger Road seismic zone, area (1) on figure 6, should be considered to be in UBC seismic zone 4 for purposes of private dwellings and other non-engineered structures.

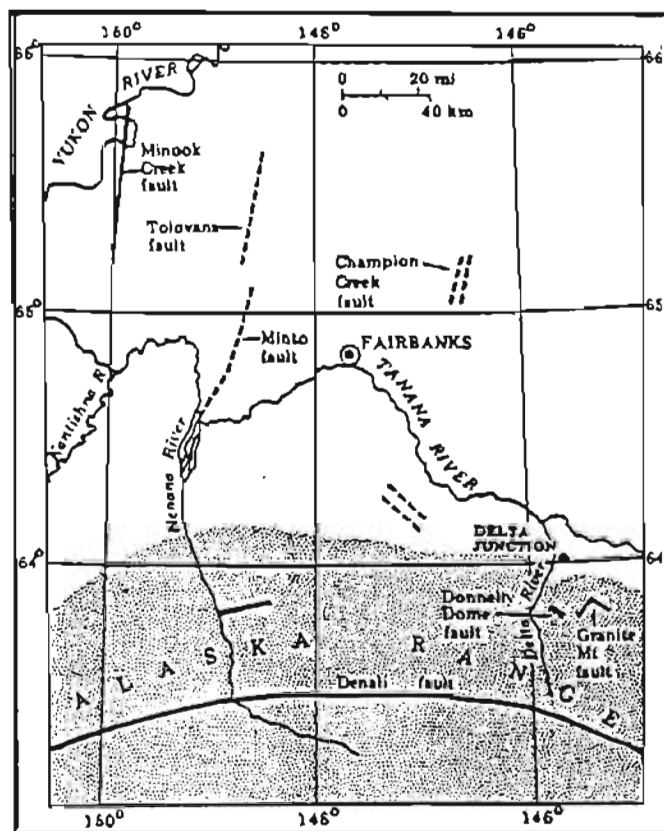
Active faults in central Alaska (Brogan and others, 1975; Gedney and others, 1972; Holmes and Pewé, 1965; Hudson and others, 1977; and Pewé and Holmes, 1964).

Figure 7: Mapped faults in the Fairbanks area. Note that even though there are many earthquakes near Fairbanks, there are no mapped faults. From Pewé (1982).

While it is likely that these two river valleys are structurally controlled, no faults have been mapped along their trends and the nature of the structural contacts or faults along which the earthquakes are occurring remains unknown (see figure 7).

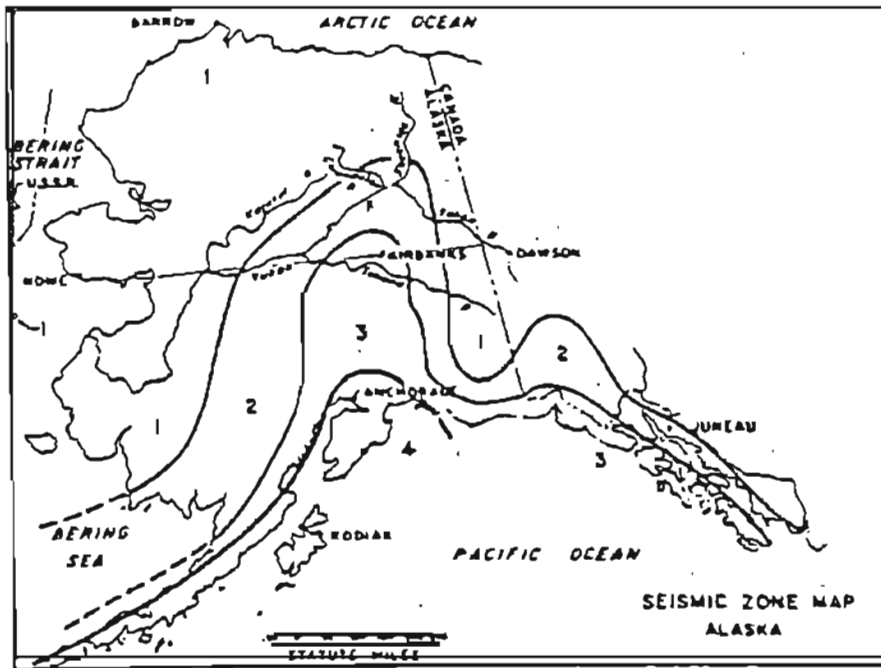
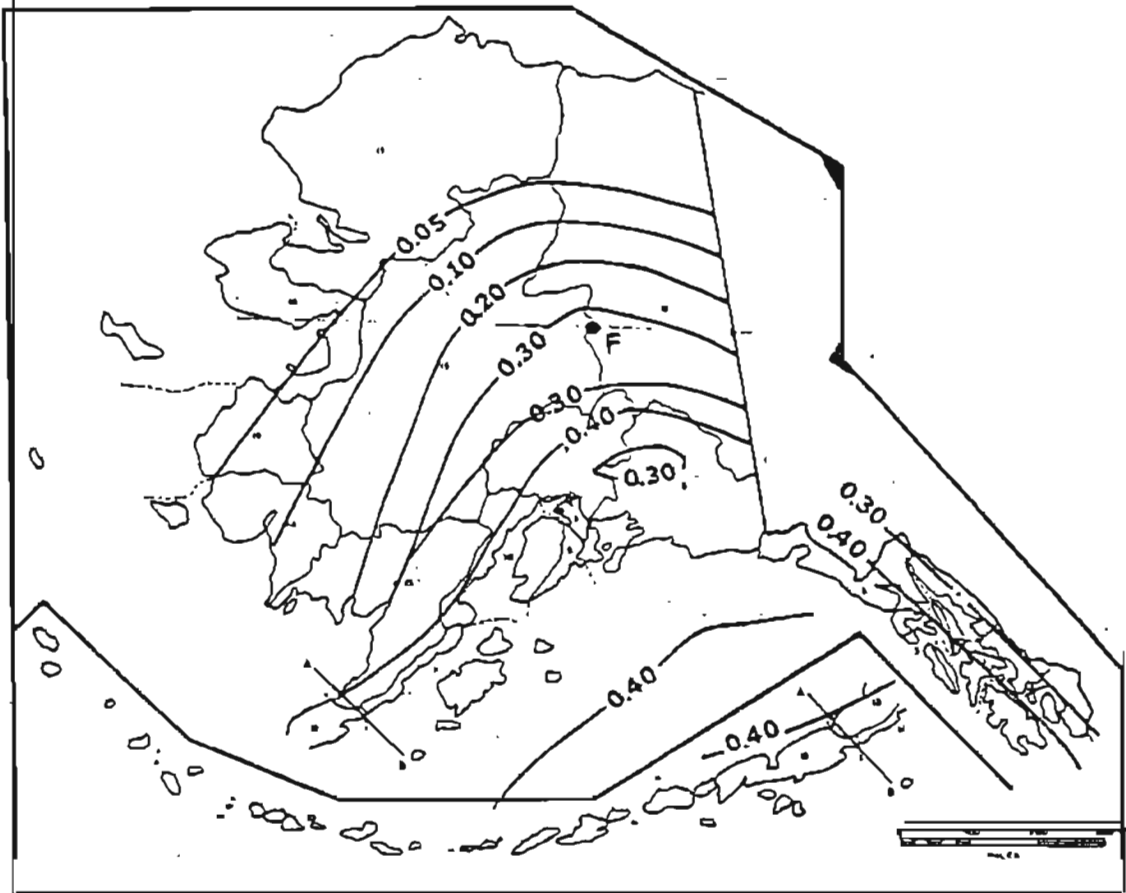
Figure 8: Uniform Building Code Seismic Zonation map for Alaska (top). Note that Fairbanks lies in zone 3. Applied Technology Council contour map of effective peak acceleration to be used for design purposes (bottom). For Fairbanks a value of slightly more than 0.3 g would be appropriate.

That the general earthquake hazard in the Fairbanks area is relatively high can be deduced from the foregoing descriptions of previous seismic activity. The level of the hazard has been assessed in a general way by the seismic zonation map for Alaska adopted by the Uniform Building Code (see figure 8, top). On this map Fairbanks is shown to be in zone 3, the penultimate ranking on a scale which ranges from 0 (negligible hazard) to 4 (highest level of hazard). A similar general picture of the hazard is given by the map shown in the bottom of figure 8. This map, published by the Applied Technology Council (ATC 3-06, 1978), depicts contours of the maximum level of peak accelerations expected across Alaska. Again, it can be seen that Fairbanks is in a zone where the expected level of strong ground motion during earthquakes is among the highest in the state (indeed, in the world).

A reasonably conservative assumption, in light of the seismic activity of the Badger Road seismic zone, is that it does represent a buried fault capable of generating a magnitude 7.5 earthquake every 400 or 500 yr.; this would translate into design peak accelerations a little higher than those given by the map in the bottom of figure 8 and the assignment of the immediate Badger Road area to seismic zone 4 instead of zone 3 as specified by the UBC map shown in the top of figure 8.

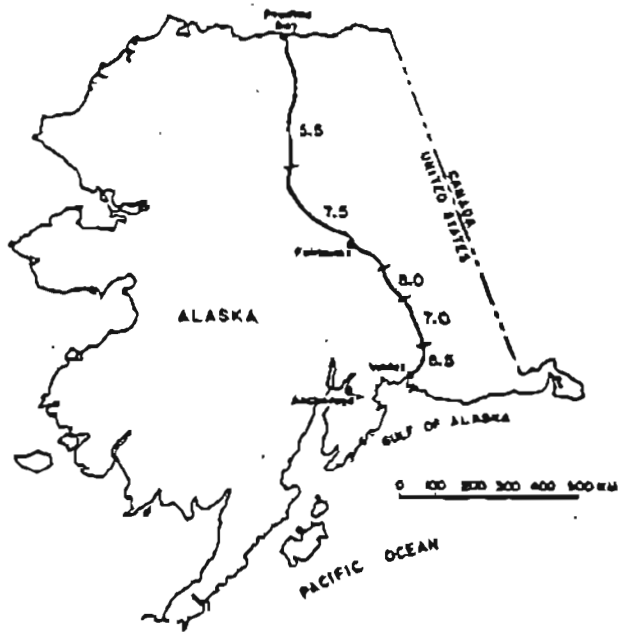
Map of proposed route of Trans-Alaska oil pipeline showing seismic zonation and magnitude of design.

Design earthquakes along the pipeline route
