UNITED STATES DEPARTMENT OF THE INTERIOR
GEOLOGICAL SURVEY

GEOLOGIC INVESTIGATIONS OF PROPOSED SHEEP CREEK, CARLSON
CREEK, AND TURNER LAKE POWER SITES, ALASKA

George Plafker

1956

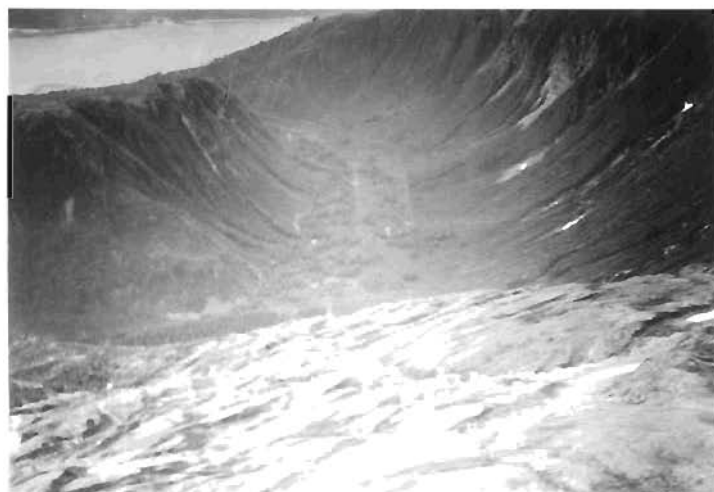
Figure 2. Aerial view of part of Sheep Creek valley.

Figure 2. Aerial view of Sheep Creek basin looking downstream (west) from drainage divide northwest of Hawthorne Peak. Note smooth, U-shaped profile of valley and talus cones at base of slopes. Buildings on valley floor near center of picture are at the Portal Camp of the Alaska-Juneau Gold Mining Company. The proposed dam site is at the lower end of the basin. Gastineau channel in background.

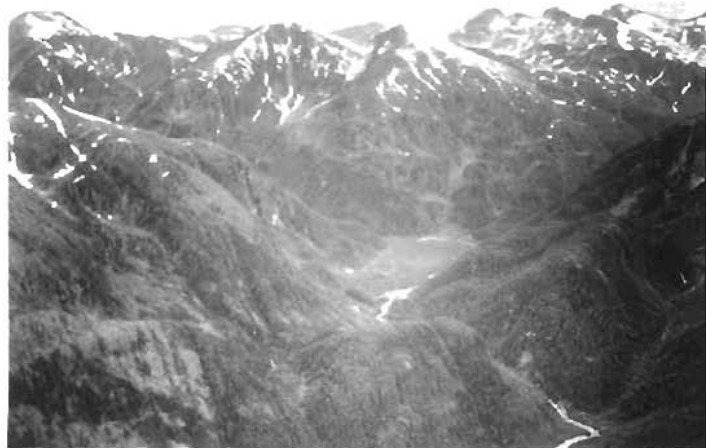
Figure 3. Aerial view of part of Carlson Creek valley.

Figure 3. Aerial view of part of Carlson Creek basin looking upstream (west) from a point over the mouth of Carlson Creek. Dam site is in gorge cut through ridge in foreground. Trend of creek at the dam site and parallel gullies on the ridge in foreground define prominent northeast-trending joint set. Creek in lower right corner of picture defines trend of the foliation. Flat-floored basin above the dam site is an alluvium-filled lake.

Carlson Creek discharges into Sunny Cove on the west shore of Taku Inlet at latitude $58^{\circ} 18.4' N.$, and longitude $134^{\circ} 08.5' W.$, a distance of 20 miles by sea from Juneau (fig. 1). Carlson Creek is formed at the confluence of its tributaries, the Salmon Fork and Gold Fork, on the west flank of Olds Mountain. From this point the creek flows with a steep gradient to its junction with the Sheep Fork which heads between Sheep Mountain and Hawthorne Peak. Carlson Creek then flows eastward at a low gradient across a flat-floored basin for slightly over 1 mile before plunging through a narrow, northeastward-trending canyon half a mile long. After emerging from the canyon the creek turns sharply southeastward, and flows on a slightly meandering course for $1\text{--}3/8$ miles to its mouth at Sunny Cove. The drainage area of Carlson Creek is 26.7 square miles, of which 23.3 square miles drains to the proposed dam site. The creek is clear with only a small proportion of melt water derived from isolated ice and snow patches in the drainage basin. See figure 3 for aerial view of part of Carlson Creek valley.

Development of water power from Carlson Creek would require a storage reservoir with a maximum estimated elevation of about 500 feet. The reservoir would cover a portion of the Carlson Creek and Sheep Fork valleys (fig. 3).

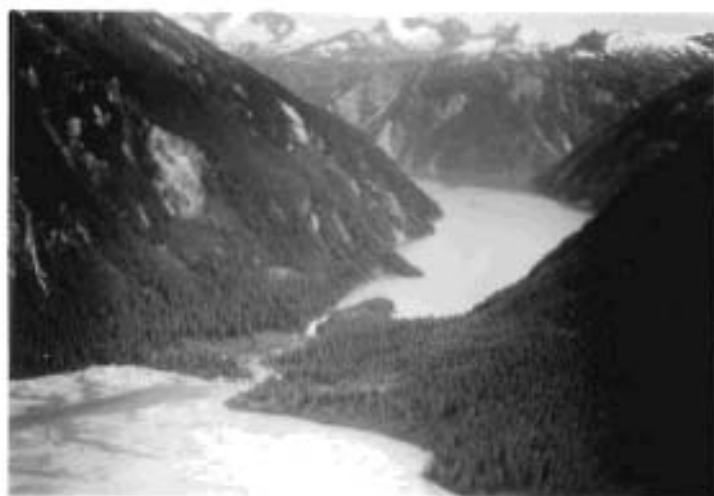
Figure 4. Aerial view of lower end of Turner Lake.

Figure 4. Aerial view of Turner Creek and lower end of Turner Lake looking east from over Taku I-100. Wide steep-sided glaciated valley occupied by Turner Lake. Large scar on steep slope to left of the lake outlet (light area) is probable source of mass slide debris at the dam site. Light-colored area at creek mouth is tidal mud flat.
