HYDROLOGY FOR LAND-USE PLANNING: THE HILLSIDE AREA, ANCHORAGE, ALASKA

OPEN-FILE REPORT 75-105

Prepared by the U.S. Department of the Interior,
Geological Survey in cooperation with the
Greater Anchorage Area Borough.

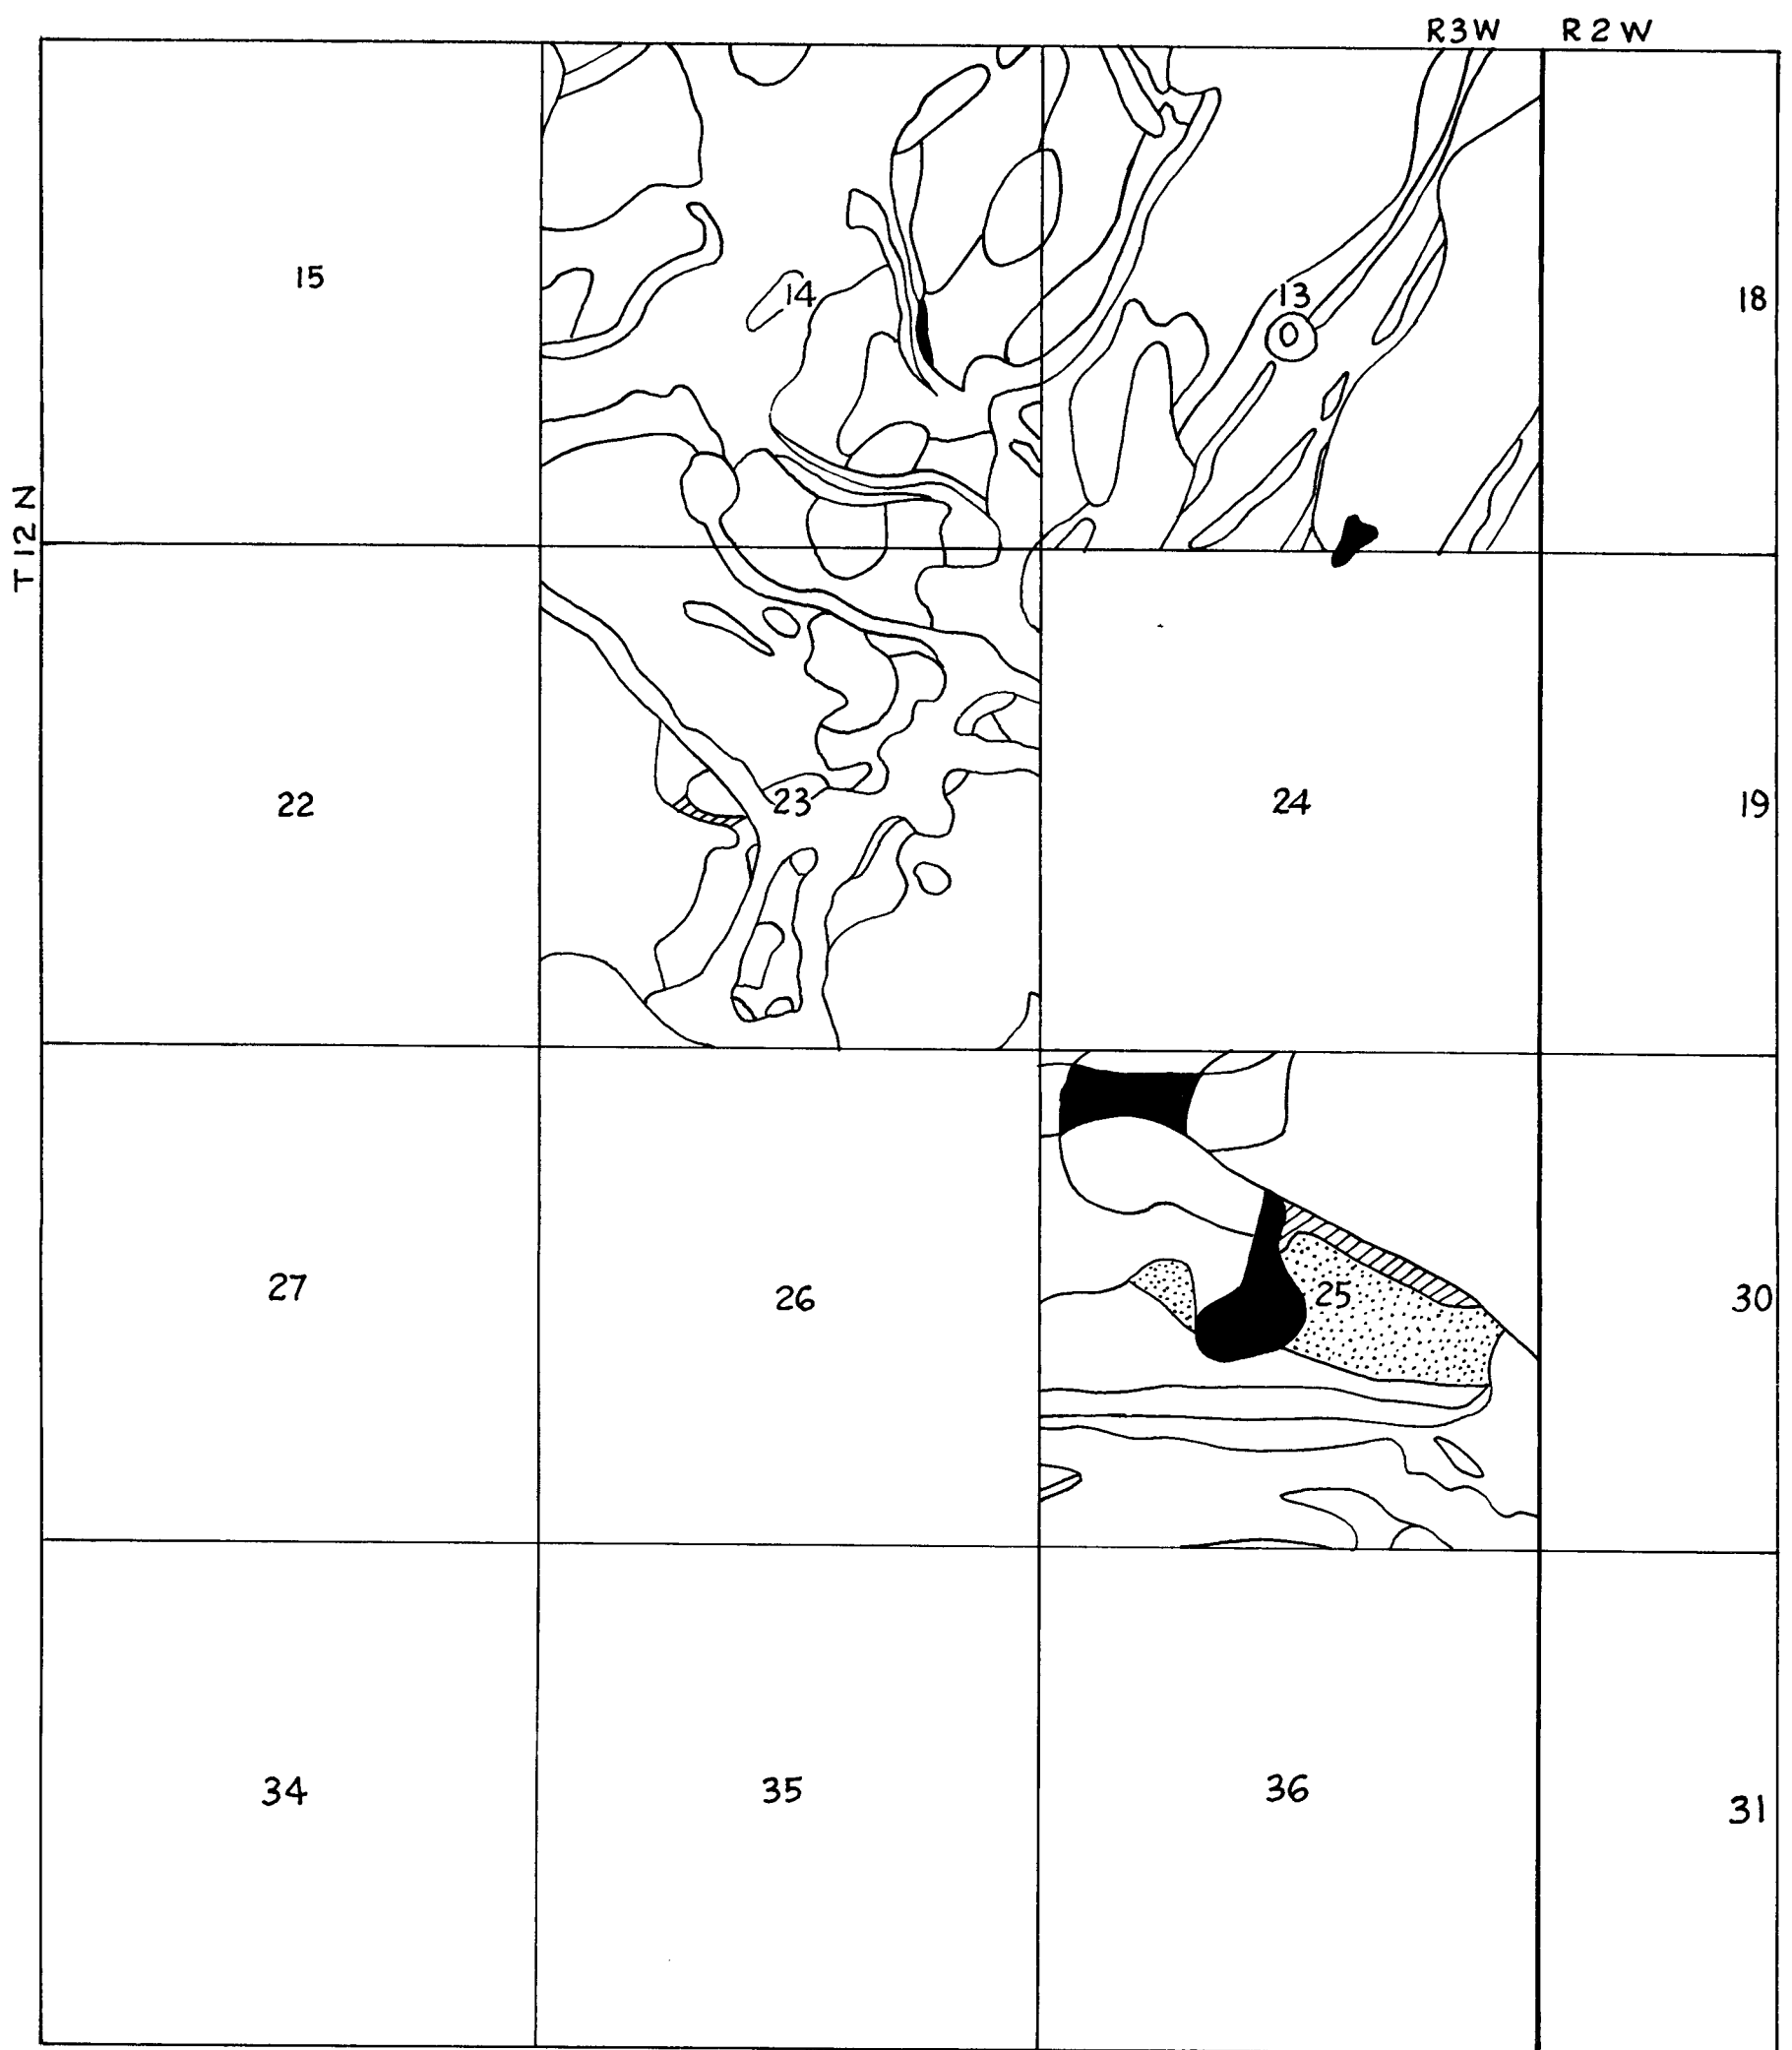
ERRATA

Figure 28.--Relative susceptibility of water resources to pollution by liquid waste disposal.

Changes on page 28 of report.

Relative susceptibility of streams, lakes and shallow ground water to pollution from septic-tank systems.

Change to purple - High

Change to blue - Low

Change to white - Very Low

Enclosed are errata sheets for Figures 28 and 30 of the subject report "Hydrology for Land-Use Planning: The Hillside Area, Anchorage, Alaska," by L. L. Dearborn and W. W. Barnwell. You may wish to insert them in your copy of the report.

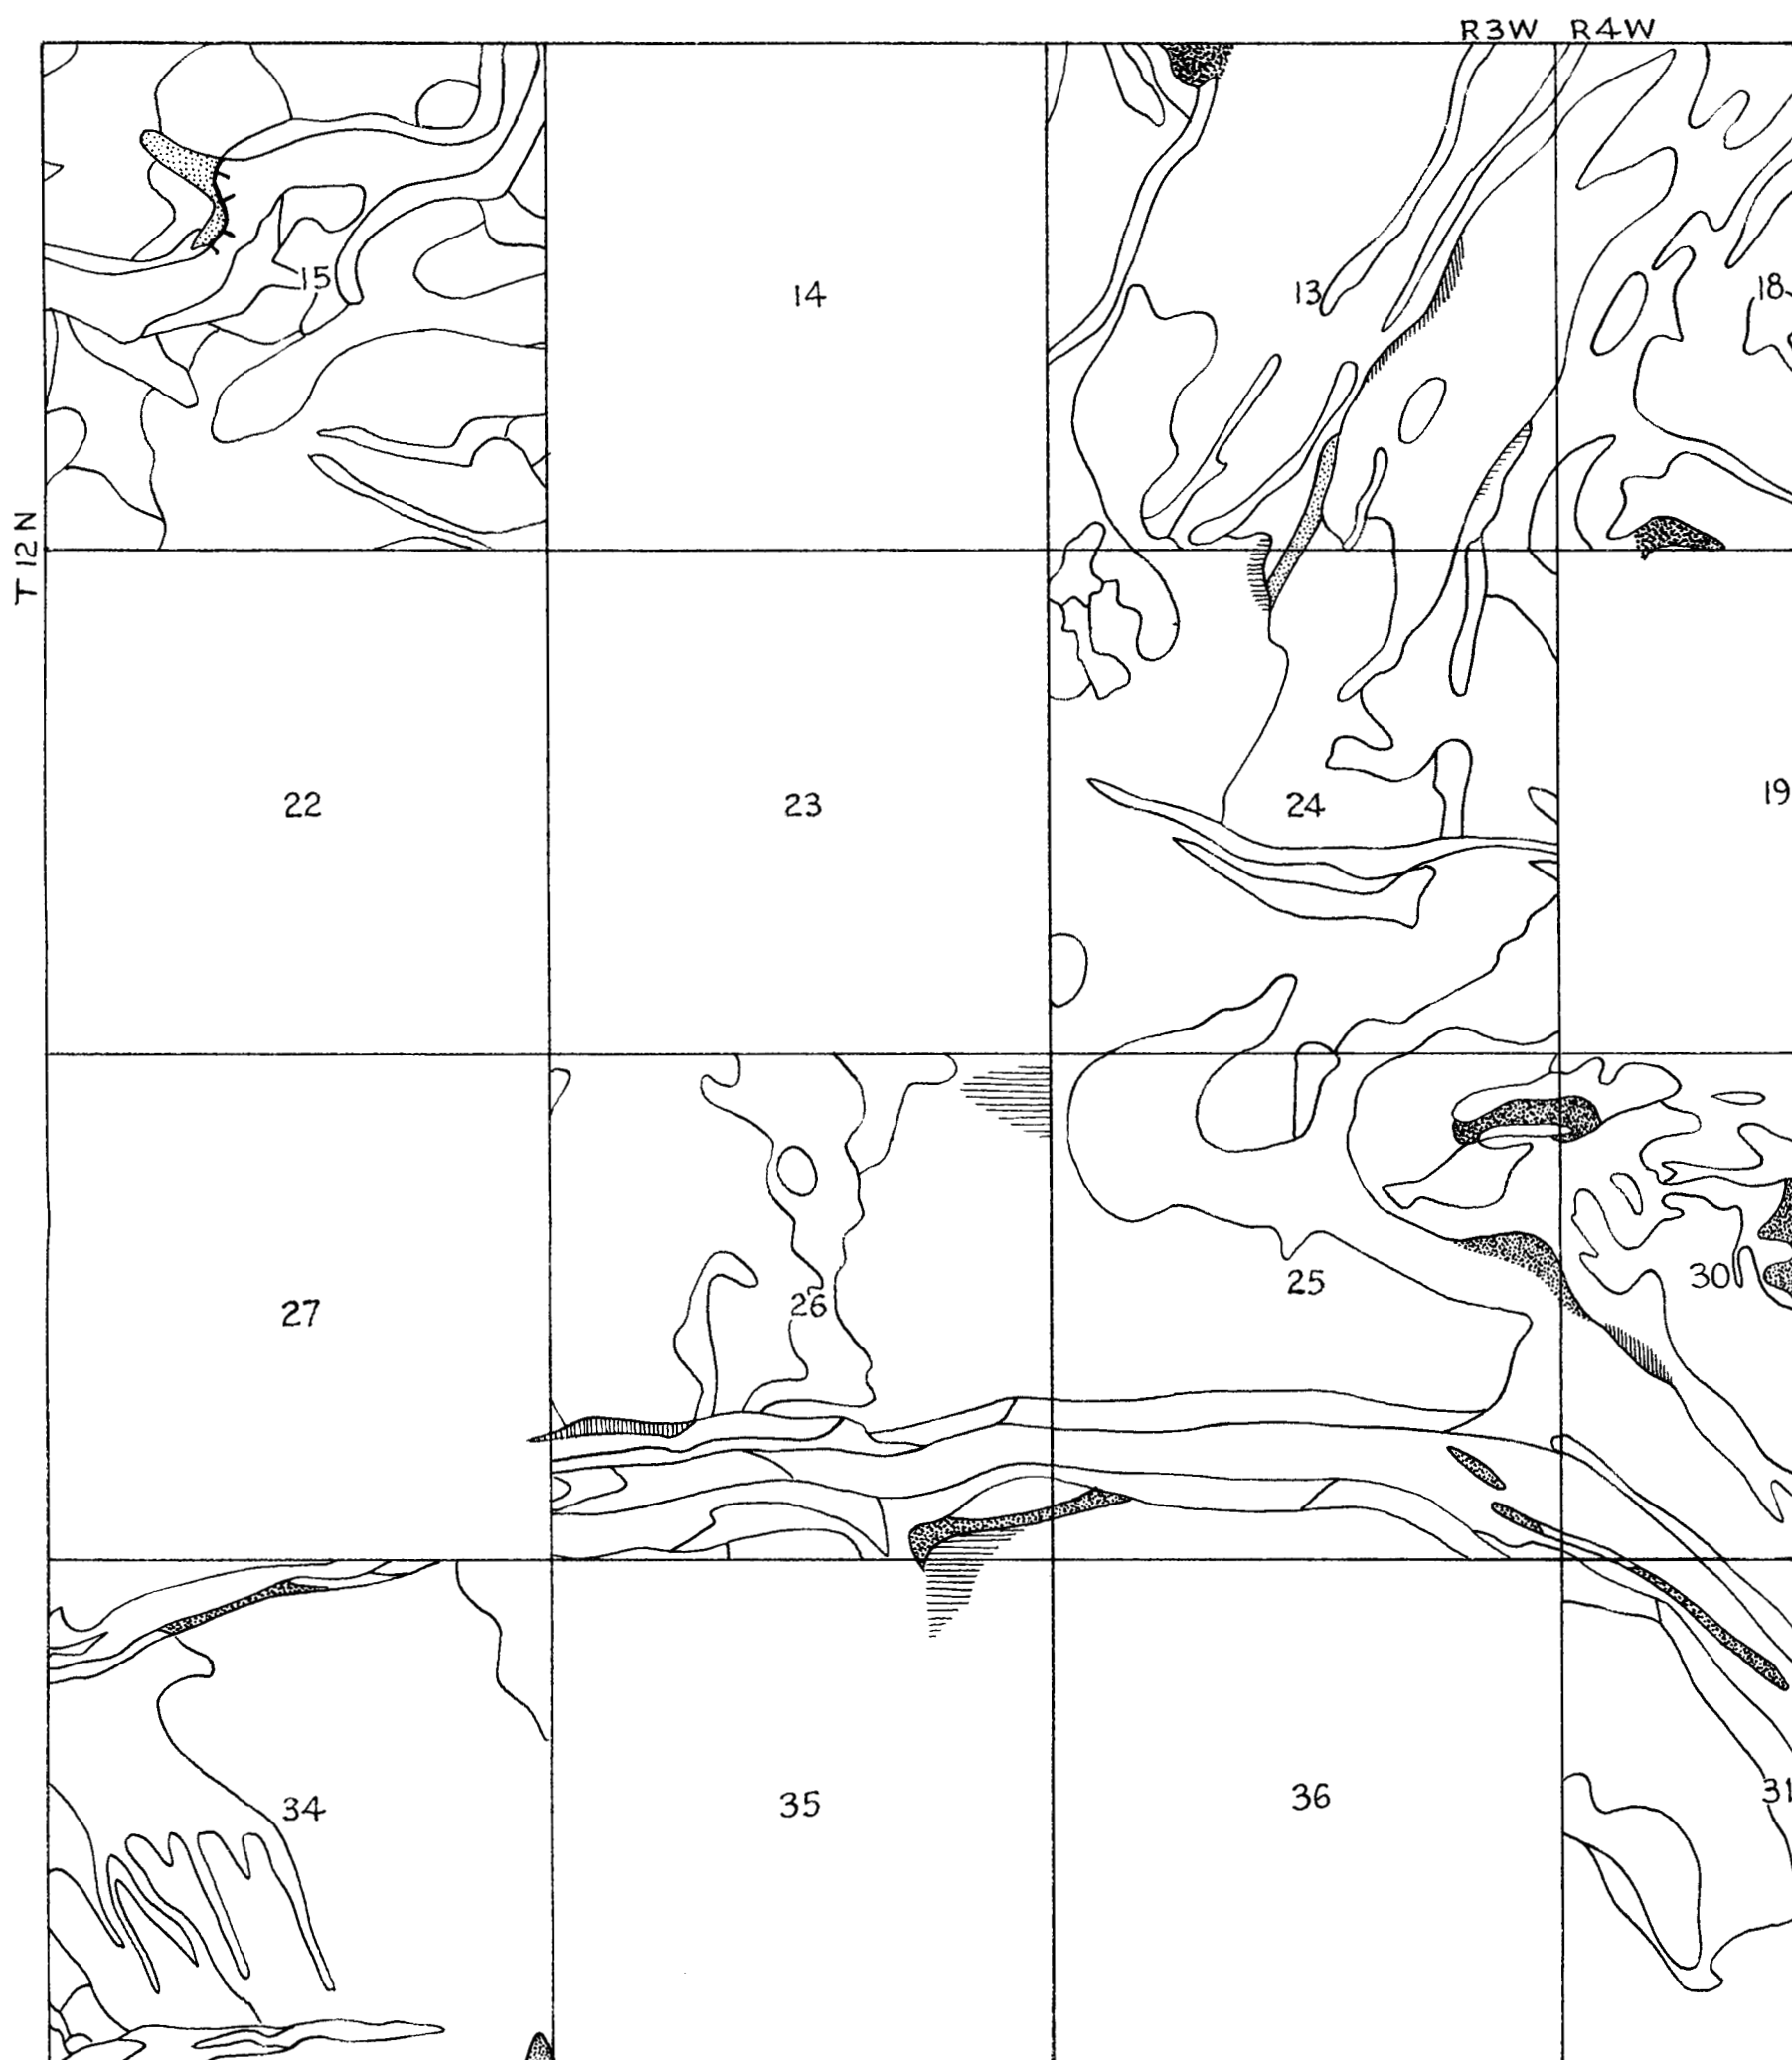
ERRATA

Figure 30.--Generalized landslope and sediment thickness near mountain front.
 HYDROLOGY FOR LAND-USE PLANNING: THE HILLSIDE AREA, ANCHORAGE, ALASKA
 By Larry L. Dearborn and William W. Barnwell
 Open-File Report: 75-105, 1975

Changes on page 30 of report

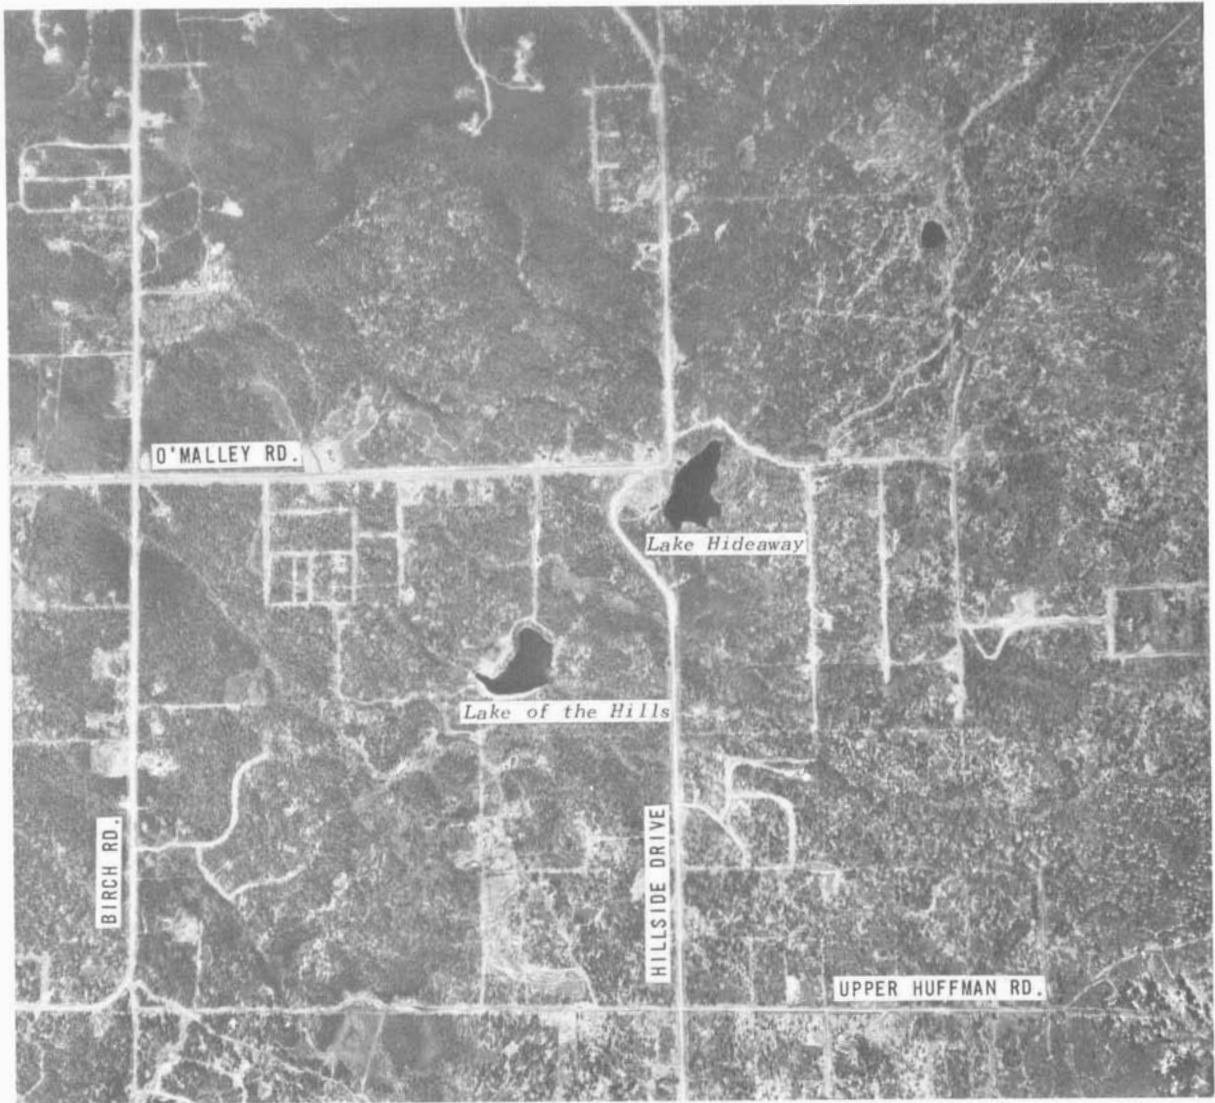
In 9 years the density of houses has more than tripled in this area. In lower photograph very few homes surround Lake Hideaway; in upper photograph many septic systems are located relatively close to the shallow lake. Continued small-tract development where springs and seeps are common will add to the potential for serious drainage problems. An altitude drop of approximately 1000 ft (300m) from east to west further complicates most modifications of natural runoff.

Figure 3.-- Suburban development in a northern sector of the Hillside area.

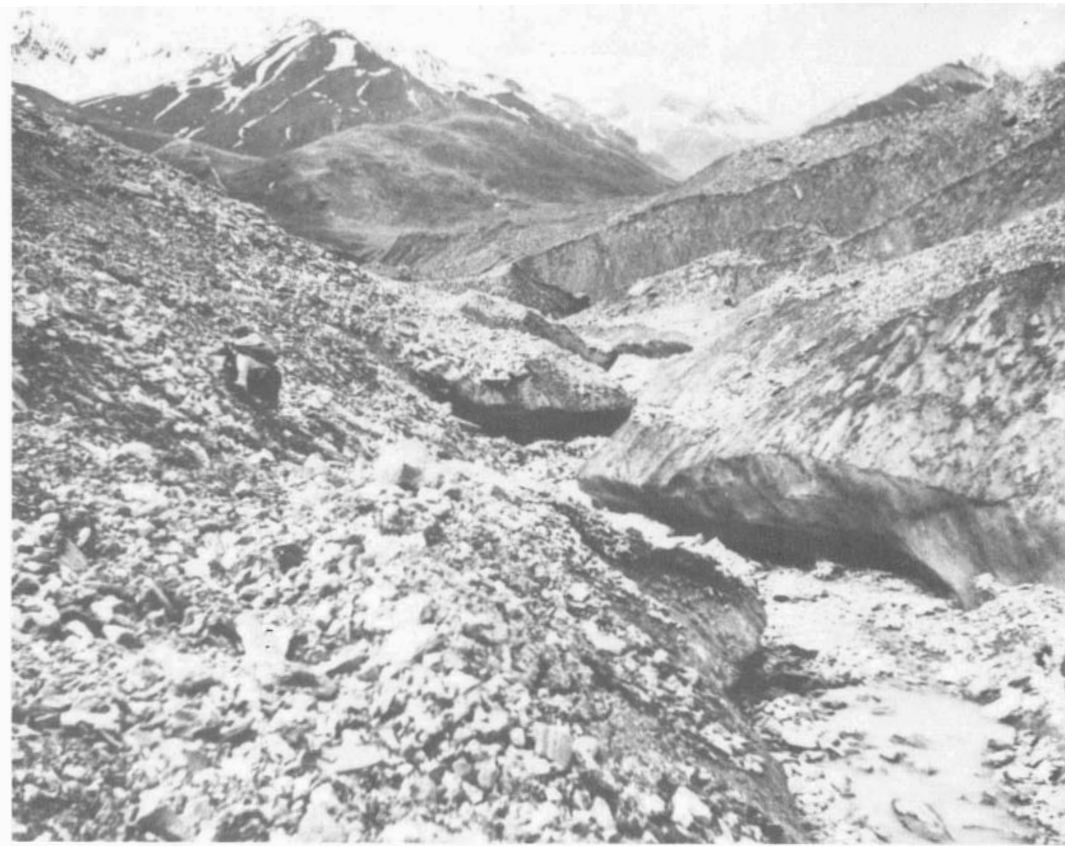
Figure 4.-- Typical depositional environment at terminus of large alpine glacier.

Rock fragments deposited directly from melting ice are angular and have a wide range in fragment size. However, in outwash streams silt and clay particles are washed from the mixed materials and the angular fragments are rounded to form gravel. Typically, in the subsurface these stream-laid deposits form long narrow beds of permeable sand and gravel, which yield water to wells.

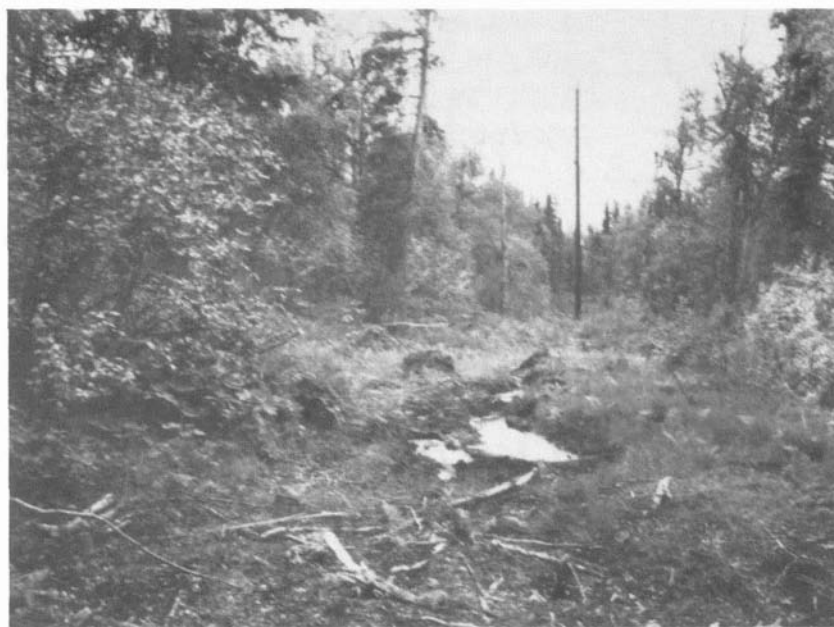
Figure 13.-- Water from springs along a power line.

Ground water surfaces upslope (left side) and seeps into a deep bulldozer rut. Although a shallow sump may be capable of supplying enough water for a household, the source may freeze or become contaminated.

Small localized springs are common in the Hillside area (fig. 13). Most of these springs flow at less than 1 gal/min (0.06 l/s) and do not have sufficient flow to be considered sources of domestic water. In a few places, abnormally large springs have been developed for single-family use by digging shallow sumps which serve as storage reservoirs. The flow of some of these developed springs is reported to have declined or stopped during prolonged cold periods. In general, springs are undependable water sources in the area, and many may become contaminated from animal or human wastes.

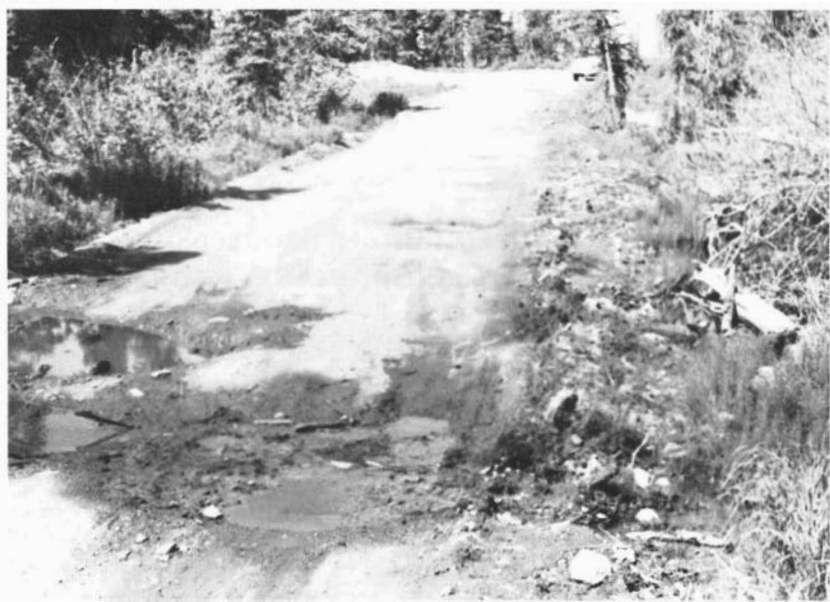
Figure 15.-- Ground-water seepage crossing road in upper O'Malley area.

This road was built along a terrace and formed a barrier causing shallow ground water to surface. Water has ponded on the uphill side and flowed over the road. Icing problems at this site are probable during the winter months.

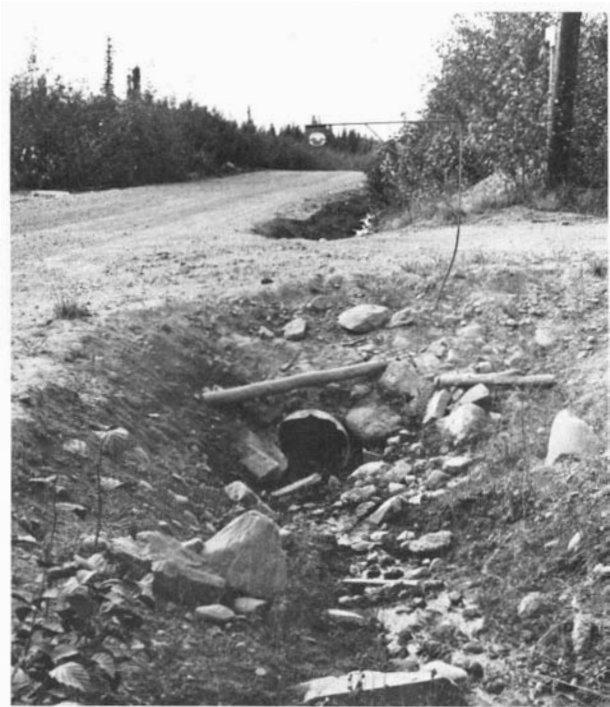
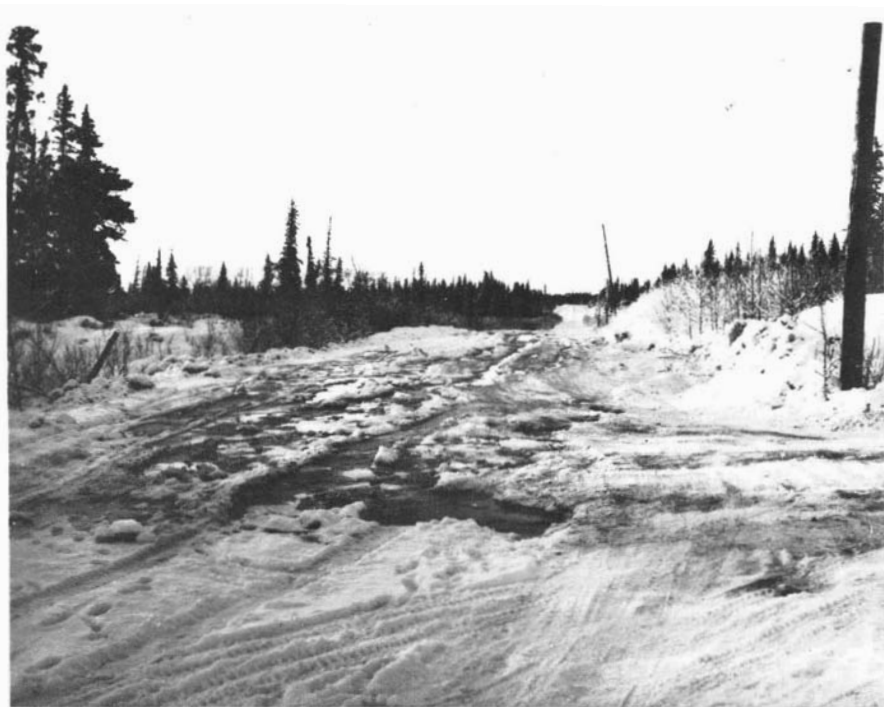
Figure 16.-- Summer drainage and winter icing at Patrick Road and upper DeArmoun Road. Year-round ground-water seepage from a nearby slope has caused a buildup of ice in the roadside ditch during winter months. This icing in December 1971 created impassable road conditions for several weeks. Excess water flowed over the icing, infiltrated the snow cover, and then seeped over the frozen ground into nearby yards.

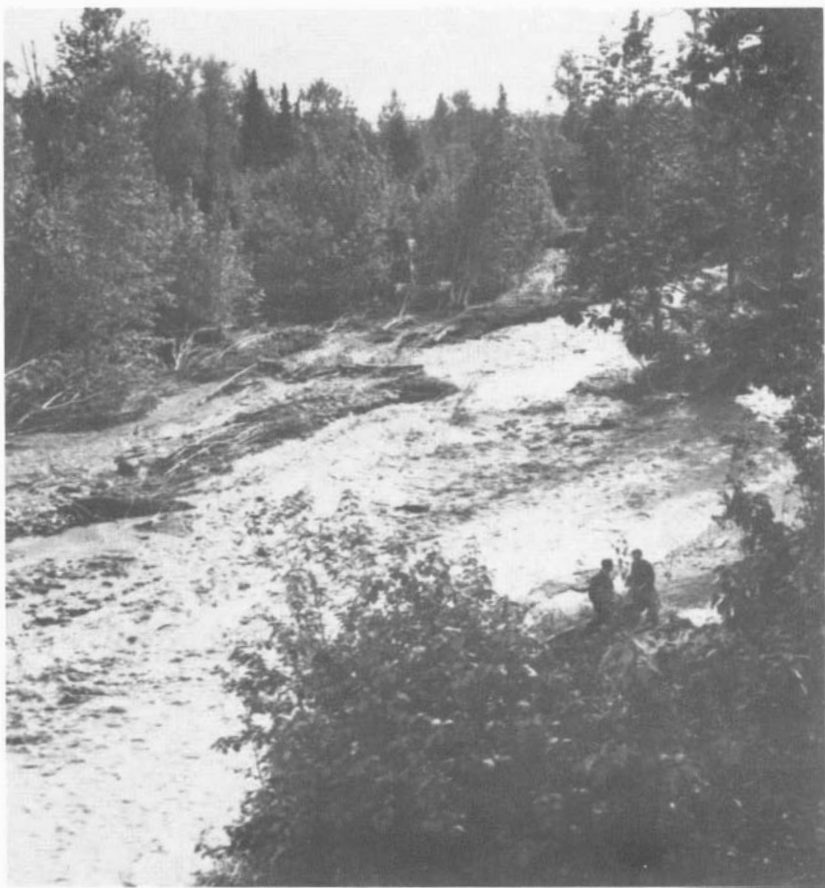
Figure 17.-- 1964 flood on Rabbit Creek.
The stream overflowed its banks and caused uprooting of trees along the flood plain. In this vicinity a wooden bridge was washed away. More severe floods than this are expected to occur.

Flood conditions have not occurred in recent years, and some residents have built on or very near the flood plain. The valley bottom of Rabbit Creek that would be inundated by the IRF has been mapped as a belt along the main channel mostly less than 50 ft (15 m) wide (U.S. Army Corps of Engineers, 1973). The flood plain for the IRF could be wider than that mapped because of the likelihood of some backing-up of water by debris lodging in the channel (fig. 17). The magnitude of backwater effects cannot be determined beforehand.

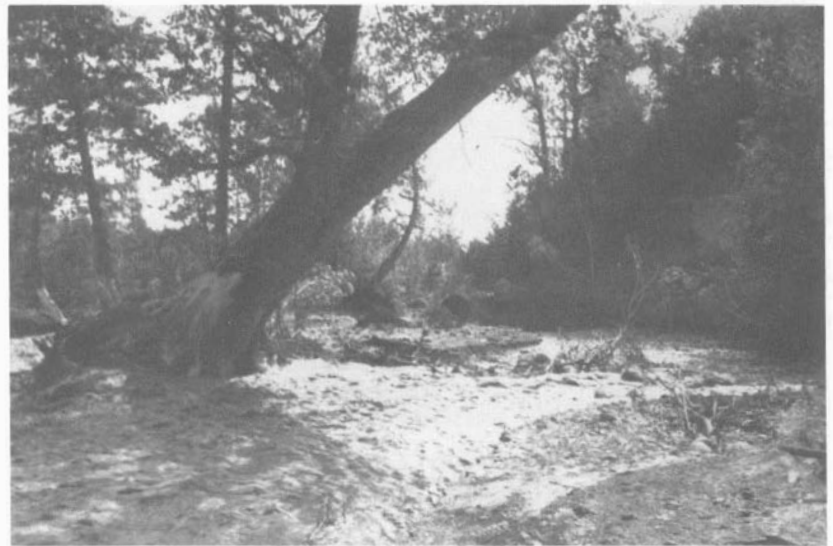
Figure 18.-- Streambed and bank erosion during 1964 flood.
A relatively steep channel in alluvial material allows Rabbit Creek to erode its banks rapidly during floods. Undermining of large trees by the shifting streamflow increases the potential for clogging of the channel.

Severe erosion of streambanks and roads during future floods on Rabbit and on Little Rabbit Creeks may result in additional risks to homes and private utilities (figs. 18 and 19). Many of these potential erosion problems could be minimized if erosion-control measures such as the use of vegetation, installation of storm-drainage systems, use of bank stabilization techniques, and provision for green belts along the major floodways were implemented. In addition, the construction of debris-collection basins along the major streams may prevent culverts and bridges from becoming plugged and reduce backwater flooding during heavy rains.

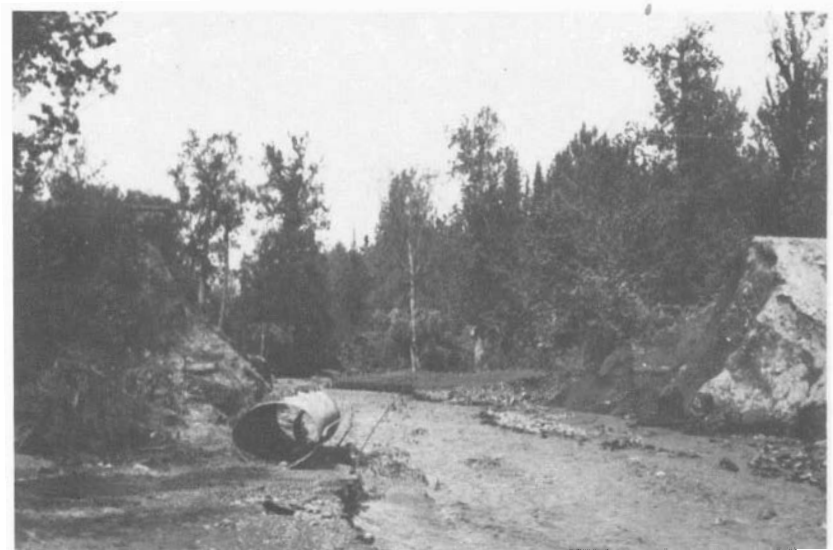
Figure 19.-- Washout of Old Seward Highway roadbed by 1964 flood on Rabbit Creek.

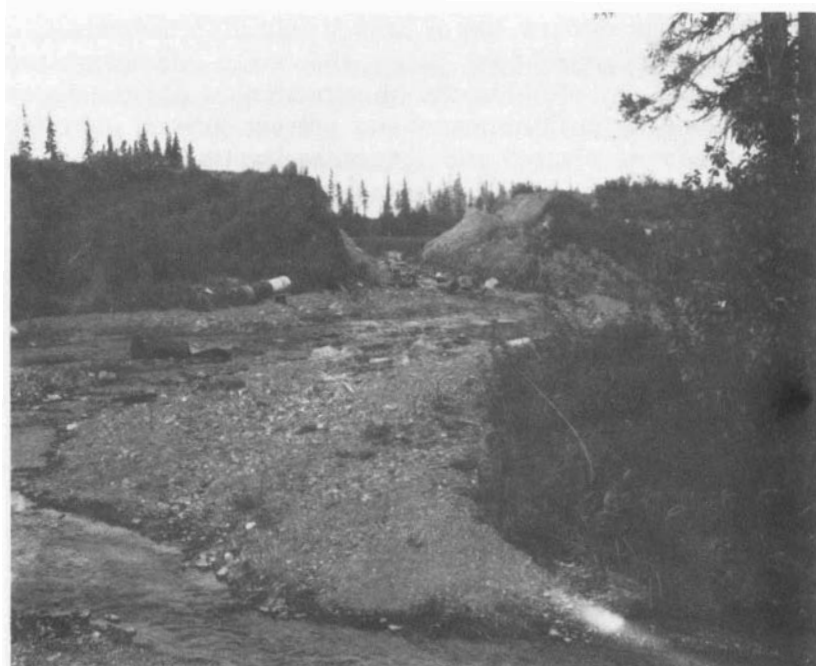
Figure 20.-- 'Lake of the Hills' earth dam after failure in 1972.

The sudden discharge of water flooded into nearby Little Campbell Creek and disrupted the natural channel.
Photograph taken June, 1973.

A small earth dam in the Hillside area failed in the spring of 1972. The earth dam was constructed in 1964 across the mouth of a swampy depression about three-fourths of a mile above Birch Road (NW¼ sec. 23; fig. 3). Little Campbell Creek was partly diverted into the area, creating a 6-acre (0.02-km²) lake. When the dam failed, a flood of water discharged into the main channel of Little Campbell Creek (figs. 20 and 21). Driveways and culverts across the creek were washed out, and one child was drowned.

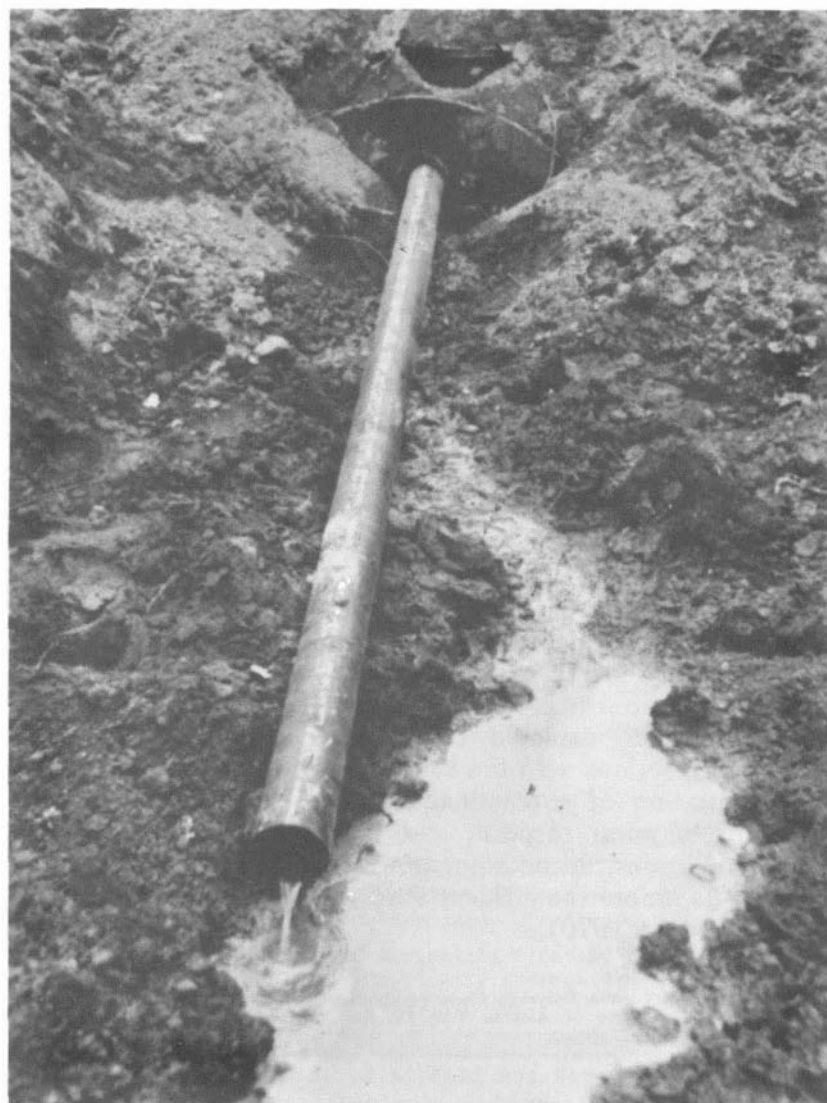
Figure 24.-- Ground water flowing through partly buried septic tank.

In this steep-sloped locality shallow ground water creates adverse conditions for the use of septic-tank systems.

As septic system density in the study area increases, effluent will increase the rate of recharge to the areal ground-water body. A future population of 10,000 people in the study area may require as many as 3,000 systems, or one system per 3 acres (0.012 km²). The total daily discharge of these systems probably would increase from the current estimated 0.4 million gal (1,500 m³) to about 1.2 million gal (4,500 m³). This increase represents an average distribution of about 130 gal (492 l) of septic wastes per day on each acre of the study area. If the water supply continues to be obtained from local wells, the supply will be in part recycled by the residents. Analysis of the water budget (fig. 12) indicates that ground-water recharge from precipitation is between 300 and 700 gal (1,140 and 2,650 l) per day per acre. If it is assumed that all effluent percolates to the ground-water body, a density of one system per 3 acres (0.012 km²) will increase local recharge by 19 to 43 percent. If development density reaches one system per acre, local recharge will be increased 56 to 130 percent and total septic system discharge may be as much as 3.6 Mgal/d (0.16 m³/s) in the study area. Present land-use trends indicate that these systems will not be evenly distributed. Consequently, pollution problems may result where high septic-tank density coincides with areas where the susceptibility of the physical environment to pollution is high (fig. 24).

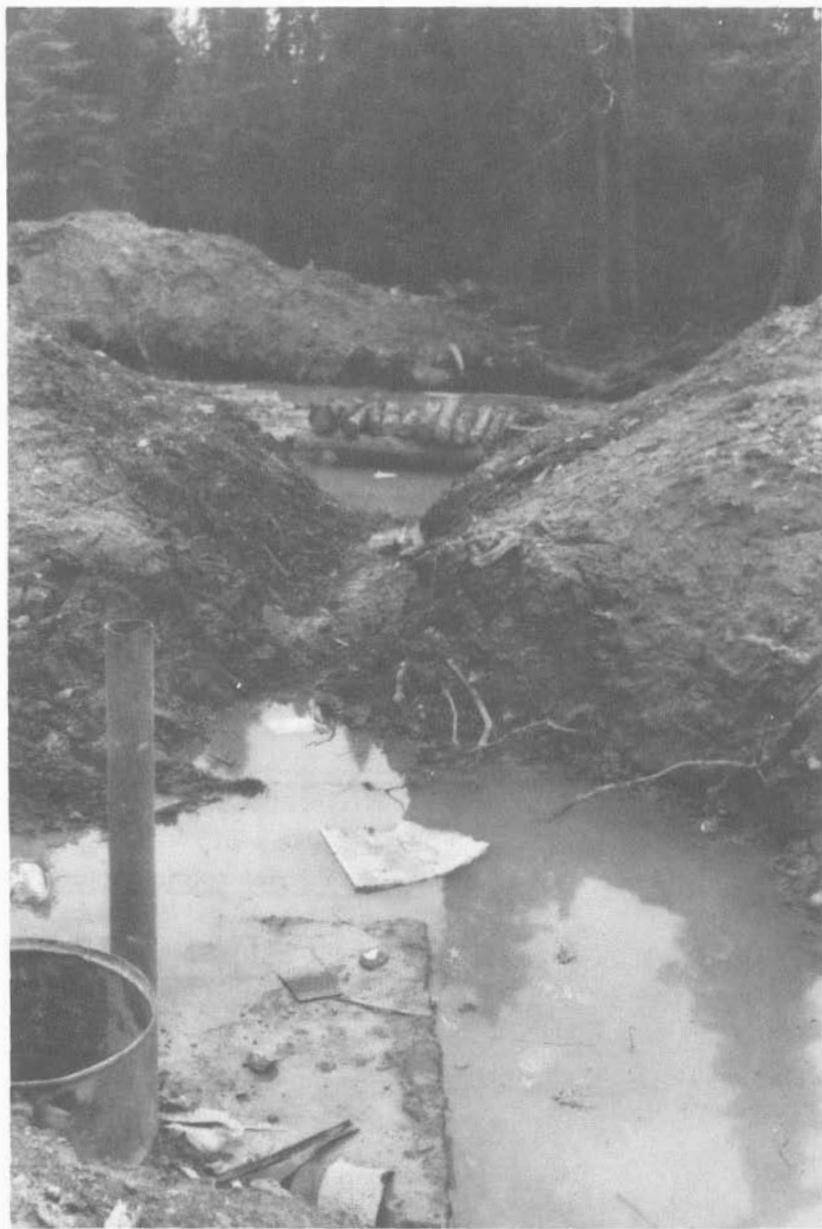
Figure 27.-- Cesspool cribbing floating in shallow ground water.

Pollution of ground water is imminent where household wastes are injected directly into saturated soils. In this type of installation, raw sewage would probably back up and overflow at the surface due to the inability of the effluent to disperse effectively. During winter months the water table may drop enough to allow freezing around a shallow disposal pit and result in a sewage back-up.

Where a seepage pit is constructed in saturated material, the effluent may overflow the pit and eventually rise to the surface (fig. 27). This occurs where the capacity of the material to transmit water is too small to allow the dispersion of septic-tank discharge. Contaminants in the effluent also mix with and pollute the shallow ground water surrounding the seepage pit.

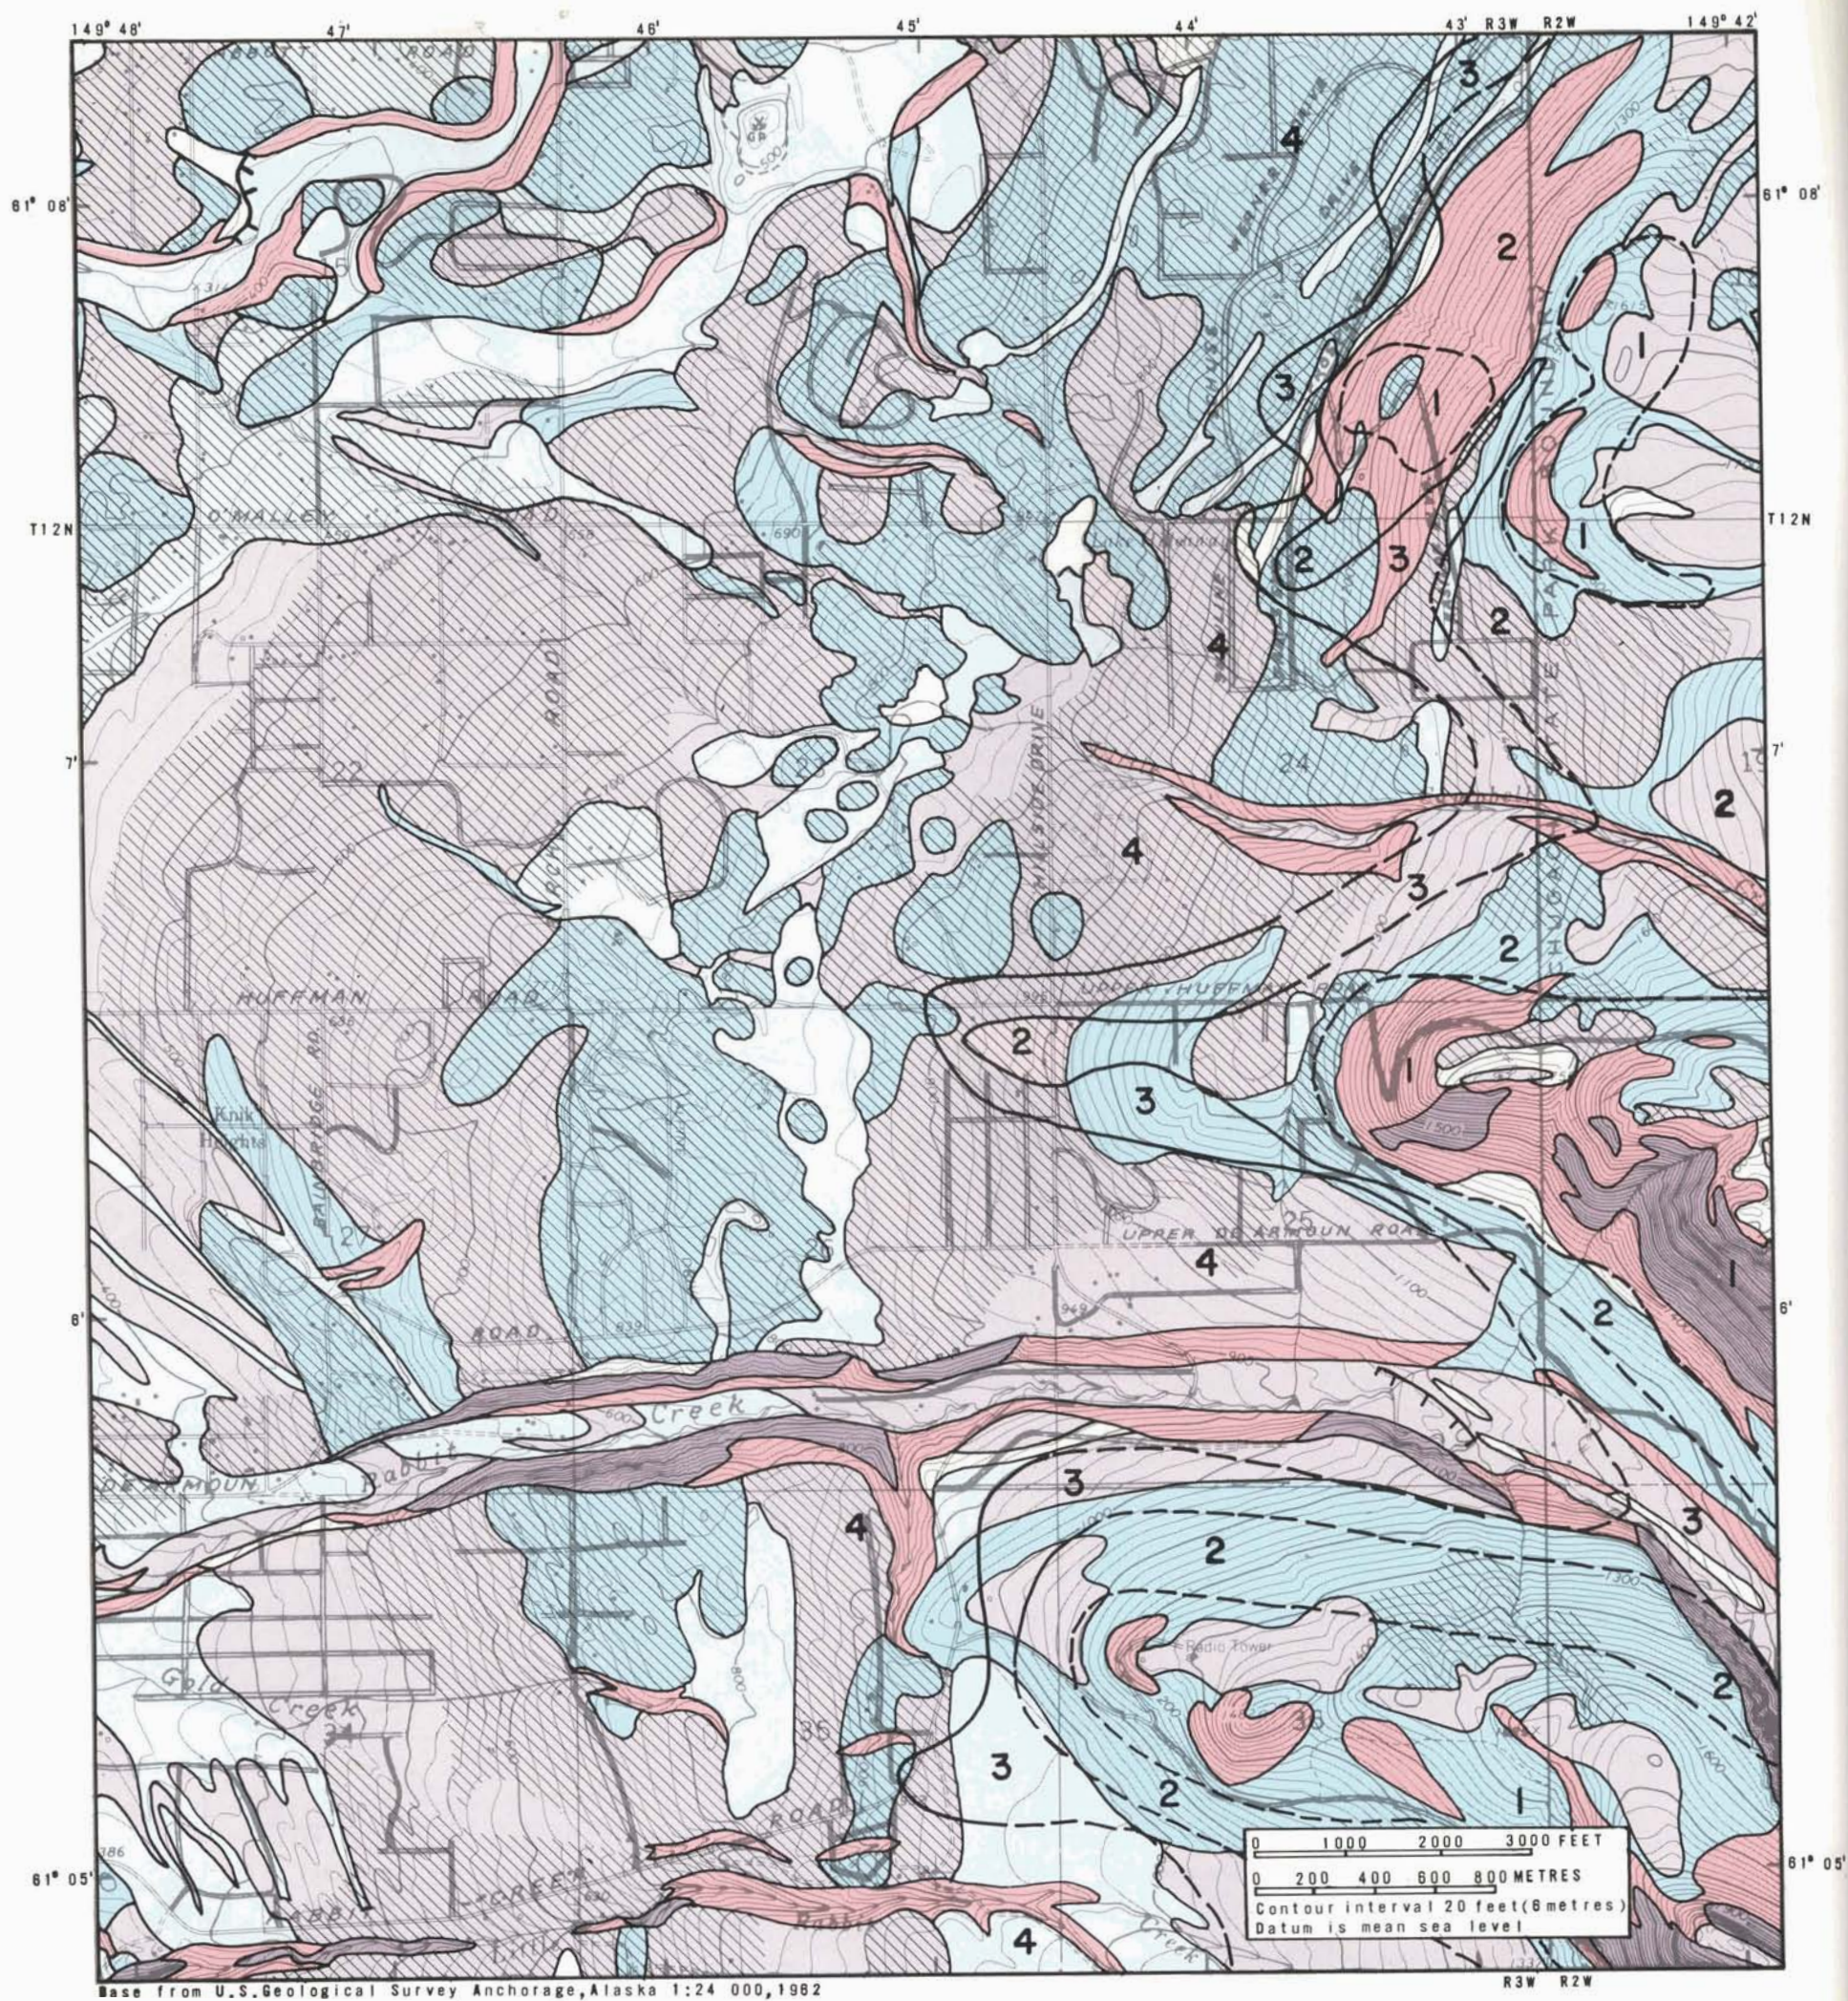
Figure 30.-- Generalized landscape and sediment thickness near mountain front.
(Landscape map by Schmoll and Dobrovolny, 1972).

Figure 30 is a land-slope map (Schmoll and Dobrovolsky, 1972) that also includes a generalized representation of the thickness of unconsolidated sediments overlying bedrock. Because local detail of land slope cannot be shown, specific sites may be locally different than shown on this map. Similarly, the thickness of sediments may be more irregular than shown in figure 30, and test borings to 25 ft (7.5 m) in depth may be necessary to determine the thickness of unconsolidated sediments in many localities east of Hillside Drive.
