CROSS-SECTION, VELOCITY, AND BEDLOAD DATA AT TWO EROSION SITES
ON THE TANANA RIVER NEAR FAIRBANKS, ALASKA, 1979

by Robert L. Burrows

Open-File Report 80-699

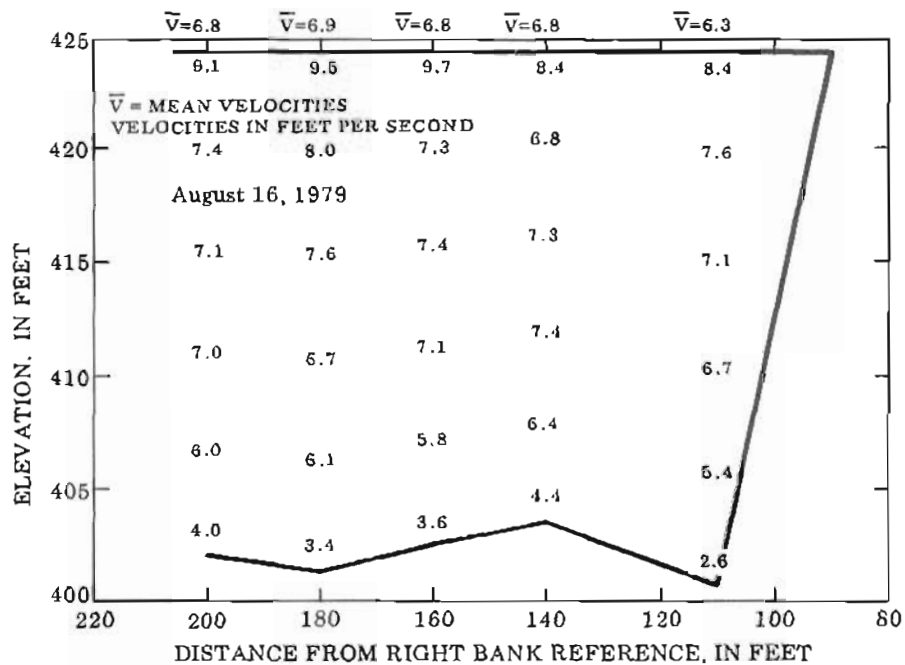
Figure 11c. -- Velocity distribution, near right bank, at cross section 10+00, airport site.

Vertical velocity distributions at cross section 6+00 are shown in figures 9a and b, 8+00 in figures 10a-d, and 10+00 in figures 11a-d. Velocities are shown at points, and the mean for each vertical is shown above the station.

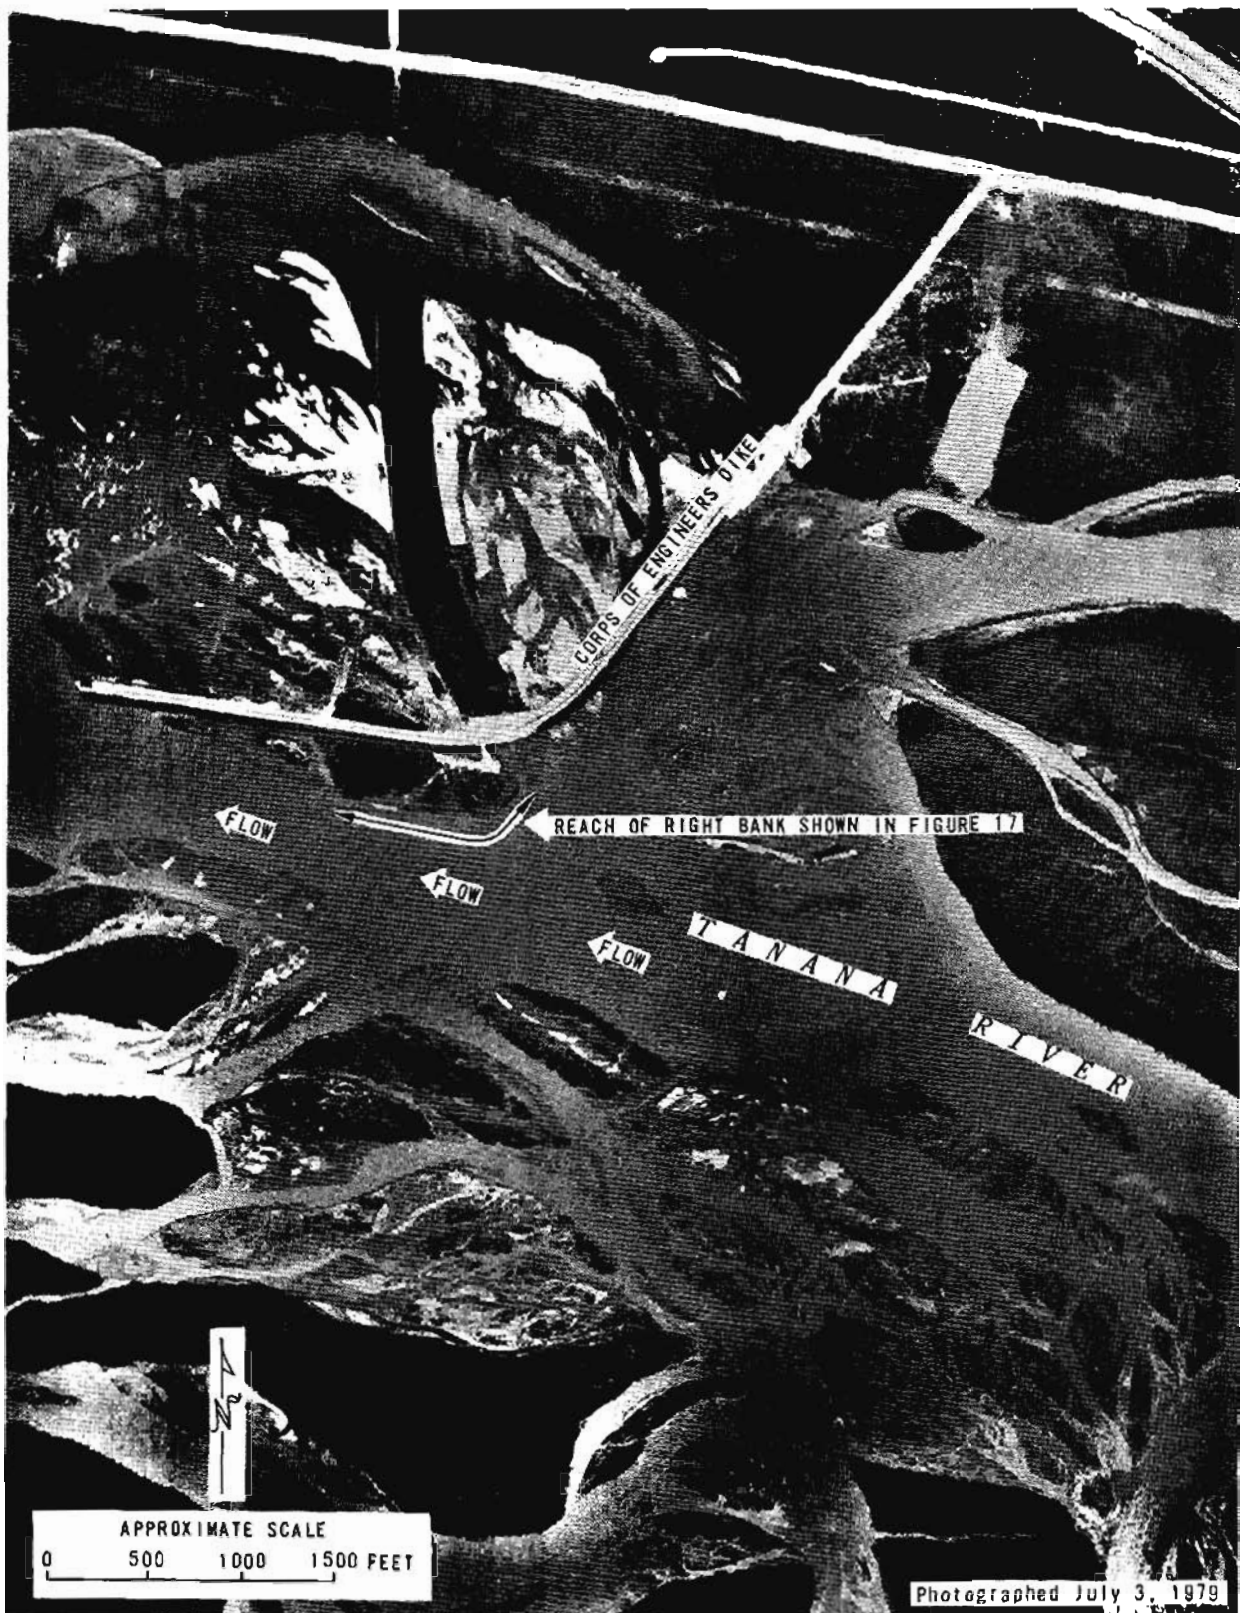
Figure 16. - Data-collection site at dike near North Pole.
