THE ALASKA RAILROAD BETWEEN ANCHORAGE AND FAIRBANKS

Guidebook to Permafrost and Engineering Problems

By T.C. Fuglestad

Division of Geological & Geophysical Surveys
Guidebook 6

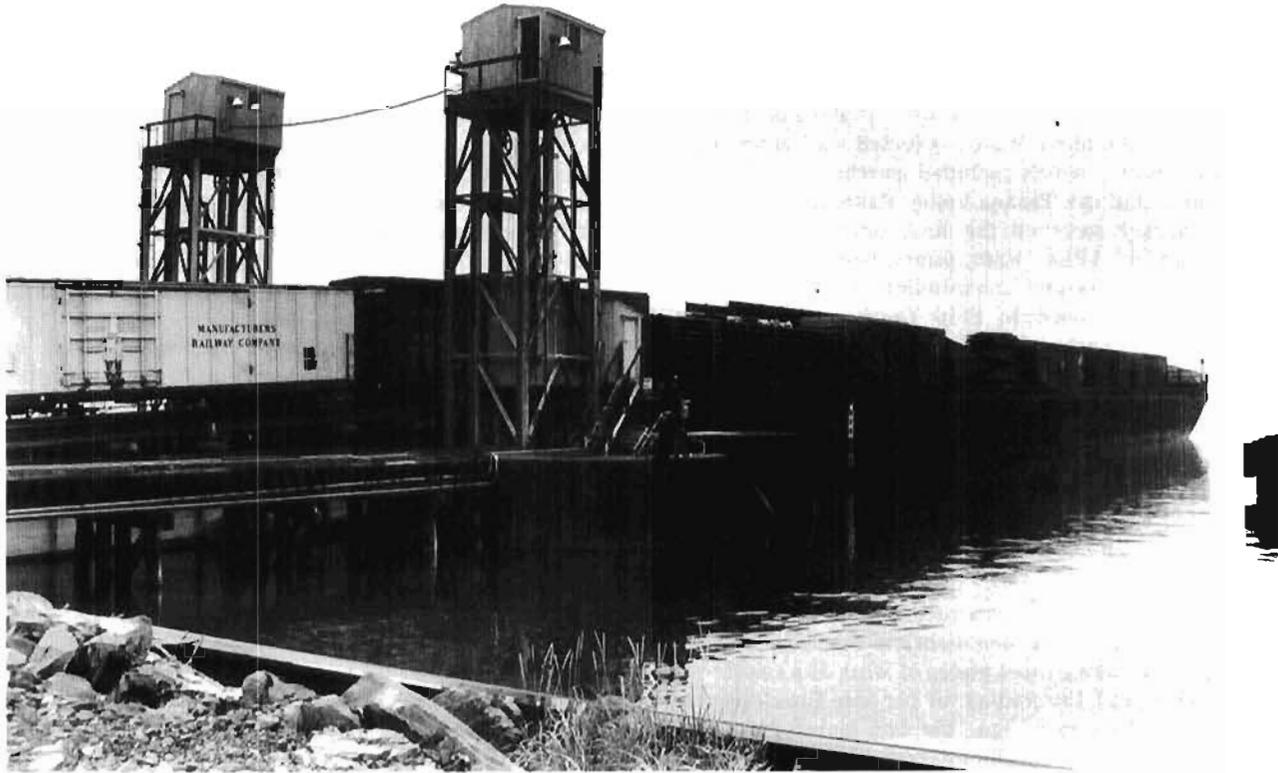
Figure 2. Car-barge slip at Whittier. Much freight destined for Alaska arrives by rail at Seattle, where freight cars are loaded directly onto huge rail barges that hold up to 64 cars each. A tandem tow of two barges usually makes the 1,590 nautical-mile (2,945 km) trip up the Inside Passage and across the Gulf of Alaska to Whittier, where the cars are unloaded at the car-barge slip and hauled to their destinations along the railroad route. This service has been offered since 1963. Photograph by Bill Coghill, 1980.

The Great Alaska Earthquake on March 27, 1964, caused heavy damage, but subsequent repair work improved the line. Today's railroad, particularly its equipment (figs. 2 and 3), is modern in many respects.

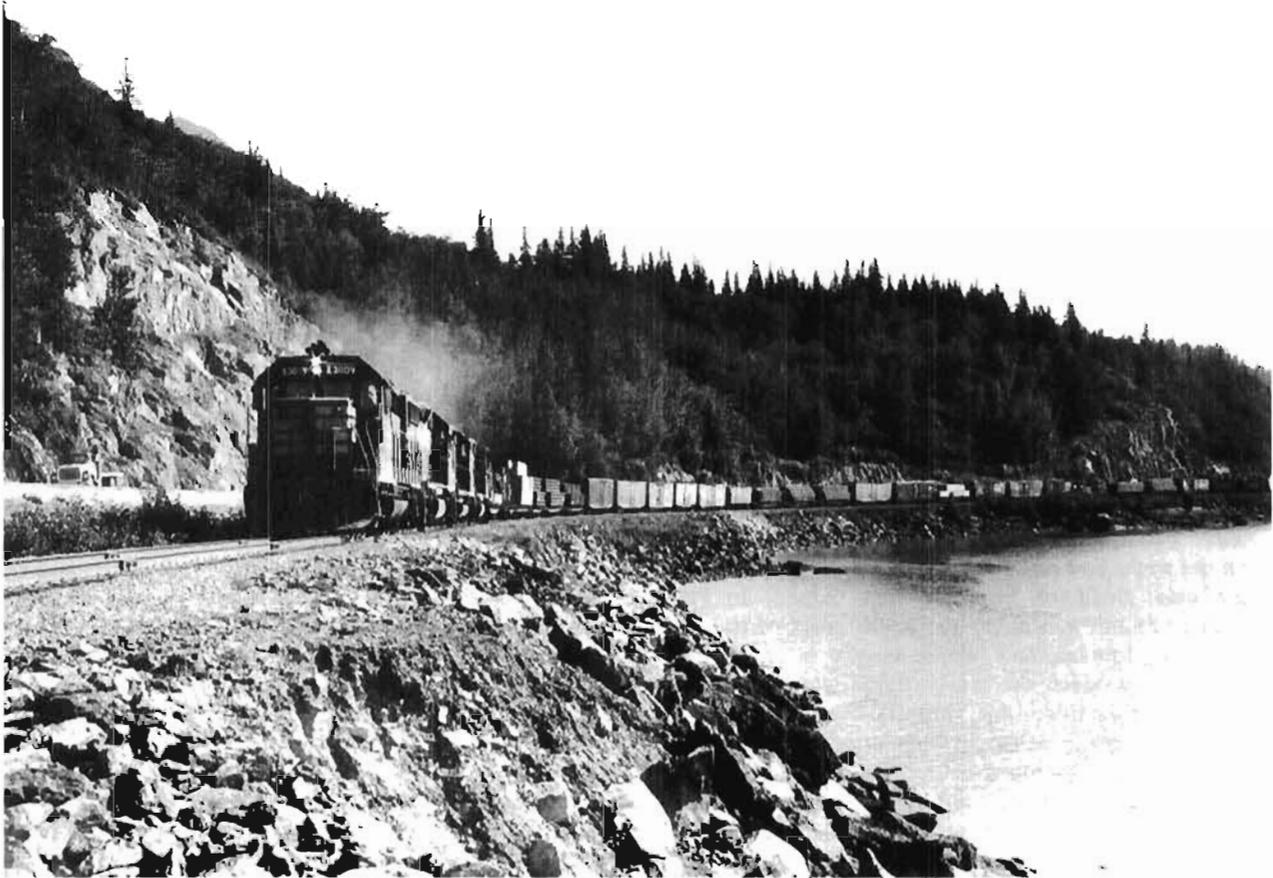
Figure 3. Extra 3009 northbound along Turnagain Arm toward Anchorage. A four-engine 'consist' totaling 12,000 h.p. heads this 80-car train, which has a gross tonnage of 5,600 tons (5,080 t). Photograph by Bill Coghill, 1980.

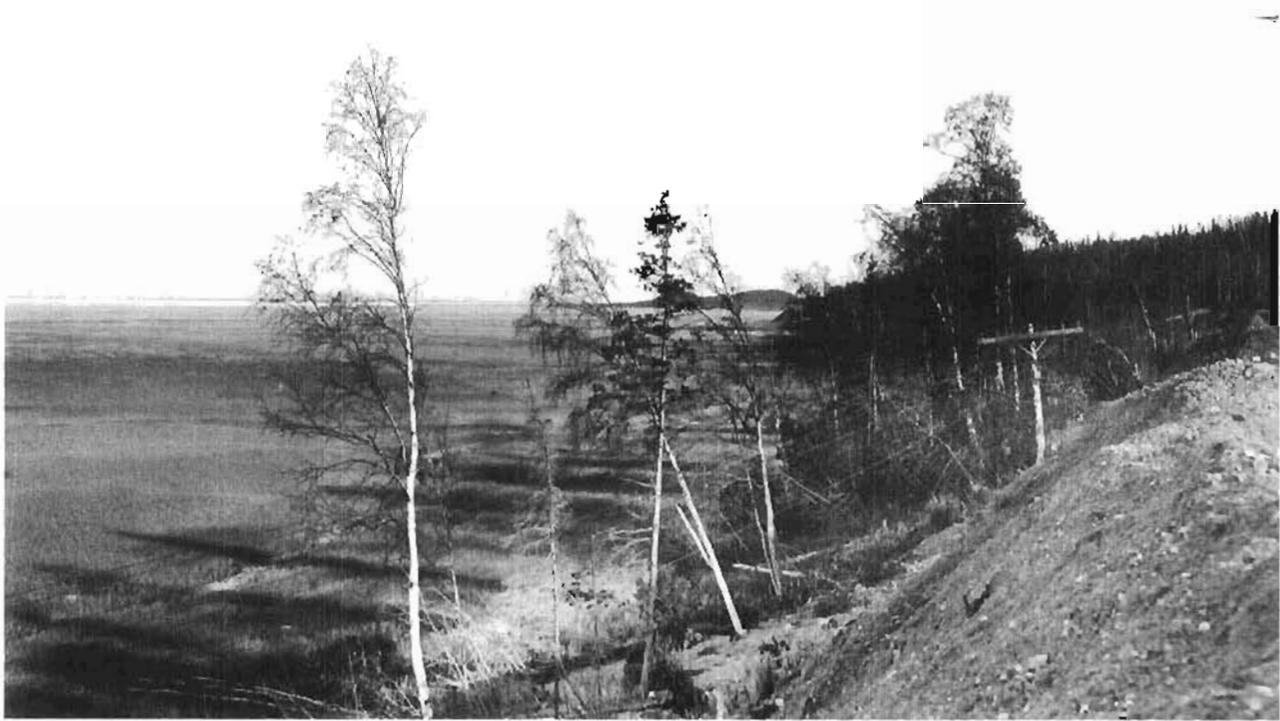
Figure 12. View (to the north) from Mile 138.0. The southern shoreline of upper Knik Arm, visible in the distance, was once far north of its present location at the toe of the railroad grade. Photograph BL 79.1.15. Alaska Railroad Collection, Anchorage Historical and Fine Arts Museum, October 12, 1918.

MILE 137.5 to 139. The railroad parallels the south shore of Knik Arm (fig. 12), which is a long estuary of Cook Inlet that has a tidal range of more than 39 ft (11 m) (measured at Anchorage).

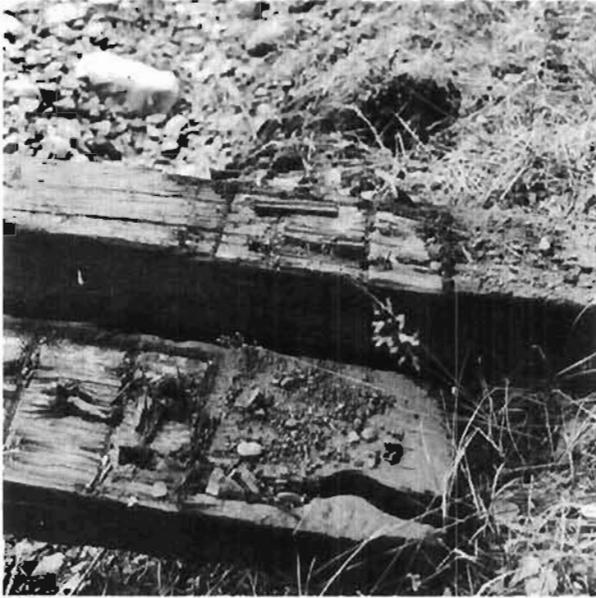
Figure 13. A 'spike-killed' tie. When track is shimmed in a frost-heave area or shim spot, track spikes are pulled out, a wooden shim is inserted under the tie plate, and track spikes are driven in. If frost heaving continues, additional shims are added. When the ground thaws, shims are removed, and the track is respiked. The location of shim spots seldom changes, but the heaving intensity may vary from year to year. Repeated spiking in a shim spot soon 'kills' the cross-tie. The life of a treated cross-tie that is repeatedly respiked may be as low as 6 yr, compared to 35 yr under ideal conditions. Photograph by Dave Atwood, 1982.

The track surface and line are difficult to maintain because the embankment materials and underlying silt are continually subject to differential heaving and settlement. Early construction records and rectangular ponds on the right indicate that side-borrow techniques were used to obtain silty fill material. The track surface and line were badly damaged by the 1964 earthquake. When the railroad was repaired, the railbed was raised substantially to compensate for local subsidence and to protect it against extreme high tides. During the 1964 earthquake, a 112-ft-long (34 m) wood trestle at Mile 142.9, now replaced with a culvert, was compressed and arched 8.5 in. (21.6 cm) by lateral spreading of surficial materials. This part of the railbed is constantly shimmed, particularly at the north end of this segment (figs. 13 and 14). The Glenn Highway is on the left.

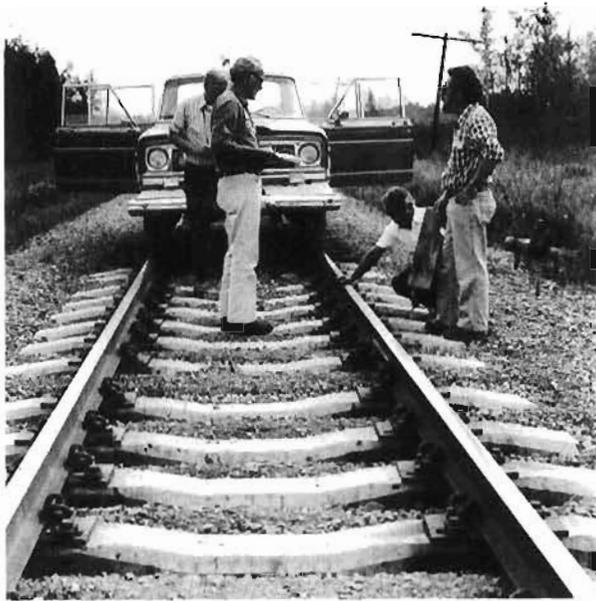
Figure 15. A short, very abrupt shim spot caused by severe differential heaving, Mile 151.2. Concrete ties were installed to test adjustable fasteners under extreme conditions. Shims up to 5 in. (12.7 cm) thick are required during the winter. See Mile 209 for further discussion of concrete ties. Photograph by Dave Atwood, 1982.

MILE 151.2. TEST SECTION OF CONCRETE TIES (fig. 15).

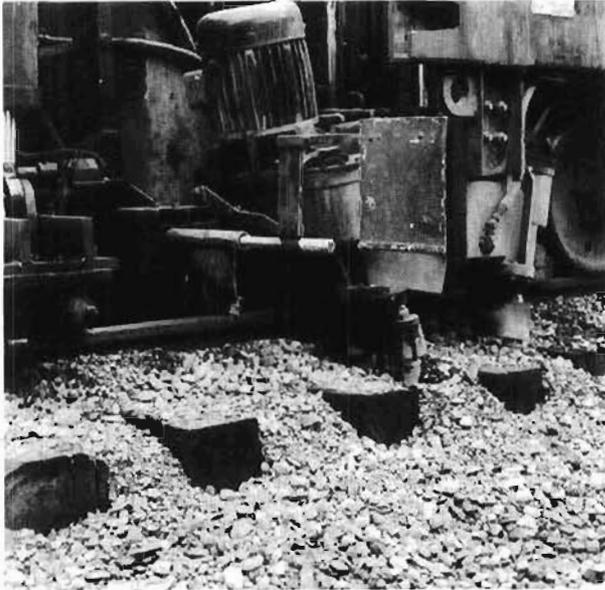
Figure 18. View of power head of automatic tamper with tamping tools inserted into ballast. Ballast is compacted under the tie by squeezing and high-frequency vibrating of the tamping tools. This function was formerly handled by a 'gandy dancer' with a No. 2 shovel. Usually only two insertions are necessary to fully tamp the tie. Photograph by Dave Atwood, 1982.

MILE 181.5. Here, the roadbed ascends an upper bench that is cut through morainal debris. Because excessive ground water and poor embankment material cause severe frost heaving, the track must be heavily shimmed during winter. The amount of heaving depends on such factors as soil and drainage conditions, embankment width, conditions in sidehill cuts and throughcuts, and depth of clean ballast. Differential heaving is more common in fill embankments than in cut sections. This is particularly true on the Alaska Railroad, where a great variety of materials were used for fill. Many shim areas are irregular, and those that affect the cross-level of the track are the most dangerous. When the track-surface distortion becomes too extensive and irregular to be remedied by shimming, 'Slow Orders' are placed on the track, and train speeds are reduced (fig. 16). Figures 17 through 19 show how modern equipment can raise and line track on crushed-gravel ballast.

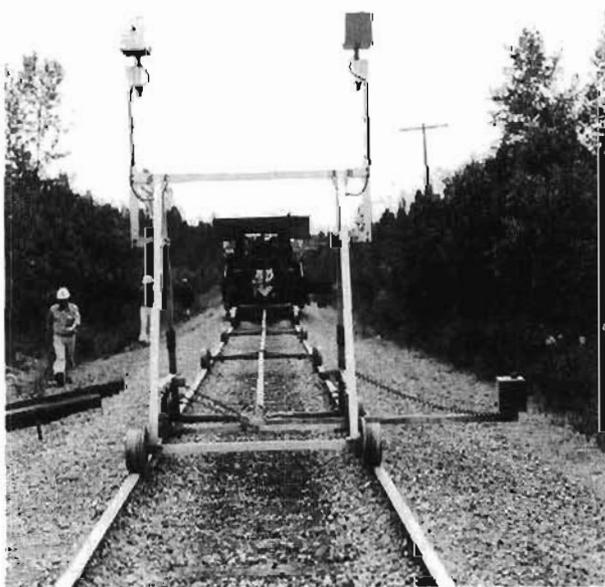
Figure 19. The project buggy transmits light beams back to the automatic tamper with its shadow boards fully extended to raise and line track. Photograph by Dave Atwood, 1982.

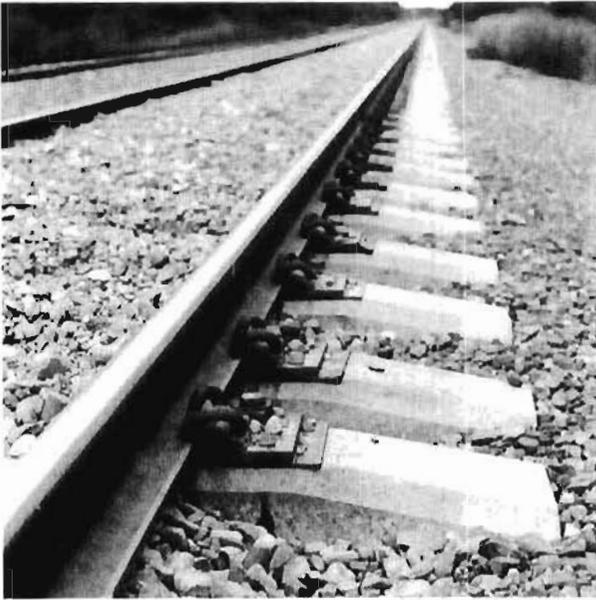
Figure 21. Concrete-tie test section, Mile 209. Concrete ties have been used for many years by the railroad industry, particularly in countries where timber is scarce. They are used here because they have adjustable fasteners that permit shimming to correct differential heaving in a known shim spot. The center of the track received a light dump of ballast before it was raised by a surfacing gang. Photograph by Dave Atwood, 1982.

MILE 209. A test section of concrete cross-ties with special fasteners was installed in a shim area in 1973 (fig. 21). Because of severe differential heaving caused by frost action, the track line must be adjusted to maintain normal operating speeds. If the ties are frozen in the ballast, conventional methods of tamping and lining the track cannot be used. When this occurs (October through May), wood shims are used to adjust any vertical displacement, and spikes are driven in new wood surfaces to adjust any horizontal displacement. As heaving increases, new adjustments are made. When the temperature warms, shims are removed in stages until

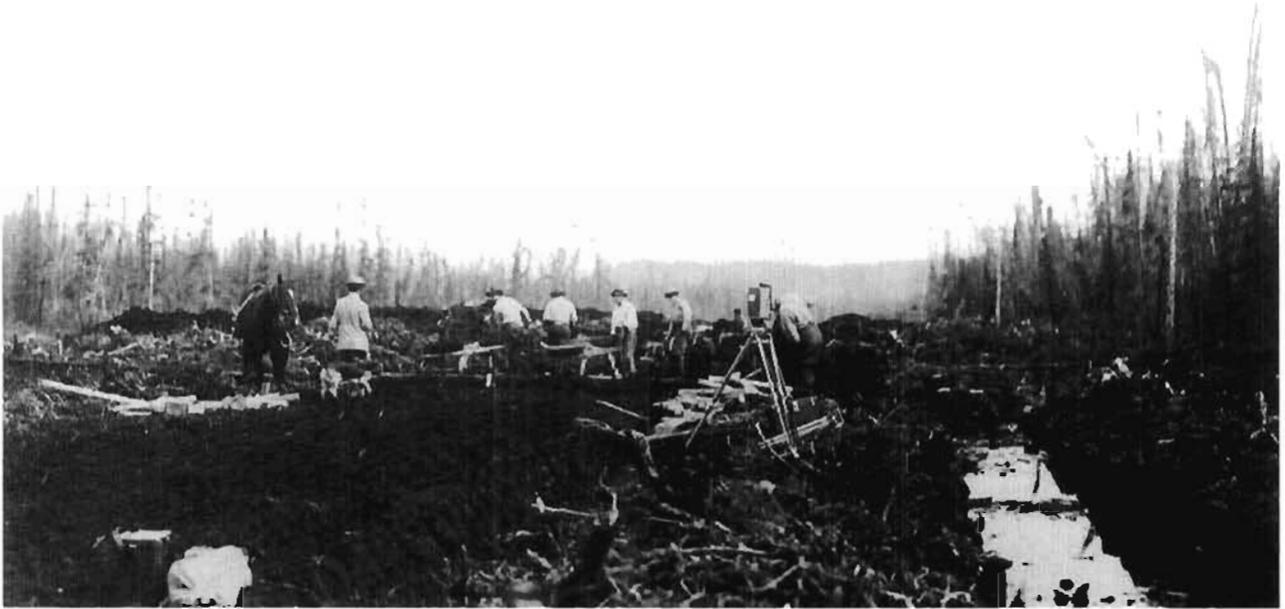
Figure 24. Side borrow, Mile 215. The source of the silty, organic material in the embankment section is the shallow, water-filled pit on the right. Photograph AEC G657, Alaska Railroad Collection, Anchorage Historical and Fine Arts Museum, 1918.

(9 km). An older, higher terrace is visible on the right. Although drainage in the area is poor and some ponds occur (fig. 24), the embankment section, which received a heavy raise of gravel during the rehabilitation period, has been relatively stable. Consequently, the railroad can maintain 59 mph⁷ (95 kmph) with normal maintenance.

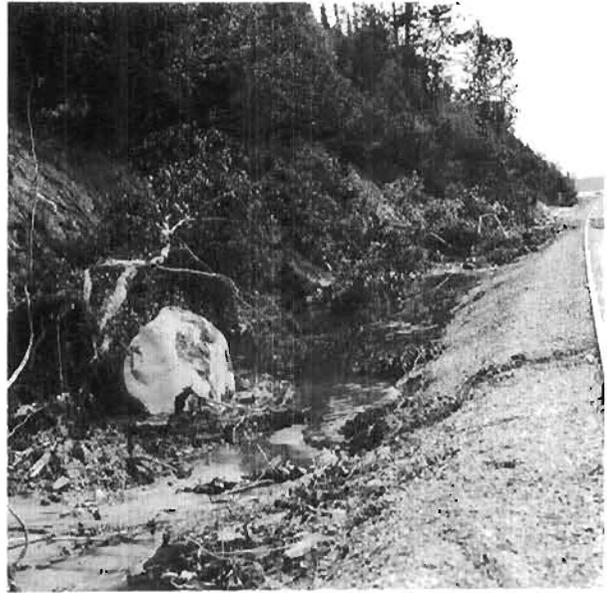
Figure 25. Heavy ditching is required to protect the roadbed and ballast section from the silt and debris in mudflows that originate on the high face above the track between Chase (Mile 236.7) and Mile 241.5. Photograph by Dave Atwood, 1982.

has a stable angle of repose. However, ground water constantly carries fine-grained silt from the overlying moraine downslope. The silt fills the ditch along the track and the voids in the crushed-gravel ballast. If the ditch section is cleared, the mantle of soil and vegetation may be undercut. When the mantle is lubricated by ground water, it slides downhill in wide swaths, exposing the underlying bedrock and often covering the track with mud and trees. When the roadbed between Mile 236 and 239.7 was constructed during the winter of 1919 to 1920 by the Alaska Engineering Commission, a steam shovel was used to make the necessary sidehill excavation. However, the roadbed on either side of this section was built earlier by station contract in 1916. There appears to be no economical way to stabilize the slope (fig. 25).

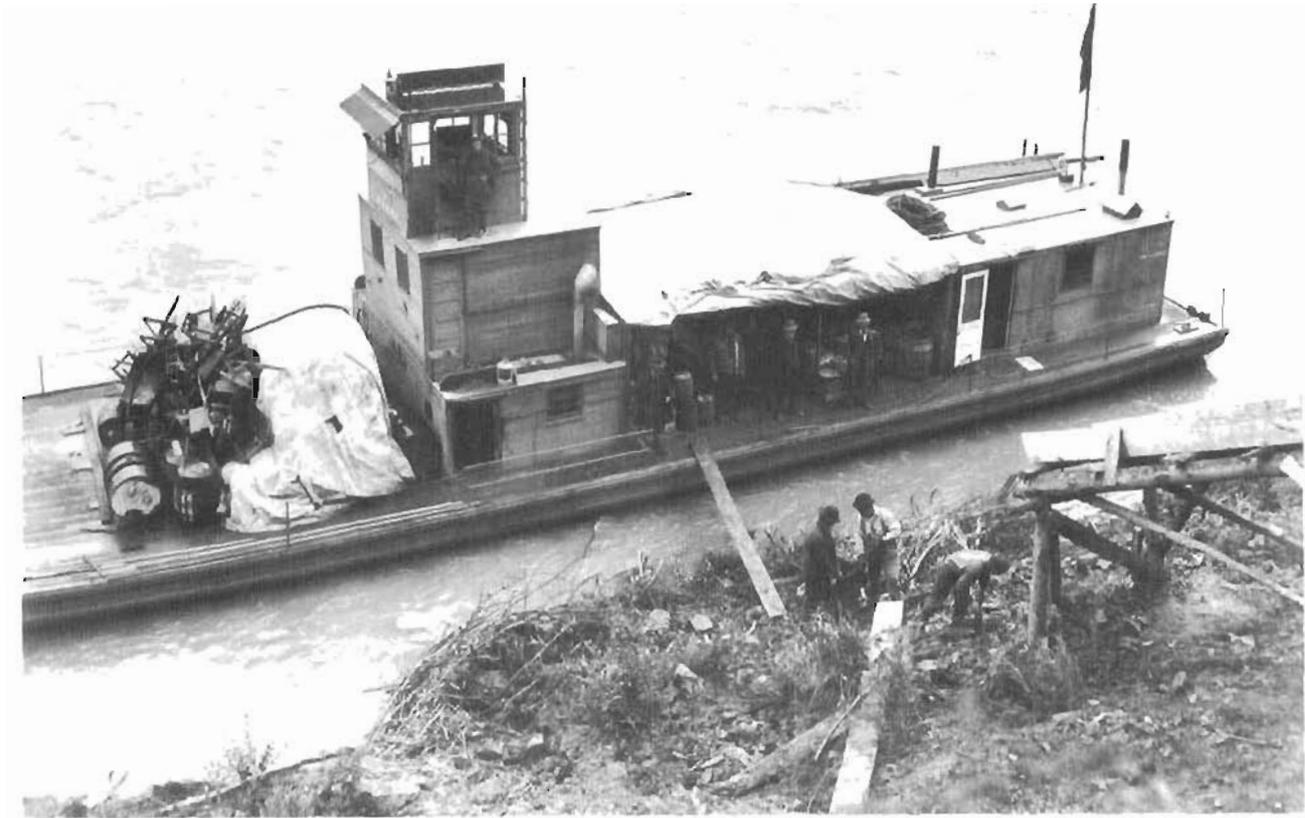
Figure 26. A riverboat 'taking on coal' opposite Mile 231. Numerous lignite veins are located here. The vessel had a special stern tunnel design to operate on the Susitna River. Photograph AEC H94, Alaska Railroad Collection, Anchorage Historical and Fine Arts Museum, August 31, 1918.

MILE 237.4. Very thin layers of low-grade coal are visible in the bedrock exposure on the right. During original construction, specially designed riverboats brought supplies this far and would 'bunker-up' on the coal for the return trip to Susitna Station on the lower Susitna River (fig. 26). Before the railroad was rehabilitated, track maintenance was extremely difficult and expensive. Culverts were useless, and open track boxes were spaced 100 ft (31 m) apart to carry off water and silt. During rehabilitation, the roadbed between Mile 236.5 and 241.5 was raised by at least 3 ft (1 m) with gravel. During spring breakup, ice jams on the Susitna River are a problem (fig. 27). In 1981, the track at this location was under water for 2 days before the ice jam broke downstream and flood waters subsided.

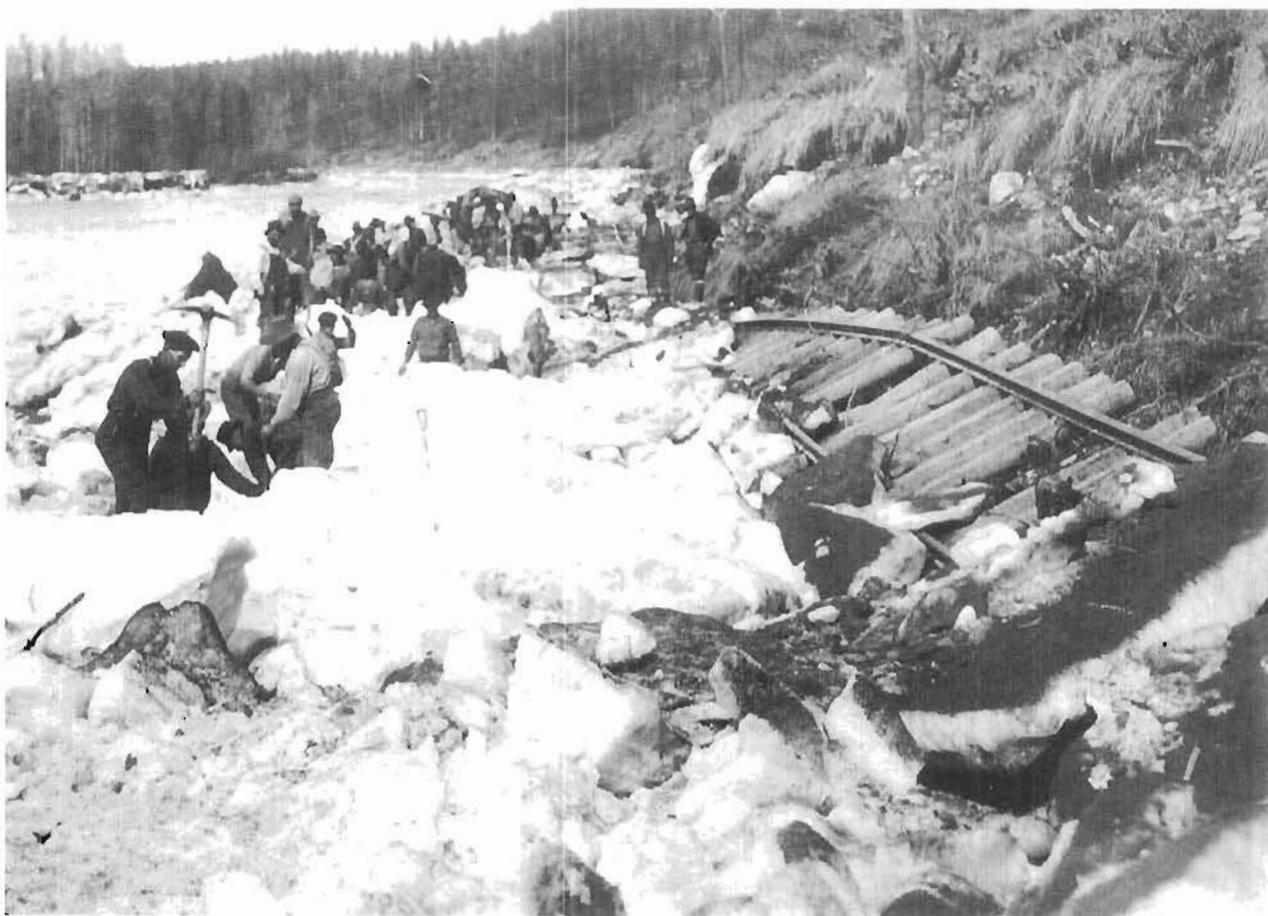
Figure 27. Results of an ice jam during breakup of the Susitna River, Mile 237.5. Note the high water formed by ice floes on the island to the left. Photograph AEC G1754, Alaska Railroad Collection, Anchorage Historical and Fine Arts Museum, May 17, 1921

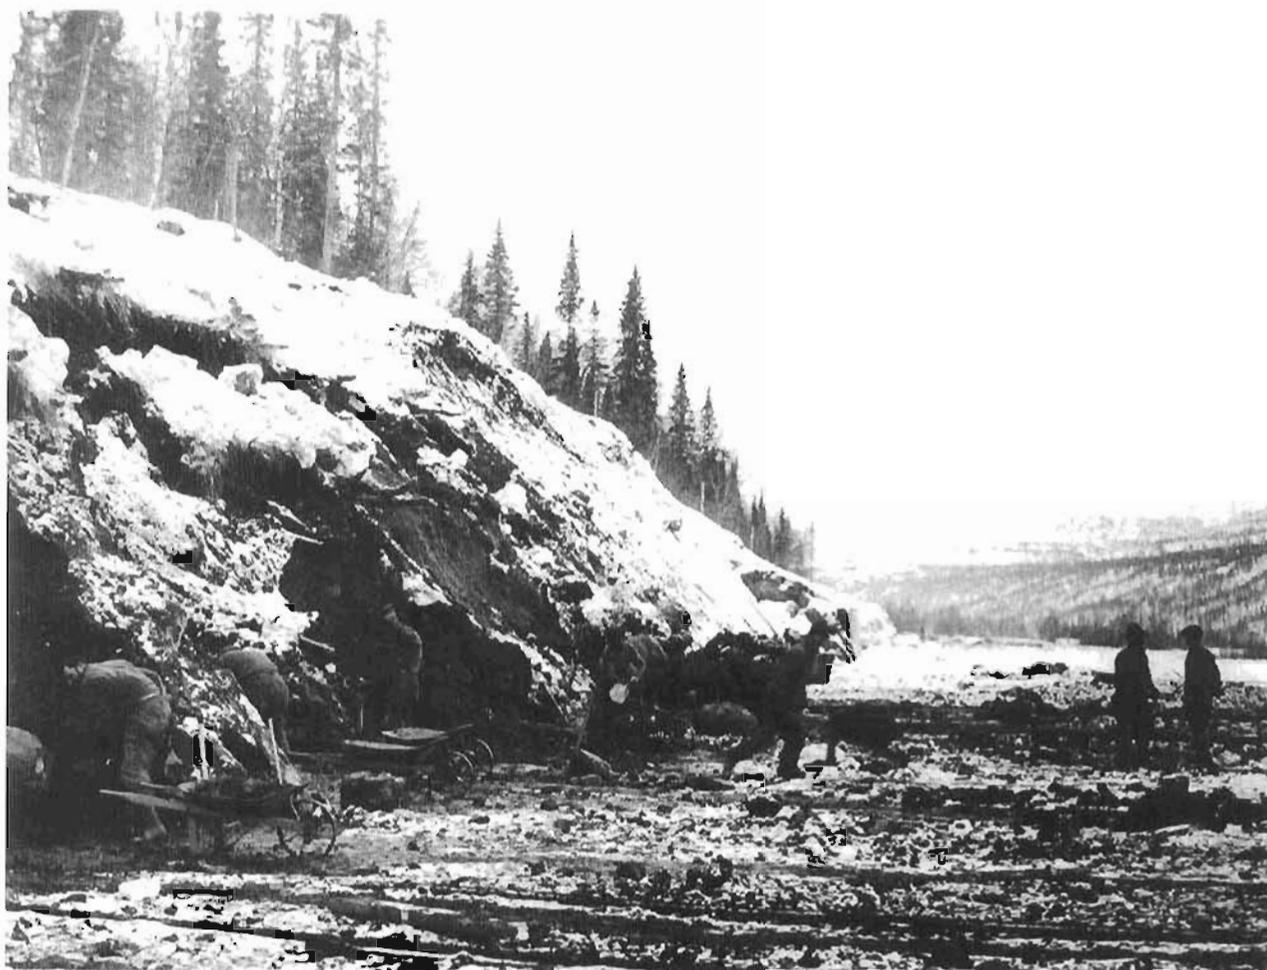
Figure 28. The station contractor had workers use picks, shovels, and wheelbarrows to excavate a sidehill cut, Mile 259. Photograph AEC G1186, Alaska Railroad Collection, Anchorage Historical and Fine Arts Museum, March 6, 1919.

MILE 259. Here, the roadbed is constructed in a bedrock cut section (fig. 28). Excessive ground water seeps into the shallow subgrade and ballast section and causes severe differential heaving. In addition, hydrostatic pressure forces the water to flow from the vertical rock face above the track level. The water causes a wall icing, which can result in side-clearance problems. Icings are common in winter and potentially hazardous to safe winter operations (fig. 29). Even during extreme cold spells, ground water continues to flow from the ground. If not checked, the icing will continue to build, fill the ditch, and reach the track, where an accumulation of only 1 or 2 in. can derail the heaviest locomotive. Because nearly all icings are remote from electrical power, standard thawing equipment on the Alaska Railroad has become the ubiquitous 'Alaska daisy,' which is a 55-gal (210 l) fuel-oil barrel that is cut in half and filled with charcoal briquets that are kept burning continuously. Rock salt is also used to encourage melt-water to flow into ditches and culverts. The severity of the icings varies, but is at its worst during a winter of light snowfall and extended stretches of cold weather. Thick snow, if undisturbed, will insulate the ground and allow ground water to flow through culverts under the track. During a bad year, the railroad may burn as many as 24,000 10-lb bags (240 tons or 220 mt) of charcoal. Under certain conditions, prima-cord explosives and a ditcher (an on-track power shovel) are used to break up ice in the ditches.

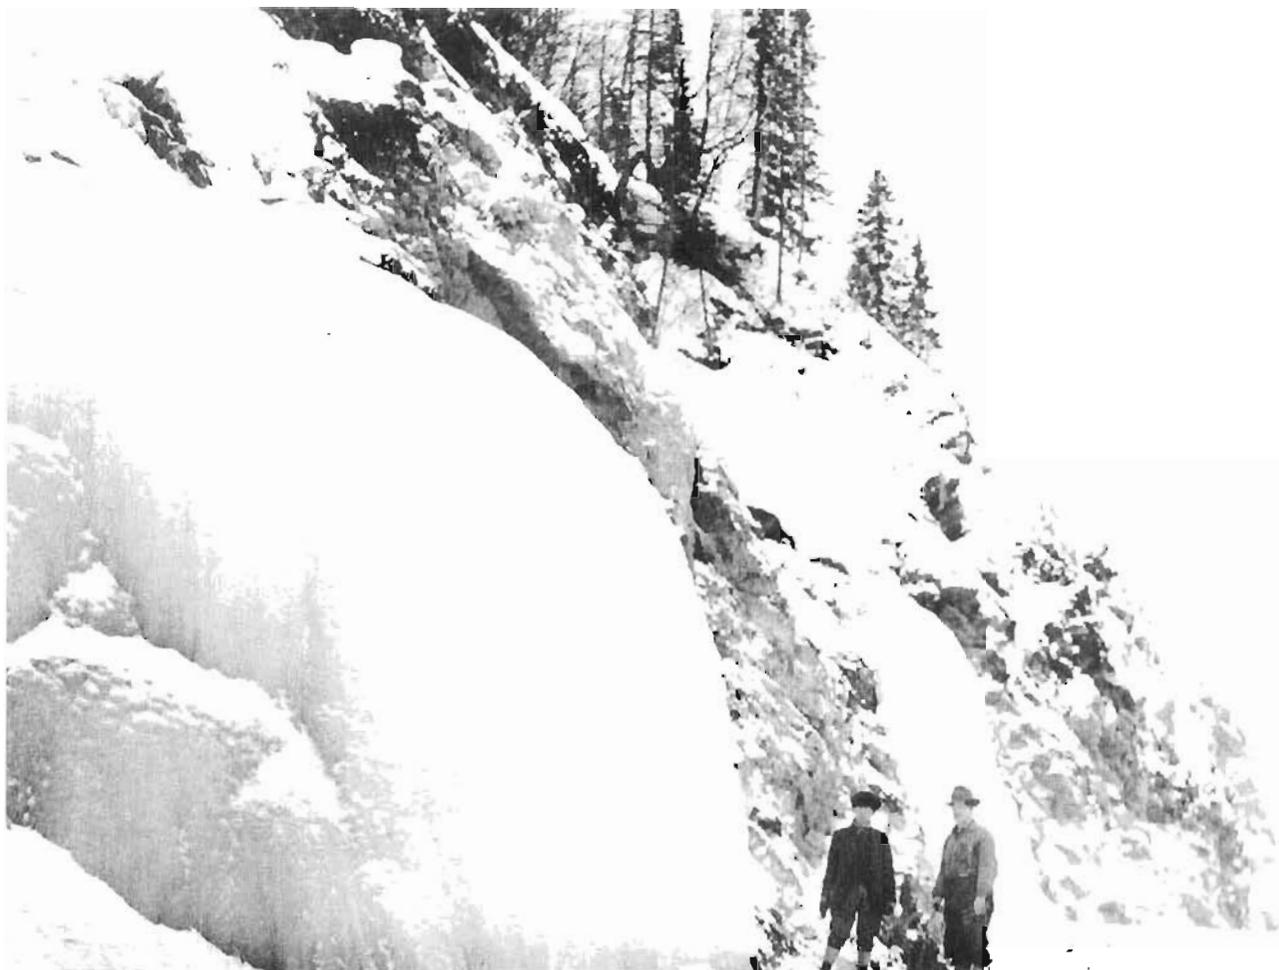
Figure 29. An icing at Mile 260. Photograph AEC G1189, Alaska Railroad Collection, Anchorage Historical and Fine Arts Museum, March 6, 1919.

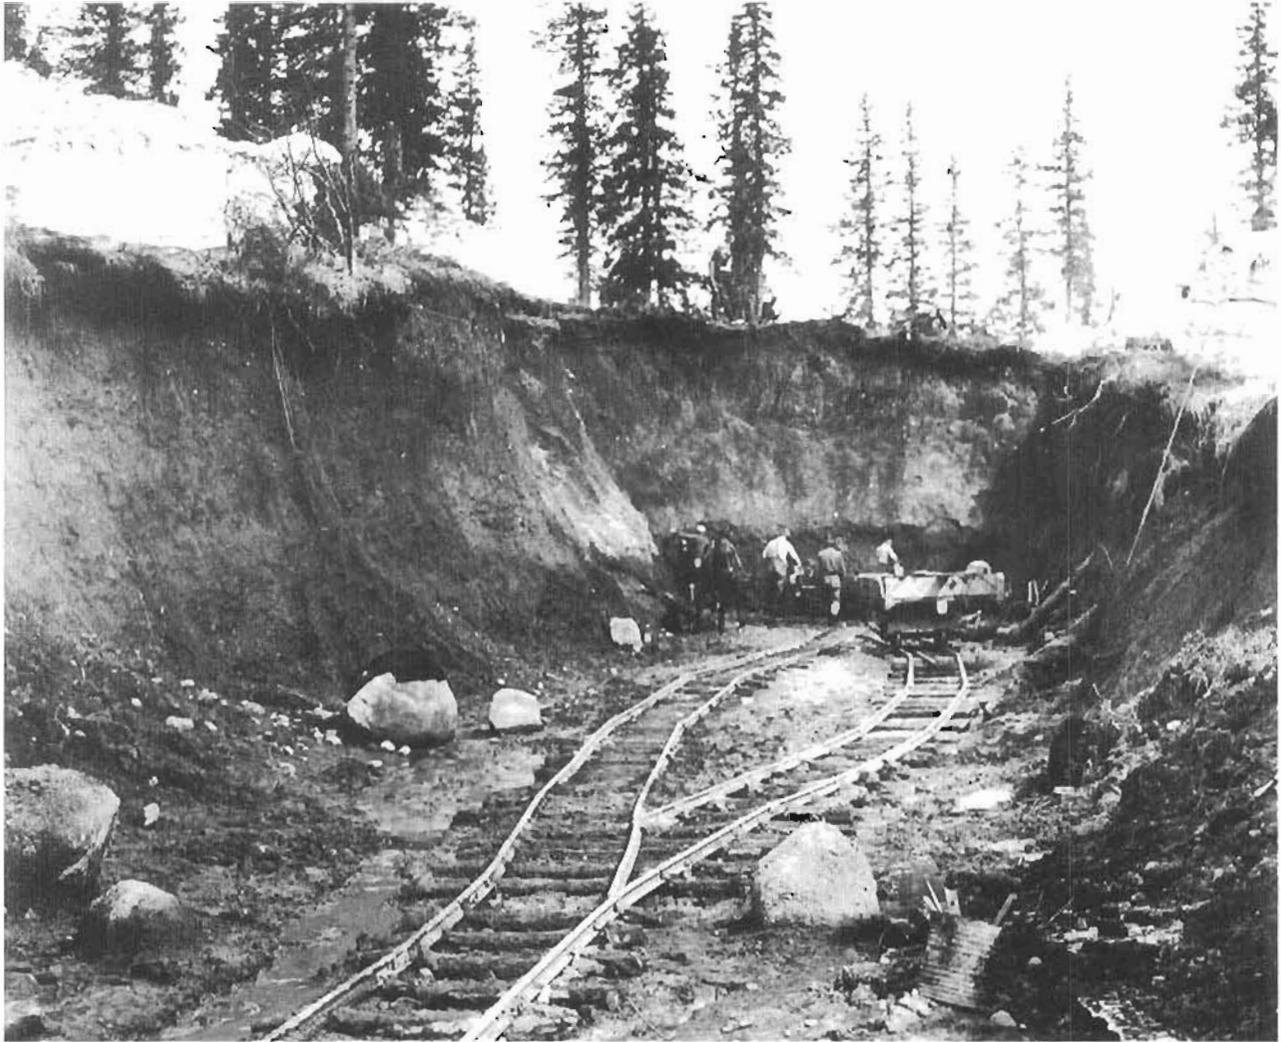
Figure 30. Station workers excavate a throughout in glacial till, Mile 282 to 283. The material was loaded into horse-drawn carts and hauled south to build the fill shown in figure 31. Photograph AEC G1567, Alaska Railroad Collection, Anchorage Historical and Fine Arts Museum, May 25, 1920.

is poor, and there are indications of discontinuous permafrost at shallow depth. Vegetation is typical of a lowland spruce-hardwood forest with pure stands of black spruce (figs. 30 and 31).

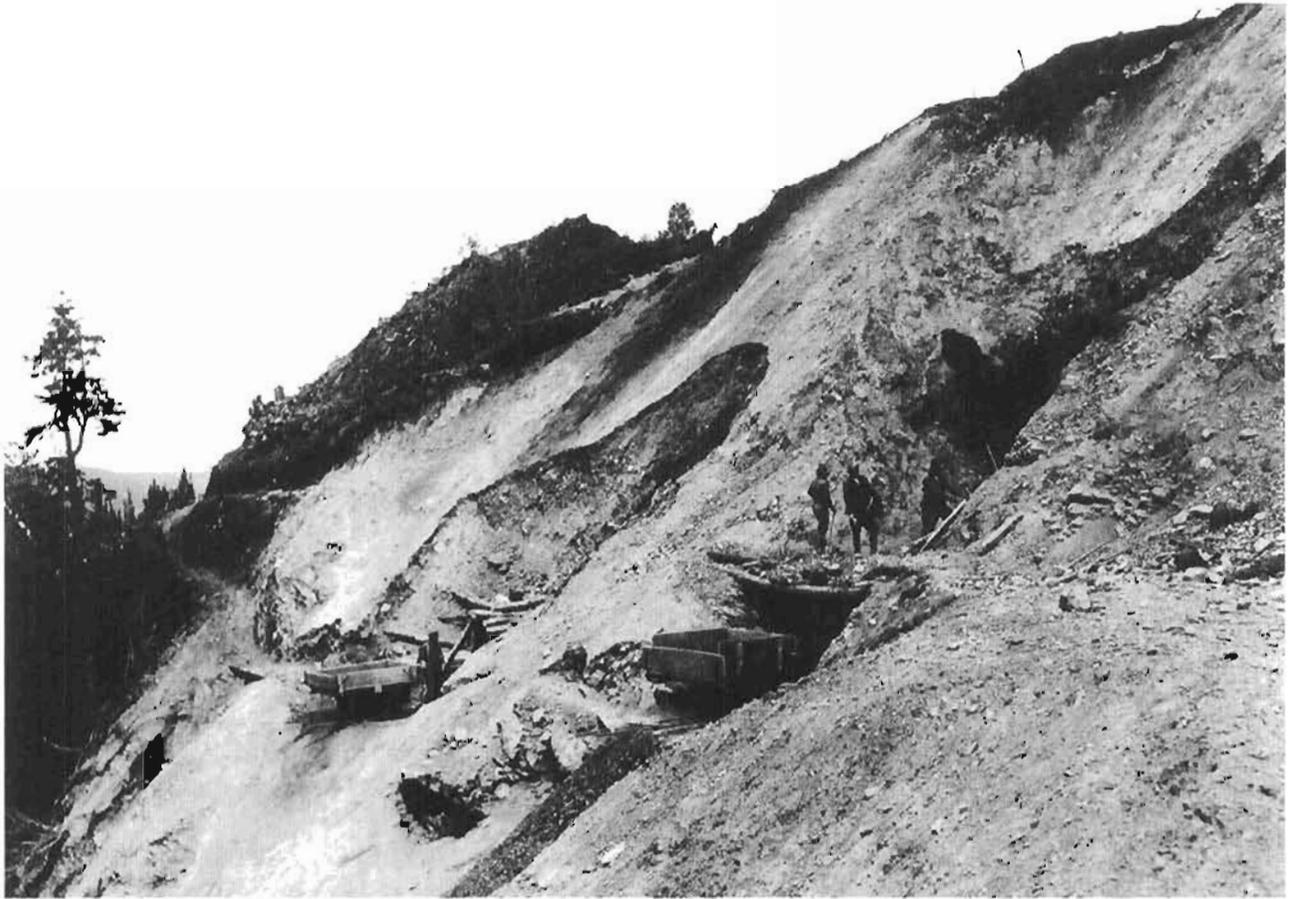
Figure 32 Sidehill excavation in glacial drift on 'Honolulu Hill,' Mile 287. Photograph AEC G1807, Alaska Railroad Collection, Anchorage Historical and Fine Arts Museum, June 20, 1921.

MILE 285.5. Begin descent on a 1.5-percent, southbound ruling grade to cross Honolulu Creek on a 150-ft-long (45 m) through-truss span near the floor of the Chulitna valley (fig. 32). This alignment avoided crossing several deep gorges on the higher bench of the original location. The original drawings show that several alternate locations were investigated, one of which involved building six tunnels, three on each side of the approaches to the gulch. The construction of the Parks Highway in this area involved a similar exercise in selecting a final alignment.

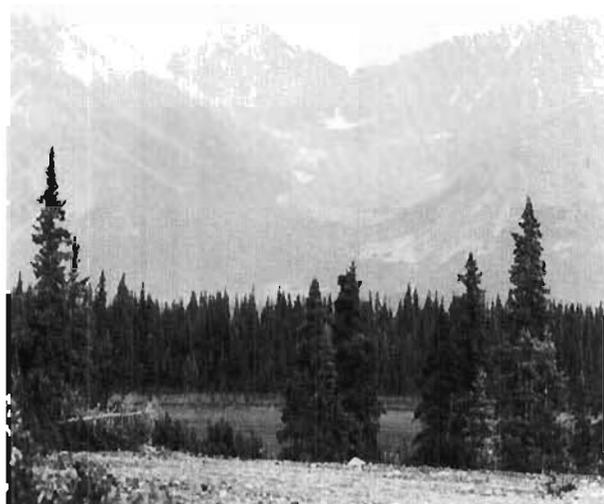
Figure 33. Mile 295.1, the first of a series of rock glaciers visible in the high valleys and cirques along the west front of the Talkeetna Mountains. Rock glaciers usually form below talus cones and aprons at the head of valleys or cirques and along lower valley walls. Their slow downslope flow, external shape, and tongue or lobate form also characterize glaciers. Photograph by Dave Atwood, 1982.

MILE 295.1. This is the first in a series of rock glaciers that are visible in the high valleys of the Talkeetna Mountains to the east (fig. 33). In this area, stands of timber in which black spruce is the predominate species have been referred to as 'liaga,' the Russian word for a typical boreal forest.

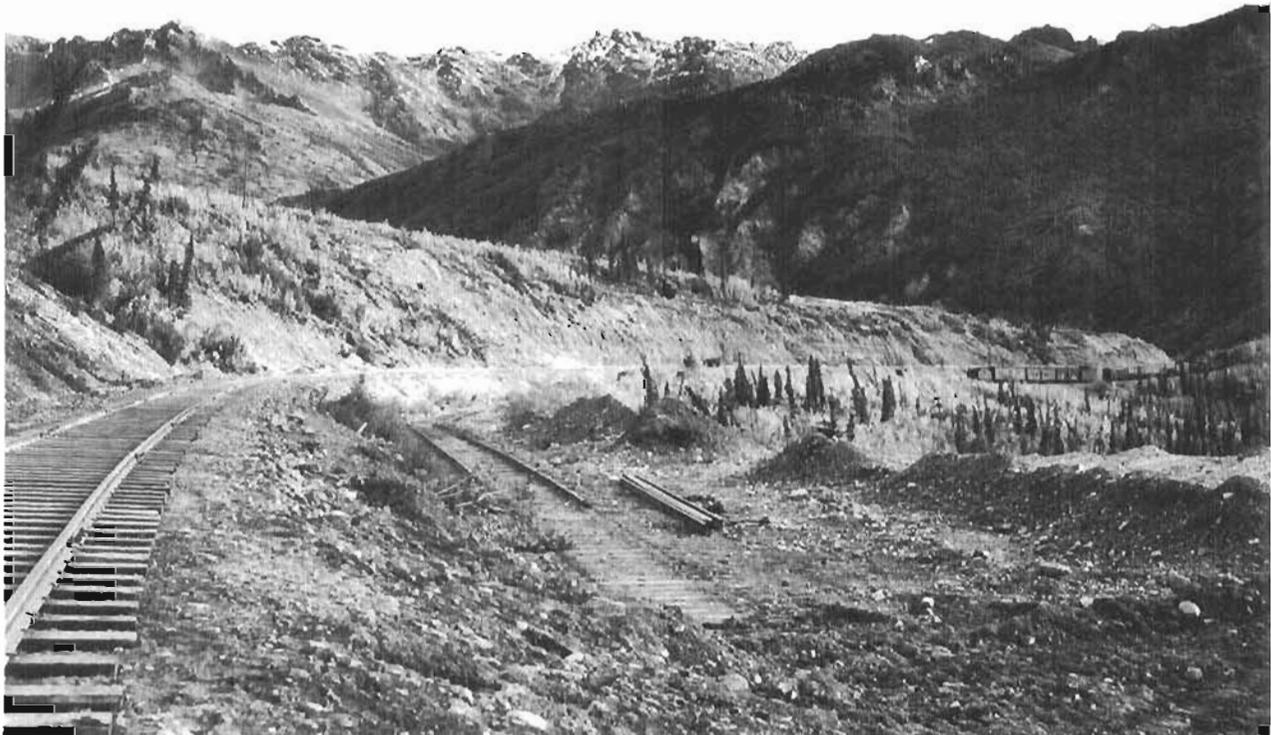
Figure 37 View of an ancient clay-filled gorge of the Nenana River. The amount of subsidence is apparent at the extreme right, where the present track is visible above the 14-ft-high (4.3 m) outfit cars that sit on the abandoned track. Photograph BL 79.2.2966, Alaska Railroad Collection, Anchorage Historical and Fine Arts Museum, August 26, 1948.

MILE 349.1 to 349.6 This is an active slide area where numerous spruce trees below the track have abruptly bent trunks, indicating that slope movement occurred long before the railroad was built. After the railroad was constructed, a sinkhole developed that required filling and raising. By 1945, the subsidence rate had increased, and a new grade was cut north into the bench. Before the railroad could be realigned to the new grade, large cracks opened and further realignment was necessary; however, subsidence continued. By the summer of 1948, the track was 15 to 20 ft (5 to 6 m) below the grade and had to be realigned 74 ft (23 m) north on a new bench beyond the area of subsidence (fig. 37). Further realignment was required in 1947 and 1950. A sinkhole still persists in this area, but it subsides at a very slow rate. In the 1940s, the diversion of surface water on top of the bench towards the track probably contributed to the rapid subsidence caused by melting permafrost within the slide area. The

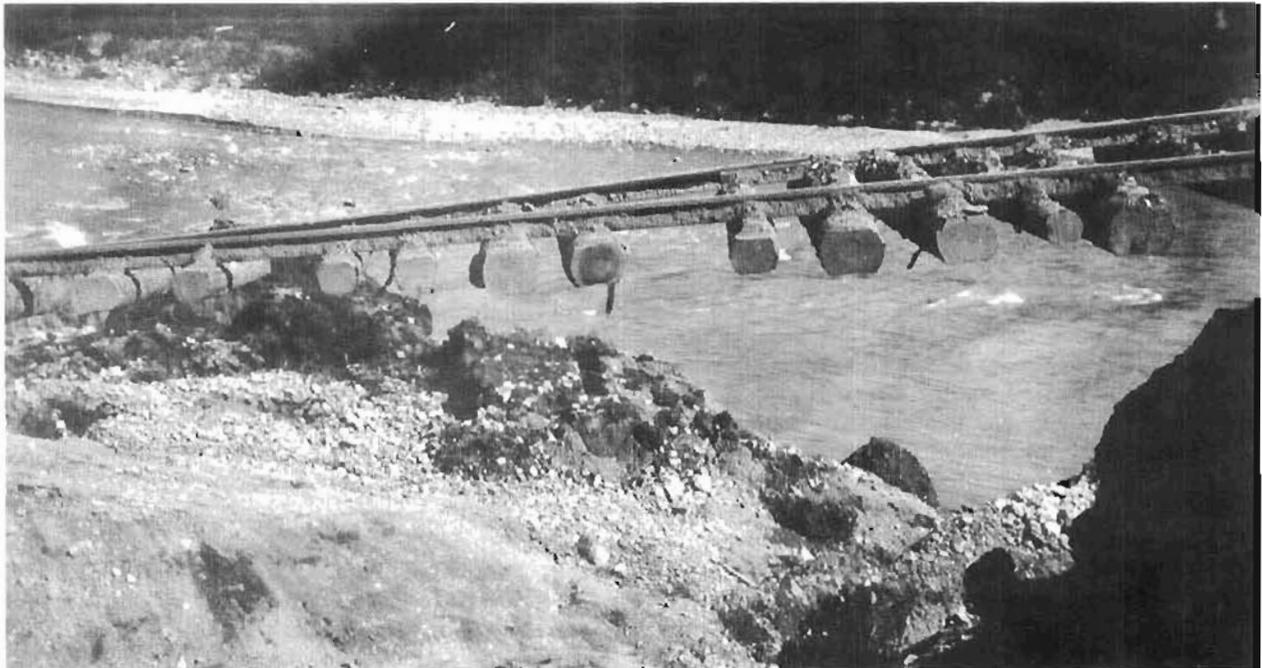
Figure 11. 'Daylight track' was created in 1923 when the roadbed suddenly failed at Mile 353. The roadbed was built on lakebed clays and was oversteepened by erosion. A 420-ft-long (128 m) wood trestle that was built to bridge the ravine remained in service until the ravine was filled in 1943. Photograph from the Alaska Railroad Collection, Anchorage Historical and Fine Arts Museum, June 16, 1923.

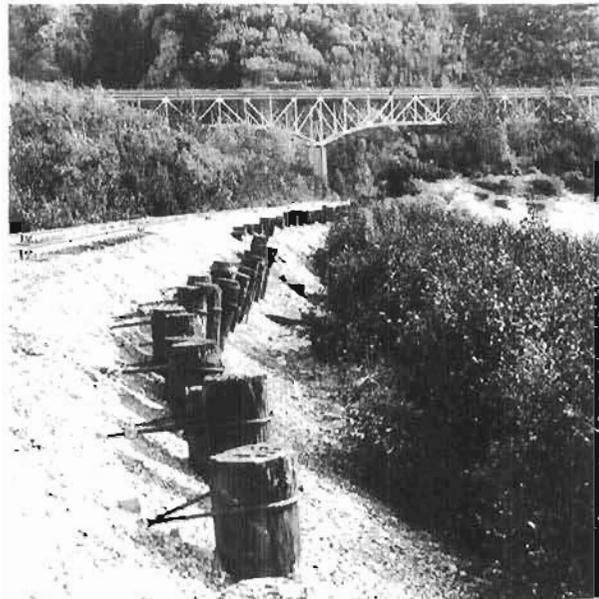
Figure 42. Pilings (35 ft long; 11 m) were driven on the outside shoulder of the track and tied back to 'deathmen' driven on the inside shoulder. The irregular alignment of the piling is due to further movement within the slide area. Photograph by Dave Atwood, 1982.

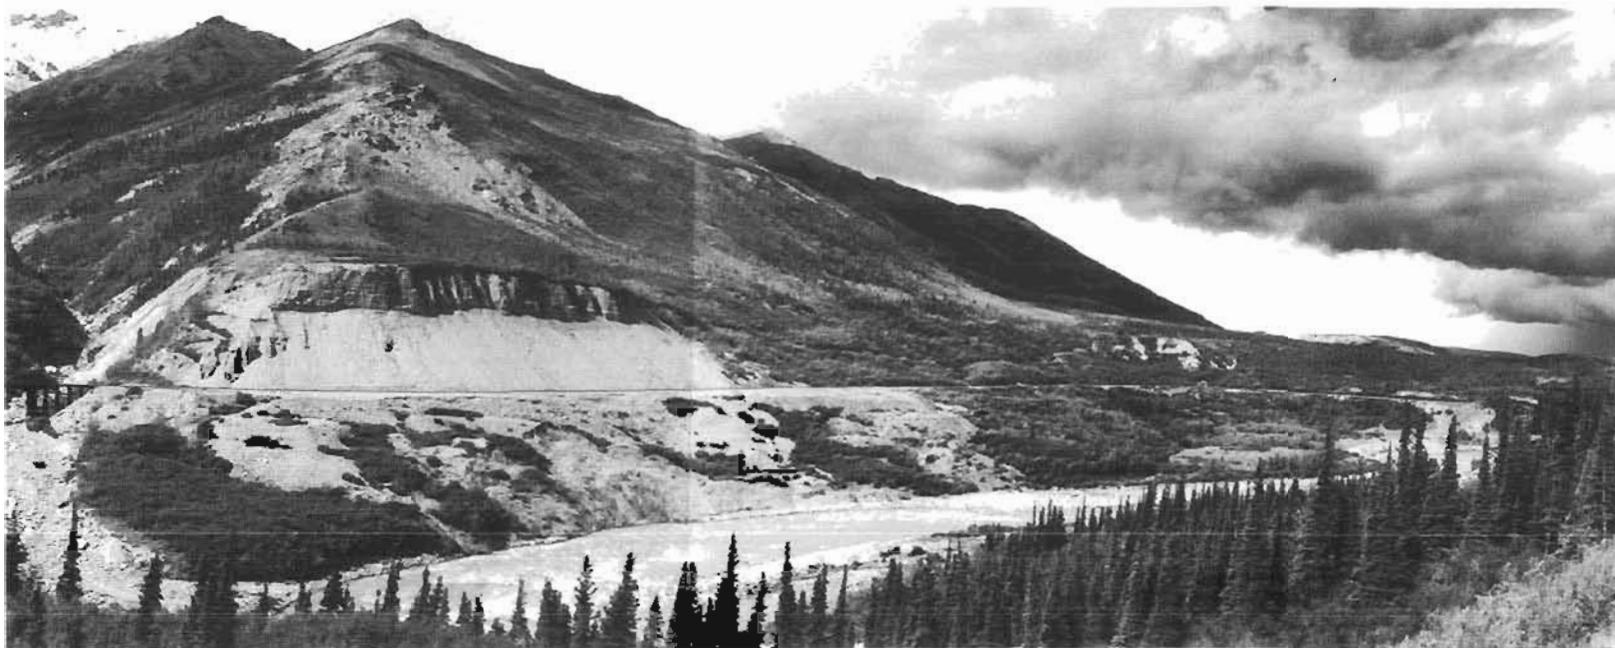
Figure 47. View of the Moody landslide area, beginning on the left at Sheep Creek (Mile 352.8) and ending in the mudflow at Mile 353.4, on the extreme right. The irregular exposed benches that lie below the track and the high terrace of outwash gravel, talus, and alluvium are a series of abandoned roadbeds and old castovers of thawed material that traveled down from the near-vertical face of the terrace. The near-vertical face was developed when the railroad made a substantial line change into the frozen terrace in 1949. When ditch lines are cleaned out with on-track power shovels, the railroad commonly casts material into spoil piles on the outside shoulder of the track and then dozes the material farther out. This added weight on the outside shoulder, combined with lateral erosion of the river, overloads the unstable slope above the river and causes a series of typical slumps and slides in the clay-rich glacial deposits. Photograph by T.L. Péwé, June 25, 1981.

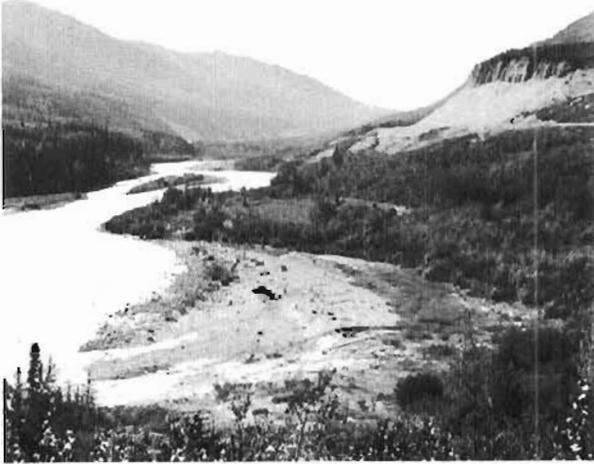
Figure 49. View (to the south from Mile 353.4) up the Nenana River, the Moody landslide area is on the right. The slumps and earthflows along the railroad through Healy Canyon are primarily caused by lateral erosion and downcutting by the Nenana River, which undermines the unconsolidated glacial deposits. These clay-rich deposits are incapable of maintaining stable, relatively gentle slopes, particularly when saturated. The gravel bar (foreground) is an abandoned river meander and represents a retreat of the river away from the toe of the Moody landslide, a position it occupied in the 1950s and 1960s. Coinciding with this retreat and after the last period of intense sliding in 1967, landslide activity has declined in the Moody landslide area. Photograph by Dave Atwood, 1982.

MILE 353.3 to 353.5 This was once the area of a very active earthflow, but is now relatively stable, probably due to the retreat of the west bank of the Nenana River. A small archaeological site was excavated in the silt mantle that overlies the bench to the left of the track (fig. 49).
