THE ALASKA RAILROAD BETWEEN ANCHORAGE AND FAIRBANKS

Guidebook to Permafrost and Engineering Problems

By T.C. Fuglestad

Division of Geological & Geophysical Surveys
Guidebook 6

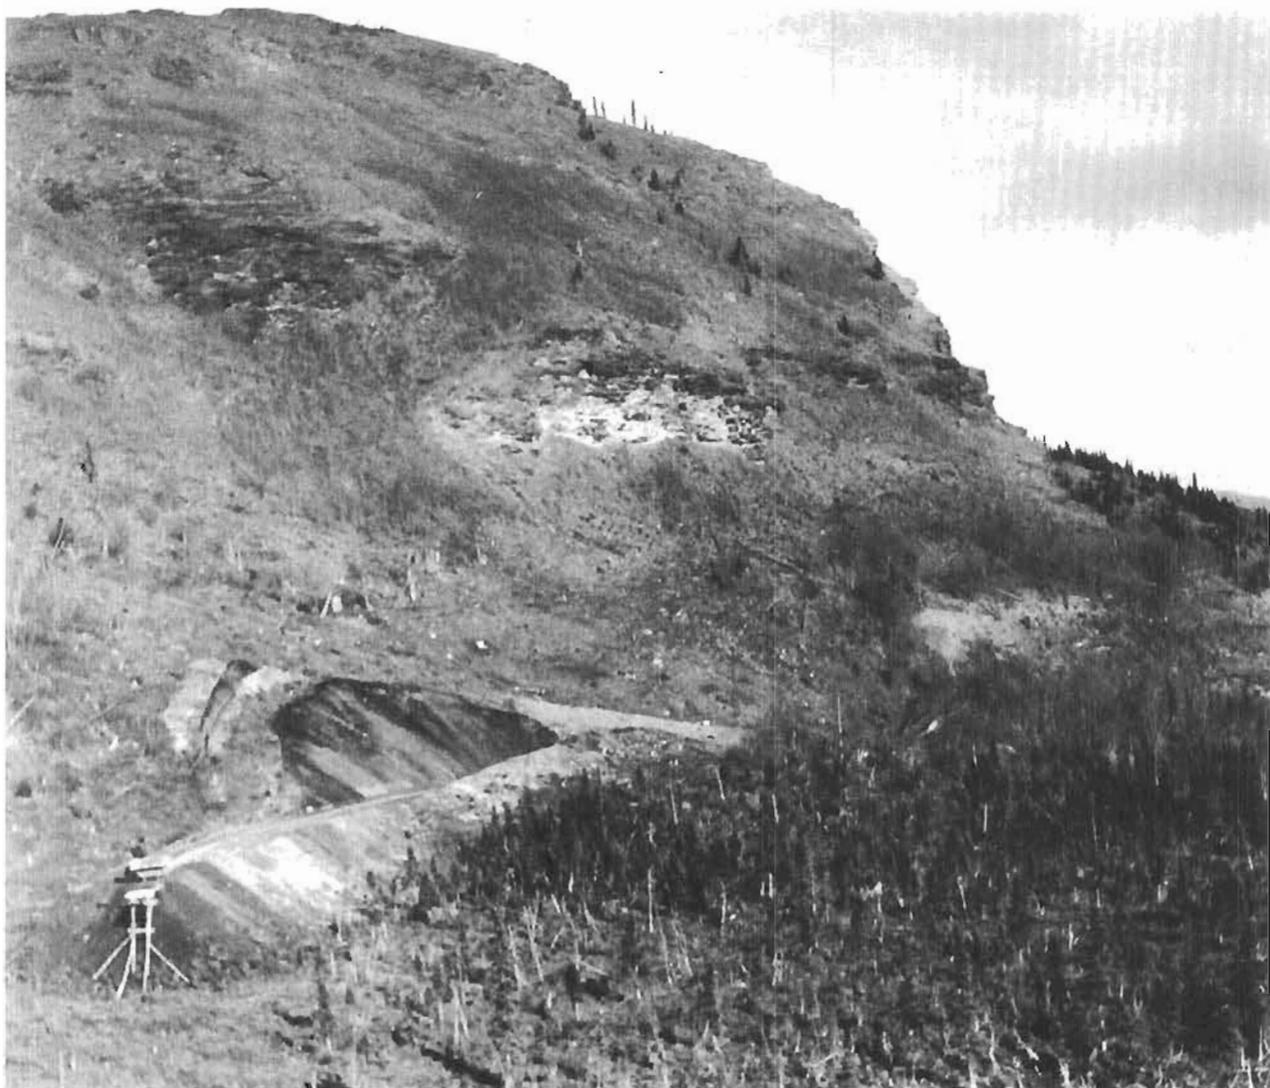
Figure 51 Station workers used light pole trestles to construct high fill sections. Mile 357.5 The hill of schist bedrock has been considerably altered by slides and slumps since this picture was taken. Photograph AEC G1683. Alaska Railroad Collection, Anchorage Historical and Fine Arts Museum, October 1, 1920.

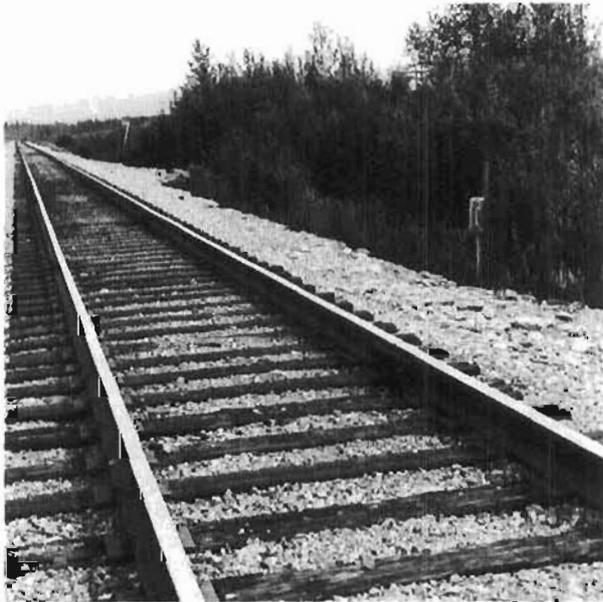
Figure 57. View of test section of insulated track with a recording thermograph on the right, Mile 139. The test section is not subject to the severe differential heaving visible in figure 63. Photograph by Dave Atwood, 1982.

MILE 439. INSULATED-TRACK TEST SECTION (fig. 57).

at least 5 in. (13 cm) of shimming because of seasonal frost heaving and permafrost degradation. Frozen ground was encountered when the instruments were installed. The instruments consist of three sets of 16 thermistors each that were installed under the styrofoam and two control strings of 13 thermistors each that were installed beyond the insulated areas. The thermistors measure the heat flow in the roadbed and around and under the styrofoam to a depth of 10 ft (3 m). Weekly readings are taken, and air temperatures are continuously recorded on a thermograph. Quarterly surveys are made to record any settlement.

determine the best design (figs. 58 through 61). Once the disruption caused by the construction of the test sections has dissipated, heat-flow data from the thermistor strings will be analyzed. Ultimately, a set of new design criteria will probably be developed for construction of railroad roadbeds in permafrost areas.

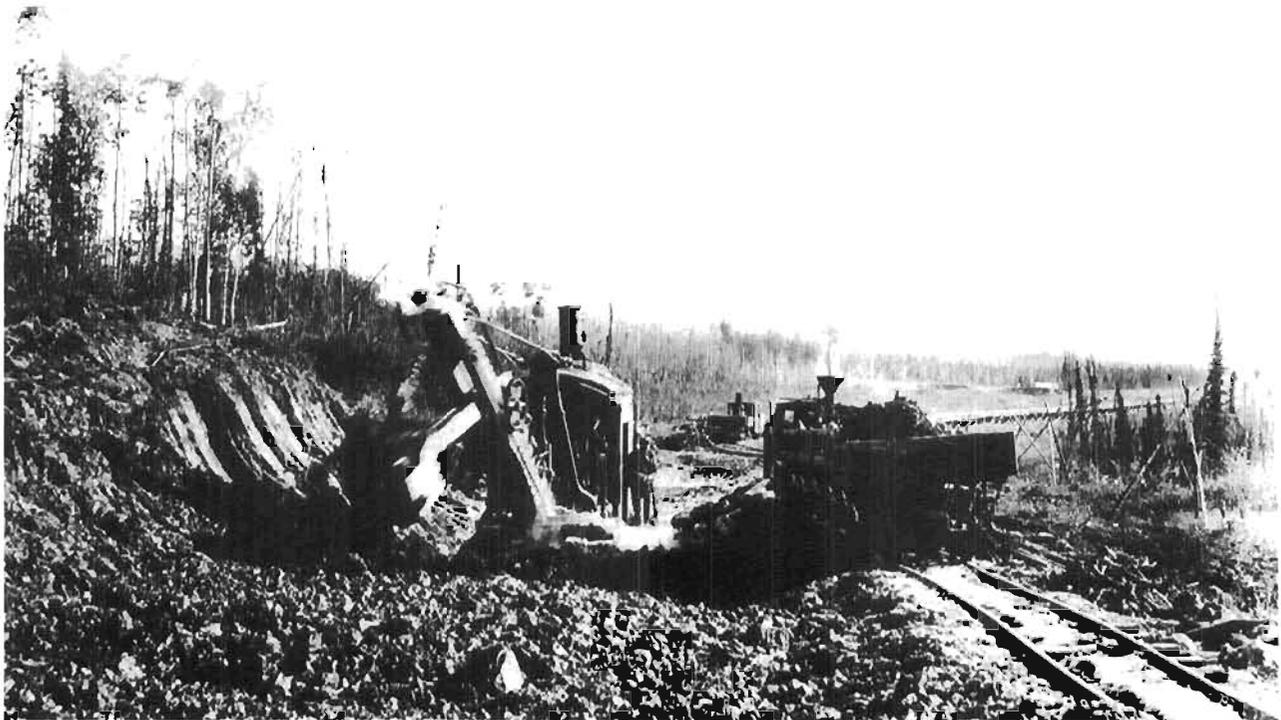
Figure 62. Borrow-pit operations at Mile 449. Dynamite was used to break up frozen silt in the low hillside to the left so that the silt could be loaded into the narrow-gauge equipment of the Tanana Valley Railroad. Part of the main line was first constructed on the light timber trestle visible in the background, it was then filled by work-train. To the right, native timber tripods that adjust readily to differential settling carry communication lines. Photograph from Alaska Railroad Collection, Anchorage Historical and Fine Arts Museum, July 26, 1919.

MILE 449. Figure 62 shows borrow operations during the original construction.

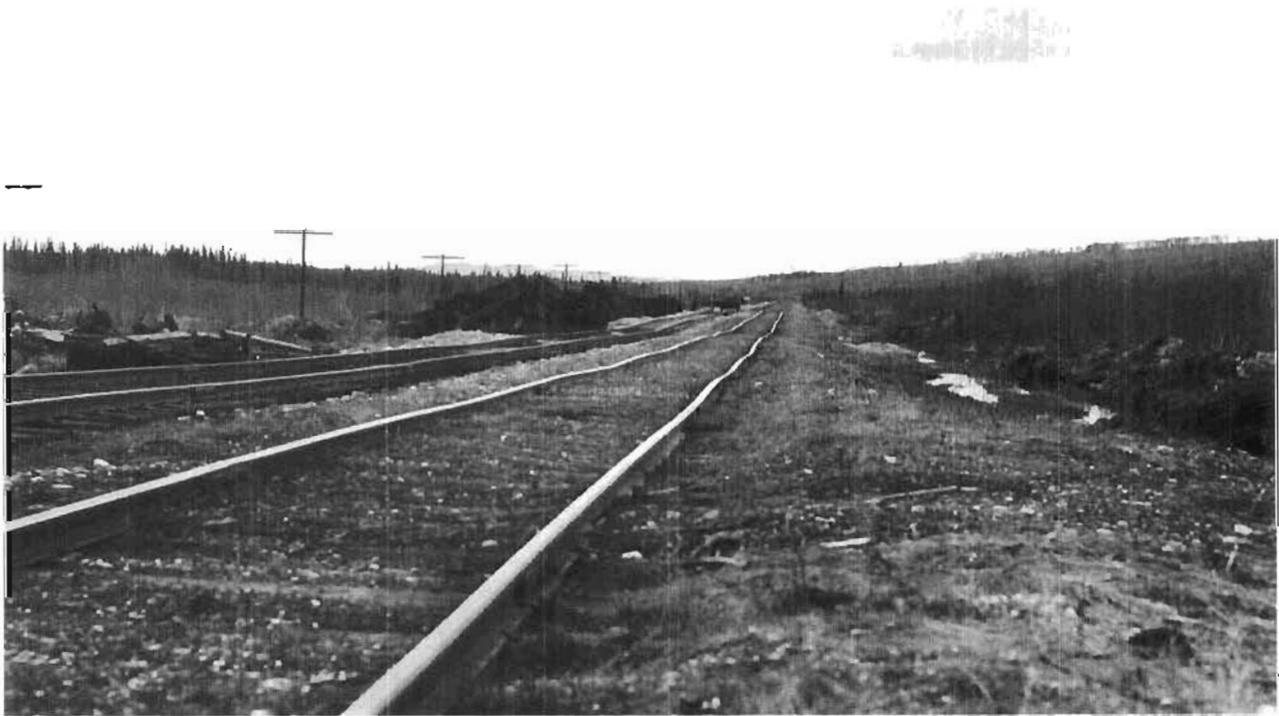
Figure 63. Example of track deformation at Sautlich (Mile 450.8) that was caused by differential settlement due to degrading permafrost. Photograph BL 79 2.3055, Alaska Railroad Collection, Anchorage Historical and Fine Arts Museum, May 1949

Poor track conditions caused by thawing permafrost are readily apparent. (Note the 'tilting' coffee in your cup, if you have one.) The side track on the right shows poor track conditions that would result if the main line were not maintained (fig. 63).

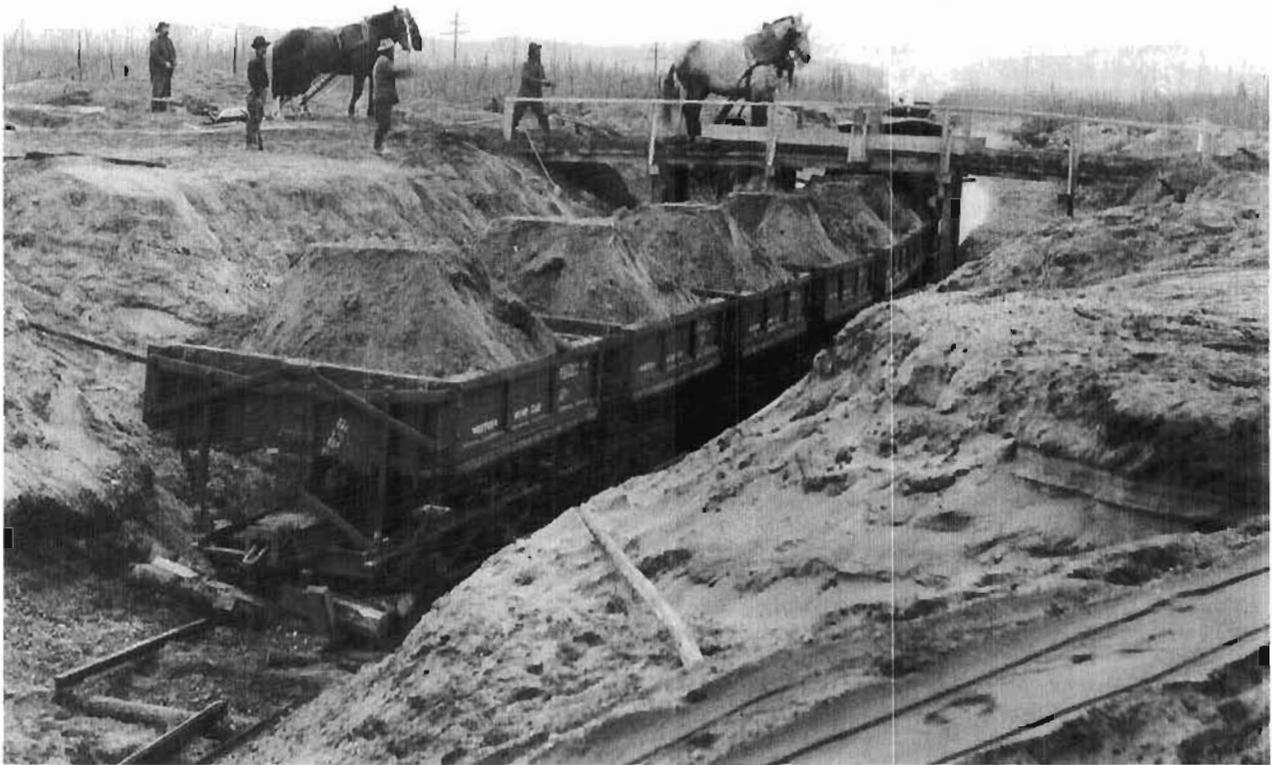
Figure 65. Early borrow-pit operation in flood-plain deposits of silt, sand, and gravel near Fairbanks. Narrow-gauge equipment from the Tanana Valley Railroad is used. Photograph from Alaska Railroad Collection, Anchorage Historical and Fine Arts Museum, October 13, 1917.

Figure 65 shows borrow-pit operations in this area in October 1917.
