Public-Data File 86-77

RESULTS OF AN AQUIFER TEST AT PETERS CREEK,
MUNICIPALITY OF ANCHORAGE, ALASKA

By
J.A. MUNTER¹

Alaska Division of
Geological and Geophysical Surveys

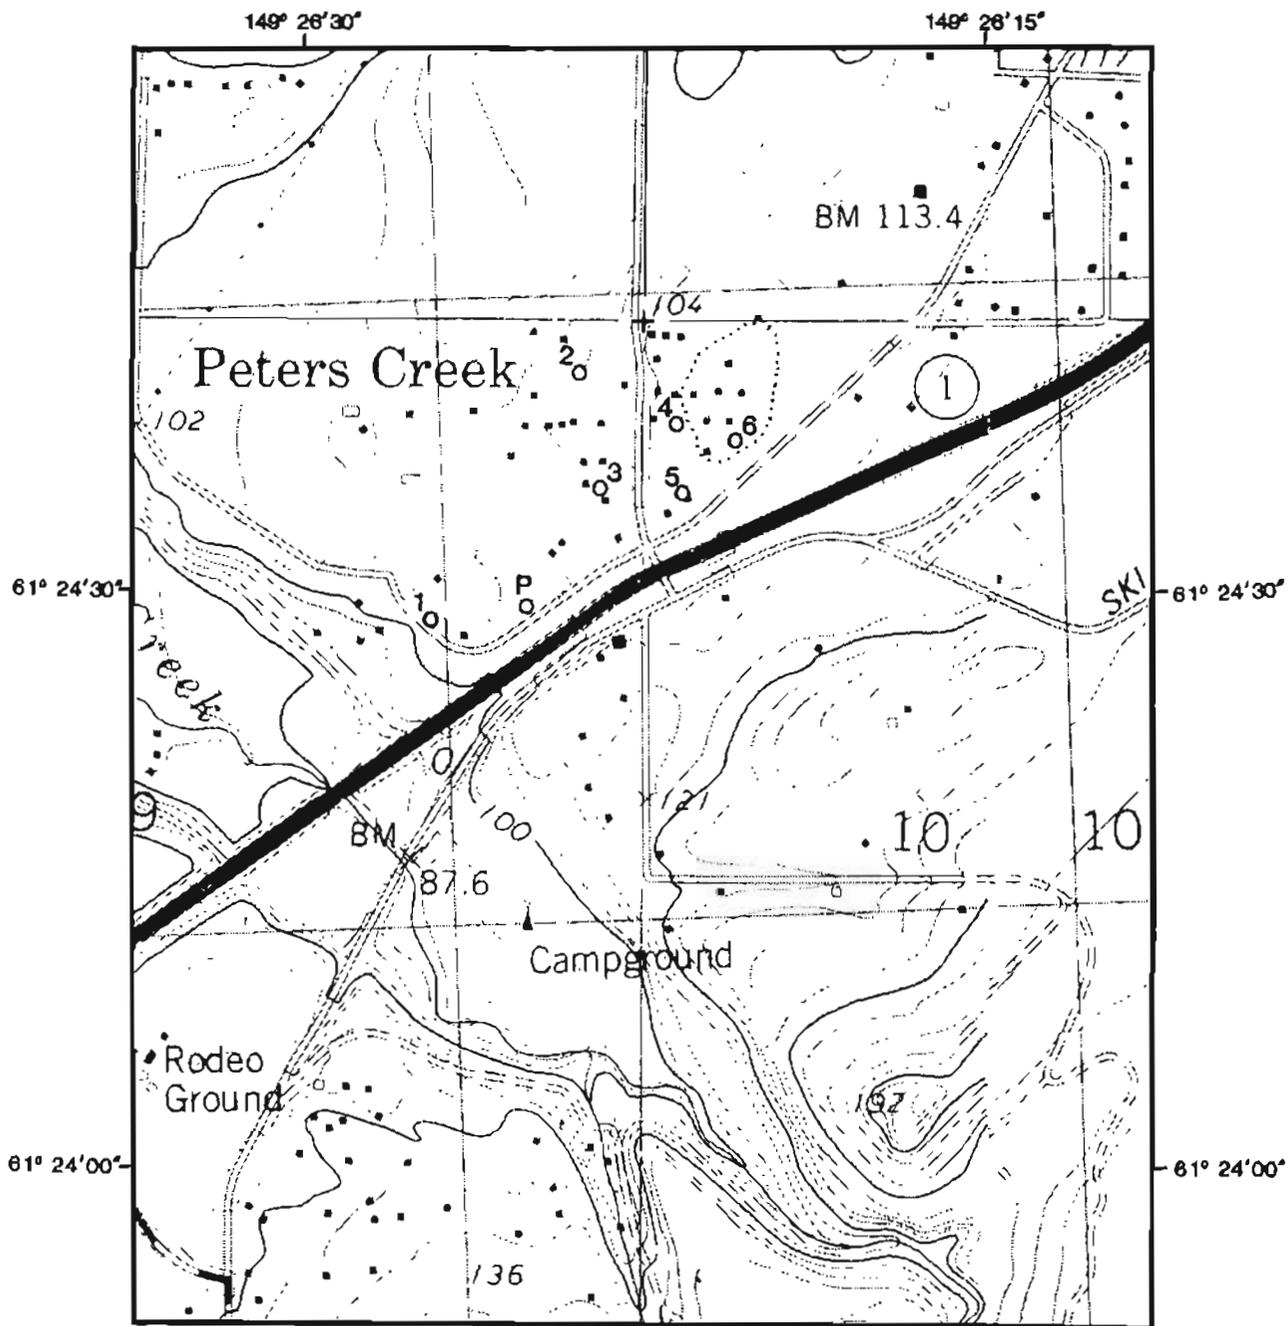
Figure 1. Locations of selected wells at Peters Creek.

EXPLANATION

--- APPROXIMATE LIMIT OF CONTAMINATED GROUND WATER

1 O LOCATION OF OBSERVATION WELL WITH WELL NUMBER

P O LOCATION OF TRADING POST WELL

Six observation wells monitored during the aquifer test are located 500 to 1400 ft from the Trading Post well (figure 1, table 1). A review of the water-level data collected prior to 6 p.m., May 1, 1986, failed to identify any positive water-level response attributable to the pumping at the Trading Post well. Water-level measurement activity was suspended prior to the installation of the fourth test pump because the likelihood of successfully pumping the Trading Post well at a rate of 40 gpm or more appeared to be low.

Table 1. Summary of observation well data. Well locations are shown in figure 1.
