SPECIAL REPORT 15

**GEOLOGIC HAZARDS OF THE FAIRBANKS AREA, ALASKA**

By  
Troy L. Péwé

First Edition, 1982  
by  
Department of Natural Resources  
DIVISION OF GEOLOGICAL & GEOPHYSICAL SURVEYS  
Fairbanks, Alaska  
Reprinted 1993

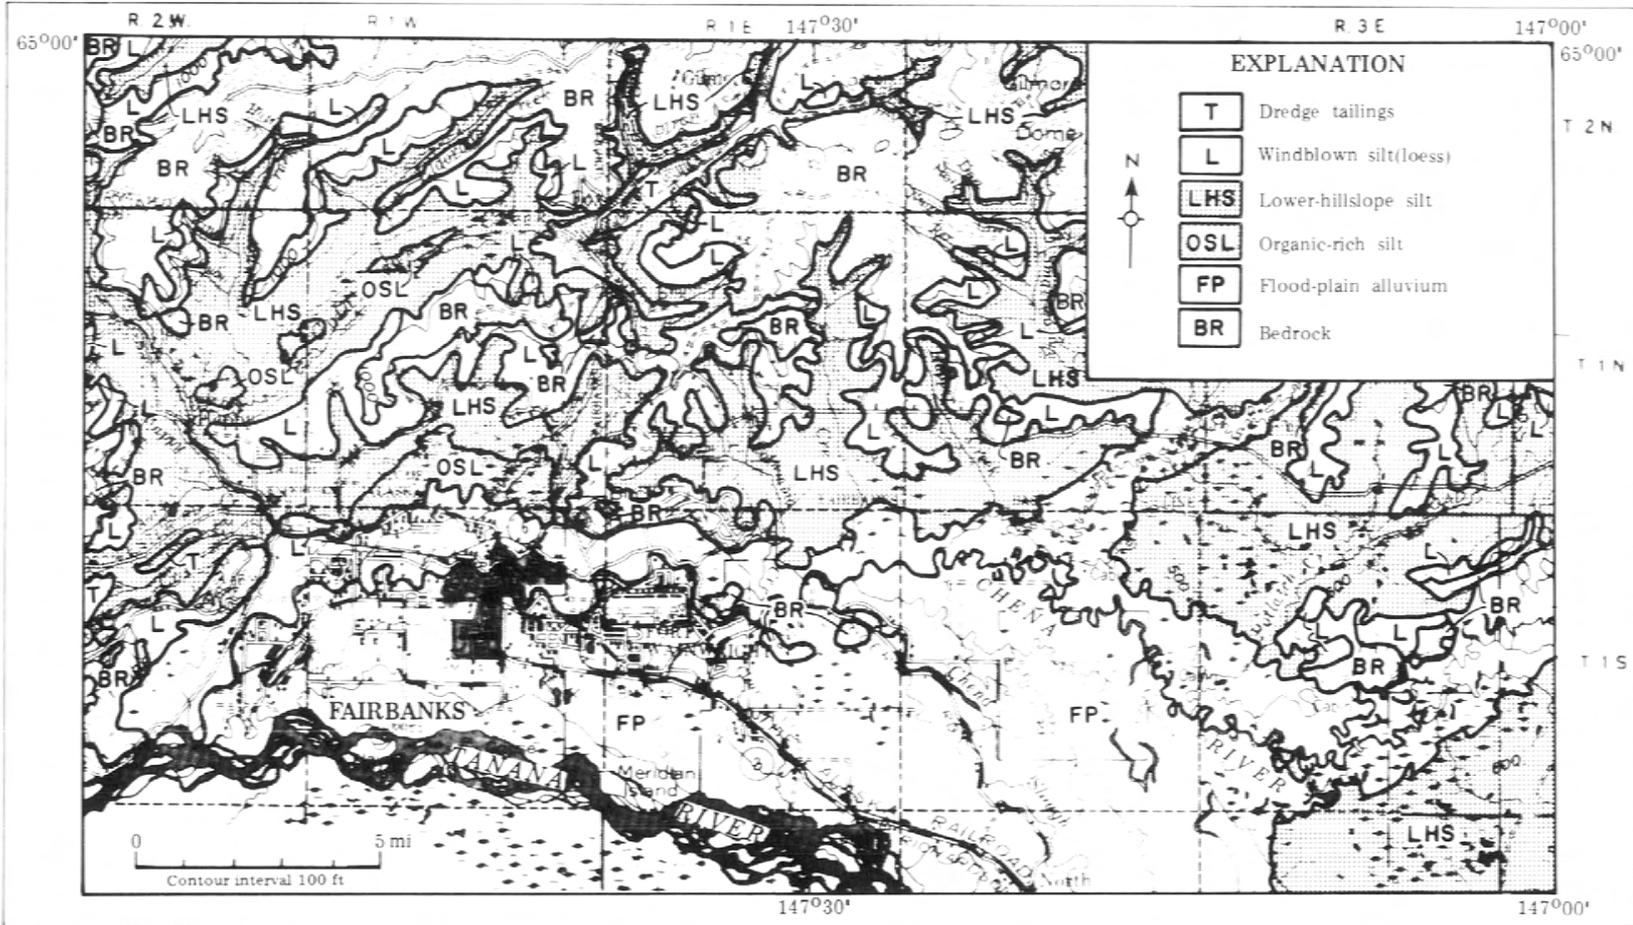
Figure 2. Geologic map of the Fairbanks area (modified from Péwé, 1958; Williams, Péwé, and Paige, 1959).

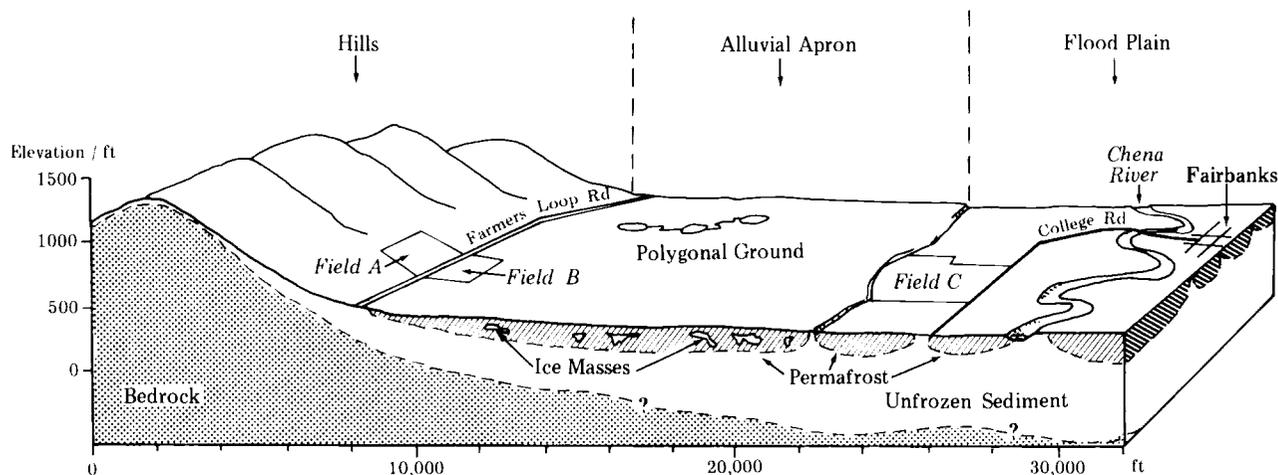
Figure 3. Diagrammatic sketch showing the character and distribution of permafrost in the Fairbanks area. Field A is not underlain by permafrost. Field B is underlain by permafrost containing large ice masses; thermokarst mounds and pits may form when the ice melts. Field C is underlain by permafrost without large ice masses; mounds and pits will not form at the surface and ground subsidence is negligible.

Polygonal ground is common in the organic-rich silt lowland south of Farmers Loop Road and north of College Road (fig. 3). Alluvial fans of silt washing down

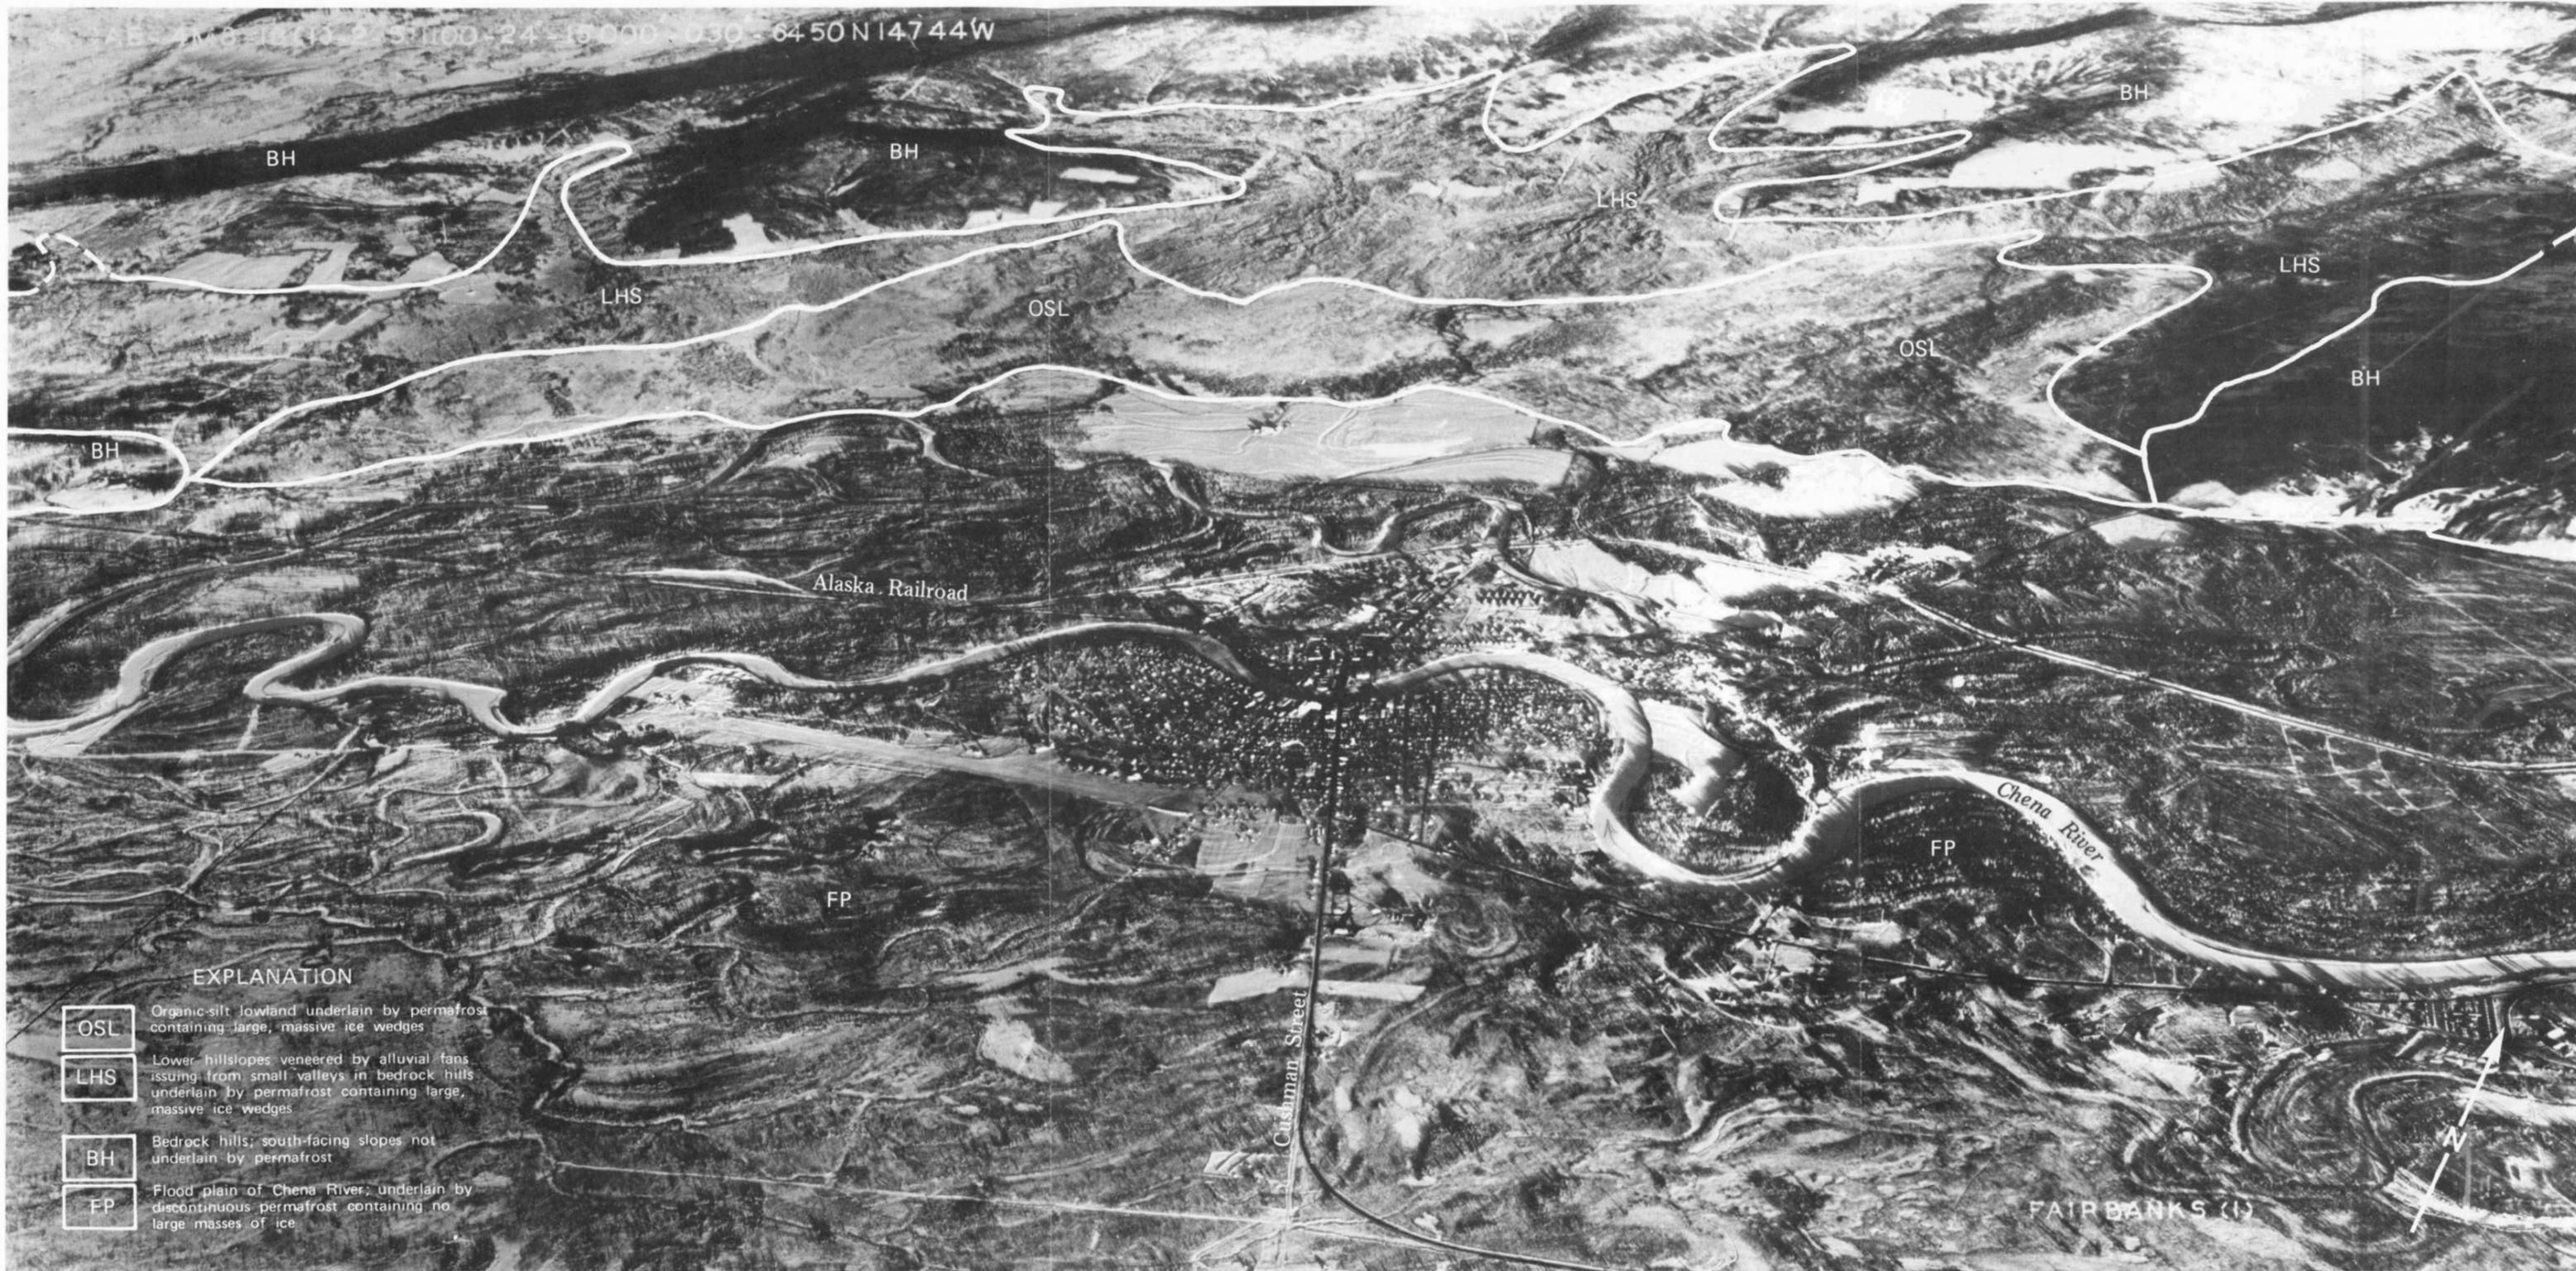
Figure 4. Oblique aerial view of Fairbanks. Photograph by U.S. Army Corps of Engineers (1946) from 15,000 feet above mean ground level.

Highways are subject to intense seasonal frost action in the Fairbanks area, particularly on the flood plain where they cross meander scars, swales, and intermittent drainage channels filled with organic silt (figs. 4, 7).

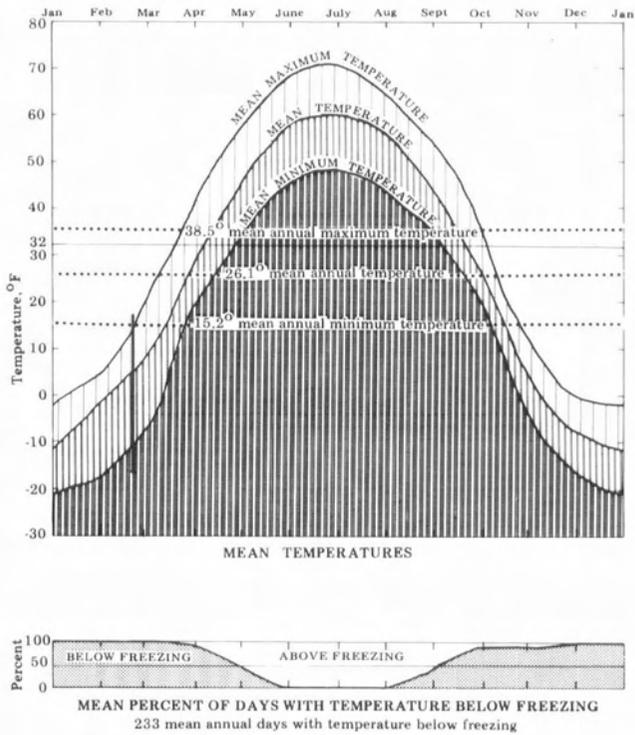
Figure 5. Temperature data for the Fairbanks area.

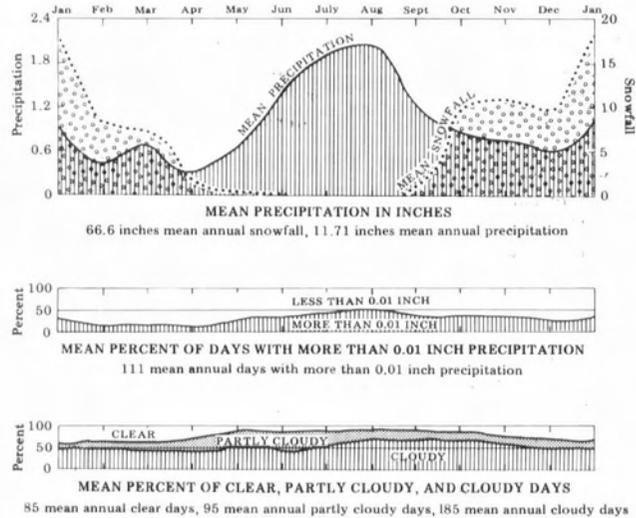
Figure 6. Precipitation and cloud-cover data for the Fairbanks area.

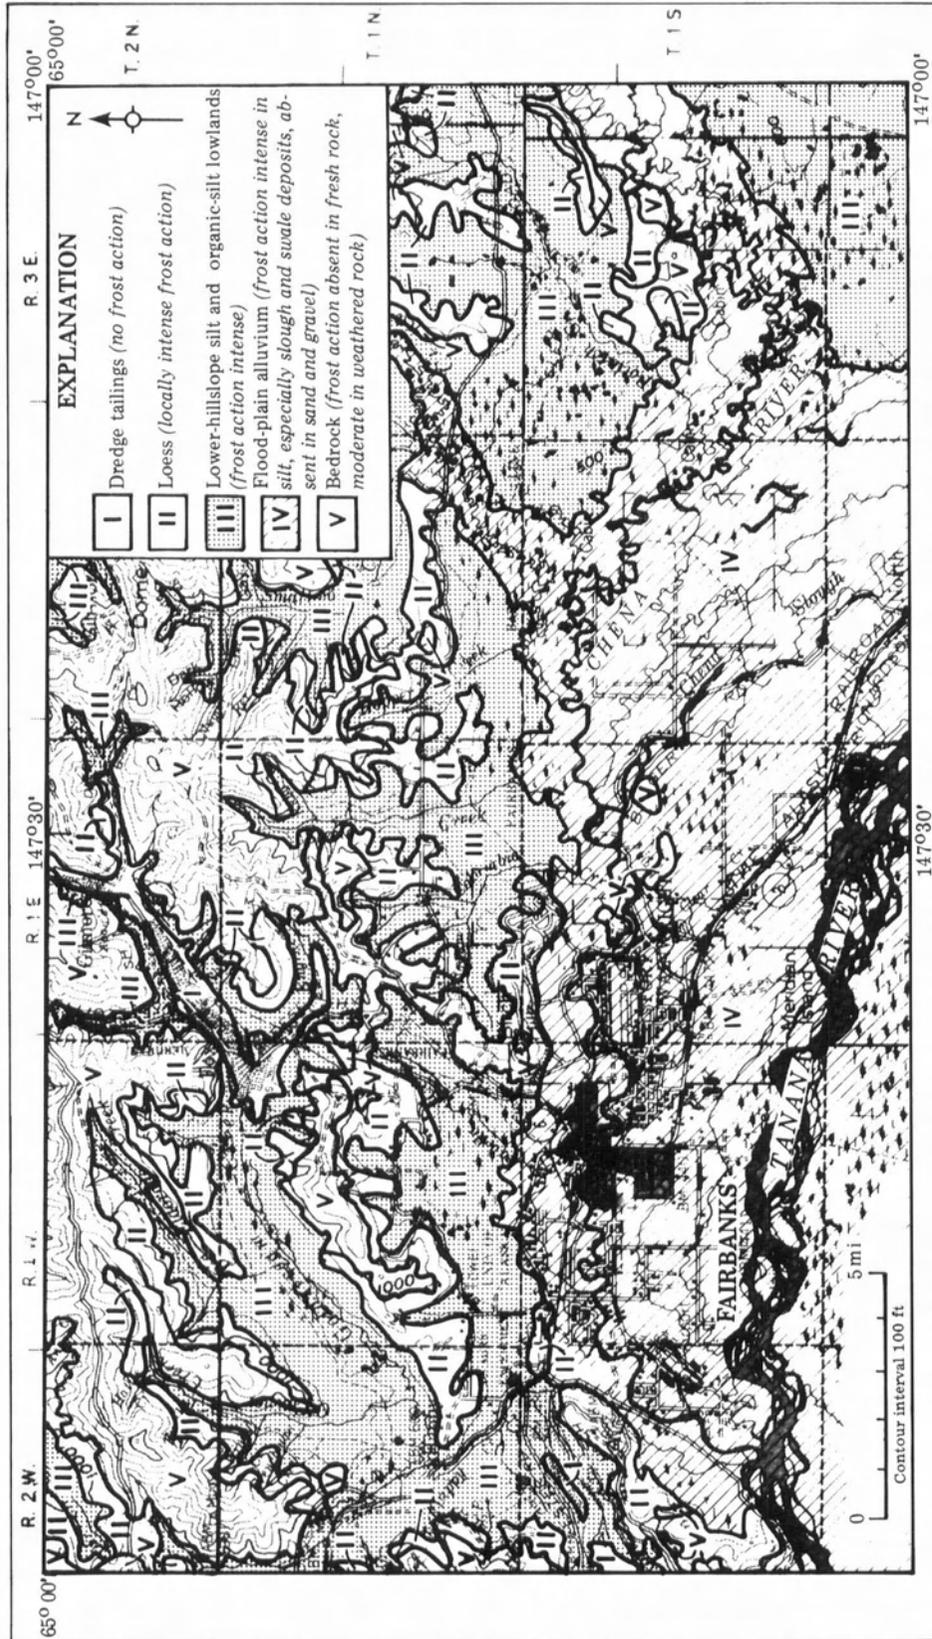
Figure 7. Map of seasonal-frost-action zones in the Fairbanks area (modified from Péwé, 1958; Williams, Péwé, and Paige, 1959).

The extensive blanket of silt, long periods of freezing, and poor drainage in the Fairbanks area provide ideal conditions for intense seasonal frost action. Four broad zones of frost-action intensity are present: a) loess-covered hills, b) lower hillslopes and creek-valley bottoms, c) organic-silt lowlands, and d) flood plains of the Chena and Tanana Rivers (fig. 7). These zones coincide with the area's permafrost zones.

Areas most intensely affected by frost action are the organic-silt lowlands between Farmers Loop Road and College Road and two small lowland areas in Goldstream Valley (fig. 7). These poorly drained areas of organic silt and peat are underlain by continuous permafrost and support few structures. College Road previously crossed the lowland, but was rerouted because of damage caused by seasonal frost and the thawing of ice-rich permafrost.

The Chena and Tanana River flood plains (fig. 7) support most engineering structures in the Fairbanks area, including the city, international airport, and Fort Wainwright. Flood-plain silt is poorly to fairly well drained. Many meander scars, swales, and intermittent drainage channels filled with 1 to 30 feet of organic silt trend sinuously across the flood plain (fig. 8). Highways and buildings on these poorly drained deposits have been seriously damaged by alternate freezing and thawing of soil moisture. Drainage improves when the vegetation is removed, because the permafrost table is subsequently lowered.

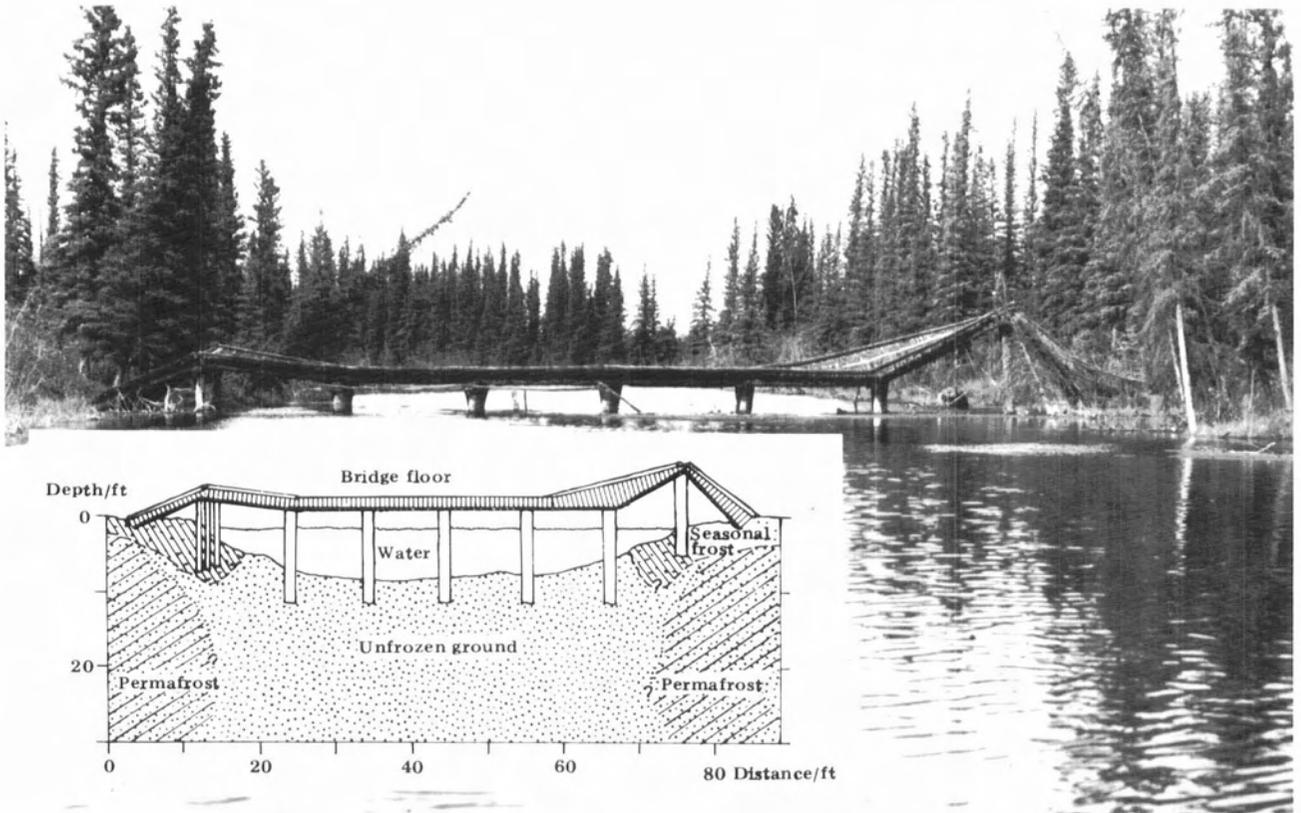
Figure 10. Frost-heaved wood piles of bridge spanning outlet of Clearwater Lake, 6 miles northeast of Delta Junction. Center piles are not affected by frost heaving because ground under creeks that are deeper than 3 feet does not freeze. Photograph 591 by T.L. Péwé, August 15, 1951 (modified from Péwé and Paige, 1963).

Many highway bridges in Alaska, especially smaller ones, are distorted and even destroyed by seasonal frost heaving of piles. Wood, steel, and concrete piles, as well as concrete piers, are affected. Piles supporting a highway bridge at the outlet of Clearwater Lake, 6 miles northeast of Delta Junction and 80 miles southeast of Fairbanks (fig. 10), were heaved 11 feet in one year. Piles supporting a bridge in Siberia were heaved 24 inches in a single year.

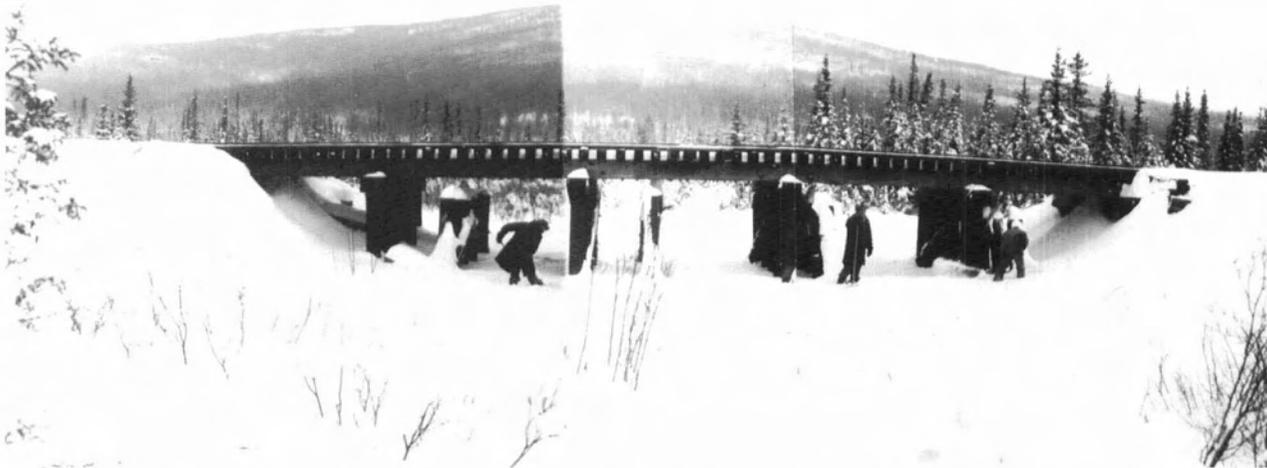
Figure 11a. View looking north of wood-pile bridge at Mile 458.4 of the Alaska Railroad. Center of bridge was frost heaved 5 inches during the winter of 1955-56. Photographs 1250-53 by T.L. Péwé, February 3, 1956.

To maintain a uniform track elevation during the winter and early spring, wedges are inserted under the rails near the ends of bridges. Up to 8 inches of cumulative shimming have been sometimes necessary to maintain a uniform height between the ends of the bridges and the elevated portion, which often rests on frost-heaved piles (figs. 11a,b). During the summer, several

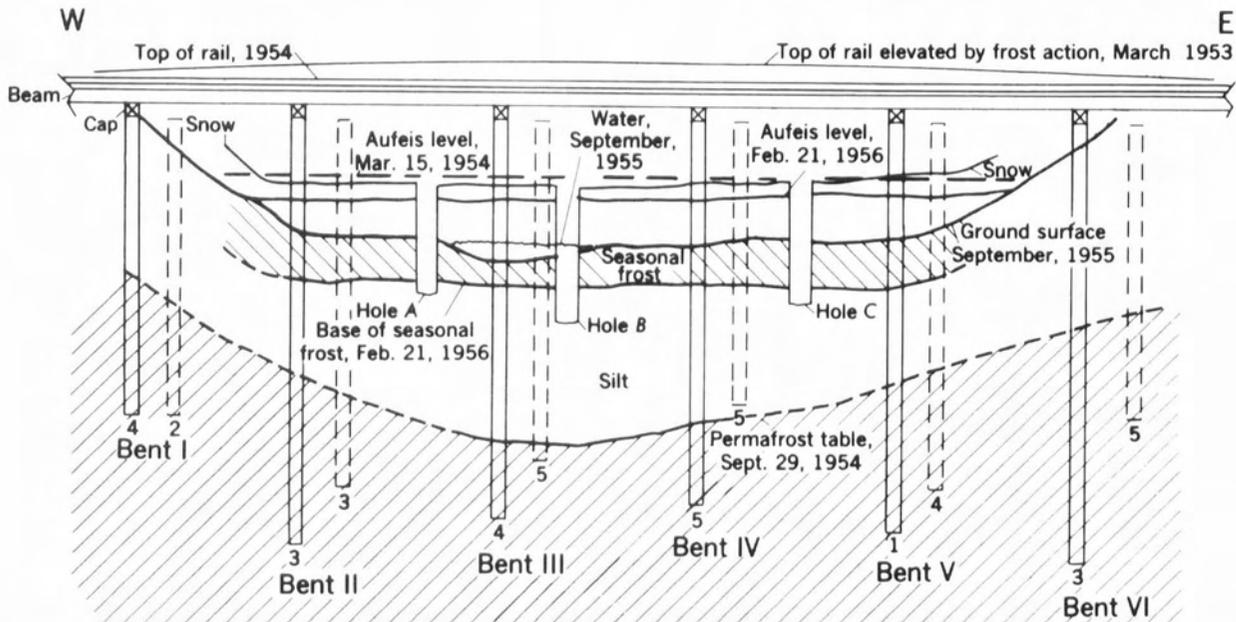
Figure 11b. Cross section of railroad bridge at Mile 458.4. Dashed lines represent disturbed piles emplaced in 1923 and forced upward by frost action through the years. To relevel the bridge, the tops of the piles were periodically trimmed. Although the replacement piles installed in 1954 (solid lines) were rooted more deeply in permafrost, they were also frost heaved and the bridge was again deformed (modified from Péwé and Paige, 1963).

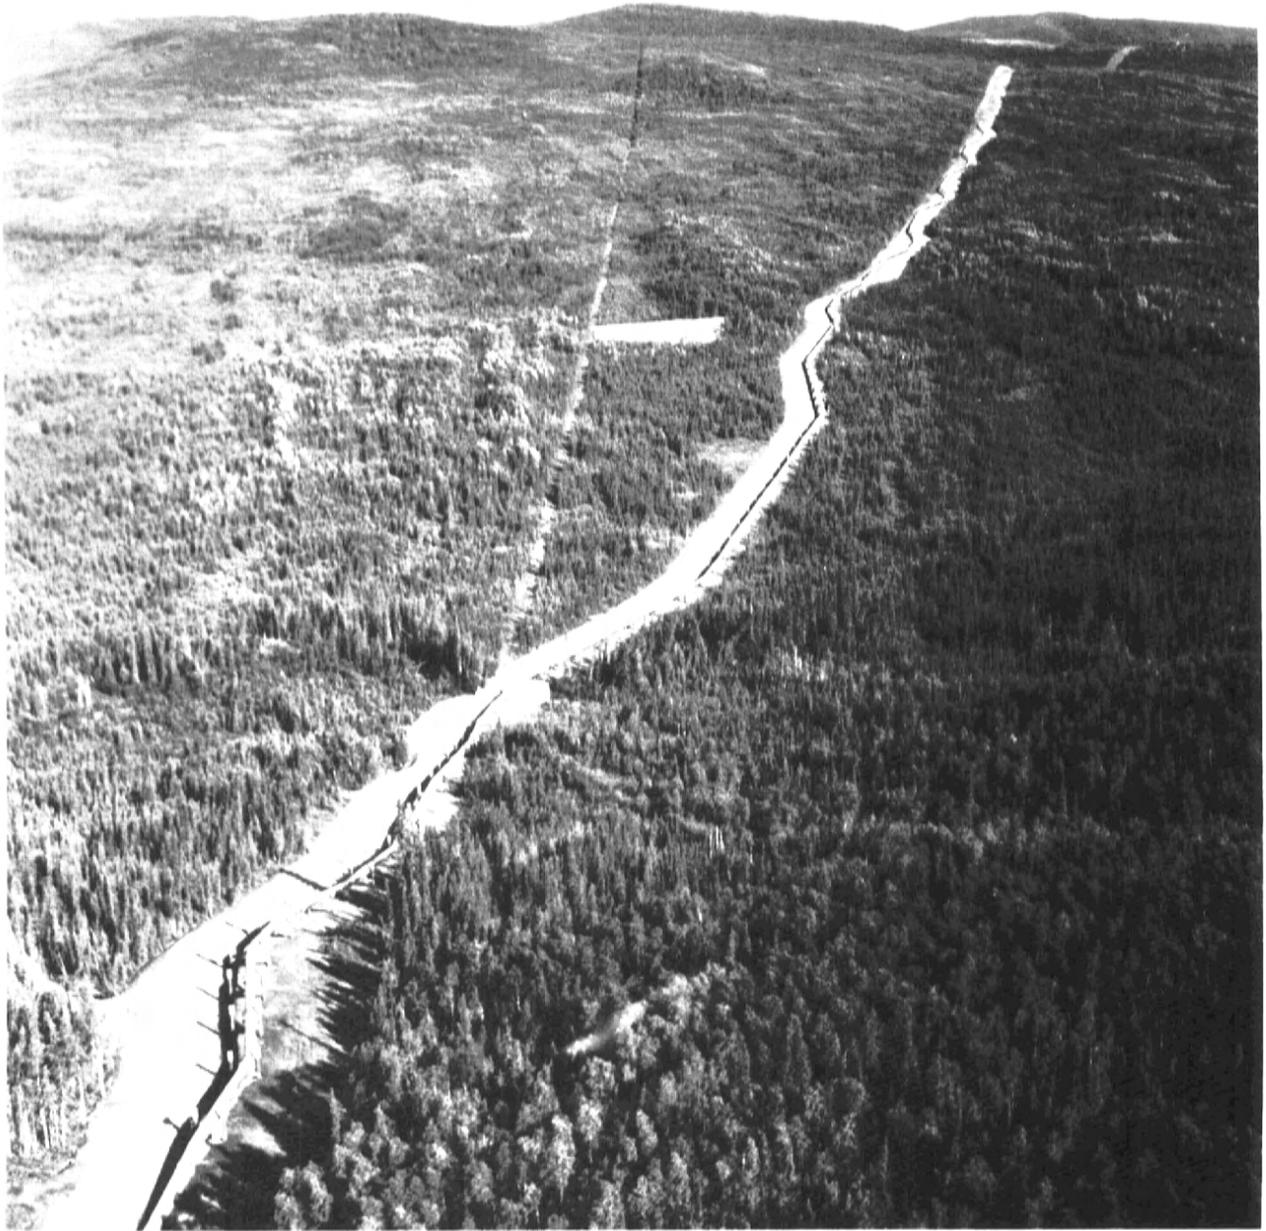
Figure 12. Oblique aerial view of elevated Trans-Alaska Pipeline north of Fairbanks. The 48-inch-diameter steel pipe is elevated on vertical-support members (VSMs) that are anchored in the underlying ice-rich permafrost. Photograph 3972 by T.L. Pewé, July 14, 1977.

One of America's engineering marvels is the Trans-Alaska Pipeline System, which transports crude oil from Prudhoe Bay to Valdez. A large percentage of the \$8-billion-project budget was devoted to overcoming permafrost- and seasonal-frost-related problems. Because the crude oil is warmer than 32°F, frozen ground will thaw in areas of pipeline burial. To prevent thawing of ice-rich zones--and its disastrous effects--382 miles of the 798-mile-long pipeline were elevated. These portions of the pipeline are supported on 123,000 piles--termed vertical-support members (VSMs)--which are 18-inch-diameter steel pipes installed in pairs to support the 48-inch-diameter oil pipe on a cross beam (fig. 12). To avoid frost effects, the VSMs were filled with hydrous gas to ensure freezing into the permafrost.

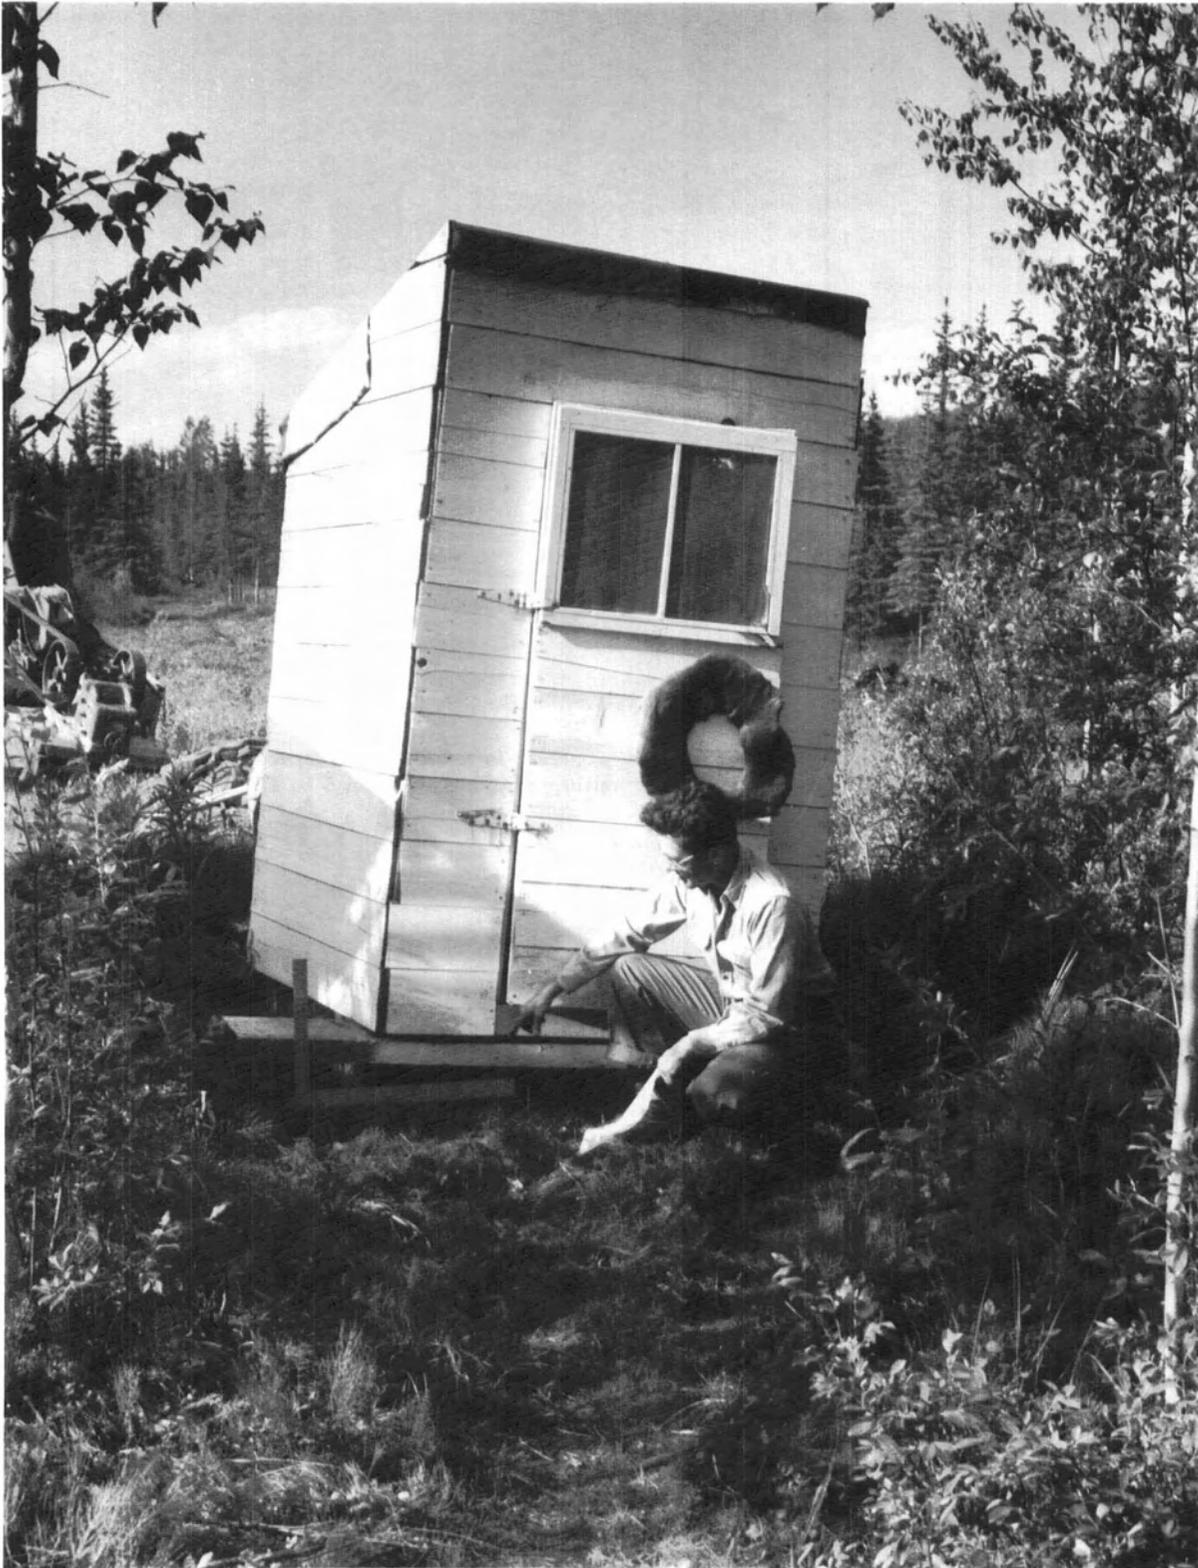
Figure 13. Frost-heaved outhouse on ice-rich, perennially frozen silt, Farmers Loop Road at crossing of Pearl Creek, 2 miles northeast of College. Photograph 950 by T.L. Péwé, June 19, 1954.

Unheated buildings are affected by seasonal frost action, especially those with basements that permit water to move along the outside (or even inside) of the building. Buildings from the smallest outhouse (fig. 13) to the largest apartment complex may be damaged. If buildings are heated, no seasonally frozen ground will form beneath them.

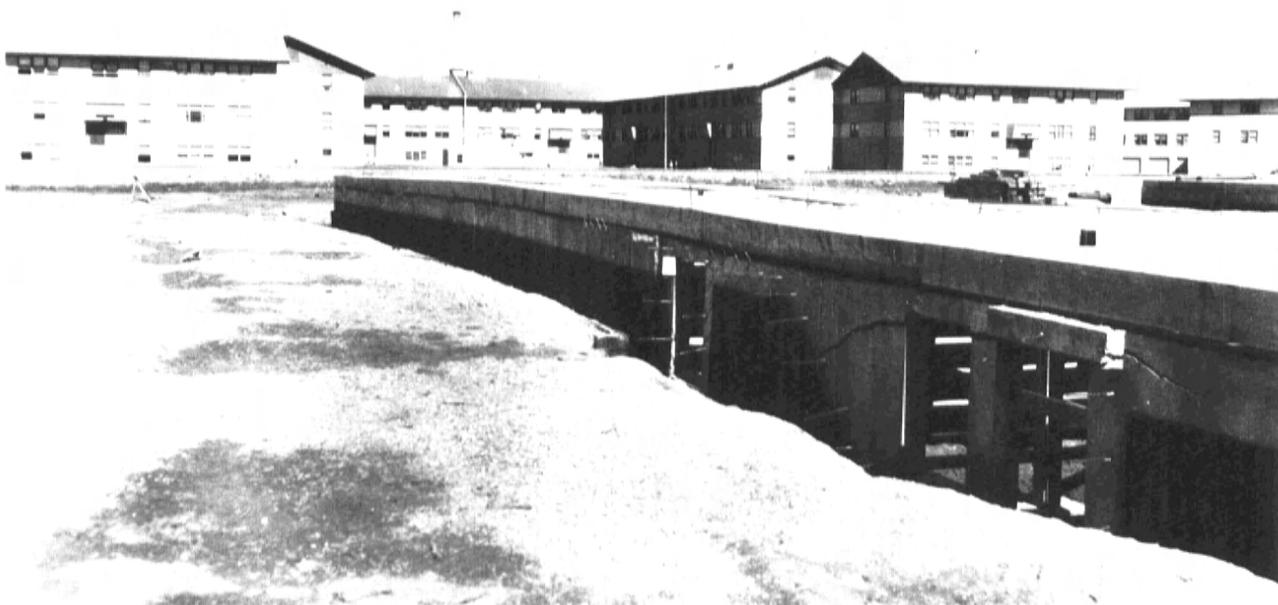
Figure 14a. Fracturing of 6-inch-thick, steel-reinforced, concrete foundation on Airport Road in Fairbanks by frost heaving during winter of 1953-54. Concrete walls and uprights heaved from 6 to 12 inches. Photograph 930 by T.L. Péwe, May 8, 1954.

An interesting example of extensive frost-induced damage in the Fairbanks area occurred along Airport Way, when a series of steel-reinforced, 6-inch-thick, poured concrete foundations were constructed on flood-plain silt in the fall of 1953. These apartment foundations were temporarily abandoned until the next construction season. Cold winter temperatures and abundant moisture that accumulated in depressions excavated for basements resulted in extensive ice formation, and the concrete structures were destroyed by heaving (figs. 14a-c). The fractured foundations were

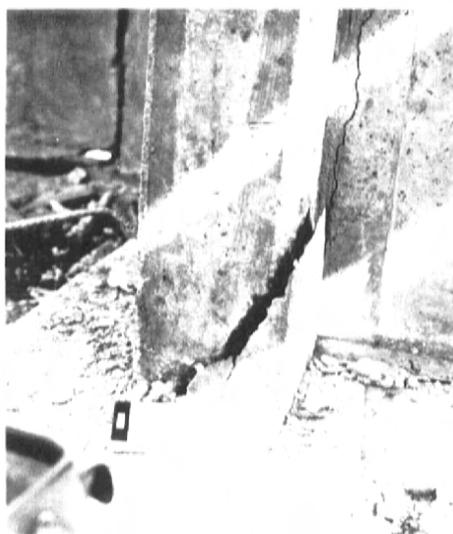
Figure 14b. Concrete upright fractured at base. Photograph 936 by T.L. Péwe, May 8, 1954.

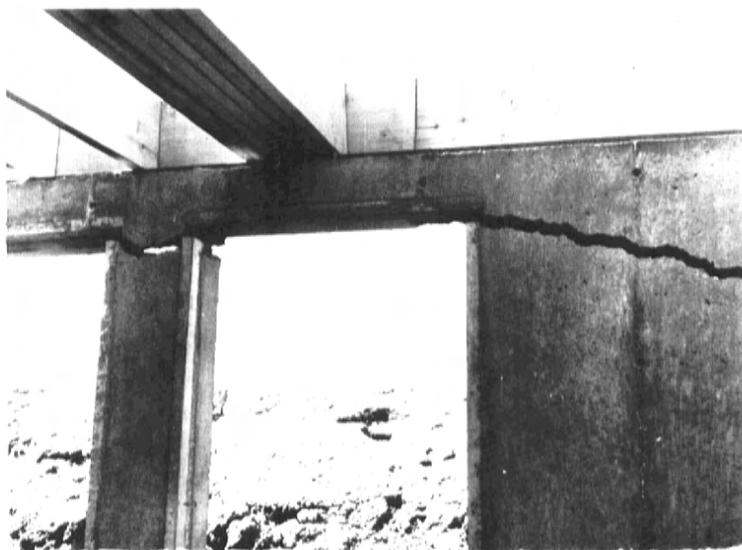
Figure 14c. Inside of fractured and uplifted foundation wall. Photograph 932 by T.L. Péwe, May 8, 1954.

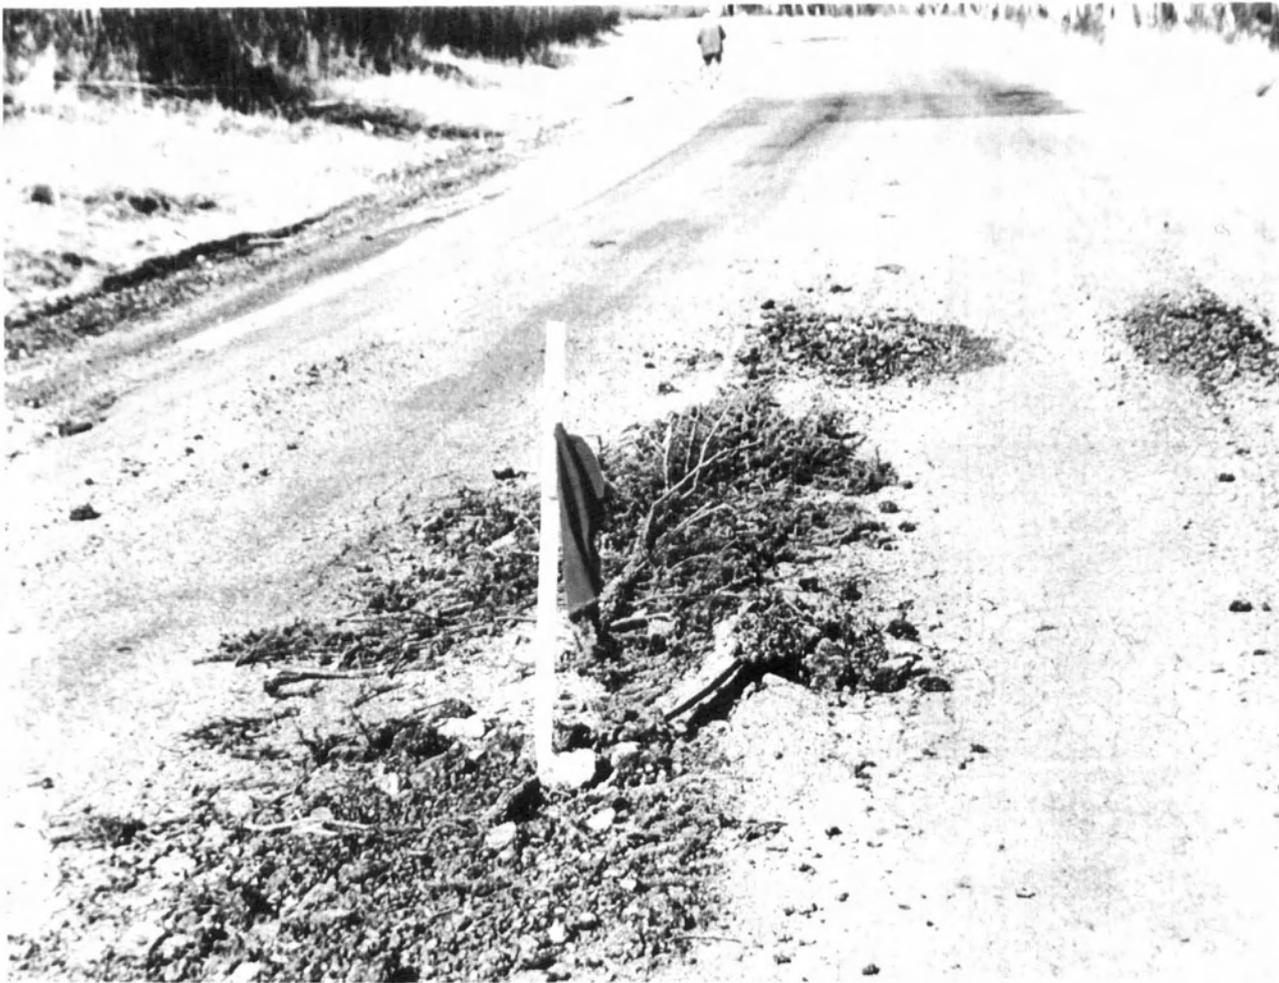
Figure 15. Disintegration of section of Farmers Loop Road north of Fairbanks during spring breakup. Thawing of seasonally frozen subgrade results in loss of bearing strength, and vehicle weight pushes pavement down into the underlying thawed, wet sediment. 'Frost boils' form when sediment is forced upward through breaks in pavement. Stakes and branches have been placed in holes to warn motorists. Photograph PK 6813 by T.L. Pewé, 1961.

across road surfaces cause such thawed, waterladen soils to squeeze through breaks in the surface pavement or gravel and form 'frost boils' (fig. 15). Vehicle weight limitations must be placed on roadways constructed on poorly drained, fine-grained sediments during 'spring breakup' (fig. 16).

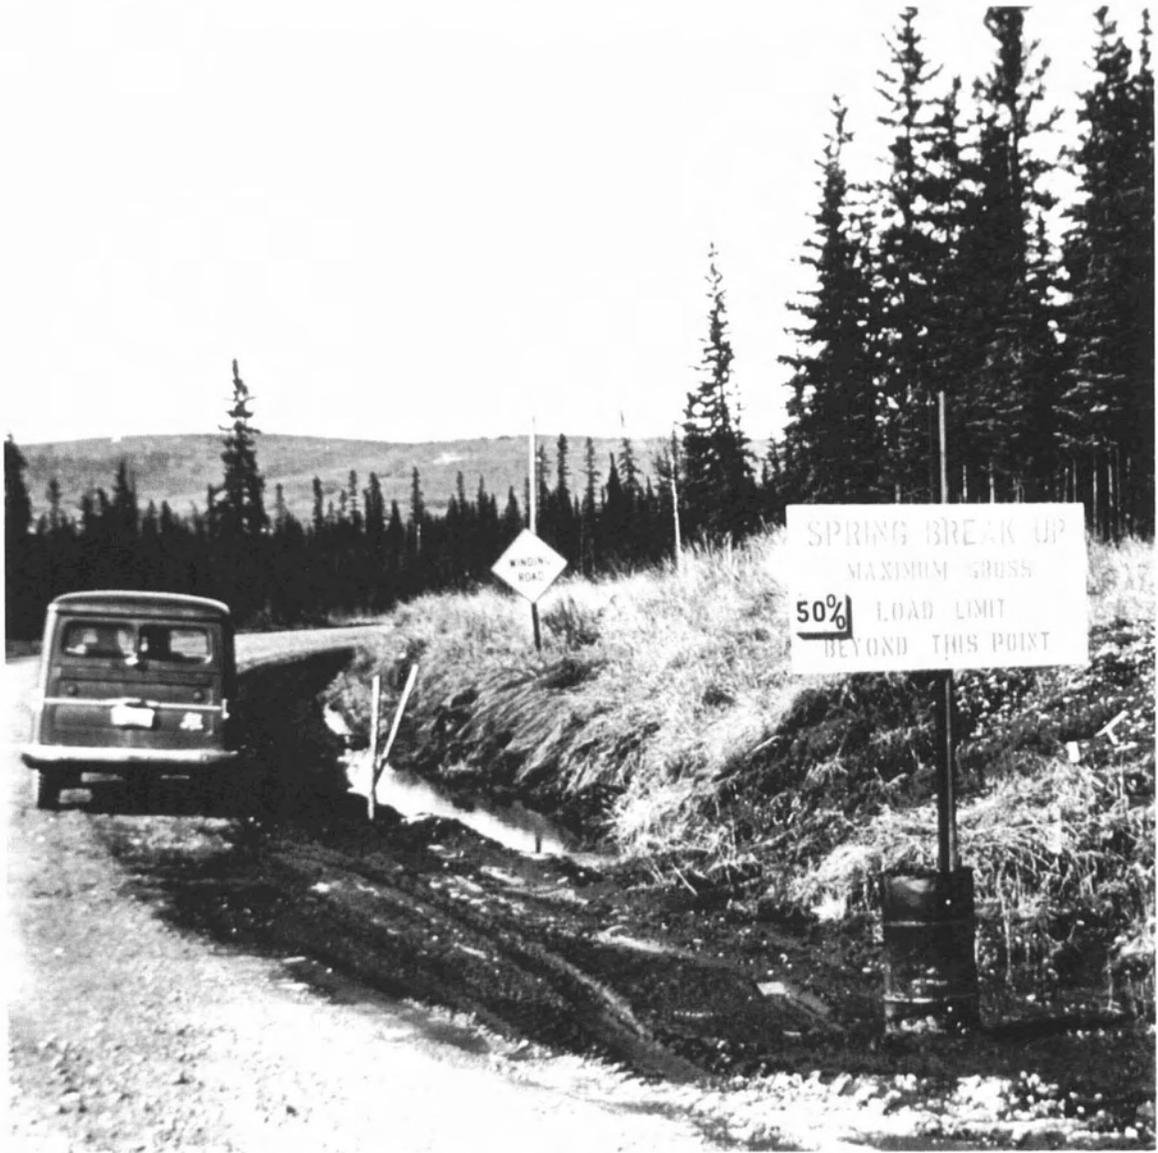
Figure 16. Thawing of seasonal frost and resultant loss of bearing strength necessitate vehicle-load limitations each spring. Water in adjacent ditch will not drain because seasonally frozen ground is present at depth under the ditch and downslope under the road. Farmers Loop Road; photograph PK 6805 by T.L. Pewe, 1961.

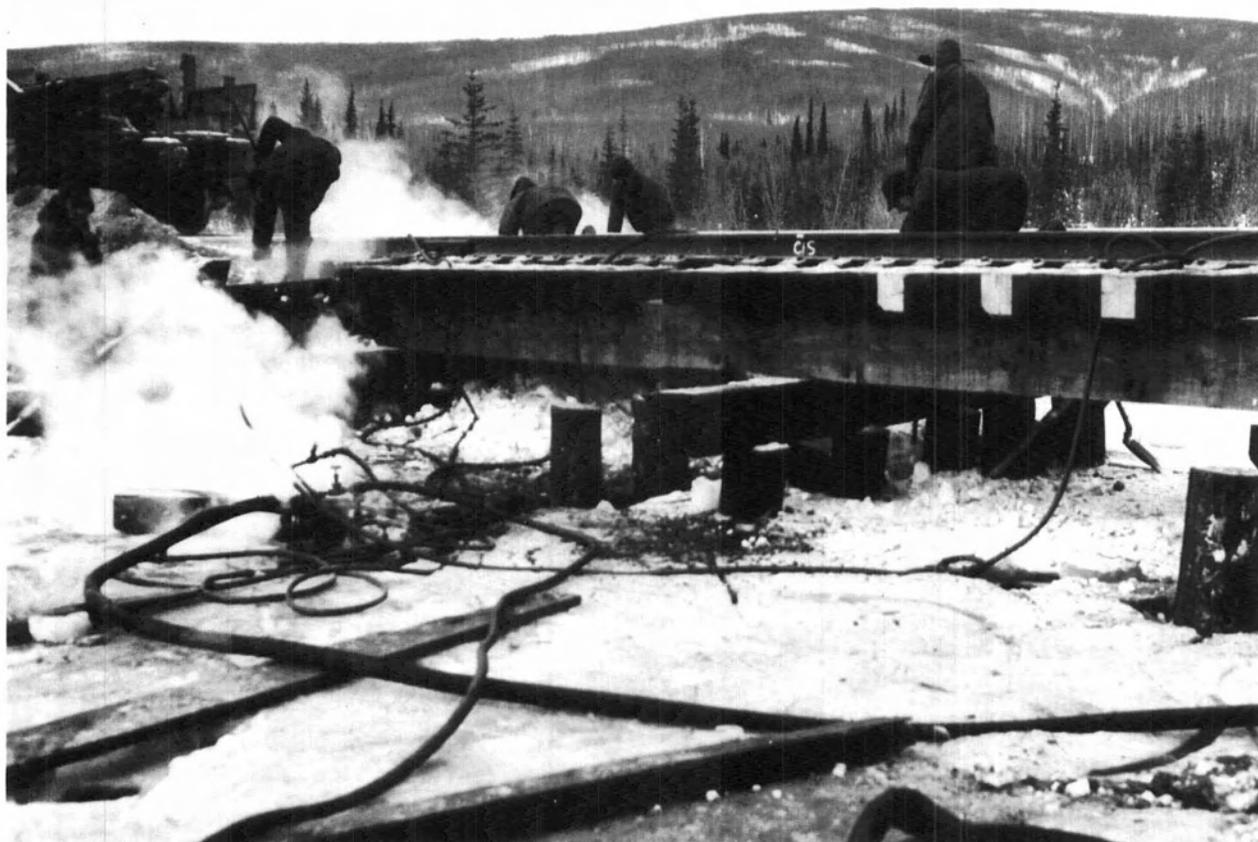
Figure 17. Installation of wood piles in Goldstream Valley, Mile 456.7 on the Alaska Railroad, 6 miles northwest of Fairbanks. Over the years, the old bridge piles were frost heaved, resulting in irregular track elevations. To rectify the problem, the tops of the piles were trimmed, but eventually installation of new piles was necessary. Steam-thawing of holes for piling emplacement, as demonstrated in this photograph, is unsatisfactory because the thawed hole is larger than necessary. In fact, thawing for a series of holes often produces a mud trench. While this technique permits easy installation of piling, considerable time is required to satisfactorily refreeze the permafrost around the piling to prevent frost heaving. Both old and new piling can be seen under the bridge. Rubber hoses in the foreground are steam lines. Photograph 837 by T.L. Péwé, February 11, 1954.
