SPECIAL REPORT 15

**GEOLOGIC HAZARDS OF THE FAIRBANKS AREA, ALASKA**

By  
Troy L. Péwé

First Edition, 1982  
by  
Department of Natural Resources  
DIVISION OF GEOLOGICAL & GEOPHYSICAL SURVEYS  
Fairbanks, Alaska  
Reprinted 1993

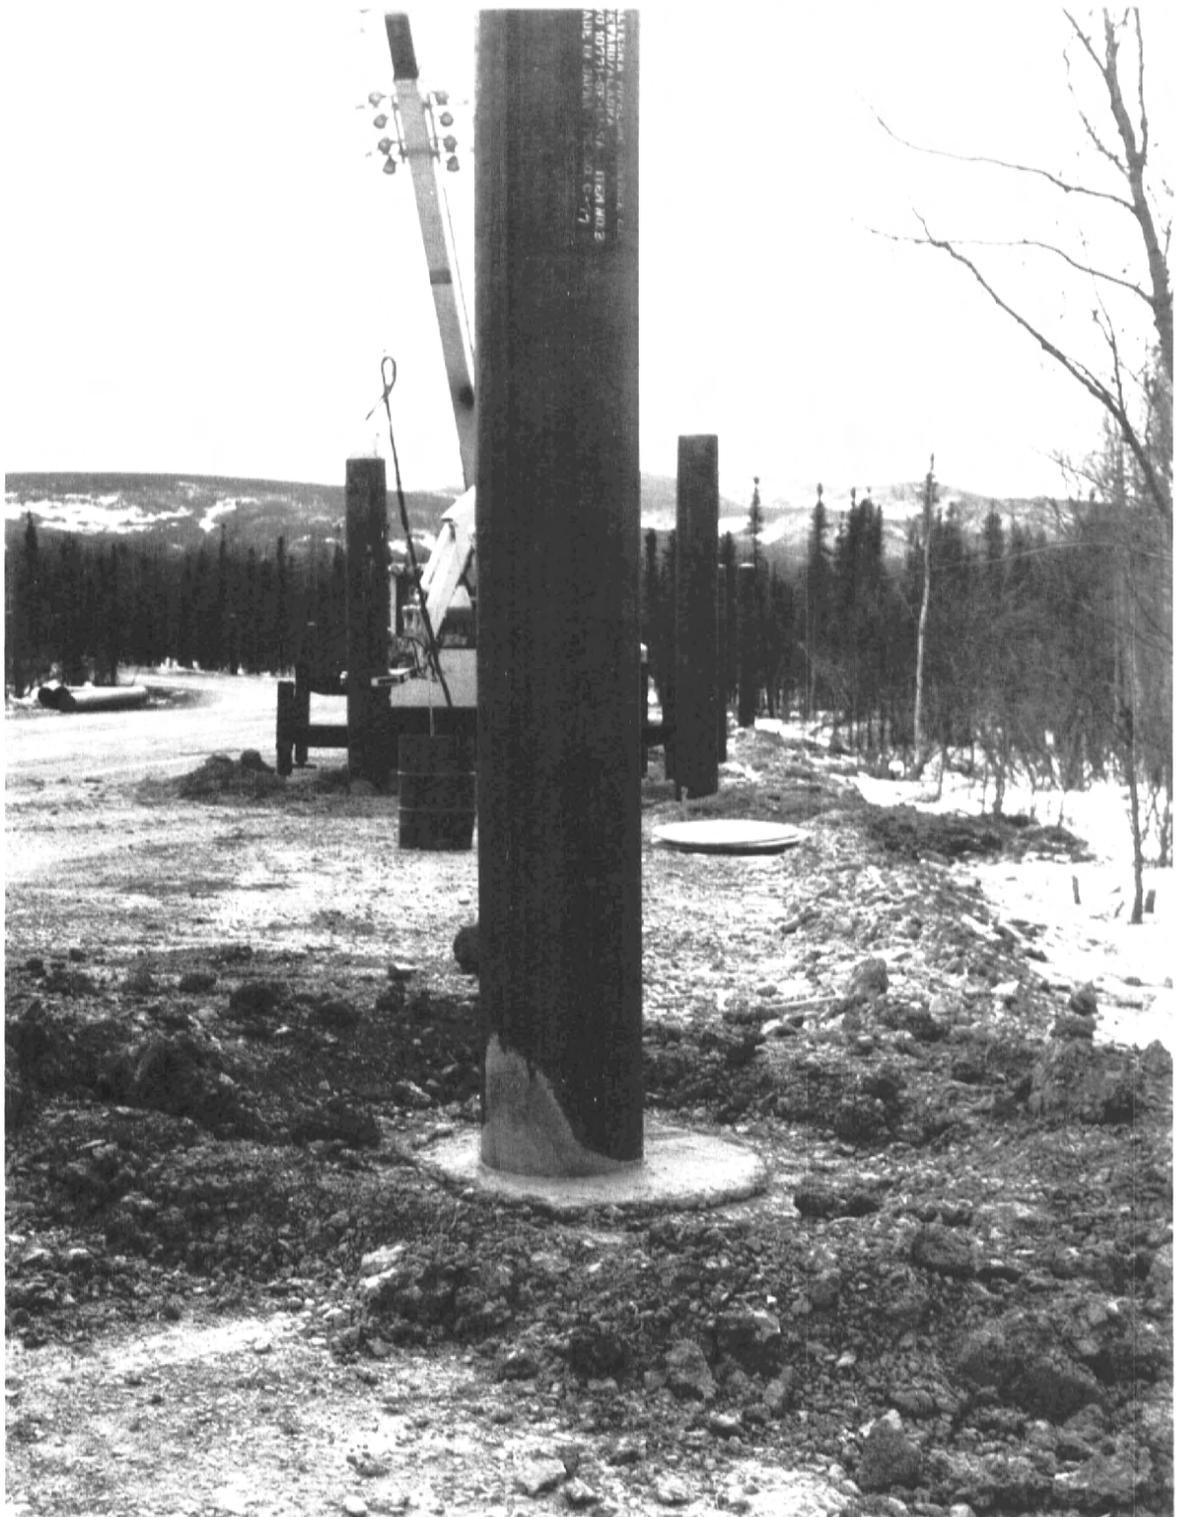
Figure 18. Installation of vertical-support member (VSM) on Trans-Alaska Pipeline near the Livengood Highway, 29 miles north of Fairbanks. The steel piles are inserted in dry-augered holes in ice-rich permafrost. The pipes are then surrounded by a cold mud slurry and allowed to freeze firmly into the permafrost before any stresses are applied. Photograph 3723 by T.L. Pewé, April 5, 1975.

The most effective method to reduce or eliminate frost heaving is to firmly anchor the pile and thereby increase the forces holding it in place. In permafrost areas piles are driven into the perennially frozen ground, and because the grip of the permafrost is greater than the upward force generated by seasonal frost, heaving is avoided. It is better to drive piles into the ground than steam thaw holes for emplacement (fig. 17), because the permafrost is less disturbed. Today, most piles are placed in dry-augered holes that are backfilled with a silt-water slurry (fig. 18). As a rule of thumb, the pile should be

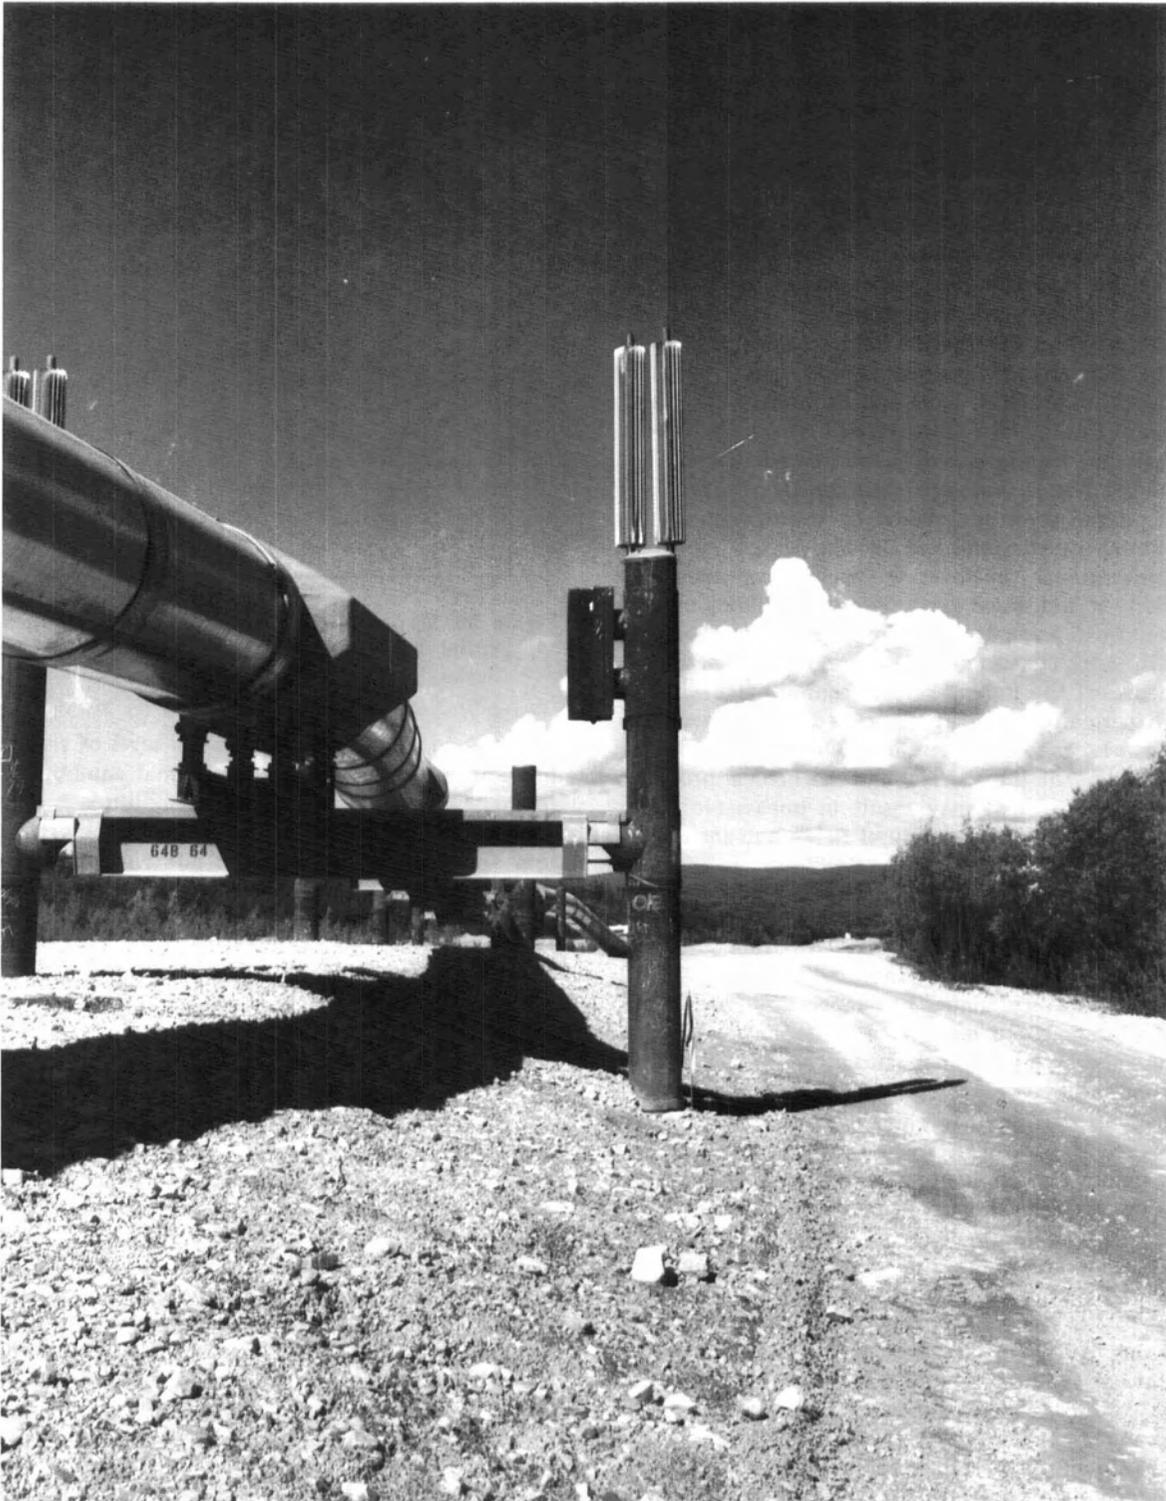
Figure 19. Elevated section of Trans-Alaska Pipeline at Engineer Creek, 5 miles north of Fairbanks. The pipeline is supported by a horizontal brace connecting two vertical-support members (VSMs). The thermal radiation fins on top of VSM enable the piles to remain frozen in the ground, thus preventing frost heaving and destruction of the line. The pipe is insulated with 4 inches of resin-impregnated fiberglass jacketed by galvanized steel. Photograph 3986 by T.L. Pewe, July 17, 1977.

Mechanical refrigeration of piles is very expensive. Thermal piles were successfully used on the Trans-Alaska Pipeline to eliminate frost heaving of VSMs. The supports were frozen firmly into permafrost, filled with hydrous ammonia gas, and equipped with heat-radiating fins (fig. 19). Each winter the ammonia gas rises to the top of the VSM, cools, liquifies, and sinks to the bottom, where it warms, boils, and again rises to the top, thereby chilling the ground whenever the ground temperature is warmer than the air temperature. The devices

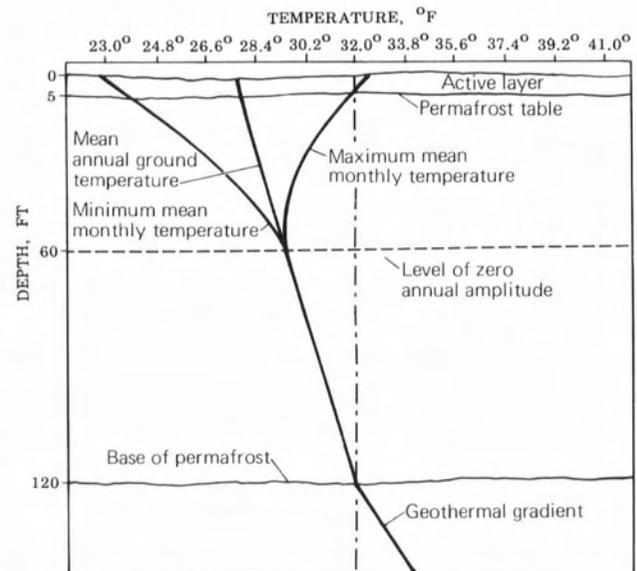
Figure 20. Hypothetical example of typical temperature profile and thickness of permafrost in central Alaska.

Examples of temperature changes in frozen ground with depth and of the upper and lower limits of permafrost are shown in figure 20. The annual winter to summer air-temperature fluctuation is reflected in a subdued manner in the upper few feet of the ground. This fluctuation diminishes rapidly with depth, from only a few degrees at 25 feet to barely detectable at 60 feet. The level at which fluctuations are hardly detect-

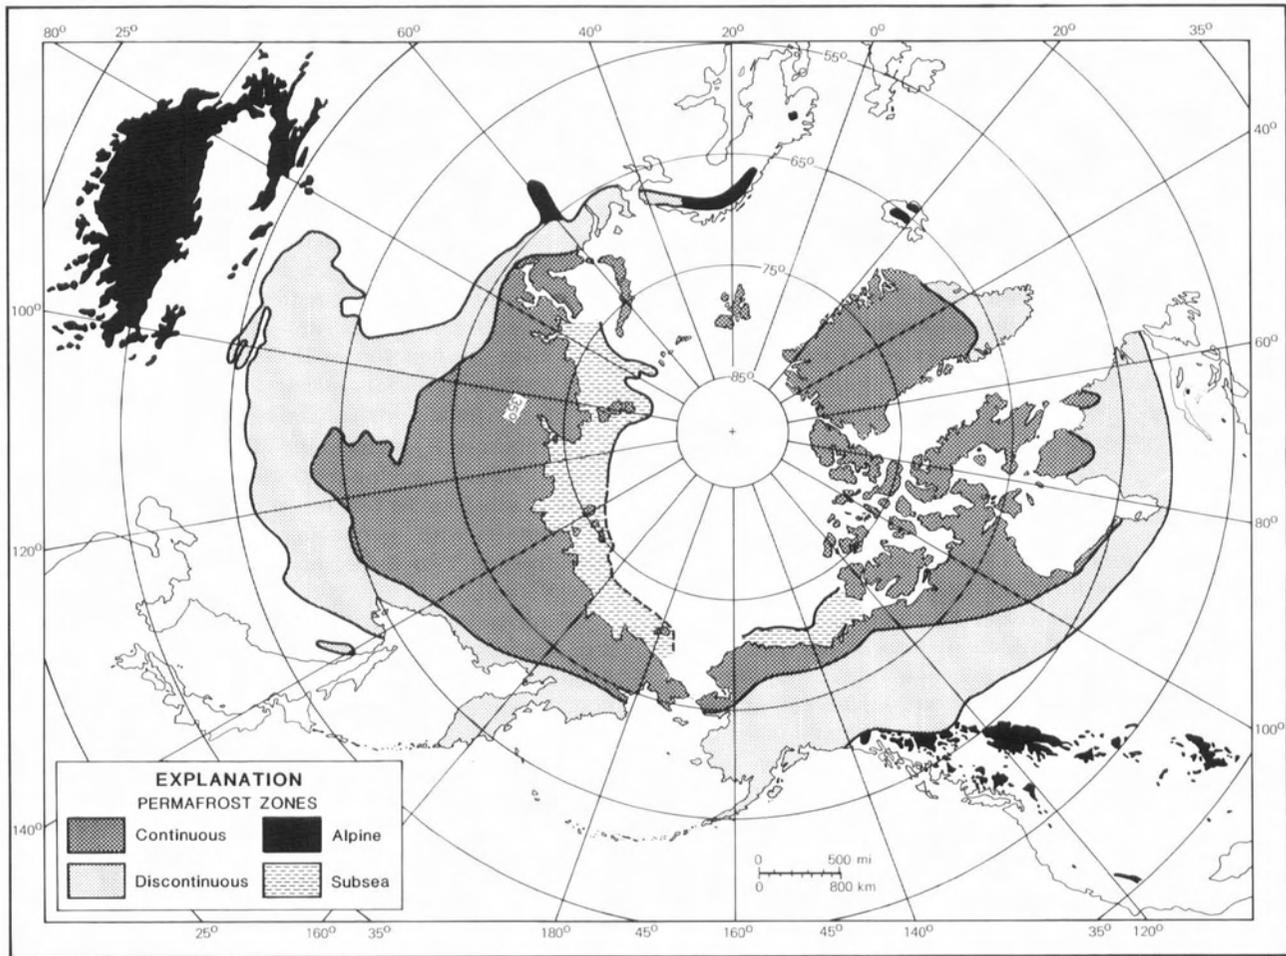
Figure 21. Distribution of permafrost in the northern hemisphere (compiled by T.L. Péwé, 1981). Isolated areas of alpine permafrost exist in high mountains and outside the map area. References: United States, land area (Péwé, 1981, unpublished); subsea (Hopkins and others, 1977; P.V. Sellmann, oral commun., May 26, 1981); Canada, land area (R.J.E. Brown, written commun., December 20, 1979); subsea (Hunter and others, 1976; A.S. Judge, oral commun., March 3, 1981); Greenland (Weidick, 1968; O. Olesen, written commun., 1976); Iceland (Thorleifur Einarsson, written commun., 1966; Priesnitz and Schunke, 1978); Norway (B.L. Andersen, written commun., 1966; L. King, oral commun., June 26, 1980; H. Svensson, written commun., 1966); Sweden (Rapp and Annersten, 1969; King, 1977); Svalbard (Liestol, 1977); Mongolia (Gravis and others, 1973); USSR, land area (Karpov and Puzanov, 1970; Gorbunov, 1978, a,b); subsea (M. Vigdorichik, written commun., 1978); China (Institute of Glaciology, Cryopedology and Desert Research, Academy of Sciences, Lanzhou, 1975, oral commun., Shi Yafeng, May 25, 1980); Tibet and Himalayan and adjacent mountains (Fujii and Higuchi, 1978; Y. Fujii, written commun., May 7, 1978; Gorbunov, 1978).

Permafrost is essentially a phenomenon of polar and subpolar regions. About 20 percent of the world's land is underlain by permafrost. Perennially frozen ground is most widespread and thickest in northern regions of the northern hemisphere. Fifty percent of the Soviet Union and Canada, 82 percent of Alaska (fig. 21), and probably all of Antarctica are underlain by permafrost. Twenty percent of China, mainly the high plateau country, is underlain by permafrost. Perennially frozen ground is

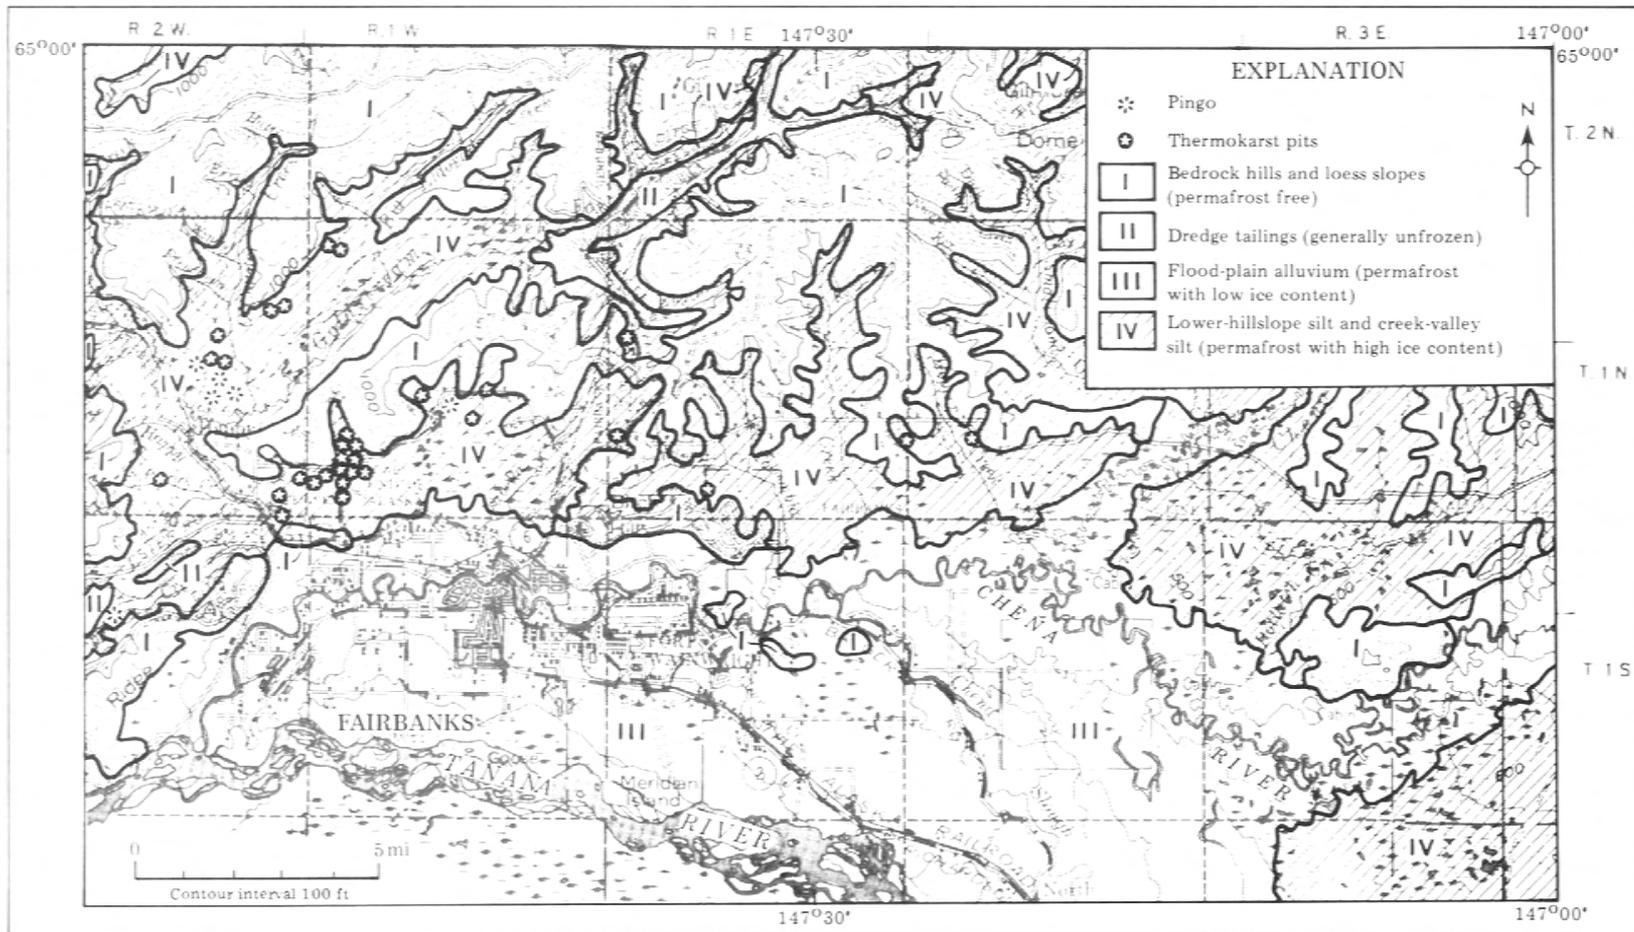
Figure 22. Permafrost map of the Fairbanks area (modified from Pévé, 1958; Williams, Pévé, and Paige, 1959).

The boundary between permafrost and permafrost-free areas (fig. 22) is determined by plotting ground temperature measurements, well-log data, distribution of thermokarst features in cleared fields, presence of surface ice-wedge patterns, and changes in vegetation.

Thermokarst phenomena in the Fairbanks area occur in the lower hillslope and creek-valley silt (fig. 22) characteristic of alluvial fans, colluvial slopes, and lowlands underlain by silt. Only in these areas does permafrost contain large ground-ice masses. Cave-in lakes are the most conspicuous thermokarst features in the silt lowlands, and thermokarst mounds and pits dominate silt fans and colluvial slopes that lie at slightly higher elevations.

All known thermokarst pits in the Fairbanks area are in cultivated or formerly cultivated fields or other clearings on alluvial fans and colluvial slopes near the boundary between permafrost-free slopes and slopes underlain by large ice masses (fig. 22). The distribution of permafrost in thin, isolated masses and a 15-to-100-foot-deep water table provide conditions favorable for pit formation. Water from melting ice and surface water can circulate freely through the thawed passageways as it progresses down to the water table. Because the water

The influence of permafrost on agricultural development varies according to permafrost zone in the Fairbanks area (fig. 22). Most agricultural development is unaffected on south-facing middle and upper hillslopes where permafrost is nonexistent. Unfortunately, much land has been cleared on the gently sloping alluvial fans and colluvial slopes (lower hillslope silt and creek-valley silts in fig. 22) extending from the hills to the flood plain. Permafrost containing large ground-ice masses underlies 40 percent of the area in figure 22; fields located in these areas are likely to develop thermokarst mounds and pits. Although mounds develop less dramatically and suddenly than pits, they constitute a more ubiquitous obstacle to cultivation.

in the USSR, Canada, China, and Alaska. From Dunbar (40 miles west of Fairbanks) to near Happy (7 miles west of Fairbanks), the Alaska Railroad is underlain by perennially frozen silt containing large masses of ground-ice (fig. 22). Differential settlement of the roadbed is extreme when the sensitive permafrost thaws (fig. 40). In the 1960's the annual maintenance cost of railroad grade in this section averaged about \$200,000. Because of permafrost thawing, an exceptionally wide roadbed constructed on a thick layer of gravel over frozen silt has not prevented track settlement of up to 2 feet per year, even 50 years after construction, according to R.M. Moore of the Alaska Railroad.

Roads and highways in the Fairbanks area are especially susceptible to deterioration and eventual destruction by thawing of ice-rich permafrost. This is particularly true of those sections of roadway that lie on the silt-covered lower hillslopes and organic-rich silt lowlands (fig. 22), where the soils contain 30 to 500 percent (dry weight) ice and large ice wedges (fig. 23). Thawing of such ground, which may be 50 to 300 feet thick, results in noticeable differential subsidence. In fact, subsidence is still occurring in areas that were cleared 50 to 60 years ago.

Almost all of Farmers Loop Road lies on ice-rich permafrost (fig. 22), and constant upkeep is necessary to maintain grade. In 1974 Farmers Loop Road was rerouted across ice-rich peat and organic silt between College Road and the east entrance to the University of Alaska (fig. 22). This one-third mile reroute cost \$170,000 (Woodrow Johanson, Alaska Department of Transportation and Public Facilities, written commun., October 3, 1977). Shortly after the subgrade was paved, differential settlement 300 feet south of the entrance to the University resulted in rebuilding and refinishing the surface (fig. 41). In 1977 leveling of the road shoulders cost \$5,000, and similar annual maintenance, including leveling with asphalt, has been necessary since 1974.

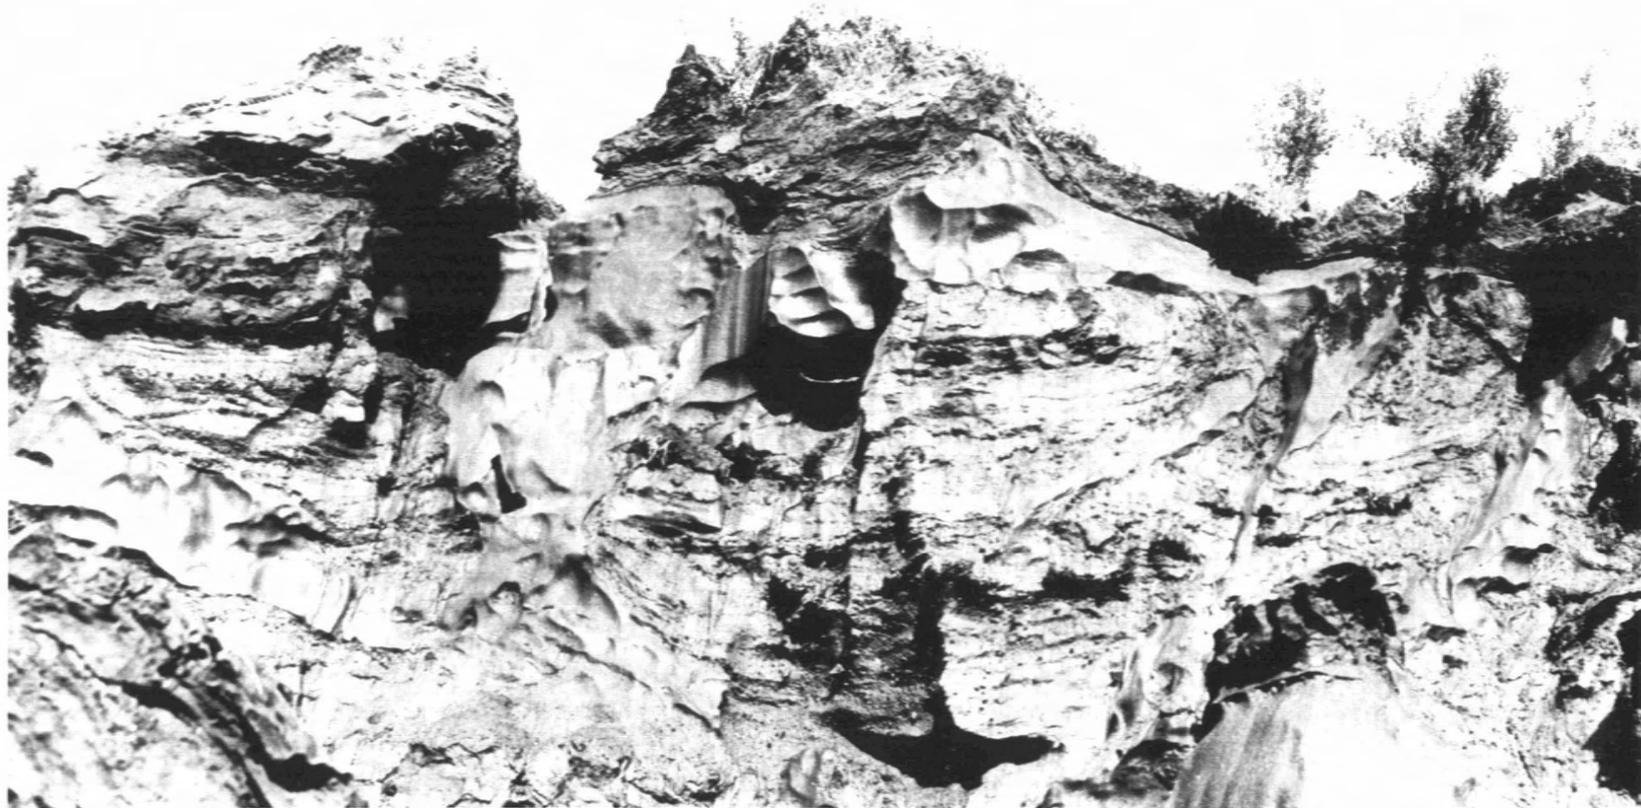
Figure 23. Panoramic view of ice wedges in organic-rich silt along the east wall of a placer gold-mining excavation at Fairbanks Creek, 15 miles northeast of Fairbanks. Photographs 277-278, by T.L. Péwé, July 10, 1948.

Figure 36. Cross section of thermokarst pit at Fairbanks Golf Course across Farmers Loop Road from KFAR-transmitter station. Note that the opening simulates the shape of the irregular ice mass shown in figure 23. Temperature measurements by Ansel Gooding, September 4, 1948.

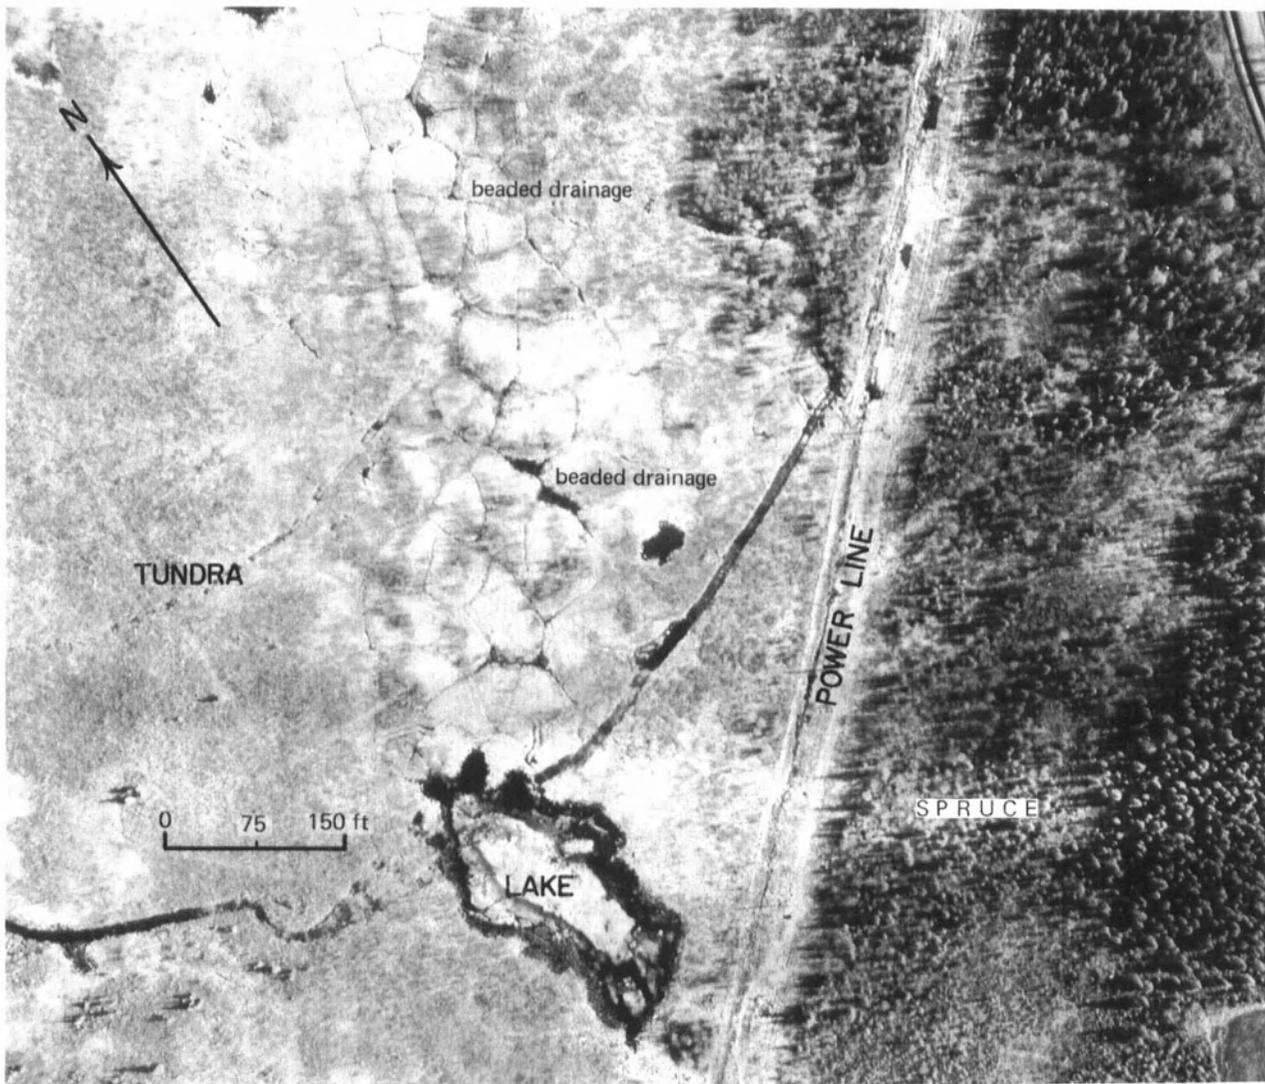
Figure 24. Aerial view of polygonal-ground pattern in silt lowland near the junction of Farmers Loop Road and Steese Highway about 1 mile northeast of Fairbanks. A polygonal network of ground ice is responsible for these surface polygons, which are 40 to 60 feet in diameter. Small lakes have developed at the junction of the polygons and formed beaded drainage. Vegetation on the right is mostly scrub birch-spruce forest with some larch; on the left is cotton-grass-shrub tundra. Black, 8-foot-wide strips that trend diagonally across the photograph are water-filled caterpillar-tractor tracks. The entire area is underlain by ice-rich permafrost. Photograph by U.S. Army Air Corps, May 9, 1947.

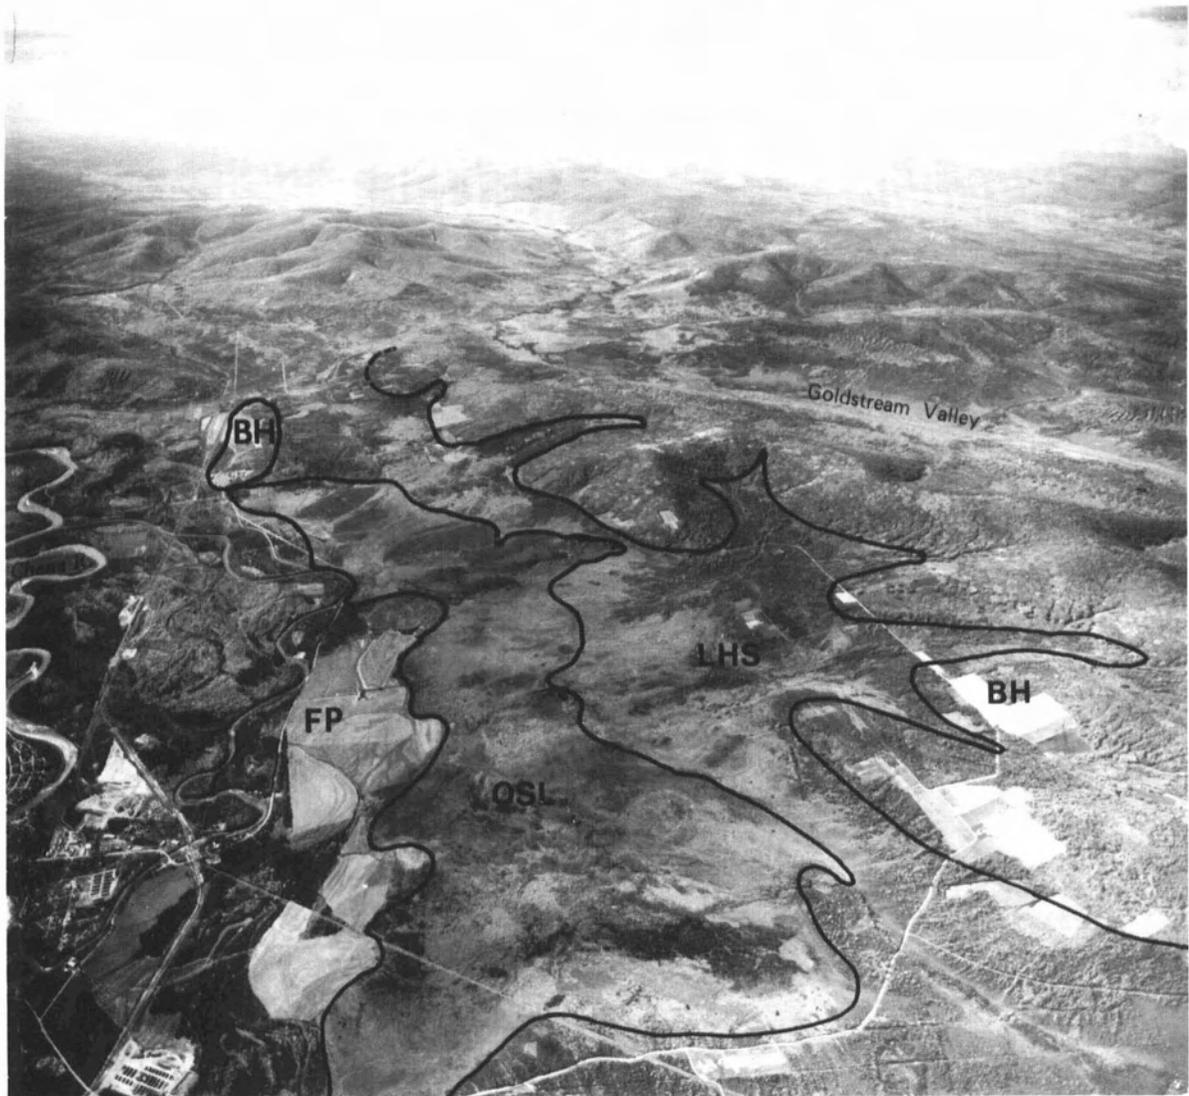
Figure 25. Aerial view of the central Fairbanks area showing typical landforms: (FP) flood plain underlain by permafrost containing no massive ice; (OSL) organic-silt lowland, and (LHS) lower-hillslopes and alluvial fans, both underlain by permafrost containing ice masses; and (BH) bedrock hills. View toward west from elevation of 10,000 feet. Photograph by U.S. Army Air Corps, 1946.

readily recognizable (fig. 25). Generally permafrost, with or without ice masses, extends a short distance upslope into the white spruce - birch - aspen forest. This boundary between permafrost and permafrost-free areas is higher on north-facing slopes that receive less solar heat than on sunnier south-facing slopes.

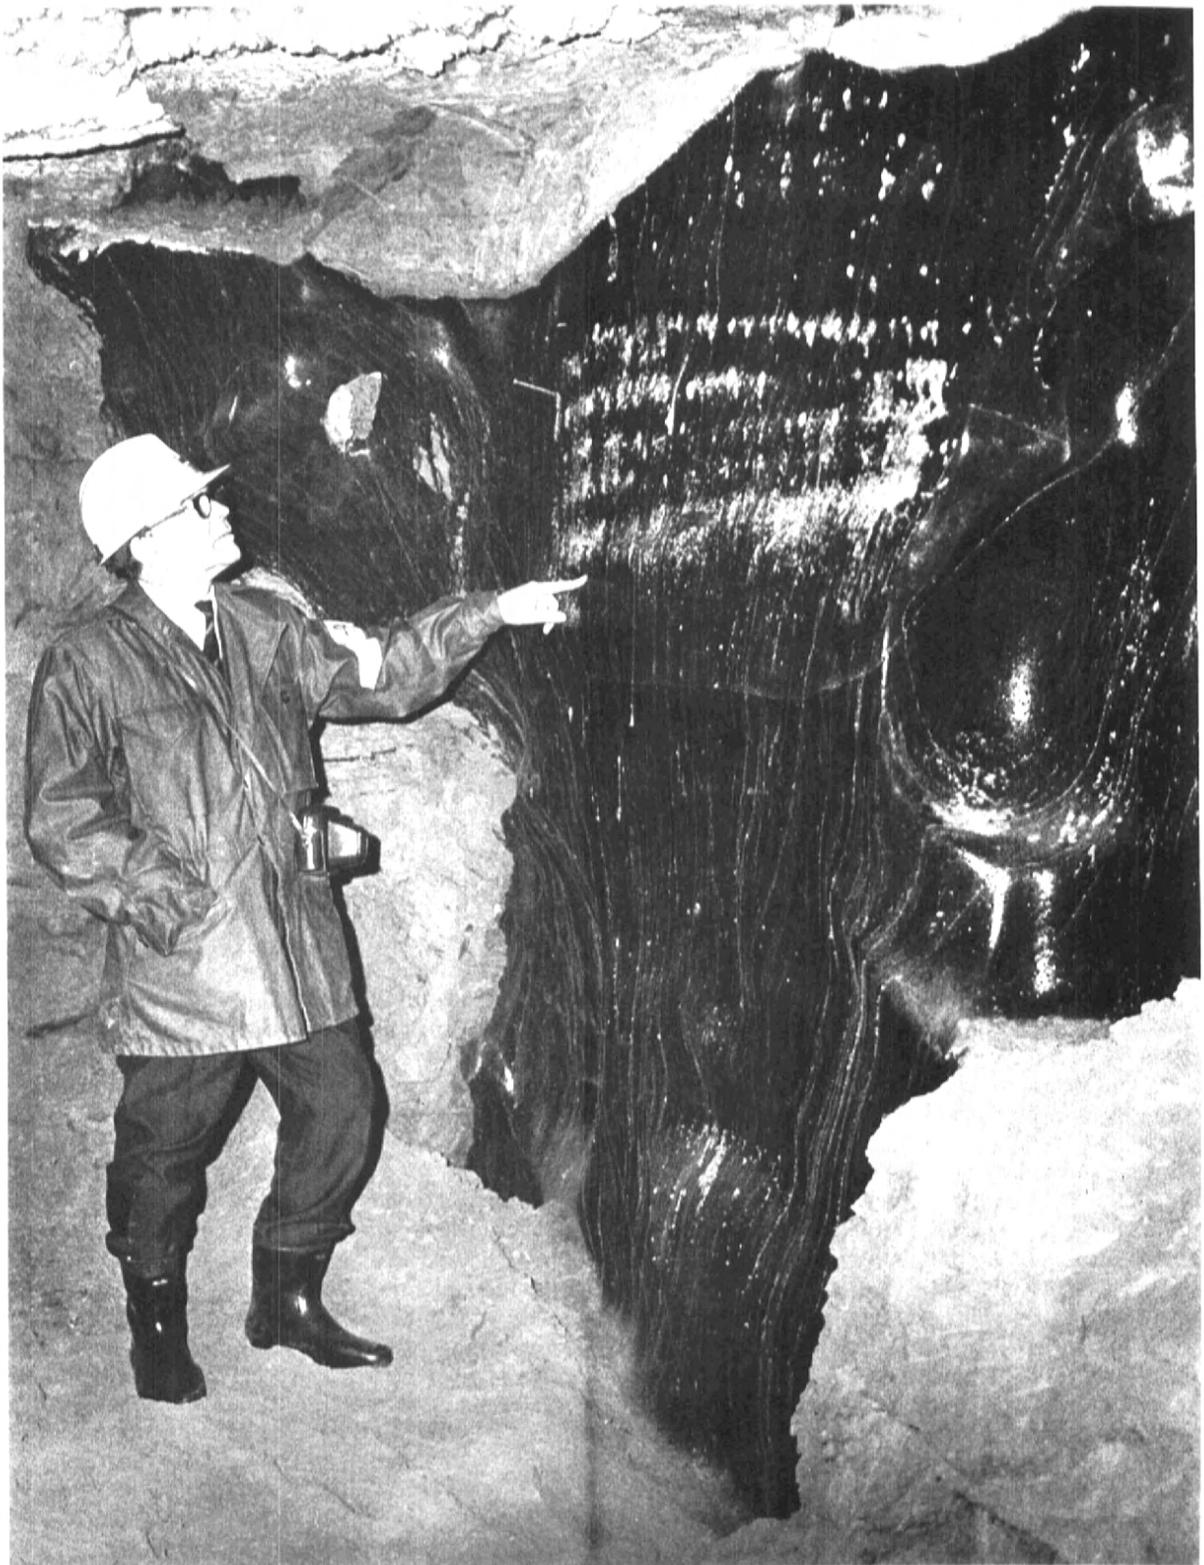
Figure 26. Foliated ice wedge exposed in permafrost tunnel excavated by U.S. Army Cold Regions Research and Engineering Laboratory near Fox, Alaska. Photograph by C.J. Romberg, 1973.

The most conspicuous type of ground ice is the large ice wedges or masses characterized by parallel or subparallel foliation structures (fig. 26). Most foliated ice masses occur as wedge-shaped, vertical or inclined sheets or dikes, 1/4 inch to 10 feet wide and 10 to 30 feet high in transverse cross section. On the face of frozen cliffs, these ice masses may appear as horizontal bodies (fig. 27).

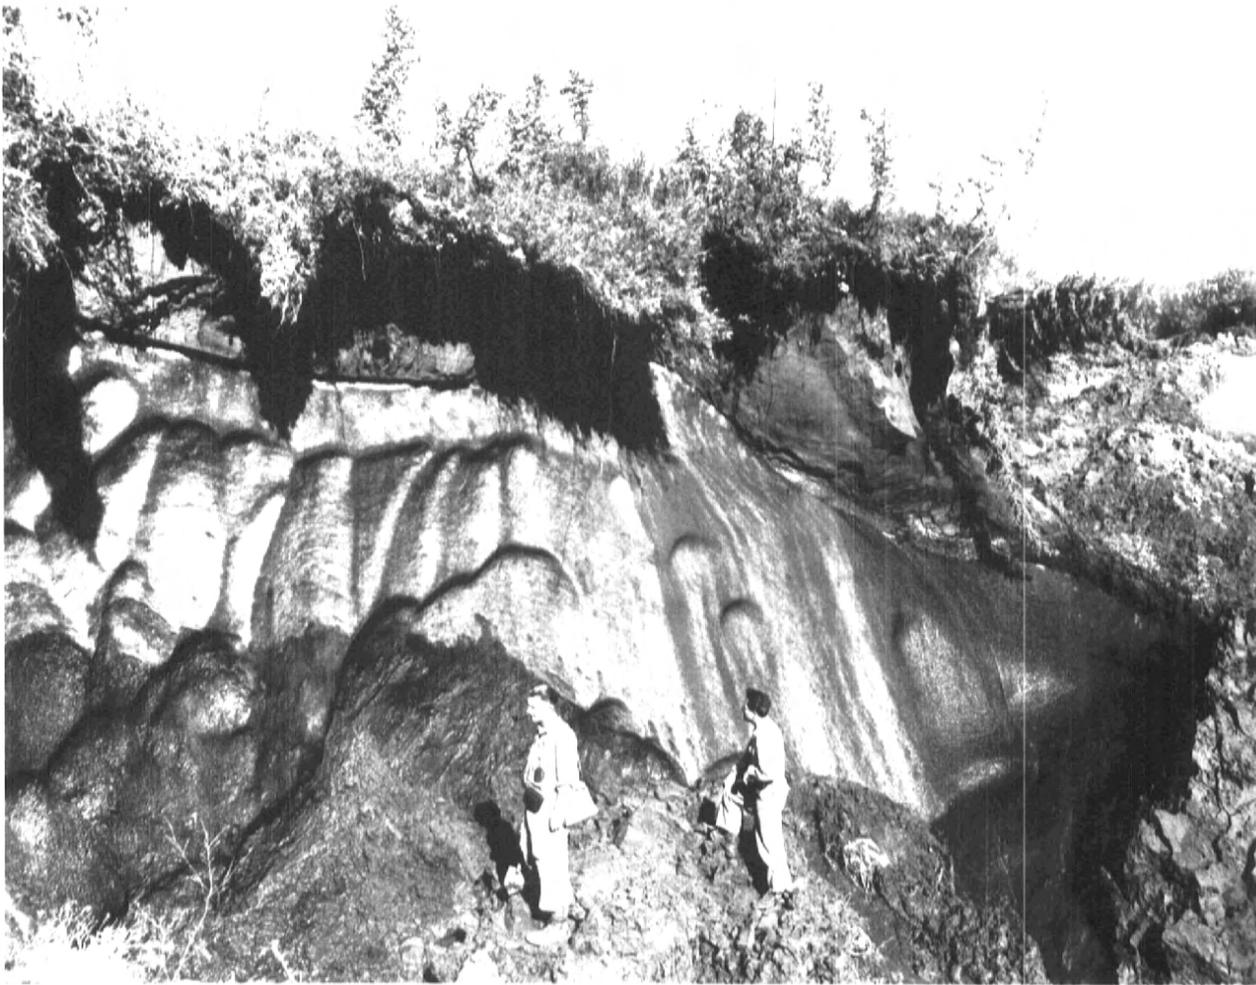
Figure 27. Large mass of foliated ground ice exposed in silt during placer-gold-mining operations at Dome, 10 miles north of Fairbanks. Photograph 1038, by T.L. Péwé, August 16, 1954.

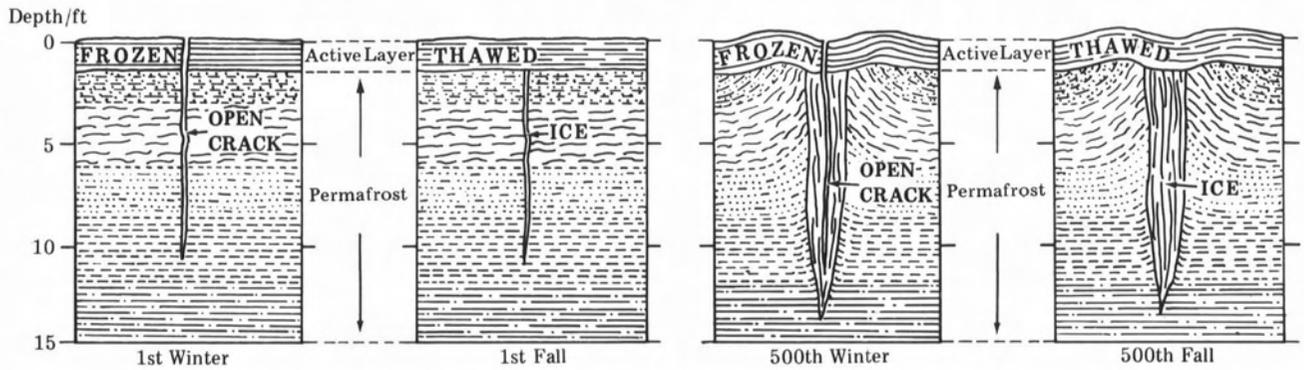
Figure 28. Schematic representation of the evolution of an ice wedge according to the contraction-crack theory--the width of the crack is exaggerated for illustrative purposes (modified from Lachenbruch, 1962, p. 5).

The generally accepted theory for the origin of ice wedges is the thermal contraction theory, which states that during winter polygonal thermal contraction cracks about 1/2 inch wide and 6 to 10 feet deep form in the frozen ground (fig. 28). In early spring, water from melting snow enters the open tension cracks; when it freezes, it produces a vertical vein of ice that penetrates the permafrost. The following summer the permafrost warms and expands, and horizontal compression bends the adjacent frozen sediments upward by plastic deformation. During subsequent winters, renewed thermal tension reopens the vertical ice-filled crack because it is a zone of relative weakness. Another increment of ice is added in the spring when meltwater enters and freezes. Over the years, this cycle produces a wedge-shaped mass of ice.

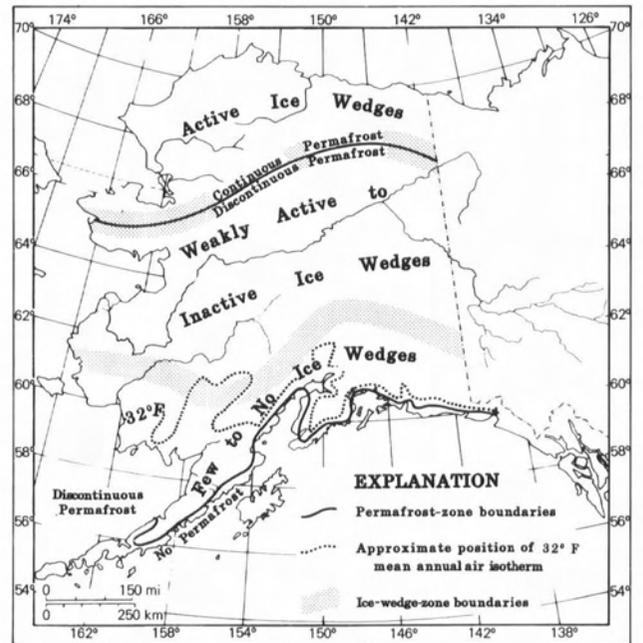
Figure 29. Distribution of ice wedges and permafrost in Alaska.

must be chilled to -40°F to -50°F for contraction cracks to form. Ice wedges are common in a climate where the mean annual air temperature is colder than 29°F. Although they actively grow in the continuous permafrost of northern Alaska (fig. 29), ice wedges are generally inactive in the discontinuous-permafrost zone of central Alaska. South of the zone of inactive ice wedges, ice wedges are generally absent.

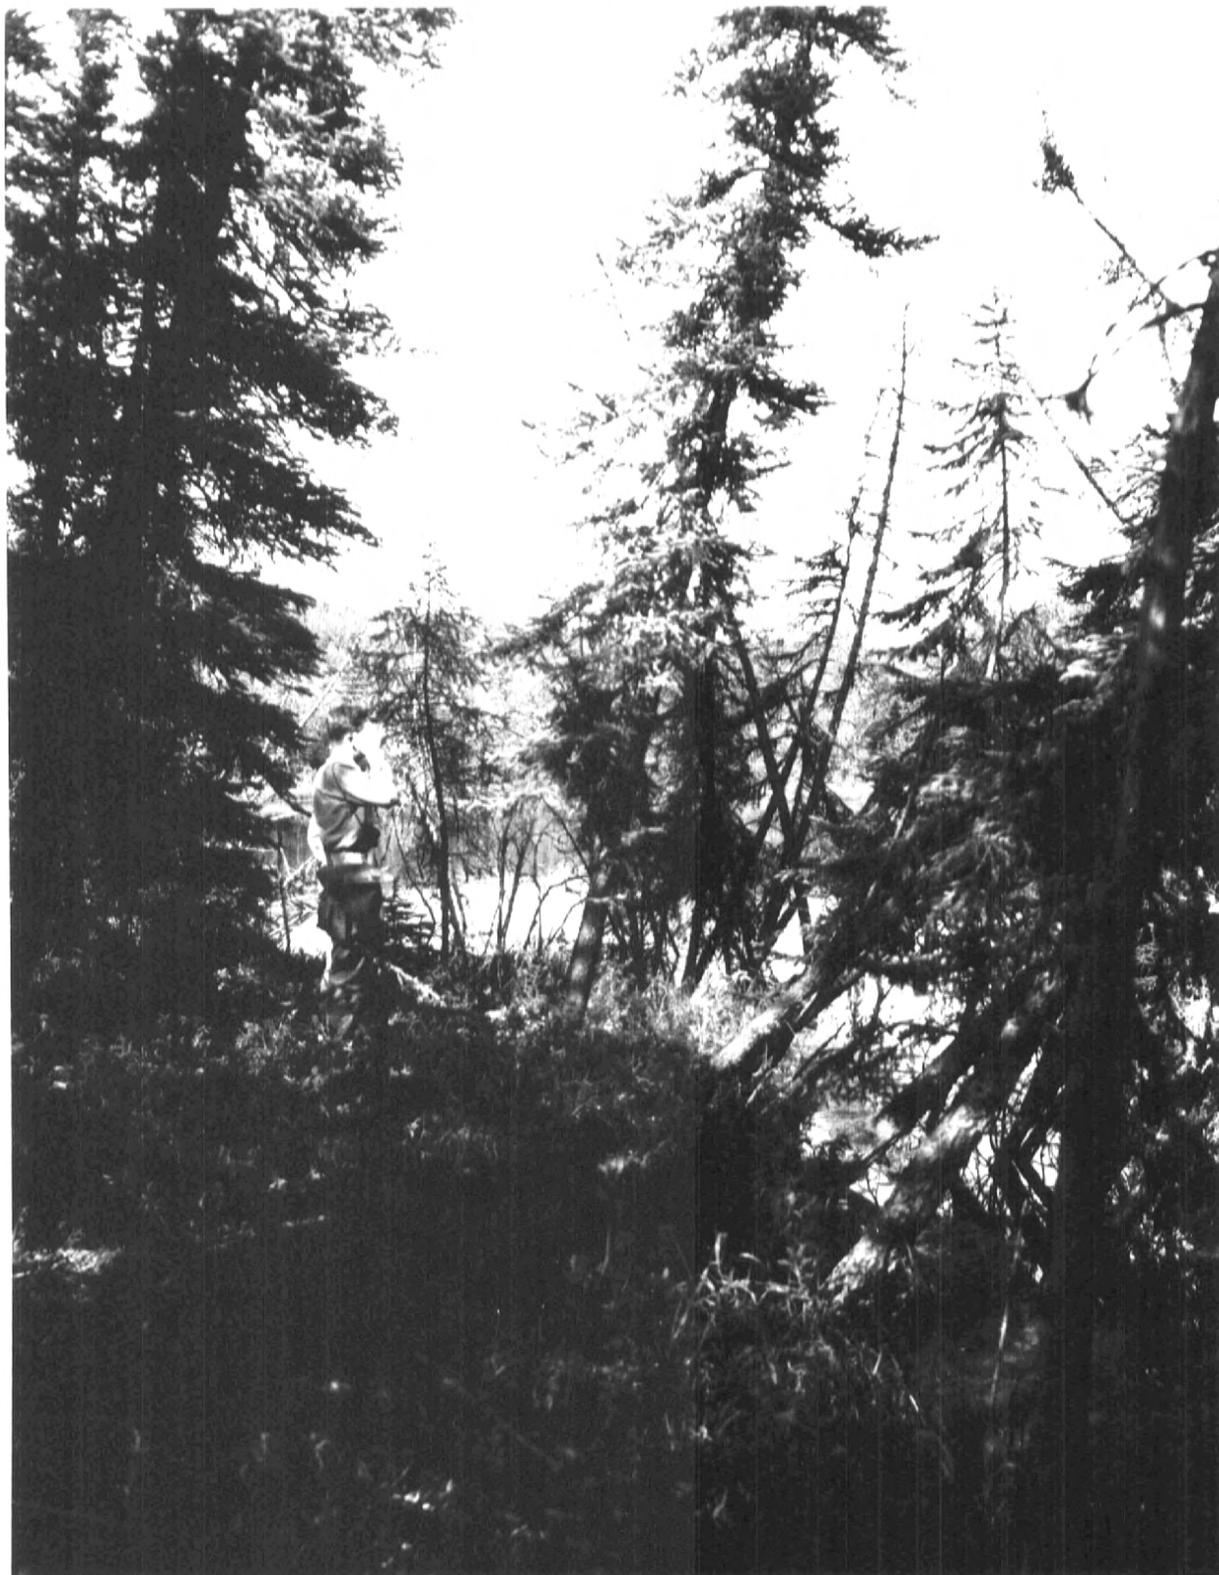
Figure 30. A cave-in lake in the silt lowland near Fairbanks, the result of thawing ice-rich permafrost. Note the spruce tilting toward the lake as the bank retreats. Photograph 321 by T.L. Péwé, July 25, 1948.

retreat under the thawing effects of water and waves (fig. 30).

table is closer to the surface on lower hill slopes, in the silt lowlands north of College Road, and in Goldstream Valley, the melting ice masses have created cave-in lakes (fig. 30) rather than pits in these areas.

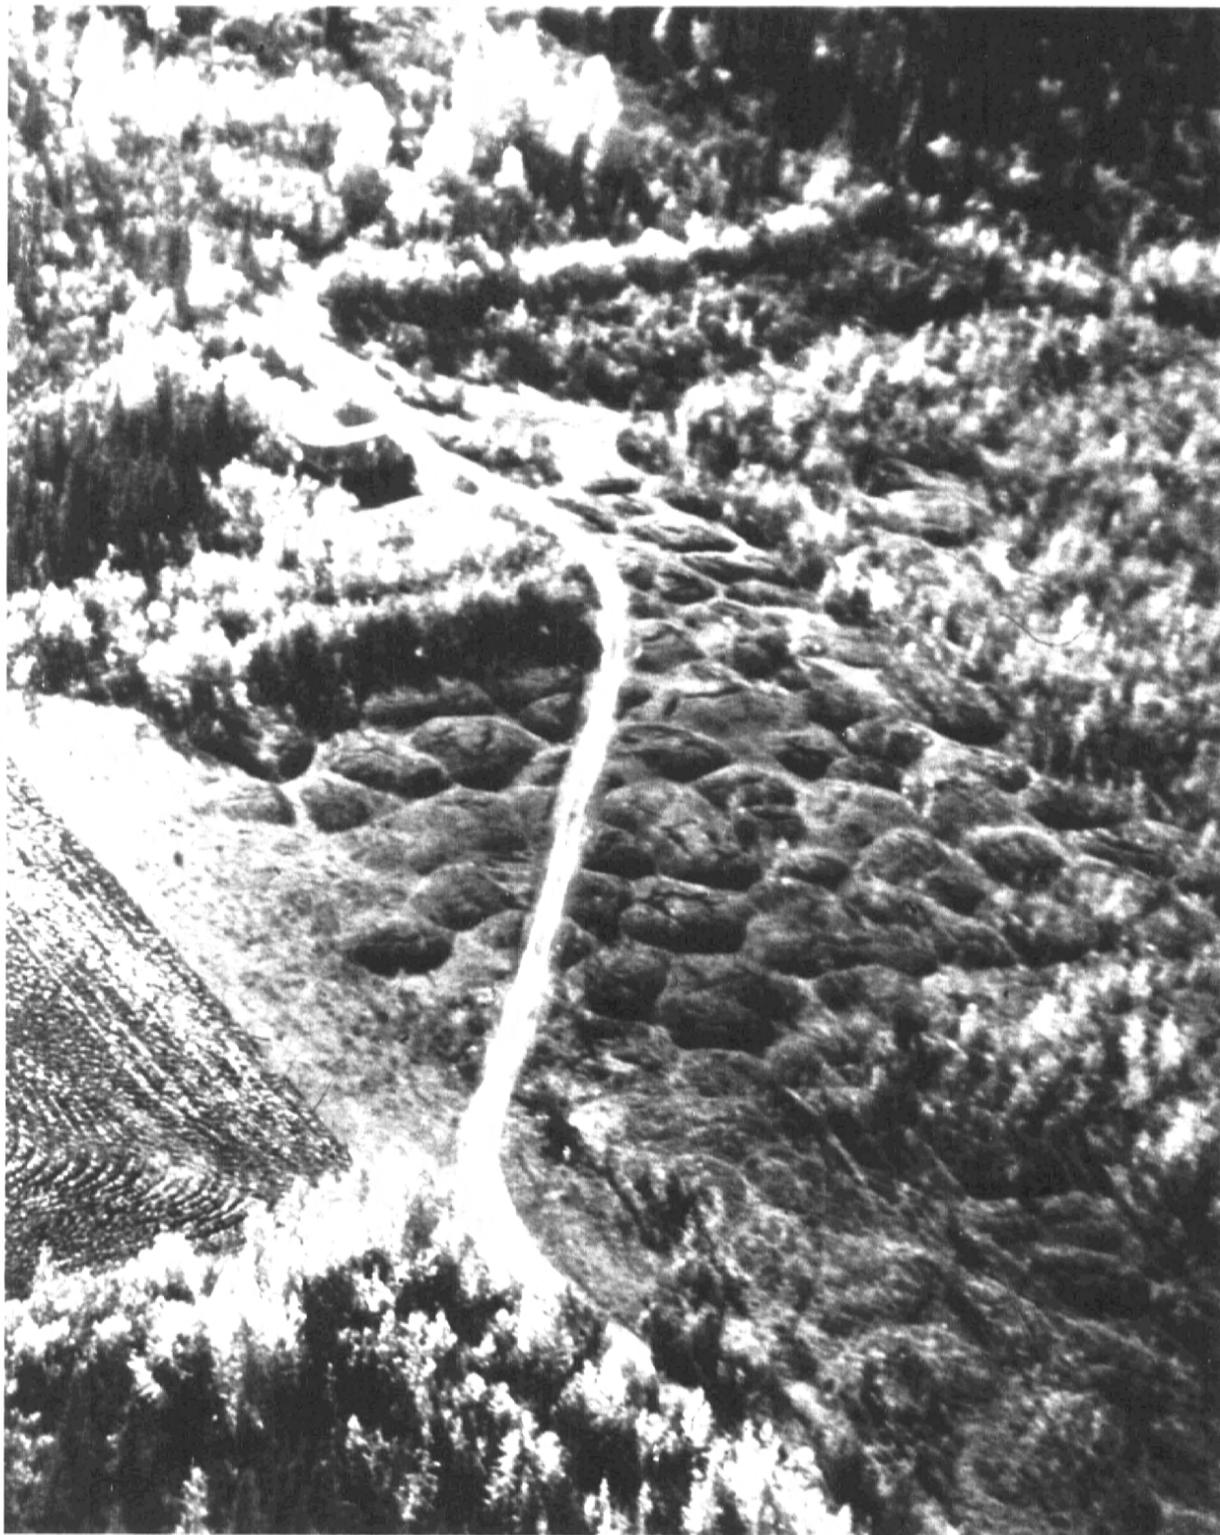
Figure 31. Low-angle, oblique aerial view of thermokarst mounds in an abandoned agricultural field at the U.S. Department of Agriculture Experimental Farm at the University of Alaska, Fairbanks. These mounds are located on the north-facing side of College Hill and are 10 to 30 feet in diameter. Photograph by R.F. Black and T.L. Péwé, September 10, 1948.

Thermokarst mounds in the Fairbanks area are polygonal or circular hummocks of loess and retransported silt 10 to 50 feet in diameter (fig. 31) and 1 to 8 feet high (fig. 32). They are most common in cultivated fields, but a few are found in abandoned reforested fields, front yards, roadways, and other cleared areas. In some fields, thermokarst mounds are separated by trenches 1 to 5 feet wide, but elsewhere trenches are poorly developed and mounds are not completely separated (fig. 33).

a field on a gentle, north-facing slope at the University of Alaska Experimental Farm (fig. 31). The smooth-surfaced field was cleared in 1908, but by 1922 pronounced individual and connected depressions that interfered with the operation of farm machinery had formed. The field was then seeded to pasture. By 1938 the mounds were 3 to 8 feet high and 20 to 50 feet in diameter (fig. 34). In November 1938 a bulldozer removed the upper part of every hummock and filled each pit until the land surface was approximately uniform. The smooth surface persisted for nearly a year; by July 1939--nearly a year later--irregularities in the smooth surface began to form. During succeeding years, polygonal mounds formed as the ground surface subsided over melting ice. By 1947 mounds in the area that
