SPECIAL REPORT 15

**GEOLOGIC HAZARDS OF THE FAIRBANKS AREA, ALASKA**

By  
Troy L. Péwé

First Edition, 1982  
by  
Department of Natural Resources  
DIVISION OF GEOLOGICAL & GEOPHYSICAL SURVEYS  
Fairbanks, Alaska  
Reprinted 1993

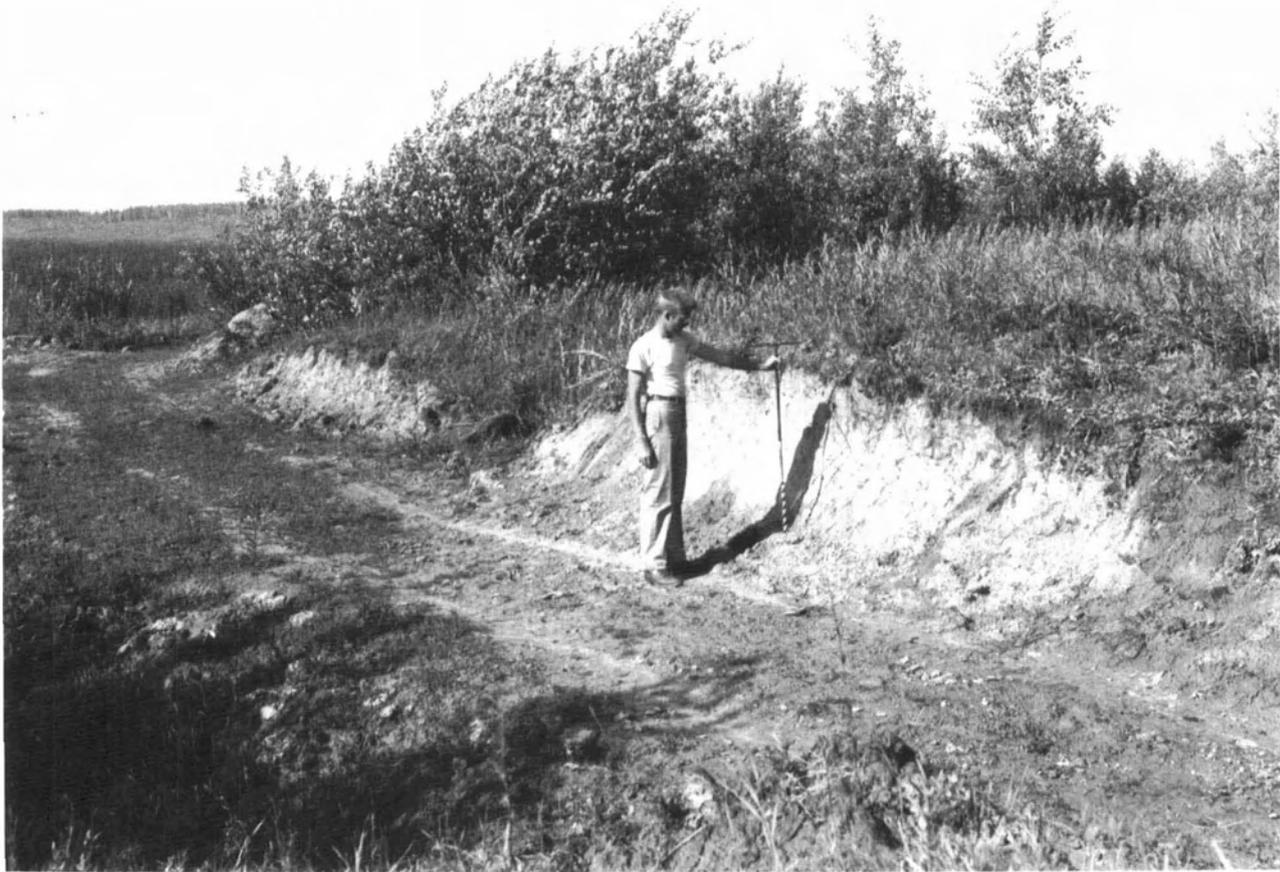
Figure 32. Closeup view of thermokarst mounds shown in figure 31. Photograph 143 by T.L. Péwé, July 23, 1947.

Thermokarst mounds in the Fairbanks area are polygonal or circular hummocks of loess and retransported silt 10 to 50 feet in diameter (fig. 31) and 1 to 8 feet high (fig. 32). They are most common in cultivated fields, but a few are found in abandoned reforested fields, front yards, roadways, and other cleared areas. In some fields, thermokarst mounds are separated by trenches 1 to 5 feet wide, but elsewhere trenches are poorly developed and mounds are not completely separated (fig. 33).

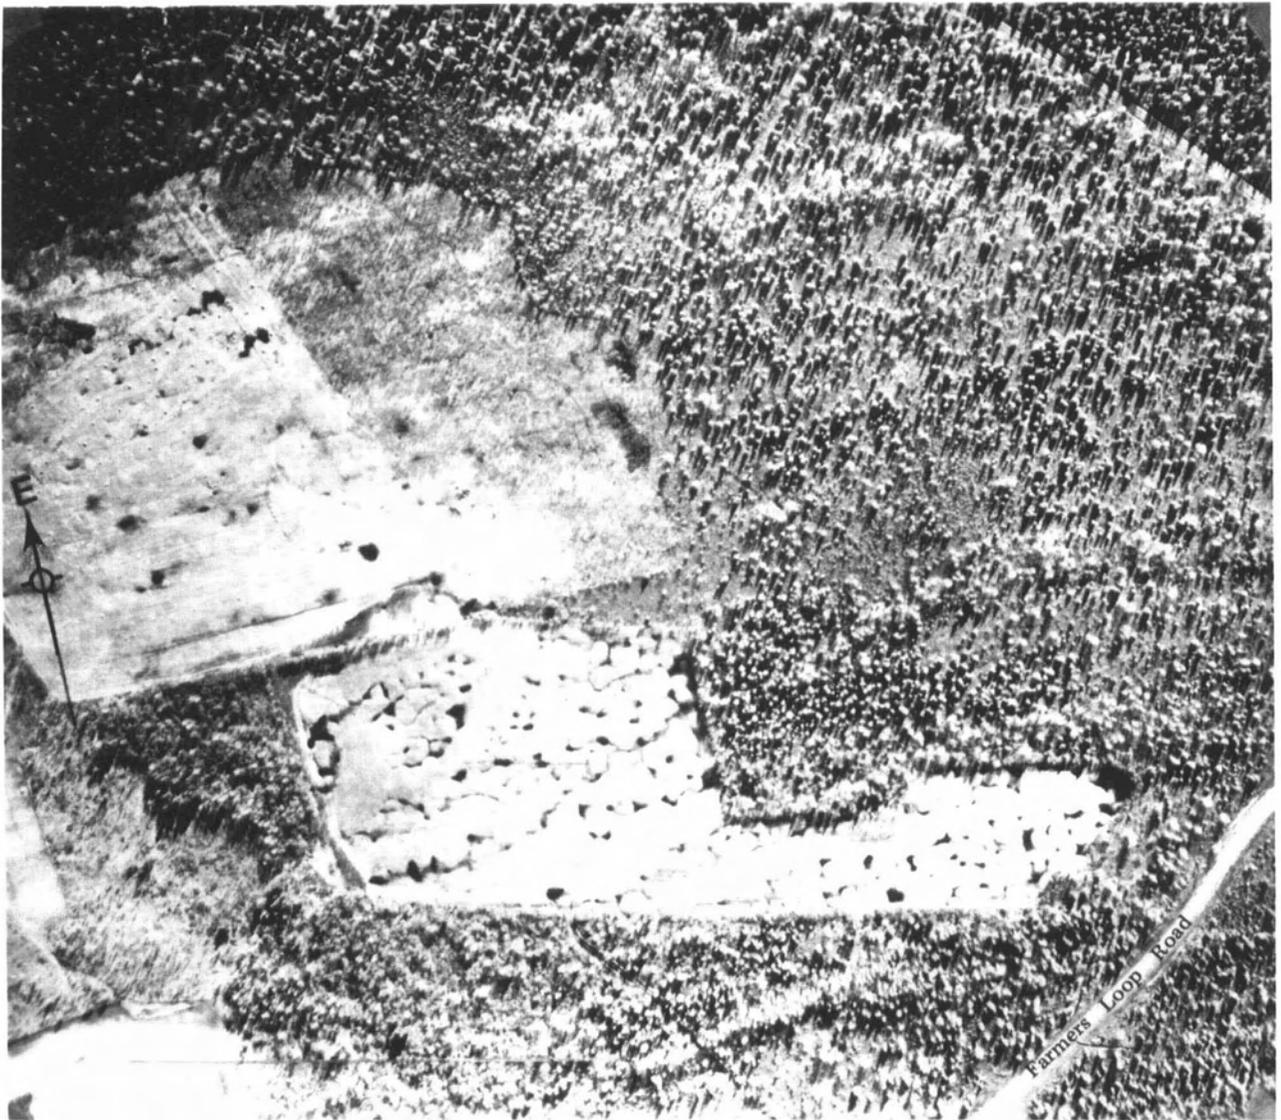
Figure 33. Vertical aerial photograph of formerly cultivated field on lower colluvial slopes in vicinity of Farmers Loop Road near the junction with McGrath Road north of Fairbanks. Well-developed thermokarst mounds about 30 feet in diameter and 6 feet high occur in the L-shaped part of the field. Many mounds are not completely separated because dividing trenches are not fully developed. Black spots in the field are water-filled depressions. Since this photograph was taken, houses have been built in the upper right corner of the photograph; they have subsequently been distorted by thawing of the ice-rich ground. Photograph 62VV46PL-MTM7346RS by U.S. Army Air Corps, May 9, 1947.

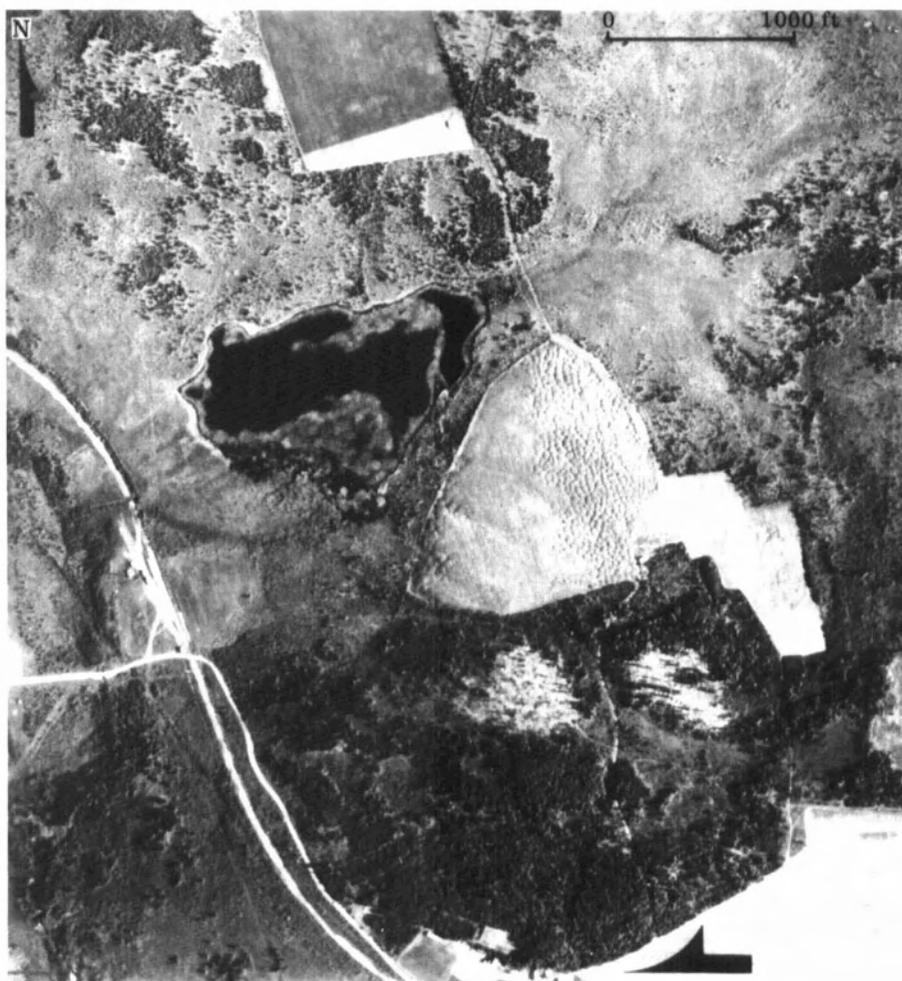
Figure 34. Vertical aerial photograph of thermokarst mounds in the University of Alaska Experimental Farm fields north of College Hill, summer 1938. In November 1938, the field was graded by a bulldozer. Compare mound development in this photograph with that in figure 35, which was taken in 1948. Photograph by Pacific Aerial Surveys, July 22, 1938.

was graded in 1938 were as large and as high as those in the field that was not graded. Maximum mound height was 8 feet. Comparisons of 1938 and 1948 aerial photographs (figs. 34, 35) reveal a similar size, shape, and position for the mounds. A soil-auger probe on July 14, 1948, revealed no ice or frozen ground 9 feet below the surface.

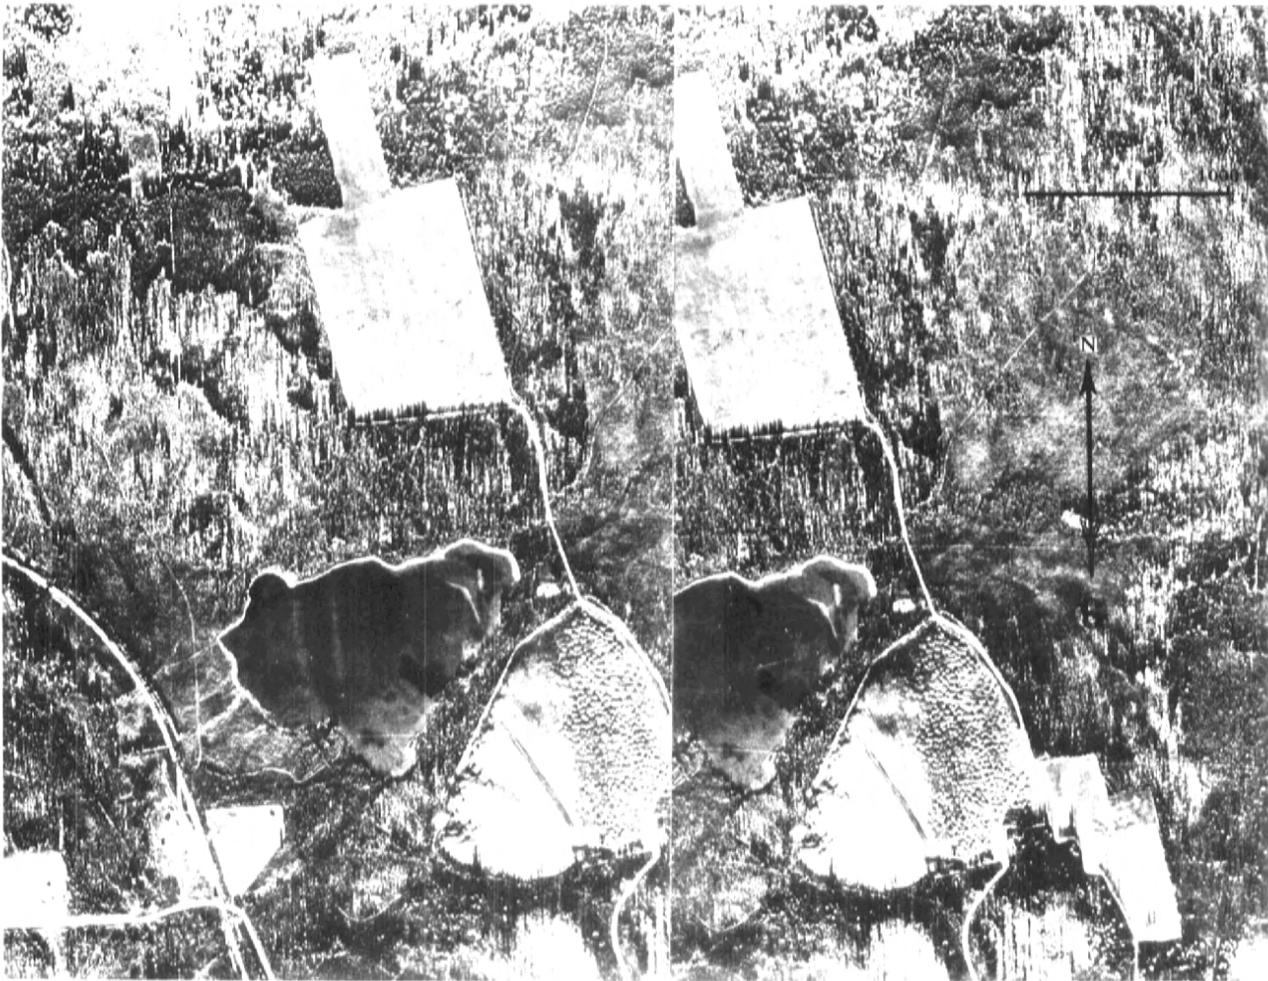
Figure 35. Stereopair of thermokarst mounds in the University of Alaska Experimental Farm fields on north slope of College Hill. Mounds shown in figures 31 and 32 are in the center of the field. Parts of the three largest fields have been abandoned. Photographs by U.S. Army Air Corps, 1948.

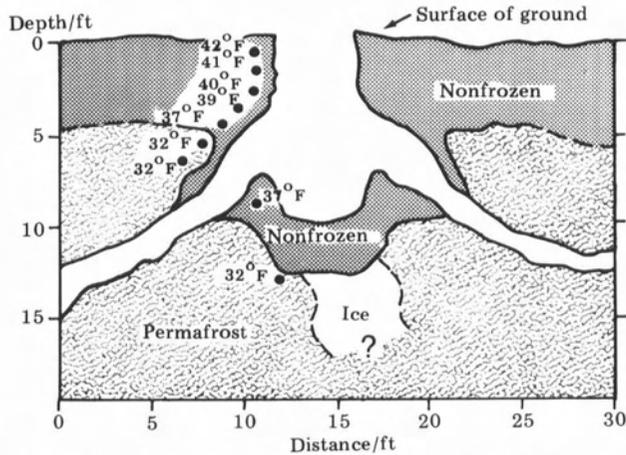
Figure 36. Cross section of thermokarst pit at Fairbanks Golf Course across Farmers Loop Road from KFAR-transmitter station. Note that the opening simulates the shape of the irregular ice mass shown in figure 23. Temperature measurements by Ansel Gooding, September 4, 1948.

Thermokarst pits are generally 5 to 20 feet deep and 3 to 30 feet in diameter. They are steep walled and commonly bottle shaped (fig. 36). Pits initiated by melting of massive ground ice are commonly enlarged and modified by surface water that is diverted into small cracks and subterranean passageways and flows 6 to 20 feet beneath the surface. The well-sorted, fine-grained silt of the Fairbanks area is readily eroded and carried in

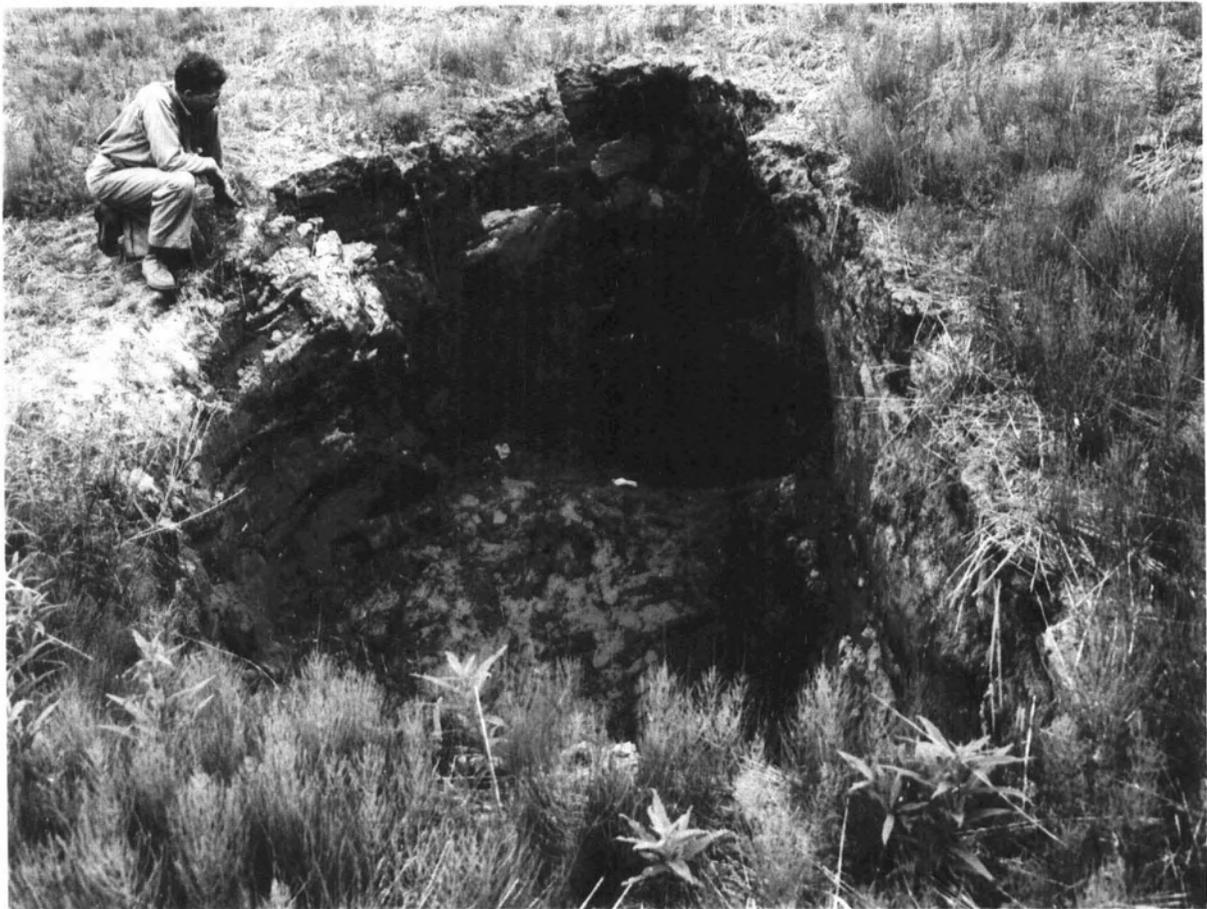
Figure 37. Thermokarst pit in thawed silt 2 miles northwest of College on the old Yankovich Homestead. The semi-circular dark area at the base of the wall on far side of pit is opening to passageway. Photograph 269 by T.L. Pewé, July 7, 1948.

branching from both ends (fig. 37). Current markings and water-deposited silt on the floors of the passageways indicate intermittent subterranean flow (fig. 38). Many pits have formed in the Fairbanks Golf Course on Farmers Loop Road over the last 30 years (fig. 39). Consequently, this is probably the only links in the world with thermokarst pits as a natural hazard.

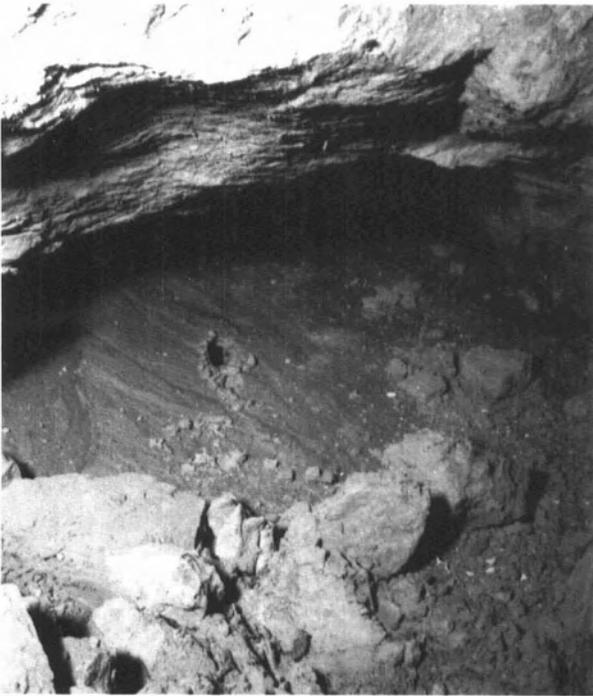
Figure 38. Current markings in underground passage leading from thermokarst pit in figure 37. Passage-way is about 1 foot high and 2 1/2 feet wide and partly filled with water-deposited silt. Photograph 258 by T.L. Péwé, June 24, 1948.

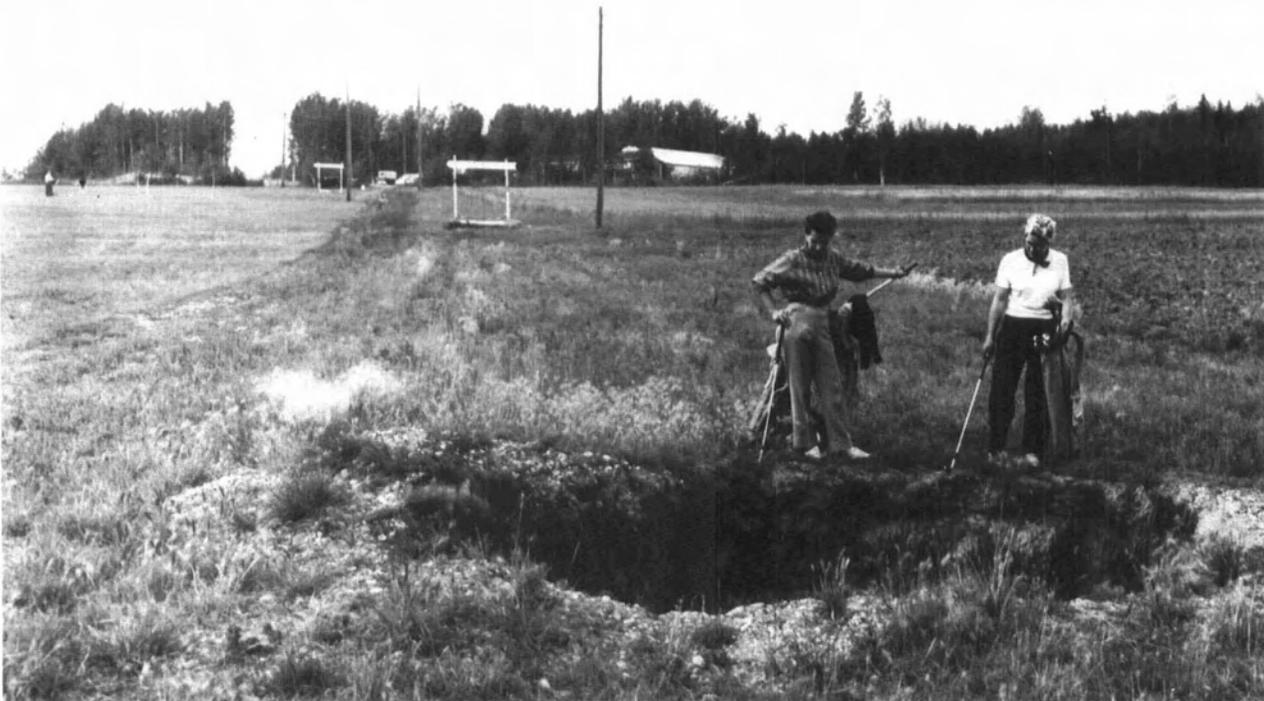
Figure 39. Thermokarst pit in loess; pits form and are filled, only to have more pits develop nearby the following year. Thermokarst pits are a unique golf hazard---and a dangerous hazard in agricultural fields. Photograph 1037 by T.L. Péwé, August 15, 1954.

the underlying permafrost melted. Ground subsidence became evident when the well in the building began to 'rise.' The casing of the well is frozen into 120 feet of permafrost, but the pump, which is set on top of the casing, continued to 'rise' above the floor (fig. 46c). When it was 1 or 2 feet above the floor, the well casing was cut off and reset at floor level. Contrary to popular opinion, the casing was not rising out of the ground; rather, the ground and building were sinking around the stable casing. Because the KFAR-transmitter building was constructed solidly (and expensively even by modern standards), the building is generally intact, except for cracks and broken buried utility connections. It has not been used as a transmitter station for several years, but stands partially subsided in the middle of the golf course surrounded by well-developed thermokarst pits (fig. 39) and mounds.

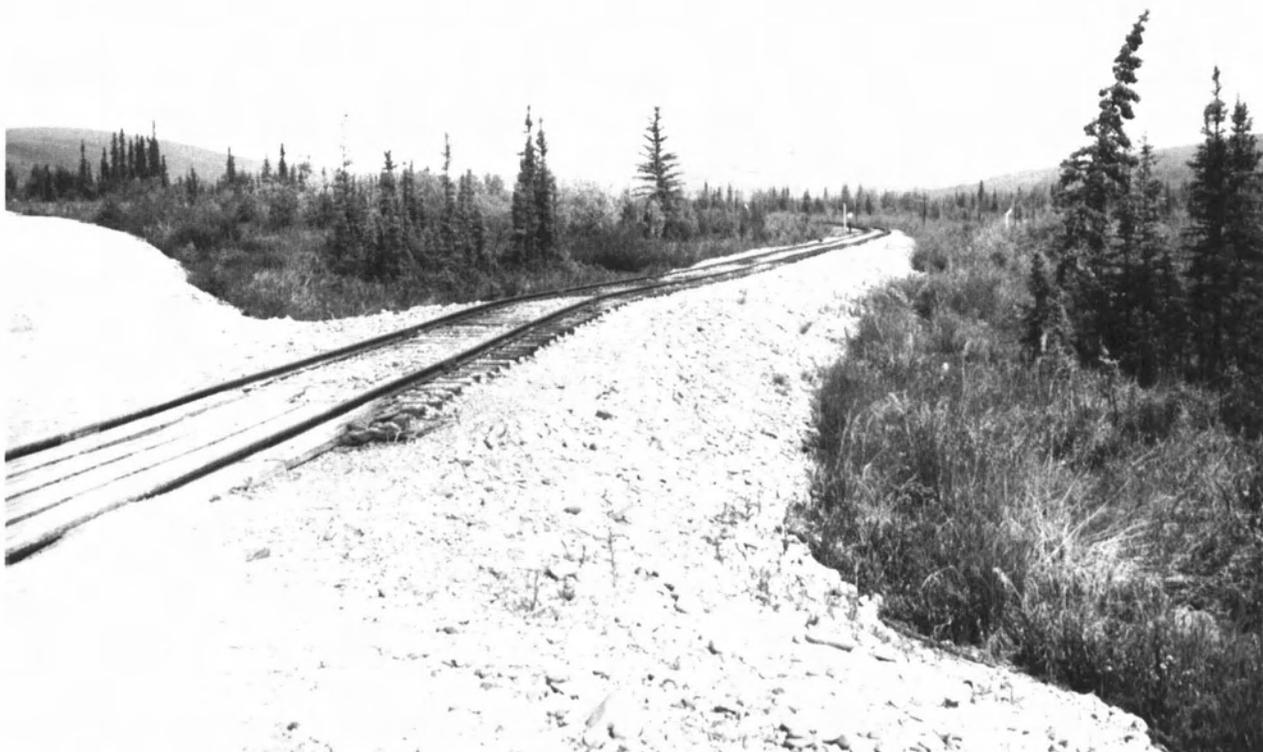
Figure 40. Differential subsidence of the Alaska Railroad bed (Mile 457, 12 miles northwest of Fairbanks in Goldstream Valley) caused by thawing of ice-rich permafrost. Photograph 946 by T.L. Pévé, June 1954.

in the USSR, Canada, China, and Alaska. From Dunbar (40 miles west of Fairbanks) to near Happy (7 miles west of Fairbanks), the Alaska Railroad is underlain by perennially frozen silt containing large masses of ground-ice (fig. 22). Differential settlement of the roadbed is extreme when the sensitive permafrost thaws (fig. 40). In the 1960's the annual maintenance cost of railroad grade in this section averaged about \$200,000. Because of permafrost thawing, an exceptionally wide roadbed constructed on a thick layer of gravel over frozen silt has not prevented track settlement of up to 2 feet per year, even 50 years after construction, according to R.M. Moore of the Alaska Railroad.

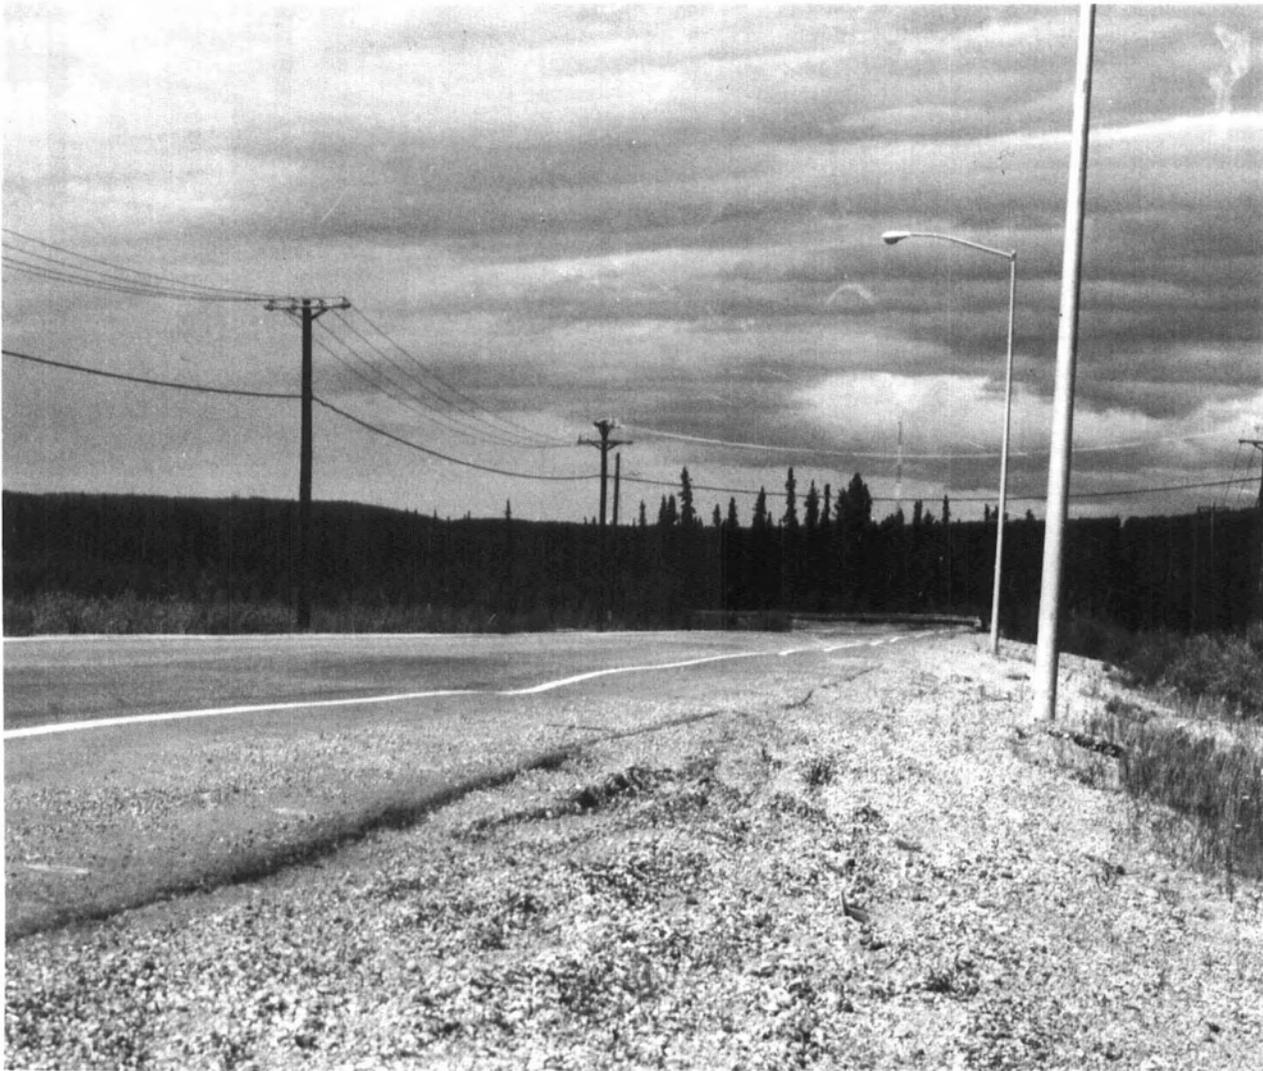
Figure 41. Irregular surface of Farmers Loop Road near the east entrance to the University of Alaska, Fairbanks. Road is constructed on a perennially frozen, silty, slough filling containing large masses of ground ice. The 4-foot-deep-gravel layer and black pavement induce deep thawing of permafrost, and consequent unequal subsidence of the road in summer. As the subgrade subsides, maintenance crews relevel the surface. During the summer of 1981, the road surface nearby was painted white to combat absorption of solar rays. Note the irregular guard rail and tilting of the light standards. Photograph 3958 by T.L. Pévé, July 14, 1977.

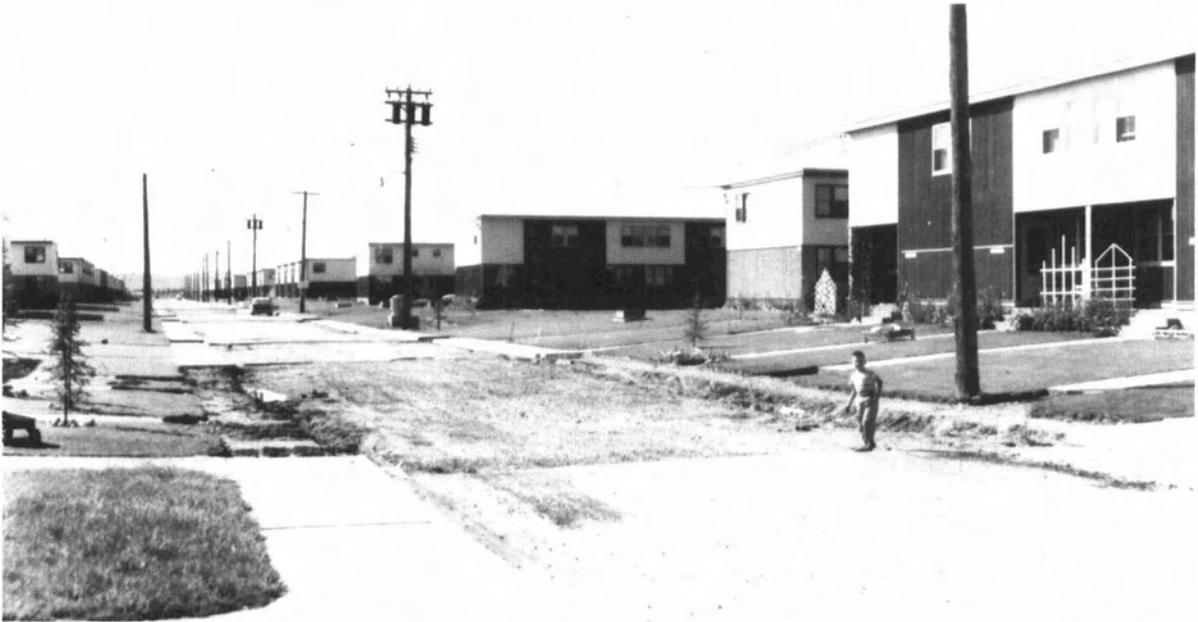
Figure 42. Ground subsidence near and under streets due to thawing of ice-rich permafrost. Damaged pavement and sidewalks have been removed where the ground has subsided, and the area has been brought to grade with additional gravel fill. View west on Balsam Street, Fort Wainwright. Photograph 1780 by T.L. Péwé, July 27, 1958.

summer of 1958, ground subsidence due to the thawing of ice-rich permafrost had caused serious damage to paved streets (fig. 42), sidewalks (fig. 43), and curbs, especially near buried, heated utilidors. Houses and utilidors were not seriously damaged. A study revealed that most, if not all, subsidence was in ice-rich silt fillings of former channels (fig. 8). Summer warming of paved areas and watering of nearby lawns caused the permafrost to thaw, resulting in subsequent damage to many structures. One might ask why most of the subsidence affected unheated structures rather than heated utilidors and homes. Construction records show that the 27-foot-deep excavations for utilidors were backfilled with gravel. Deep excavations were also made under houses to provide a thick thermal insulating blanket for the underlying permafrost. However, excavation for the streets was only 2 to 6 feet. If the silt-filled channels were only 20 to 25 feet thick, then most, if not all, of the ice-rich material was removed in the excavations

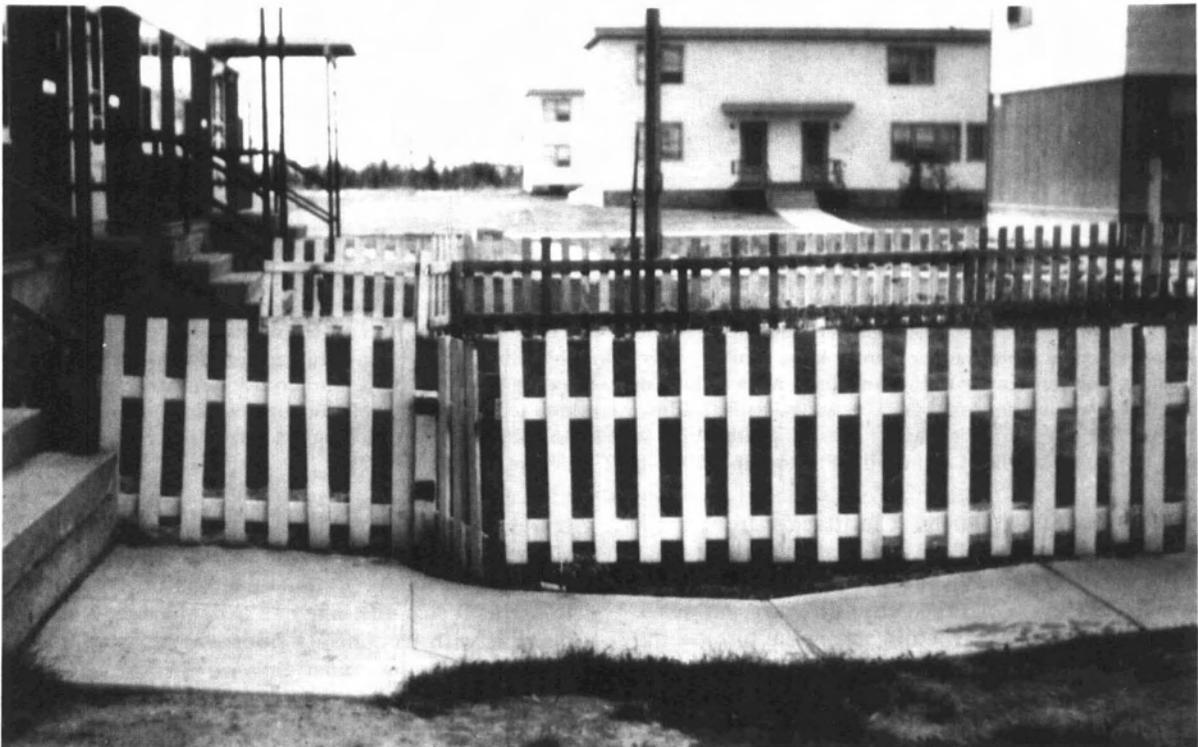
Figure 43. At Building 4106 Fort Wainwright this concrete crosswalk settled about 8 inches near the porch and several more inches in center because of thawing of ice-rich permafrost. Photograph by S.W. Muller, July 27, 1958.

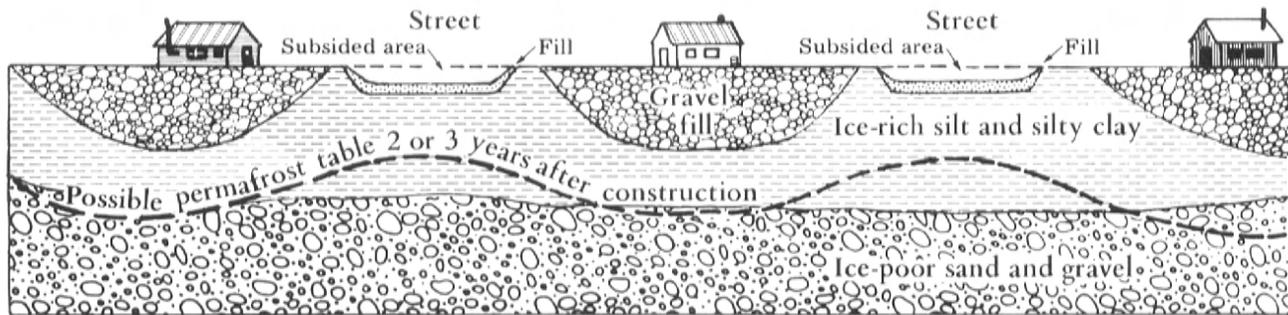
Figure 44. Diagrammatic sketch of housing area between Eighth and Ninth Streets on Balsam Street, Fort Wainwright, showing subsidence of ground near and under streets caused by thawing of ice-rich permafrost (fig. 42). Much of the housing development was built on up to 20 feet of ice-rich slough and swale alluvium overlying flood-plain gravel. Areas under houses did not subside significantly because most silt was removed and replaced with gravel backfill.

beneath utilidors and houses (fig. 44). The thawing of ice-rich permafrost then, affected only those areas of shallow excavation.

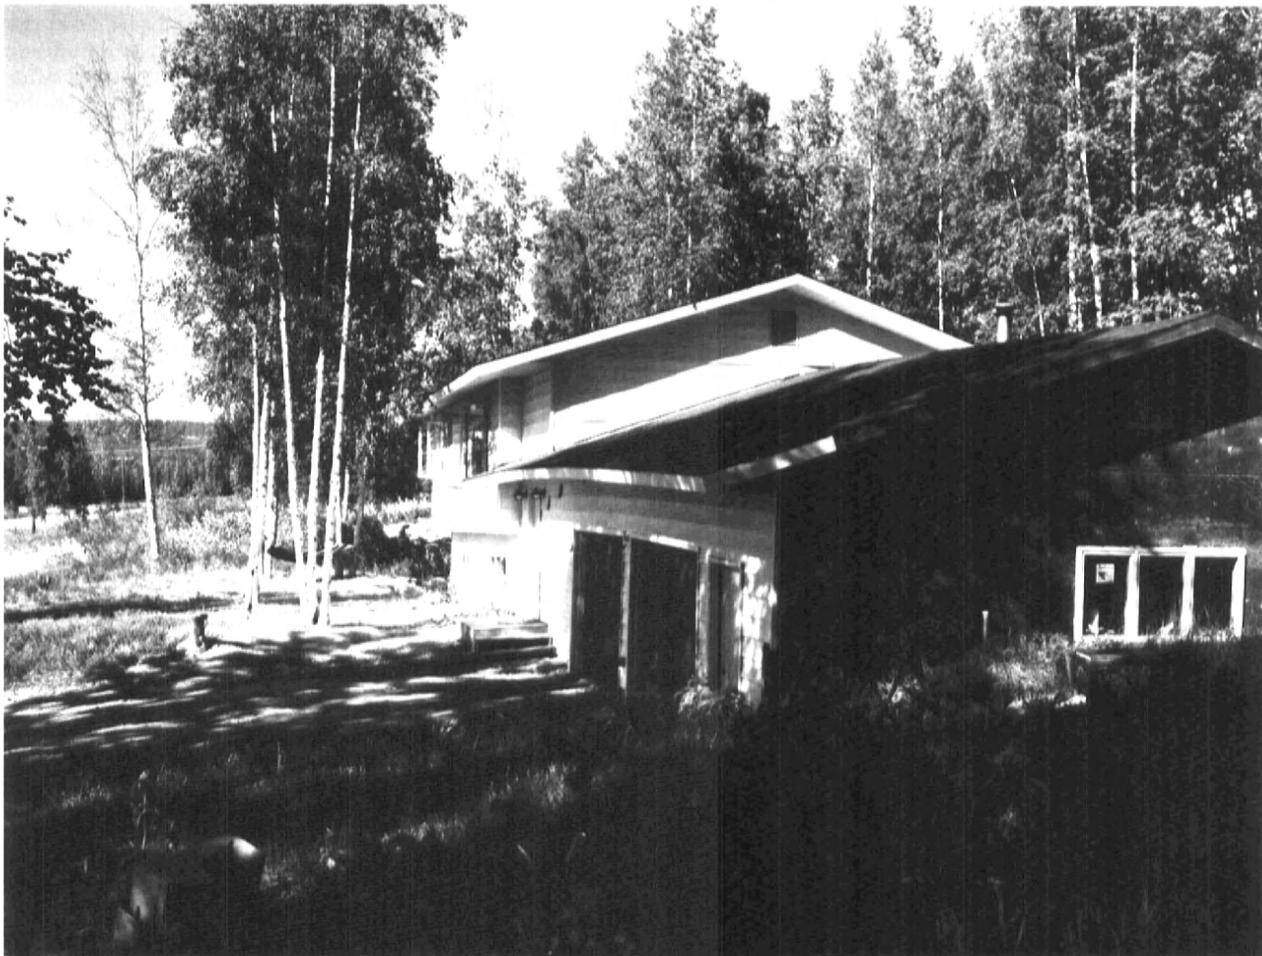
Figure 45. This house was constructed in about 1974 on ice-rich permafrost near the contact with the permafrost-free, west-facing slope on Birch Hill (Péwé, 1958; Péwé and Bell, 1975a). The heated basement under the main part of the house is subsiding but the unheated garage is not. Resulting stresses are bending and stretching the structure, causing breaking, pulling, and buckling of the siding and frame, especially where the garage joins the heated section of the house. The far end of the house appears to have subsided 1 to 2 feet. Photograph 3993 by T.L. Péwé, July 17, 1977.

been available from federal agencies since 1948--and earlier from some mining companies--lots continue to be sold and buildings continue to be constructed in a manner that will result in deformation, increased maintenance costs, and perhaps abandonment. Such construction is continuing (fig. 45) along Farmers Loop, McGrath, and Steel Creek Roads and in other areas where "the ground is good because large spruce trees are present." Real-estate signs proclaiming the joys of building in areas that are obviously underlain with ice-rich permafrost are only too common near Fairbanks.

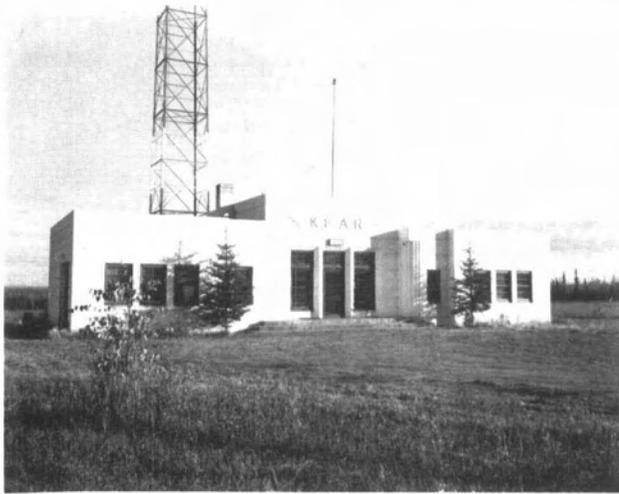
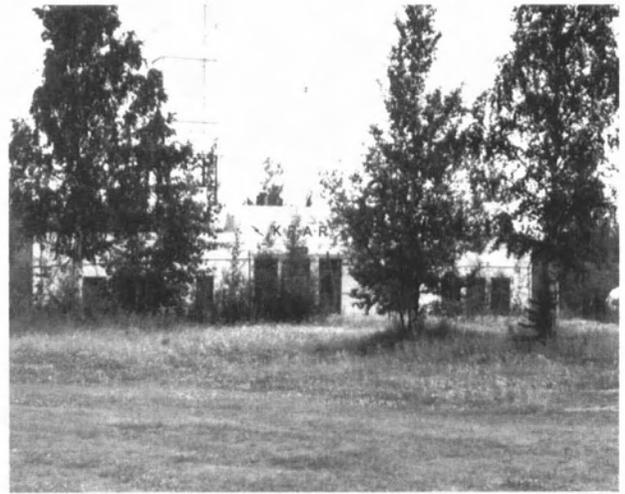
Figure 46a. The K-FAR-transmitter station constructed in 1939 had settled 2 or 3 feet by 1948. Only two of the original front-door steps are visible. Although slight cracks had formed in the building, the structure was intact. Photograph 363 by T.L. Péwé, September 9, 1948.

Figure 46b. By 1977, the K-FAR-transmitter station had subsided 4 to 5 feet; note the ground surface at the base of the windows. Needless to say, the building was abandoned, but it is remarkably intact after subsiding almost 40 years. Photograph 4005 by T.L. Péwé, July 14, 1977.

One notable exception is the former KFAR-transmitter building constructed in 1939 near Farmers Loop Road. Because this reinforced concrete building settled as a block (fig. 46a-b), it was not seriously deformed as

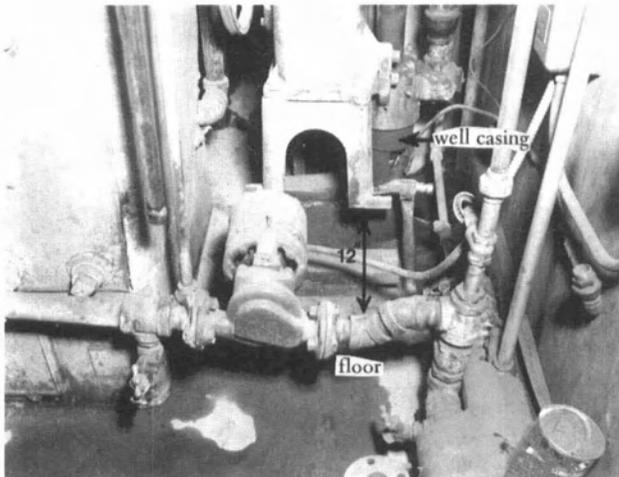
Figure 46c. By 1948, the top of the well casing and bottom of the pump in the K-FAR-transmitter station were 12 inches above the floor because of ground subsidence caused by thawing of ice-rich permafrost. Photograph 296 by T.L. Péwé, July 14, 1948.

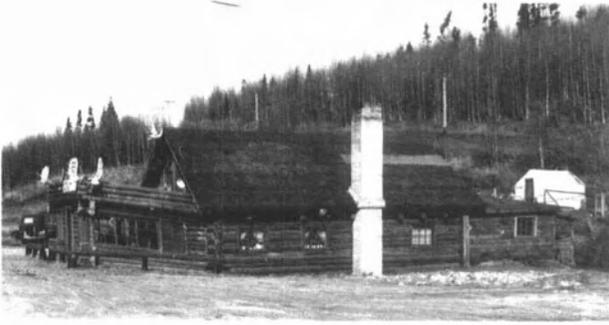
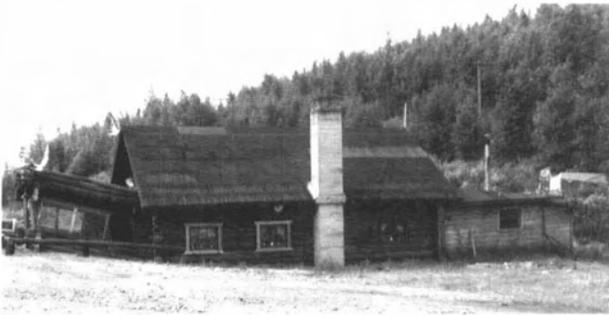
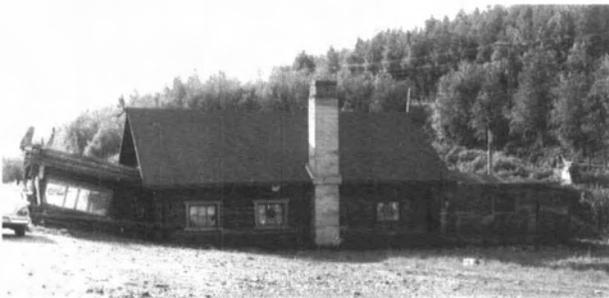
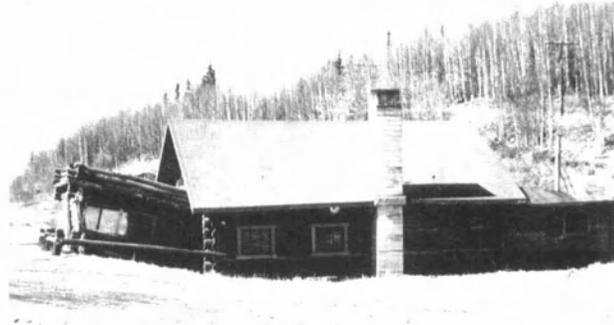
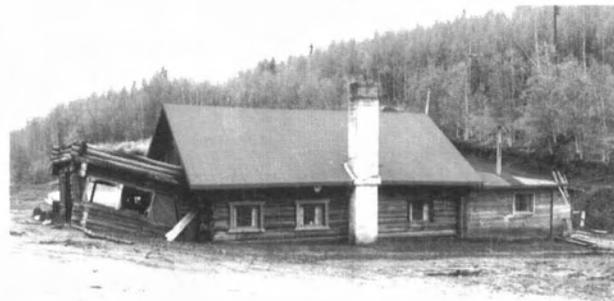
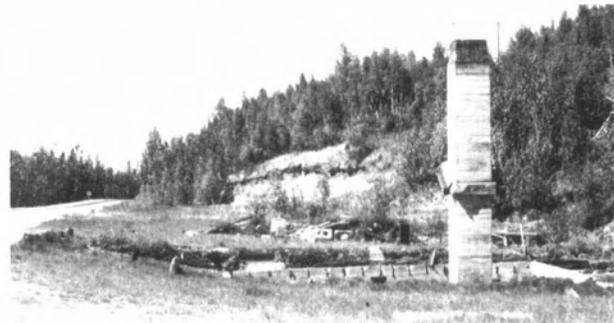
Figure 47a. Bert and Mary's Roadhouse at Mile 275.7, Richardson Highway, central Alaska. This large log building was seriously deformed and eventually destroyed by ground subsidence caused by thawing of ice-rich permafrost. Heat from the furnace located in the front of the building caused that part of the structure to sink most rapidly. Built in 1949, the building showed little deformation until 1952; by the fall of 1953 the building had subsided 2 feet below the level of the unheated porch. Photograph 854 by T.L. Péwé, April 2, 1954.

Figure 47b. By 1957 the building had subsided even more, dragging down the unheated front porch and small utility room (rear). Photograph 1399 by T.L. Péwé, July 15, 1957.

Figure 47c. Further subsidence had occurred by 1959, but the building was still in use. Photograph 1870, T.L. Péwé, June 18, 1959.

Figure 47d. By 1961 the building was abandoned as a roadhouse; the porch windows were broken during deformation. Photograph PK 7073 by T.L. Péwé, August 19, 1961.

Figure 47e. The porch and attached utility room were even more deformed in 1962. Photograph 2072 by T.L. Péwé, May 29, 1962.

Figure 47f. In 1964 the roadhouse was razed, exposing the differentially subsided concrete basement walls. Photograph PK 8631 by T.L. Péwé, June 17, 1964.

near the front of the building. The attached front porch and rear service building were not heated. Figures 47a-f present a pictorial record of the sinking of the roadhouse from 1954 to 1964, when the entire structure was razed. The front of the heated structure, where the furnace was located, subsided most rapidly. The unheated porch and utility buildings did not sink immediately, but were dragged downward as the rest of the building settled.

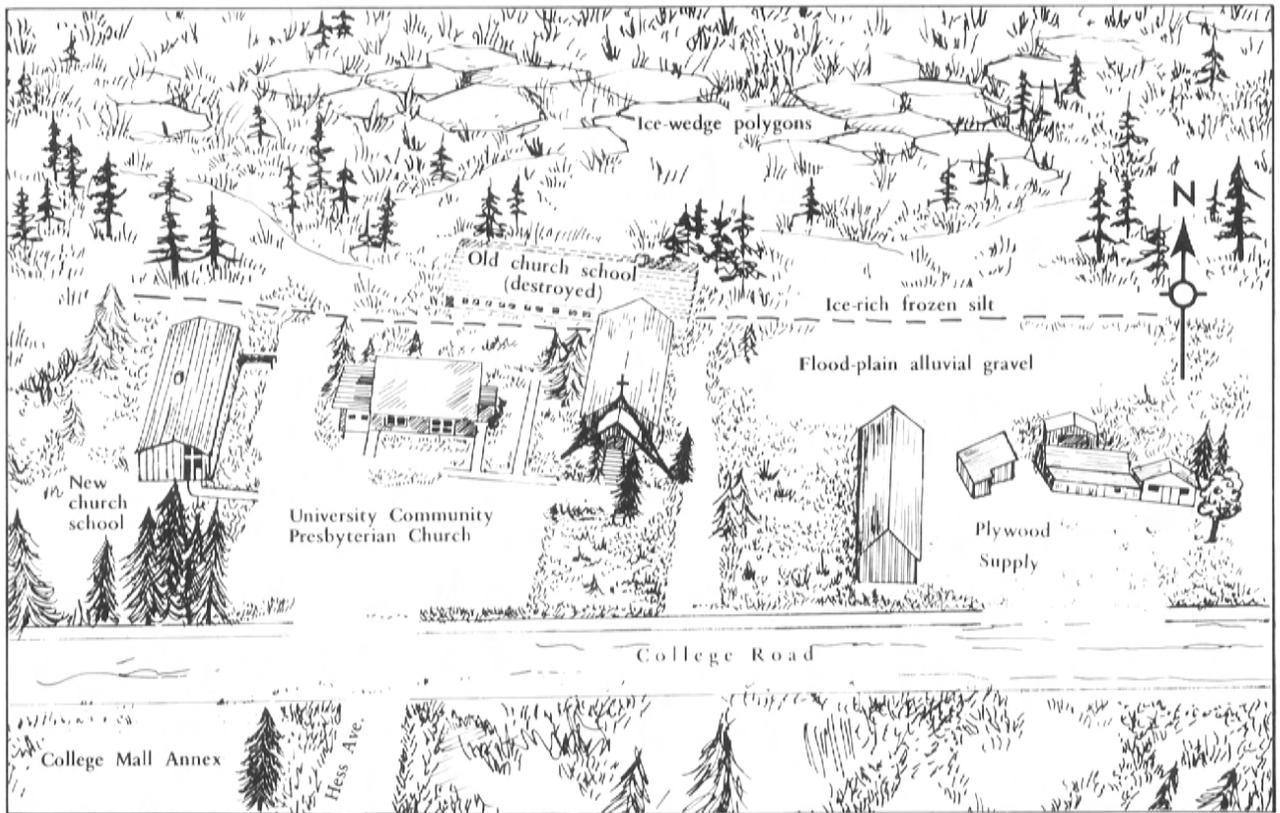
Figure 48. Sketch from 1955 oblique photograph of the University Community Presbyterian Church Manse and old church school in College. Buildings in foreground are on flood-plain alluvial gravel and church school is on ice-rich permafrost. Note the ice wedges diagrammatically expressed as polygonal ground. The old school collapsed several years later as underlying ice melted. The new school building and other modern structures are sketched as of 1981. Photography courtesy of E.H. Beistline.

gravel in 1949. In 1955 a church-school building was constructed 30 feet from the sanctuary (fig. 48) north of the contact between flood-plain sand and gravel and ice-rich silt (fig. 49). The one-story, heated, block school building with its concrete floor was soon deformed and destroyed as the underlying ice melted; the building was condemned in 1961 and removed. Construction and removal costs (1981) constituted a loss of about \$150,000. In 1962 a new church school was built on the flood plain west of the manse at a cost of approximately \$150,000. At current prices, this unfortunate experience with ice-rich permafrost cost more than \$300,000.

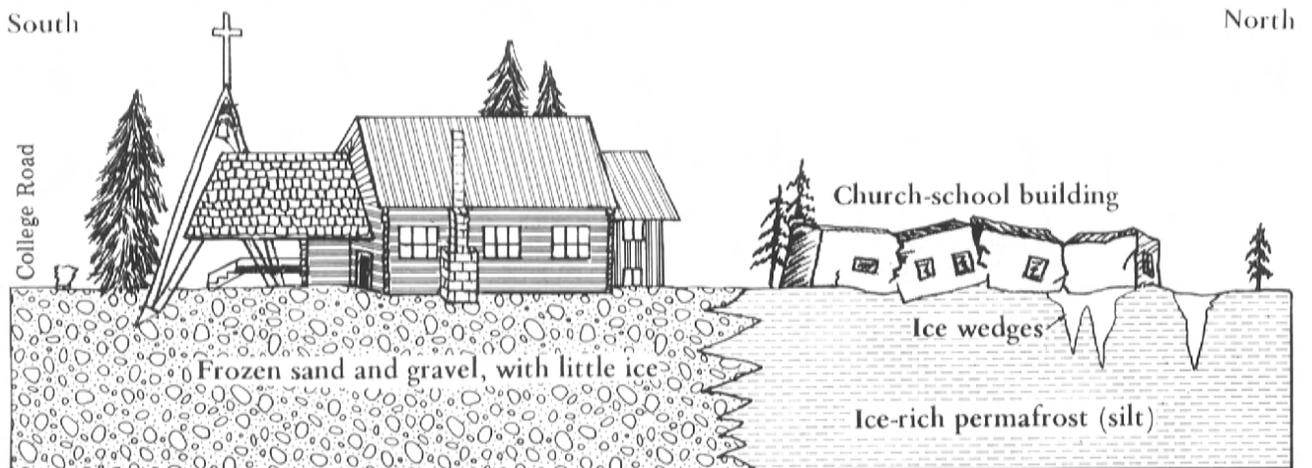
Figure 49. Diagrammatic sketch of sanctuary of the University Community Presbyterian Church and former church-school building in College. The sanctuary was built on perennially frozen flood-plain sand and gravel that contains scant ice. Thus, there has been little subsidence of the building. In 1955, the former church-school building was constructed 30 feet to the north, on ice-rich permafrost, across the boundary between the flood-plain gravel and retransported silt. Permafrost under the heated block building soon thawed, and as the building subsided it was distorted and had to be razed 6 years later.

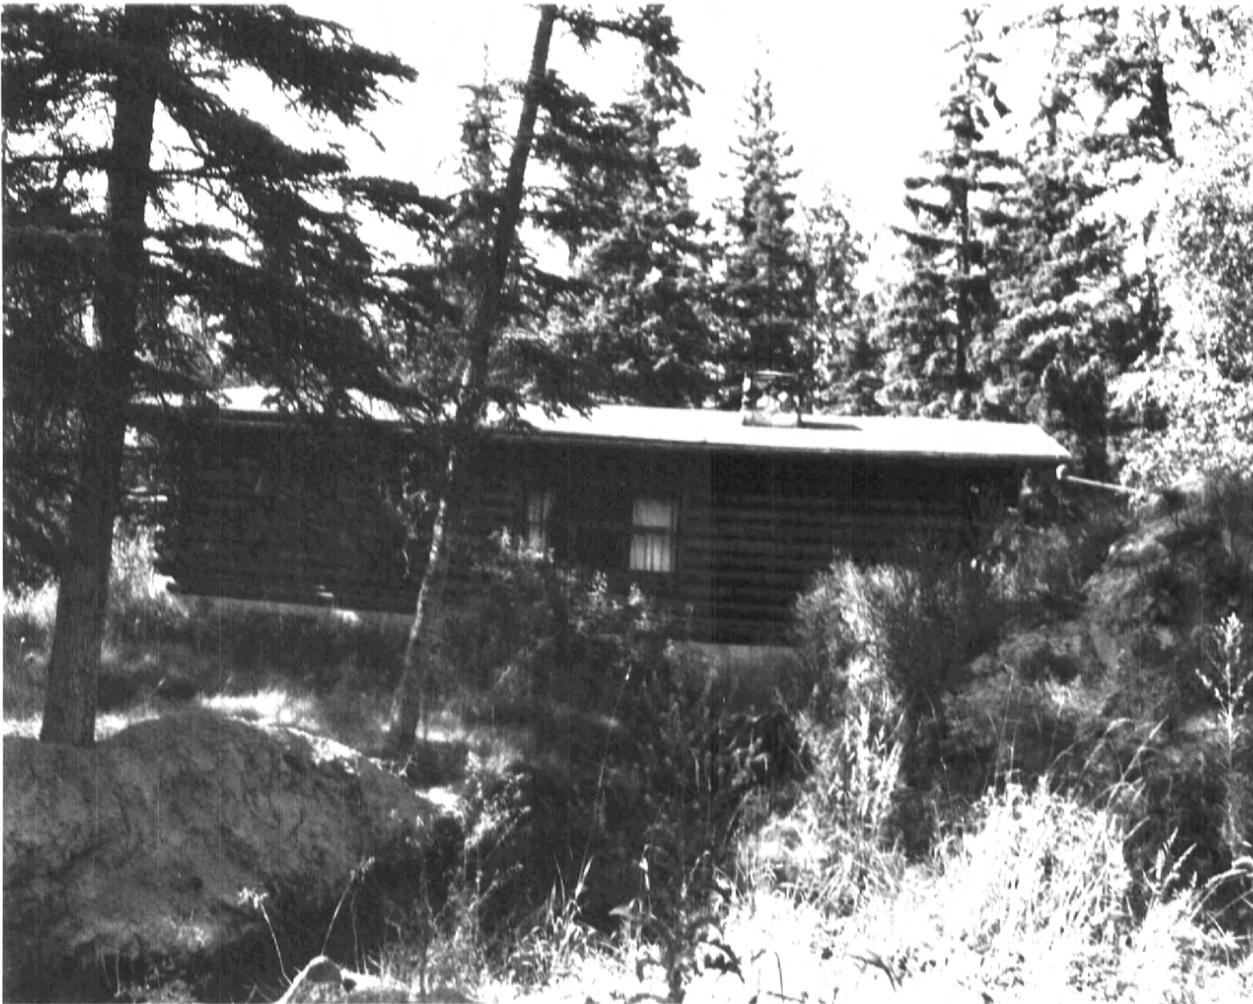
Figure 50. Tilted, modern log cabin with full, heated concrete basement built on ice-rich permafrost (Péwé, 1954). Location is 3 miles north of Fairbanks near the McGrath-Farmers Loop Roads' junction (see figure 33 for aerial photograph of area). Heat from the 3- to 4-year-old cabin is thawing the permafrost; the greatest subsidence (about 4 feet) is near the furnace and fireplace. The foundation is severely cracked, and distortion of the house has broken windows and drain pipes and jammed doors and windows. Recent repairs entailed breaking up the basement slab, leveling the house with jacks, backfilling with gravel, and repouring the basement slab and wall foundation. Because thaw is not complete, additional settling is expected. Photograph 4001 by T.L. Péwé, July 14, 1977.

There are numerous examples of the distortion and destruction of heated buildings by the thawing of ice-rich permafrost (figs. 50-52). Obviously, the solution is to construct in permafrost-free areas or on permafrost with a relatively low ice content.
