SPECIAL REPORT 15

**GEOLOGIC HAZARDS OF THE FAIRBANKS AREA, ALASKA**

By  
Troy L. Péwé

First Edition, 1982  
by  
Department of Natural Resources  
DIVISION OF GEOLOGICAL & GEOPHYSICAL SURVEYS  
Fairbanks, Alaska  
Reprinted 1993

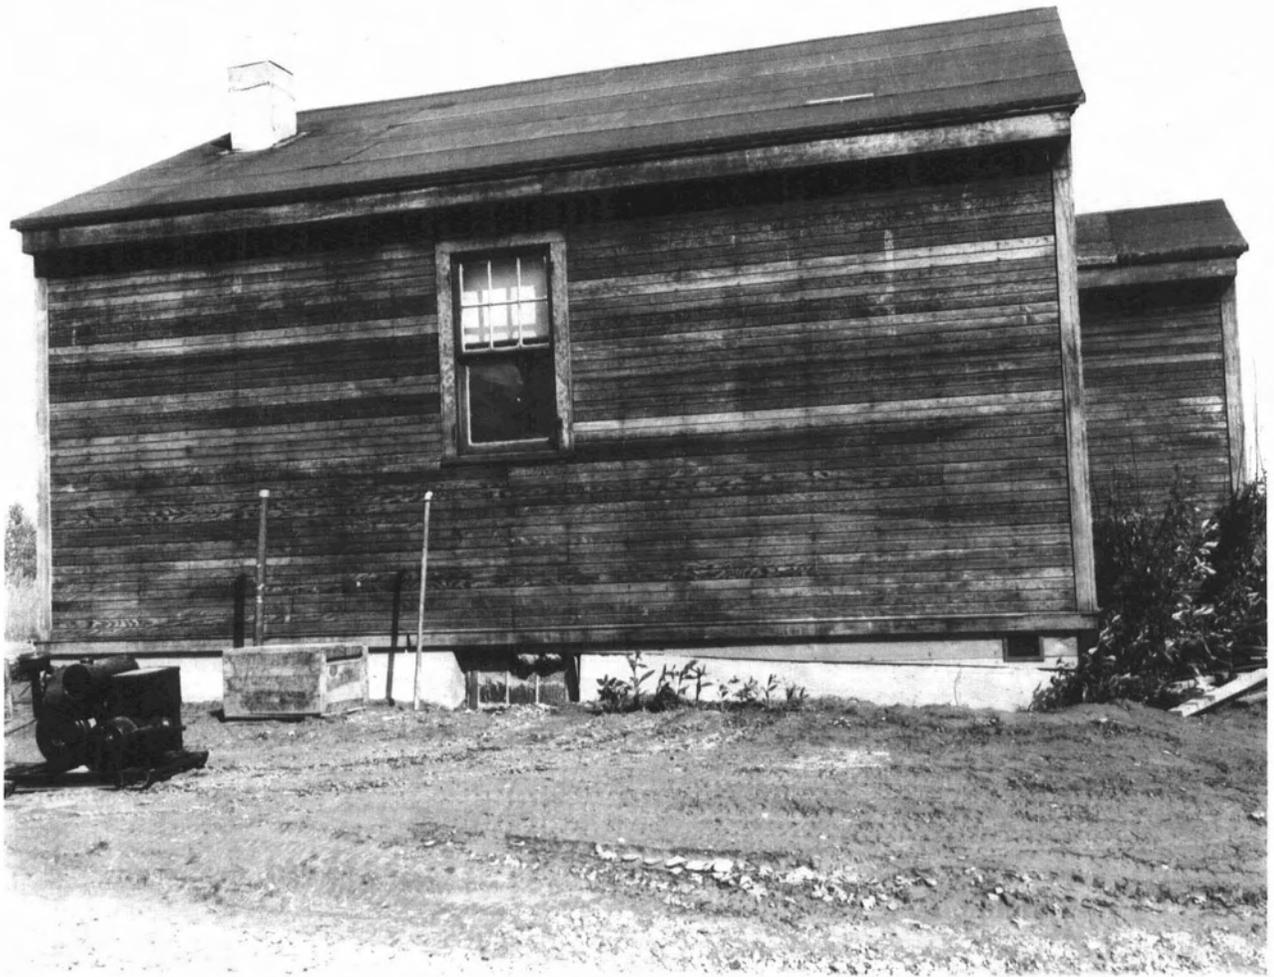
Figure 51. Heated concrete basement under frame house subsided 18 inches on south side of building. This World War II era house is located on ice-rich permafrost about 200 yards north of Ballaine Lake near the University of Alaska. Note the wooden, wedge-shaped addition that was added to the foundation in 1946 to level the building. Photograph 187 by T.L. Pewé, August 14, 1947.

There are numerous examples of the distortion and destruction of heated buildings by the thawing of ice-rich permafrost (figs. 50-52). Obviously, the solution is to construct in permafrost-free areas or on permafrost with a relatively low ice content.

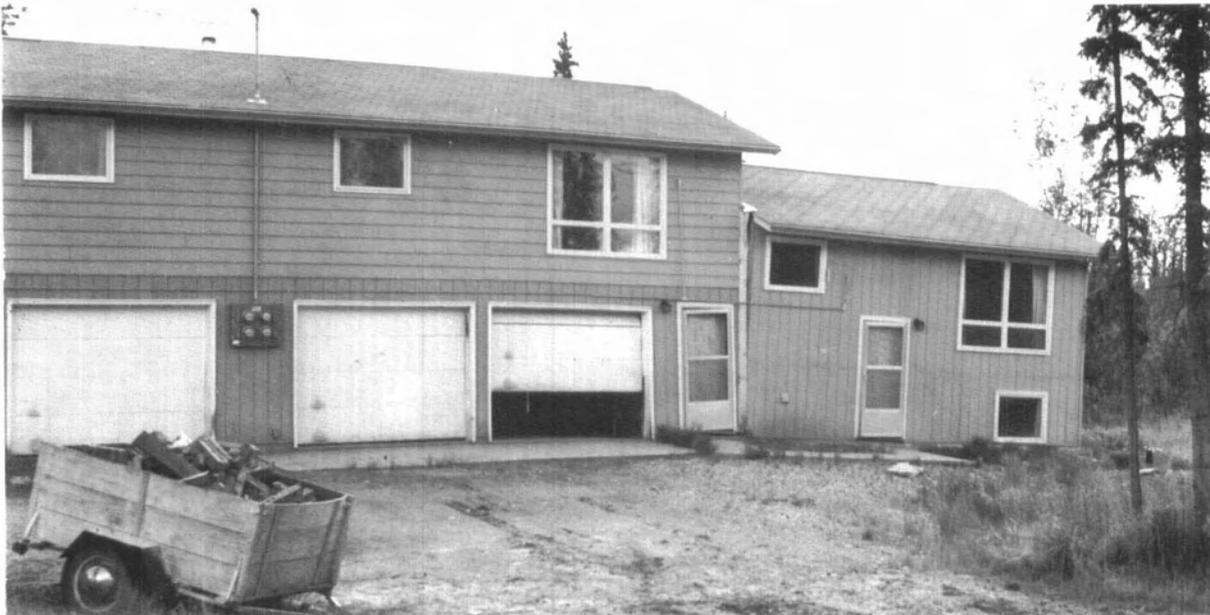
Figure 52. Frame house with heated basement near Farmers Loop Road north of the University of Alaska, Fairbanks. Note separation of the building and distortion of doors caused by melting of underlying ice-rich permafrost. Photograph 3326 by T.L. Péwé, June 19, 1972.

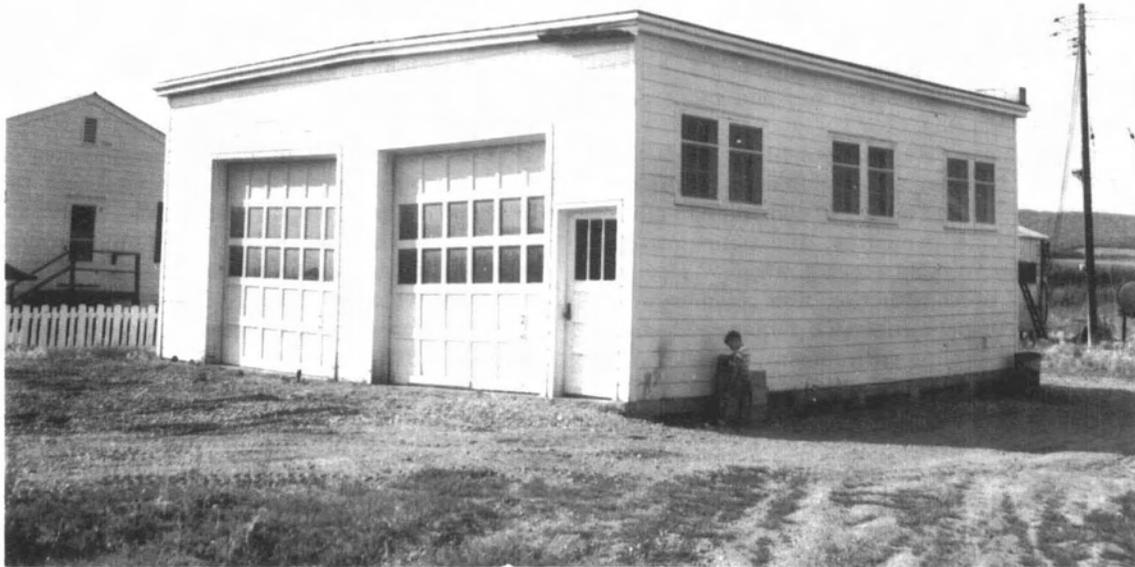
Figure 53. Building constructed with air vents in foundation to facilitate removal of structural heat. To prevent thawing of underlying permafrost, heated buildings may be constructed with such passageways to allow air circulation under the structure. The 4-inch-high vents in the foundation of this building were insufficient to dispose of building heat and the permafrost thawed, resulting in building subsidence. Location is the Cold Regions Research and Engineering Laboratory Permafrost Experimental Station, U.S. Army Corps of Engineers, Farmers Loop Road, Fairbanks. Photograph 1782 by T.L. Péwé, July 26, 1958.

on piles is a common solution. Another method is to provide openings under the building for cold-air circulation and building-heat dispersion (figs. 53, 54). Unfortunately, many heated buildings require constant and expensive adjustment as the foundation sinks; in many instances the building must eventually be abandoned.

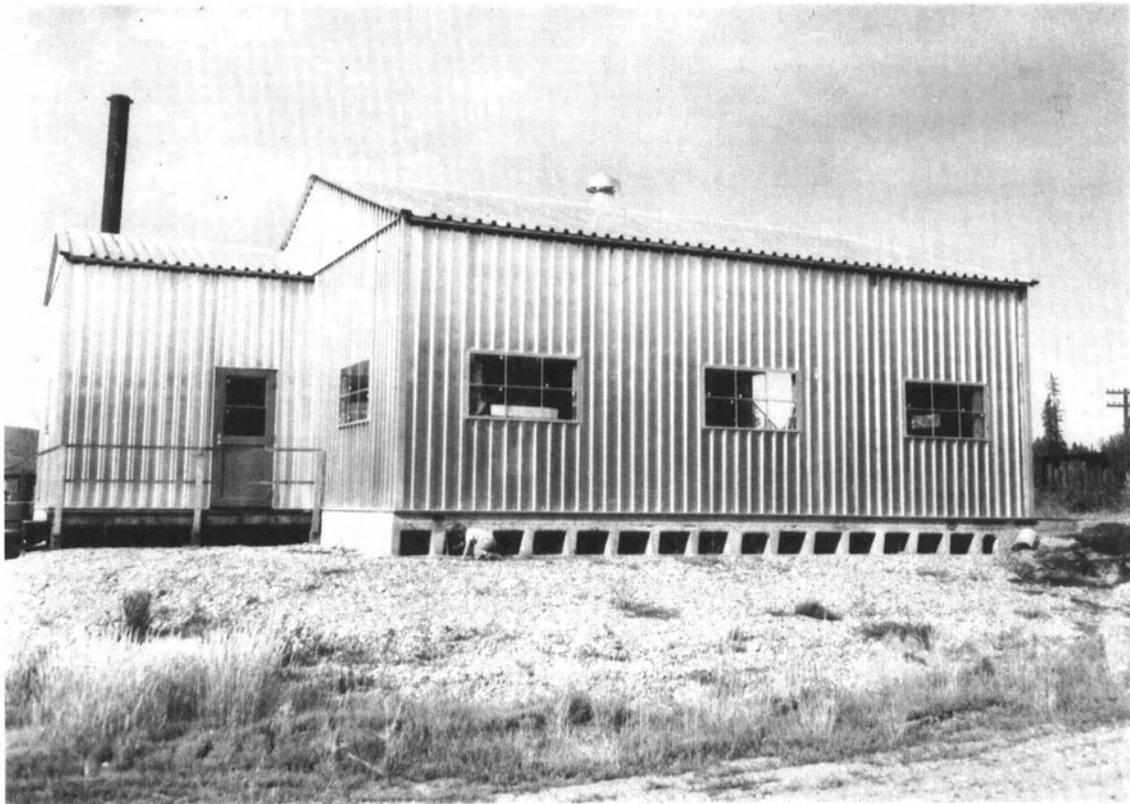
Figure 54. Twelve-inch-high air vents in the concrete foundation of this building prevent thawing of underlying permafrost. Location is Cold Regions Research and Engineering Laboratory Permafrost Experimental Station, U.S. Army Corps of Engineers, Farmers Loop Road, Fairbanks. Photograph 1783 by T.L. Péwé, July 26, 1958.

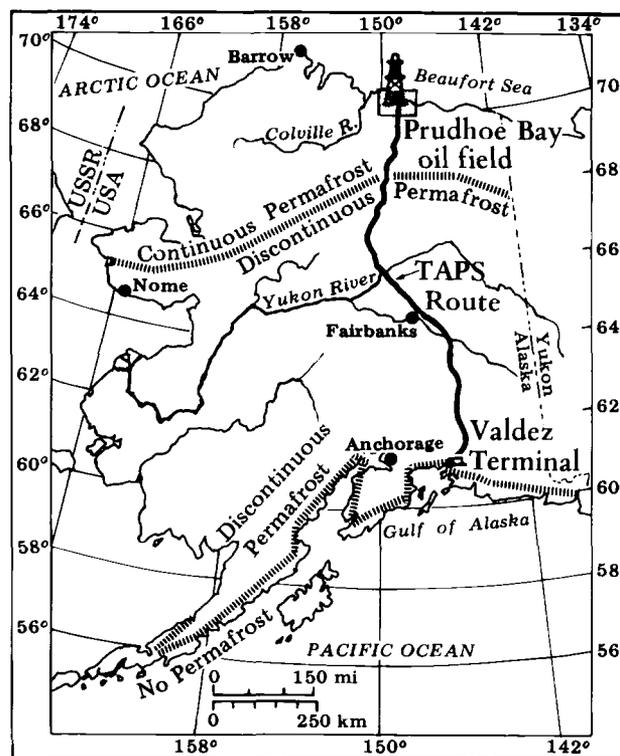
Figure 55. Route of the Trans-Alaska Pipeline System through three permafrost zones.

The pipeline crosses the continuous and discontinuous permafrost zones (fig. 55), as well as an area along the southern segment of the route that contains no permafrost. In areas where permafrost is nearly ice free, or where permafrost is absent, the pipe is buried in the conventional manner. About 409 miles of the pipeline

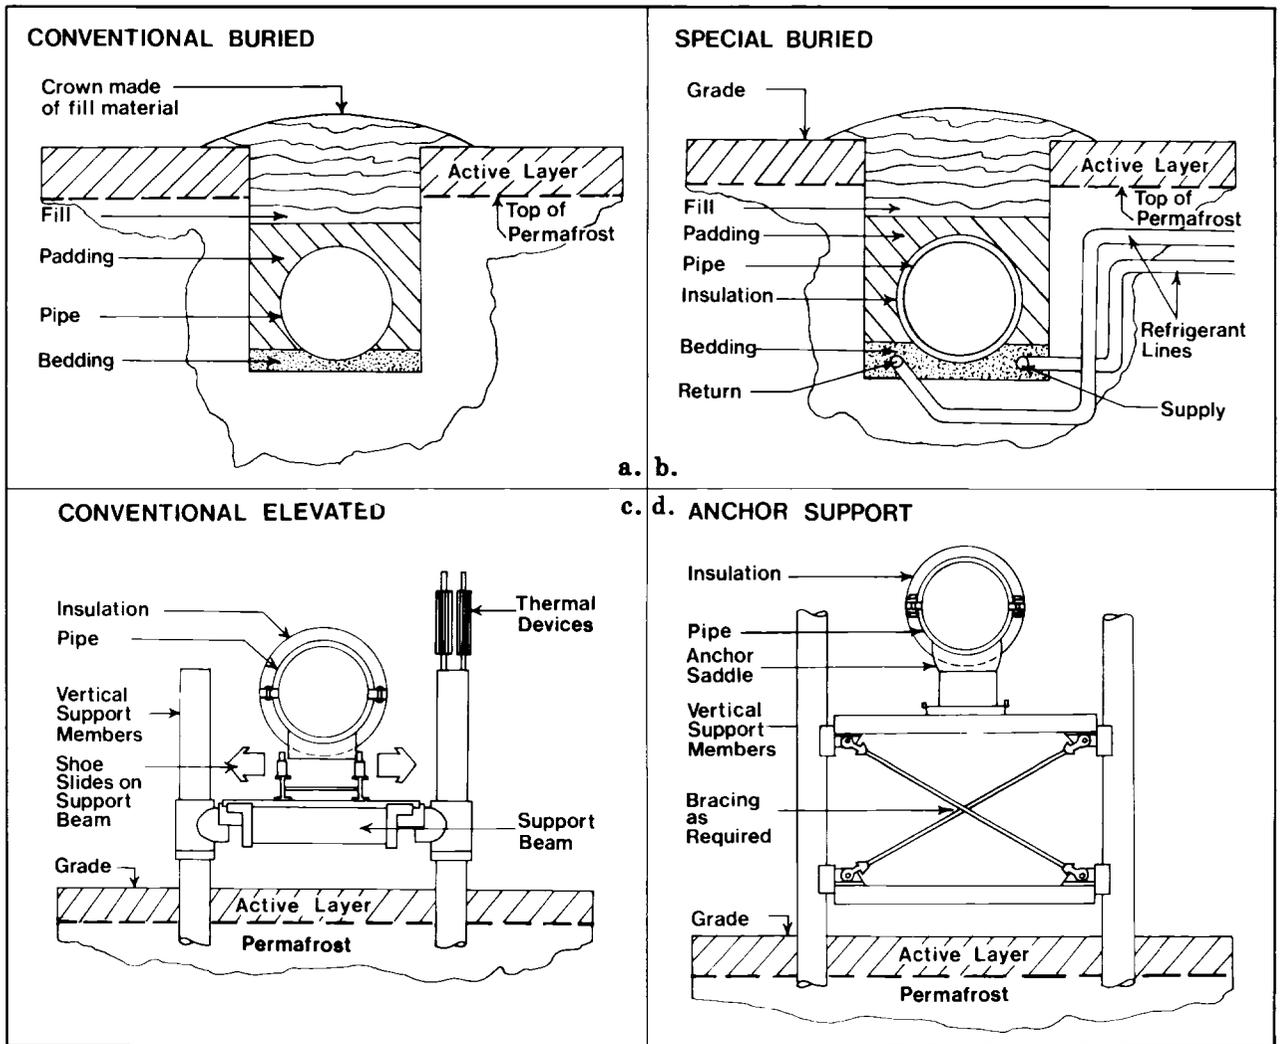
Figure 56a-d. Various construction modes used during construction of the Trans-Alaska Pipeline System. Conventional burial was used in permafrost-free areas and areas of low-ice-content permafrost. Special burial was used for short sections requiring a permanently frozen state. The conventional elevated mode was used in areas of ice-rich permafrost; movement of the pipe is allowed to compensate for expansion caused by warm oil. The anchor-support mode was used above ground in ice-rich permafrost but no movement of the pipe is allowed. Diagram courtesy of Alaska Pipeline Service Company.

are conventionally buried (fig. 56a).

Seven short sections of the line, totalling about 7 miles, are buried and refrigerated (fig. 56b). In these sections the pipe was insulated with 3 inches of polyurethane foam covered by a resin-reinforced fiberglass jacket. The permafrost is maintained by electrical refrigeration units that pump chilled brine through small pipes buried beneath the pipeline.

of the pipe into lateral movement. In these sections, the pipe is mounted on a sliding shoe (fig. 56c). As the line expands or contracts, the pipe slides back and forth across the horizontal-support member. To stabilize the pipe on the crossbeams along the line, it is anchored by special platforms at the end of each zigzag configuration (every 800 to 1,800 feet) (fig. 56d). The elevated pipe is insulated with a 4-inch-thick layer of resin-impregnated fiberglass jacketed with galvanized steel. This insulation keeps the oil warm and in a pumpable state for the period of time necessary to complete any unexpected maintenance, should oil flow cease.

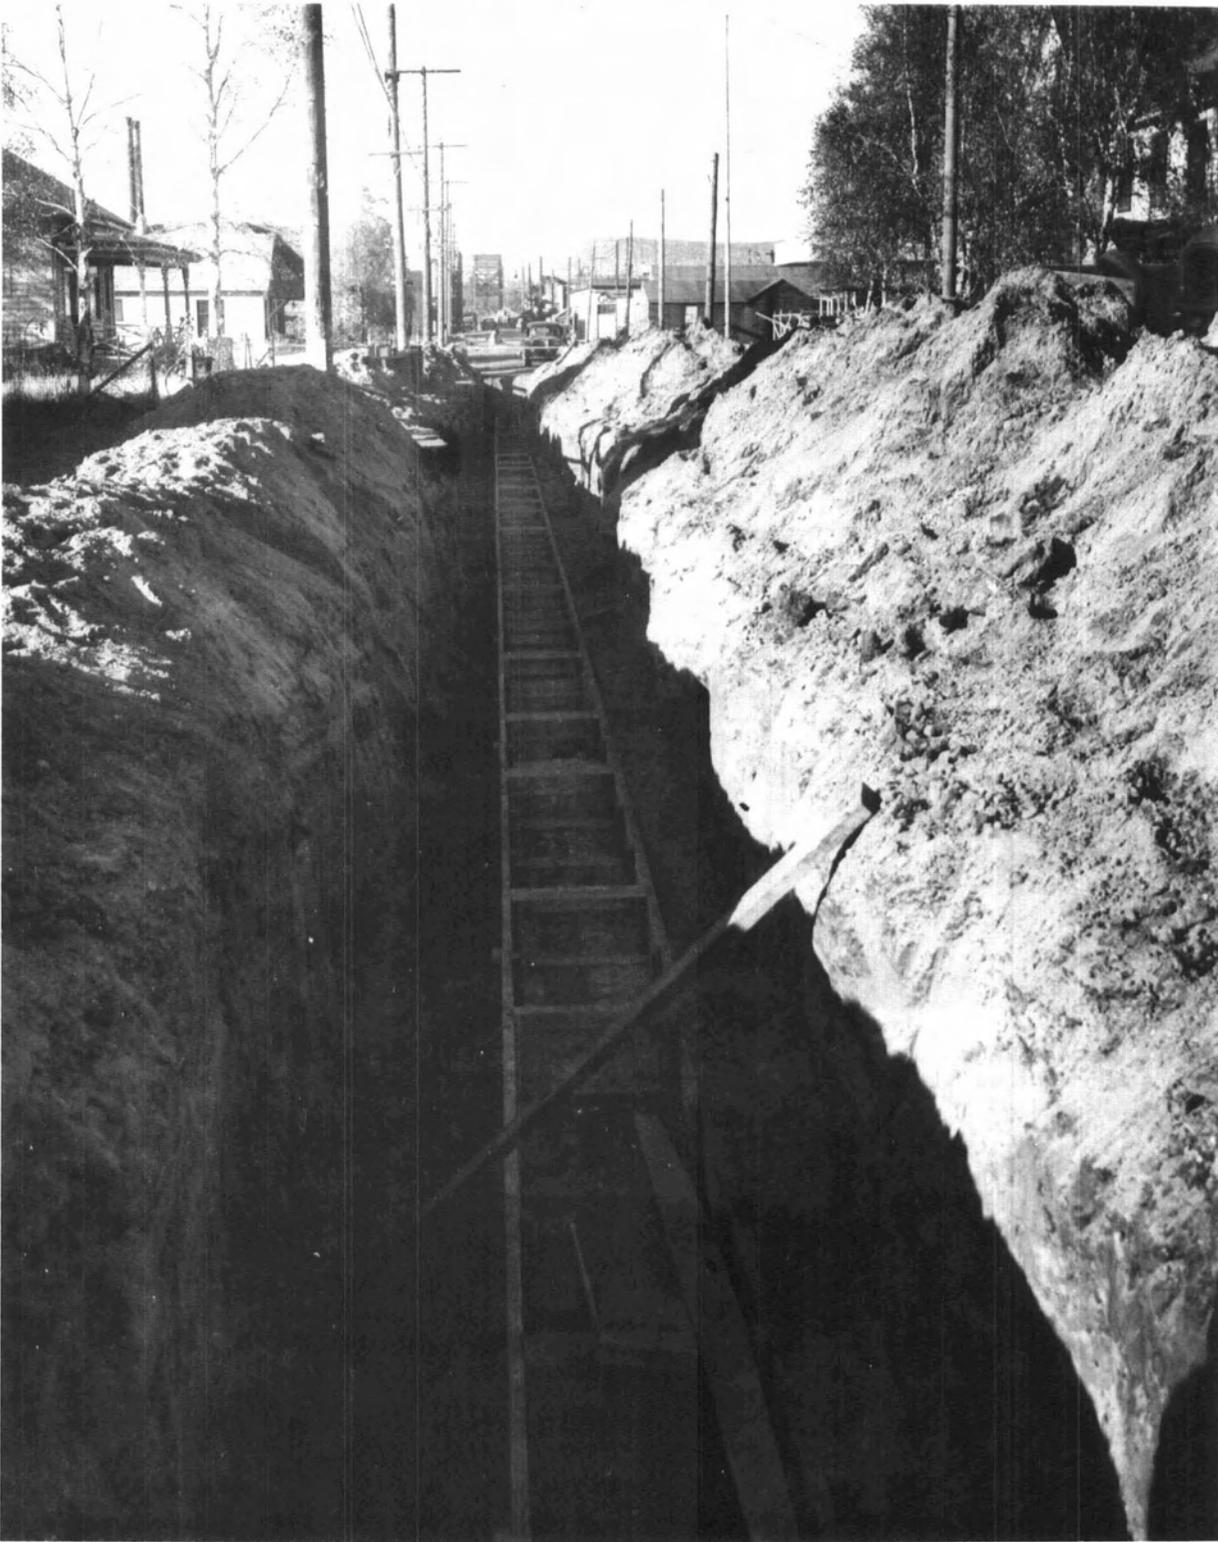
Figure 57. Early-day utilidors along Cushman Street in Fairbanks were simple wood boxes used to prevent the enclosed utility lines from freezing in seasonal frost and permafrost. Note former Cushman Street bridge over the Chena River in the distance. Photograph 127 by T.L. Péwé, September 11, 1946.

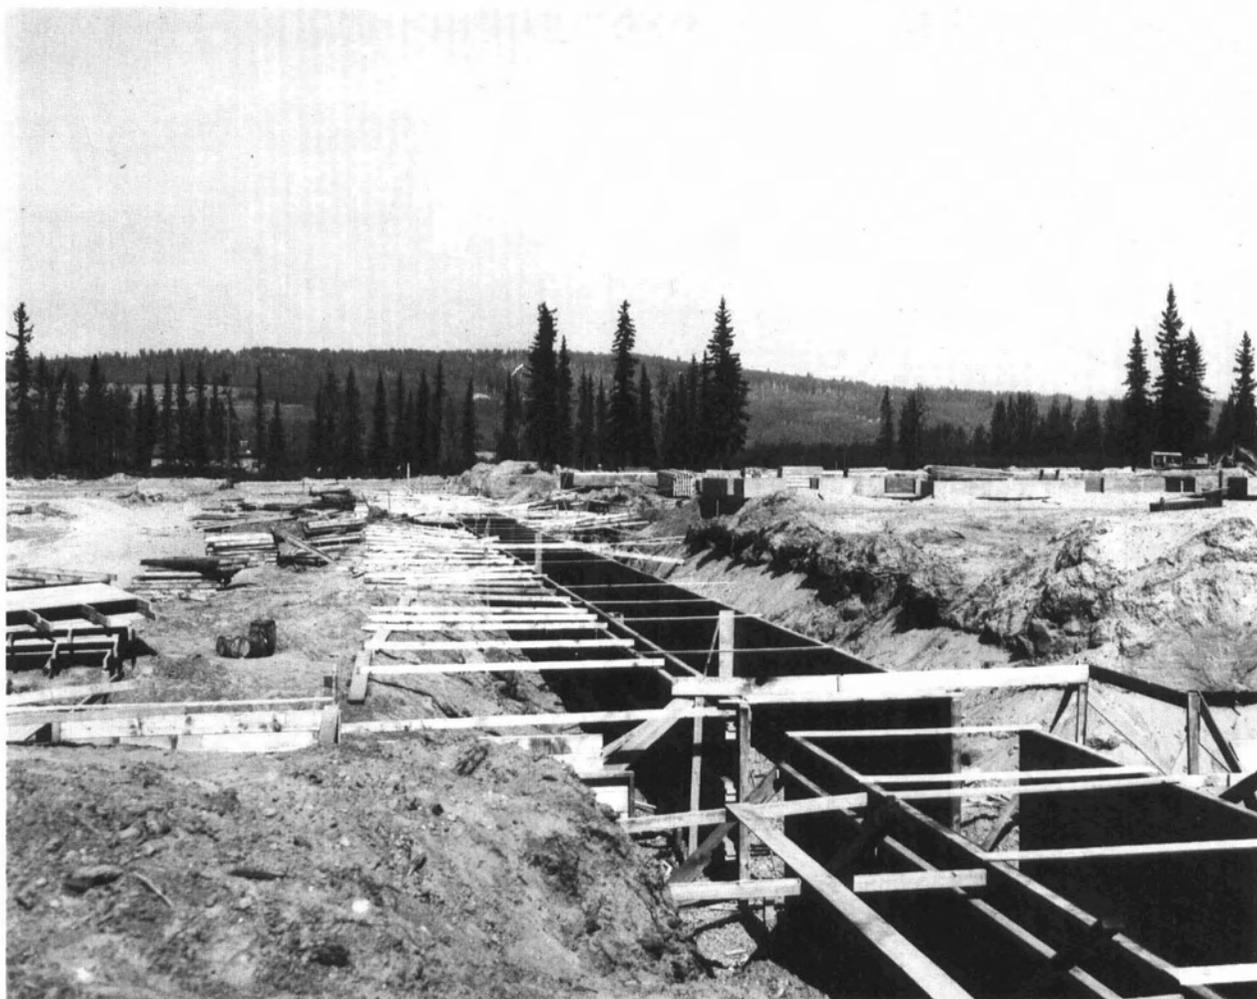
Figure 58. Concrete utilidor under construction at Fort Wainwright near Fairbanks. This area is on the Chena River flood plain and is underlain by perennially frozen sand and gravel with a low ice content. Photograph 139 by T.L. Péwé, July 16, 1947.

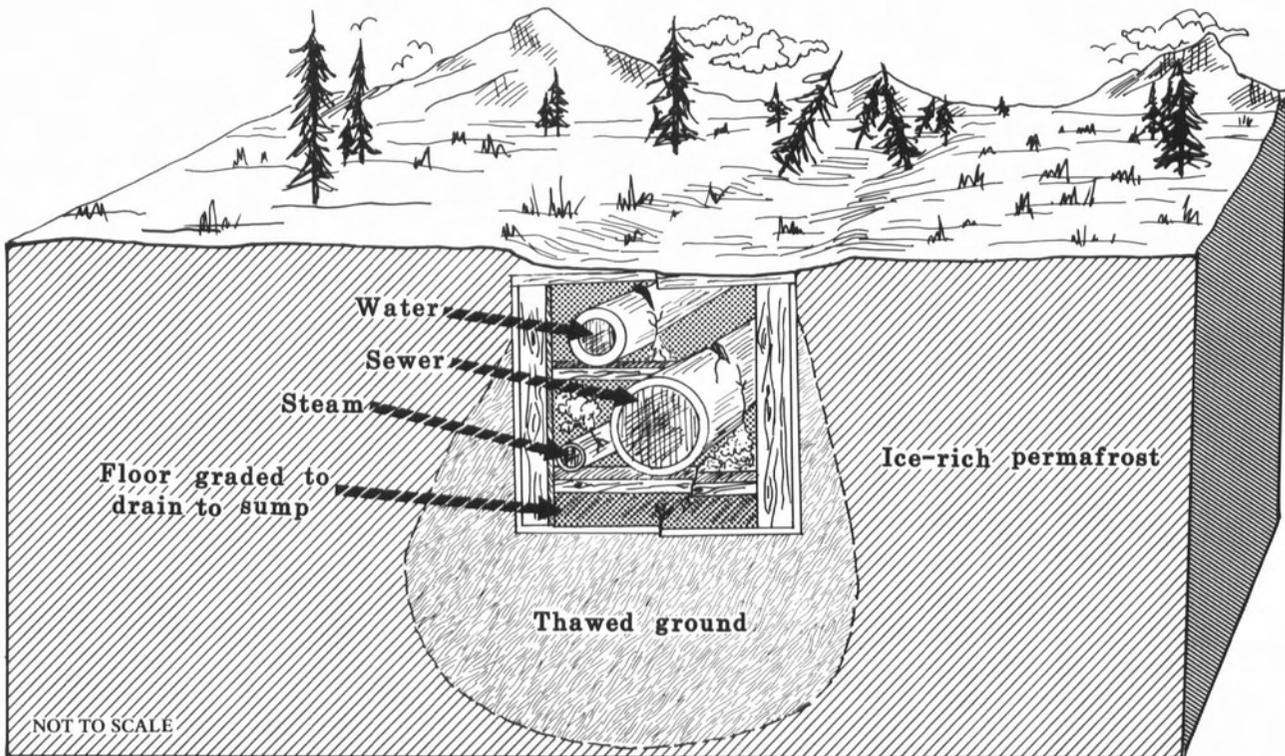
Figure 59. Diagrammatic sketch (exaggerated) of a utilidor buried in ice-rich permafrost. Heat from the utilidor has thawed the ground, and allowed the irregular subsidence of the utilidor that resulted in broken pipes. This is not an uncommon occurrence in permafrost areas, especially where the ice content is not uniformly distributed.

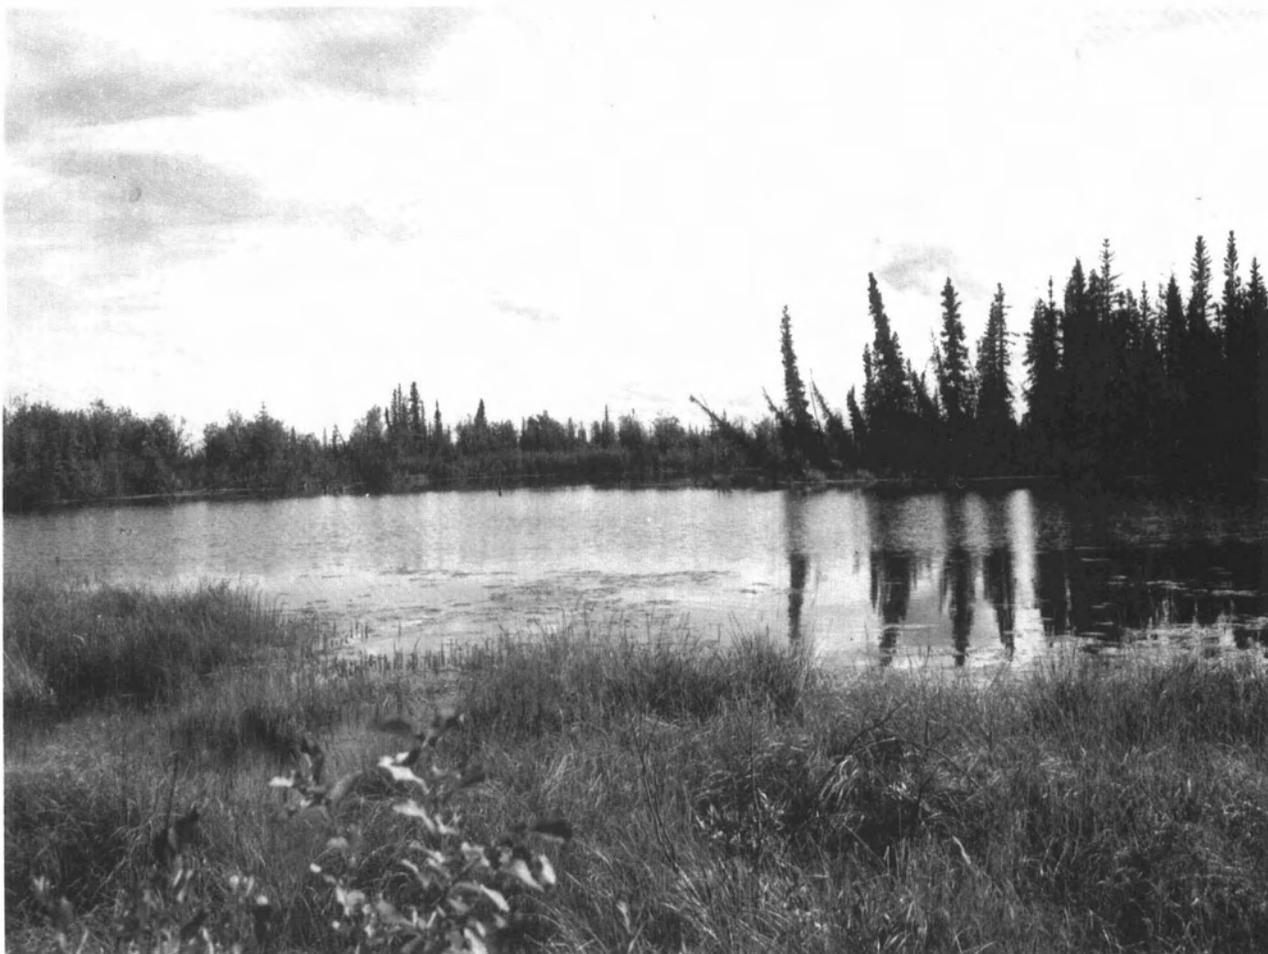
Figure 60. Trees tilting into Paul Lake, a cave-in lake near Farmers Loop Road north of Fairbanks. As the warm lake water thaws ice-rich permafrost along the lake's banks, the ground subsides and trees slowly tilt into the lake. Photograph 320 by T.L. Péwé, July 25, 1948.

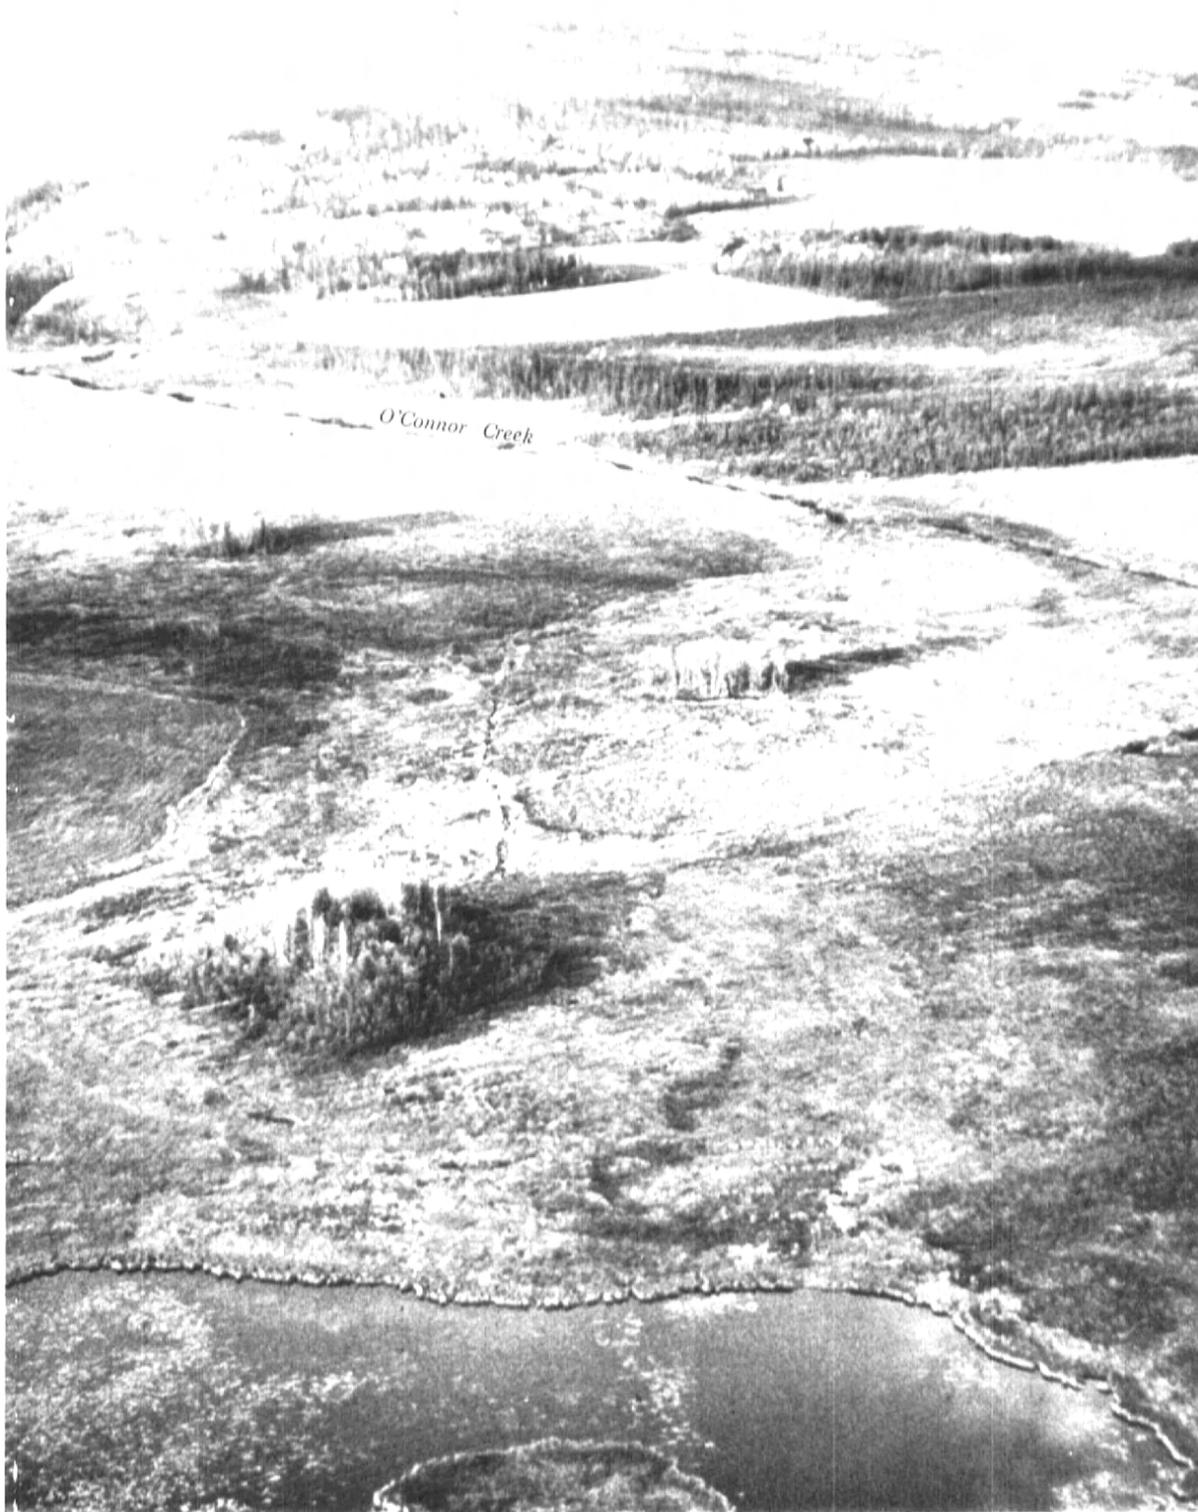
Figure 61. Aerial view toward north of three ice-cored pingos in perennially frozen silt in Goldstream valley. The well-drained conditions on the surface of the pingos allow spruce, aspen, and birch to thrive. Large pingo at lower left is 30 feet high and 300 feet in diameter. Photograph by Florence Weber, September 23, 1964.

peat. In the Fairbanks area pingos that occur in permafrost at the base of hills indicate the presence of silty sediments and ground water. Most pingos occur where the permafrost table is close to the ground surface. Vegetation is generally stunted or consists of low bushes. Because pingos stand above the landscape and have a well-drained surface, they support healthy stands of birch, aspen, and white-spruce trees, which contrast sharply with surrounding vegetation (fig. 61).

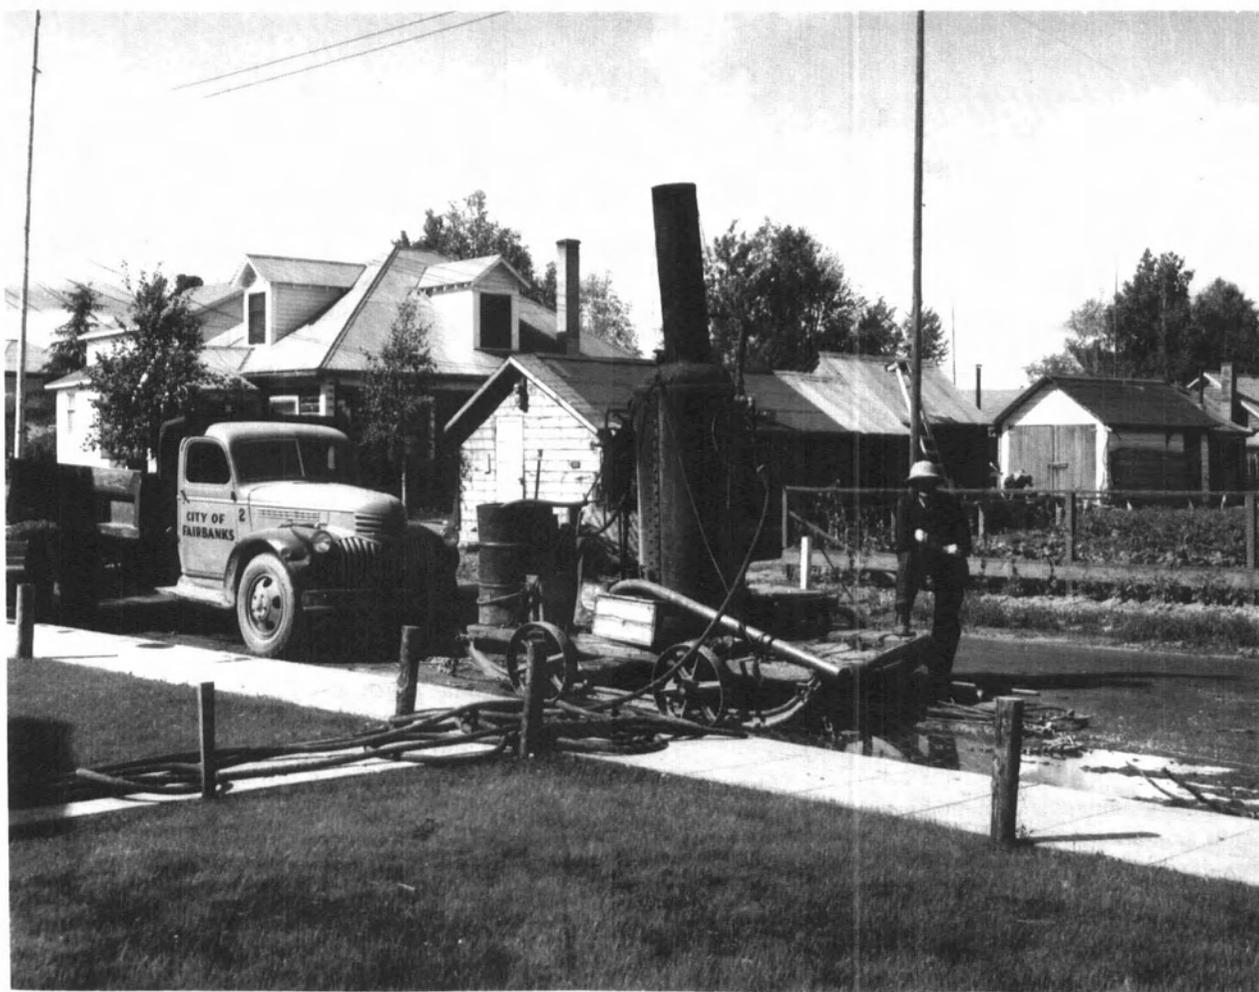
Figure 62. Portable steam boiler for thawing wells and sewers, Lacy and Fifth Streets, Fairbanks. This city-operated steam boiler was regularly used to thaw wells and sewers prior to the establishment of a city water system. It was equipped with wheels in summer and runners in winter. Freezing of wells and sewers is not uncommon in the Fairbanks area today. Photograph 329 by T.L. Péwé, June 30, 1948.

In small-diameter wells that penetrate thick permafrost, water tends to freeze as easily in July as in January, especially if the wells are not used for several weeks. Because the temperature of the steel pipe in these wells is at or below the freezing point of water, ideal conditions exist for the freezing of stationary or slow-moving water. The more often the well is used, the less likely the water is to freeze. Wells that become frozen, or begin to freeze, were previously thawed with steam (fig. 62), but today many wells are kept open with electrical heating tapes.

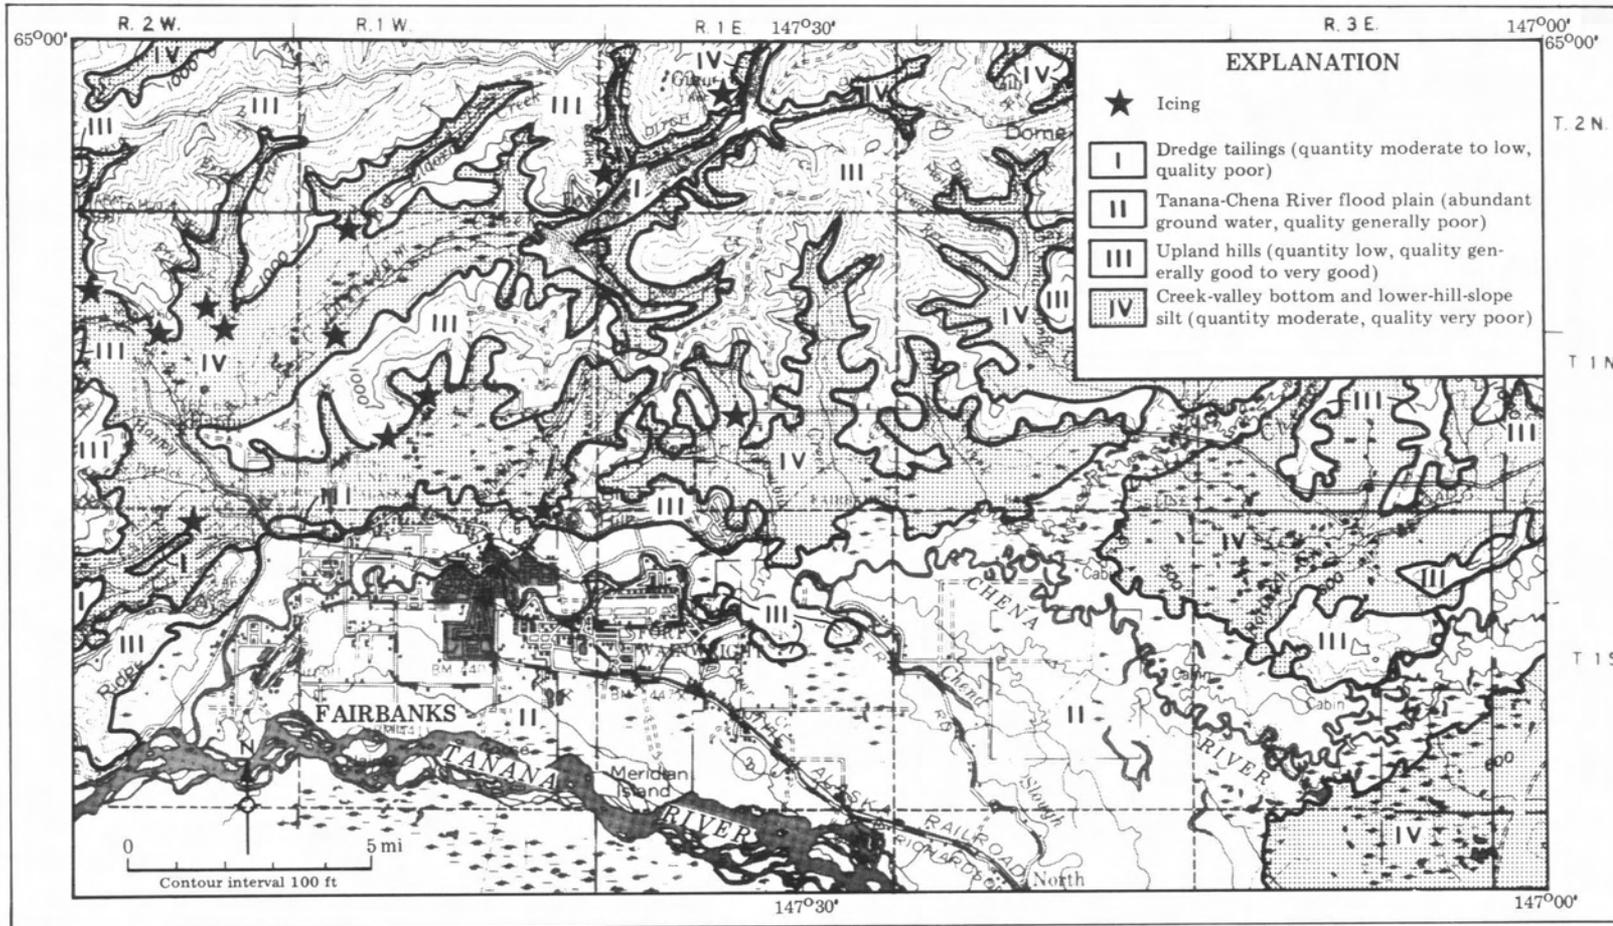
Figure 63. Ground-water map of the Fairbanks area, Alaska (modified from Péwé, 1958; Williams, Péwé, and Paige, 1959).

General areas of uniform ground-water conditions are the flood plains of the Tanana and Chena Rivers, the bedrock hills, and the lower hillslopes and creek-valley bottoms. The latter include organic-rich silt lowlands at the base of the hills (fig. 63). Topographic position, water-bearing properties of the rocks and sediments, and distribution of permafrost are prime factors controlling ground-water distribution.

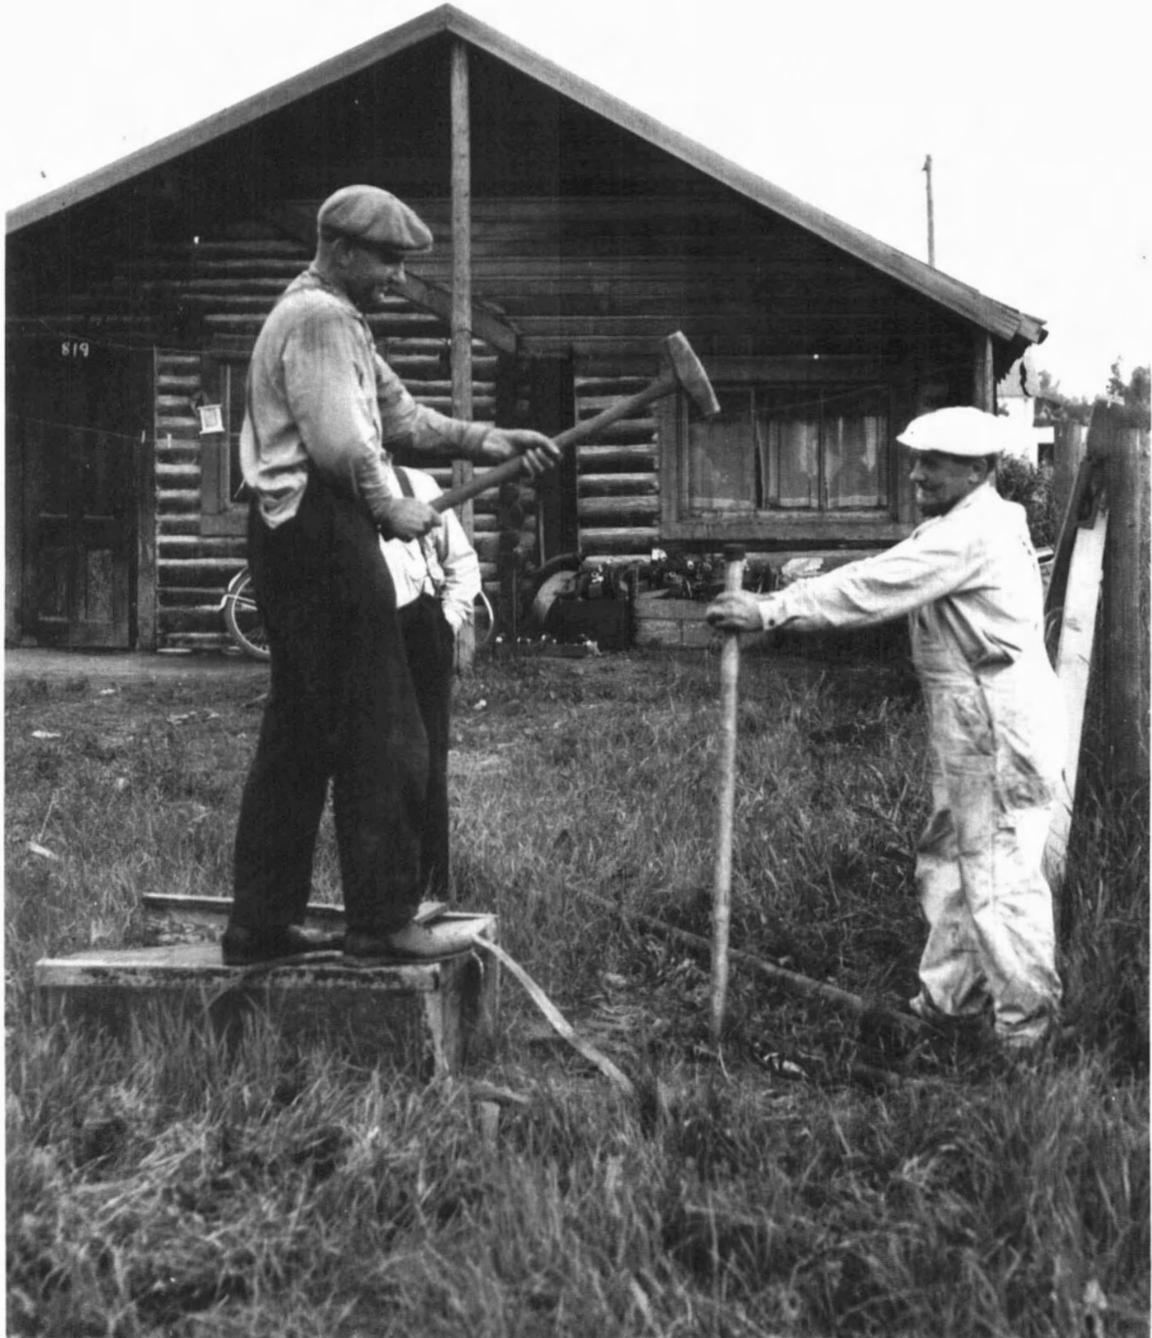
Figure 64. Driving a 2-inch-diameter well at 819 Seventh Street, Fairbanks. Before World War II, and until about the 1950's, it was common to develop a well on the flood plain (fig. 2) by driving a perforated pipe 20 to 40 feet into the alluvium. Today this technique is used on the flood plain in outlying areas, but a municipal water system provides water within the city limits. Water from shallow wells is often contaminated. Photograph 314 by T.L. Péwé, July 17, 1948.

Water is supplied to many residents in the Fairbanks area by hundreds of small-diameter (2-inch) private wells (fig. 64). Some 2-inch wells yield as much as 40 gallons per minute and records indicate that yields as high as 3,000 to 3,400 gallons per minute with a drawdown of 10 to 15 feet are available through large-diameter wells less than 100 feet deep. Many wells are only 15 to 30 feet deep and draw water from above permafrost or from unfrozen zones within permafrost. Other 100- to 250-foot-deep wells draw water from unfrozen sediments below the frozen layer. Large yields are available in gravel layers above and below permafrost.

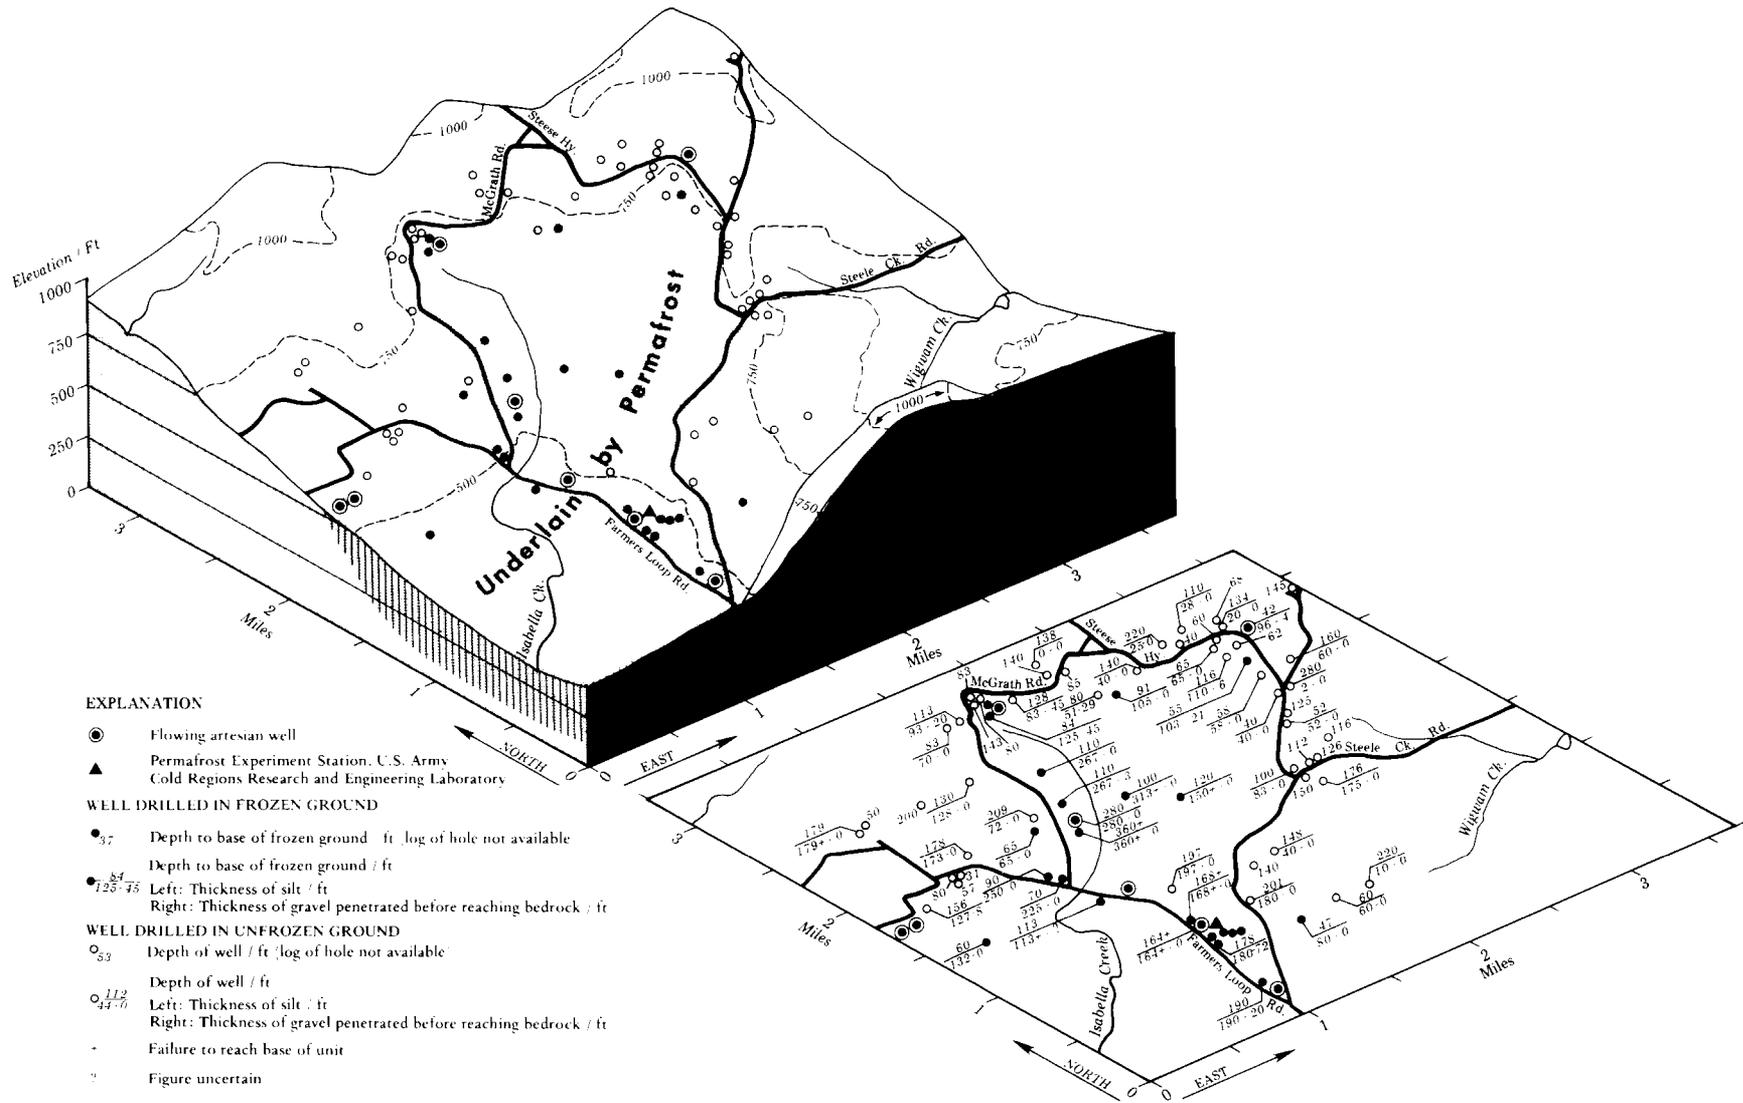
Figure 65. Map of upper Isabella Creek valley in the Farmers Loop Road, McGrath Road, and Steese Highway area 2 miles north of Fairbanks, showing location and thickness of permafrost and location and depth of wells.

Artesian wells occur on lower slopes just a short distance below the boundary between permafrost and nonpermafrost areas (fig. 68). At least a dozen such artesian wells are known north of Fairbanks and in outlying creek valleys; eight artesian wells have been reported in the upper Isabella Creek area near Steese, McGrath, and Farmers Loop Roads (fig. 65). Artesian water occurs in sandy gravel, bedrock, or less often, in silty sand.

Several artesian wells that flowed without control for some time created serious problems. The most well-documented artesian well in the Fairbanks area was drilled in May 1946 to a depth of 108 feet at the U.S. Army Cold Regions Research and Engineering Laboratory Experimental Station on Farmers Loop Road (fig. 65). Two dry wells, each 165 feet deep, were drilled that year. The third hole encountered water under such high hydrostatic pressure that it gushed about 4 feet above the ground surface, carrying gravel particles as large as 2 inches in diameter. Later measurements indicated that the water pressure was equivalent to a ground level 28 feet above the existing ground surface (fig. 69). The hole was immediately cased, but water flow outside the casing thawed the surrounding permafrost.

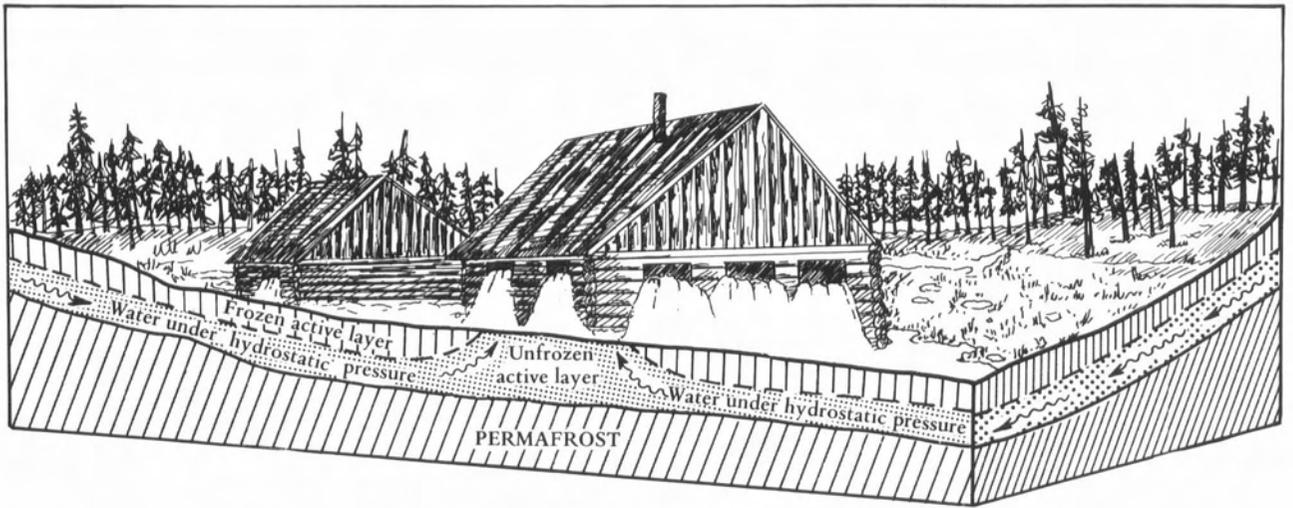
Figure 67. Water moving downslope under hydrostatic pressure is trapped between the thickening seasonal-frost layer and underlying permafrost table. The unfrozen ground beneath the heated building provides an exit for the water, and it bursts through the floor, filling the building and pouring out the windows into the subzero weather. As the water freezes, the building is filled with ice (modified from Muller, 1945).

Alexander Alexandervitch Tihonrovov was showering in a heated bathhouse one winter day in a northern valley in Siberia. As he washed, he noted cold water welling up between the floor boards and covering the floor. He rushed outside into the subzero weather and watched as water poured from the windows. The water quickly froze, and soon the building was filled with ice; ice 'waterfalls' draped from the windows to the ground (fig. 67). This is not an unusual story, and examples are known from Siberia and North America.

But what destroyed the house? As illustrated in figure 67, this type of icing results from ground-water movement in a permafrost terrain. In this instance, as winter progressed, shallow ground water under hydrostatic head percolated downhill above the permafrost table, and was trapped between the underlying permafrost and the ever-thickening seasonal-frost layer. The only place the pressurized water could escape was beneath the heated house.
