SPECIAL REPORT 15

**GEOLOGIC HAZARDS OF THE FAIRBANKS AREA, ALASKA**

By  
Troy L. Péwé

First Edition, 1982  
by  
Department of Natural Resources  
DIVISION OF GEOLOGICAL & GEOPHYSICAL SURVEYS  
Fairbanks, Alaska  
Reprinted 1993

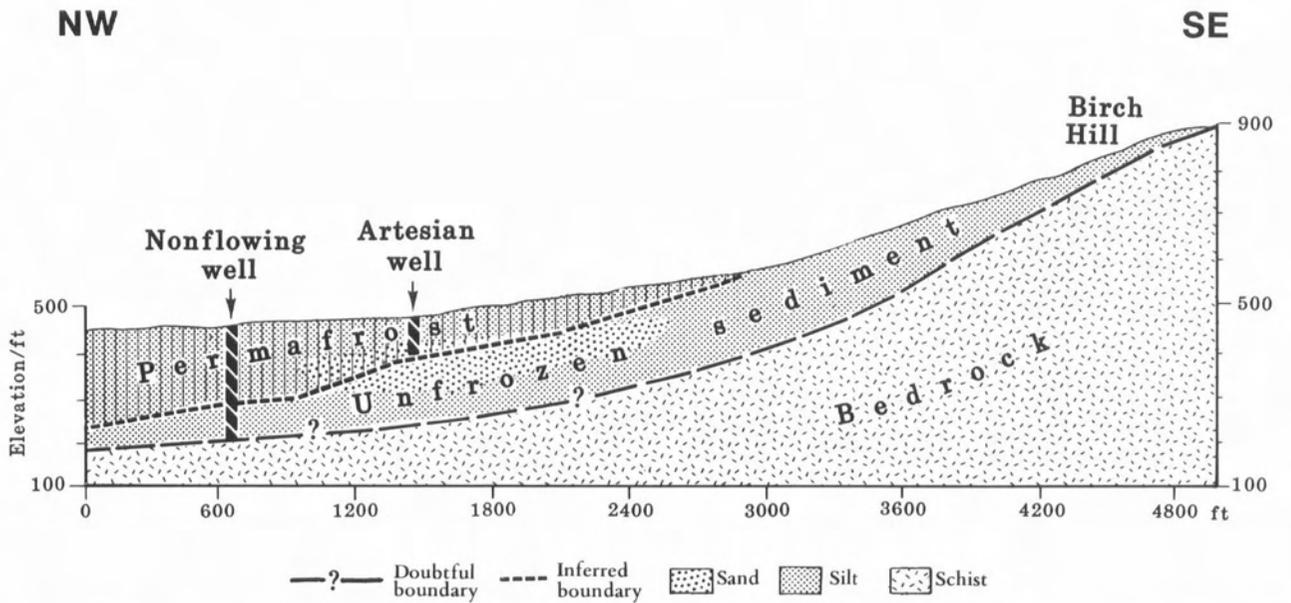
Figure 68. Diagrammatic sketch of geology and ground-water conditions at site of artesian well at U.S. Army Cold Regions Research and Engineering Laboratory Experimental Station on Farmers Loop Road north of Fairbanks. The permafrost acts as a confining layer for ground water that originates as precipitation falling on the unfrozen upper slopes of Birch Hill.

Artesian wells occur on lower slopes just a short distance below the boundary between permafrost and nonpermafrost areas (fig. 68). At least a dozen such artesian wells are known north of Fairbanks and in outlying creek valleys; eight artesian wells have been reported in the upper Isabella Creek area near Steese, McGrath, and Farmers Loop Roads (fig. 65). Artesian water occurs in sandy gravel, bedrock, or less often, in silty sand.

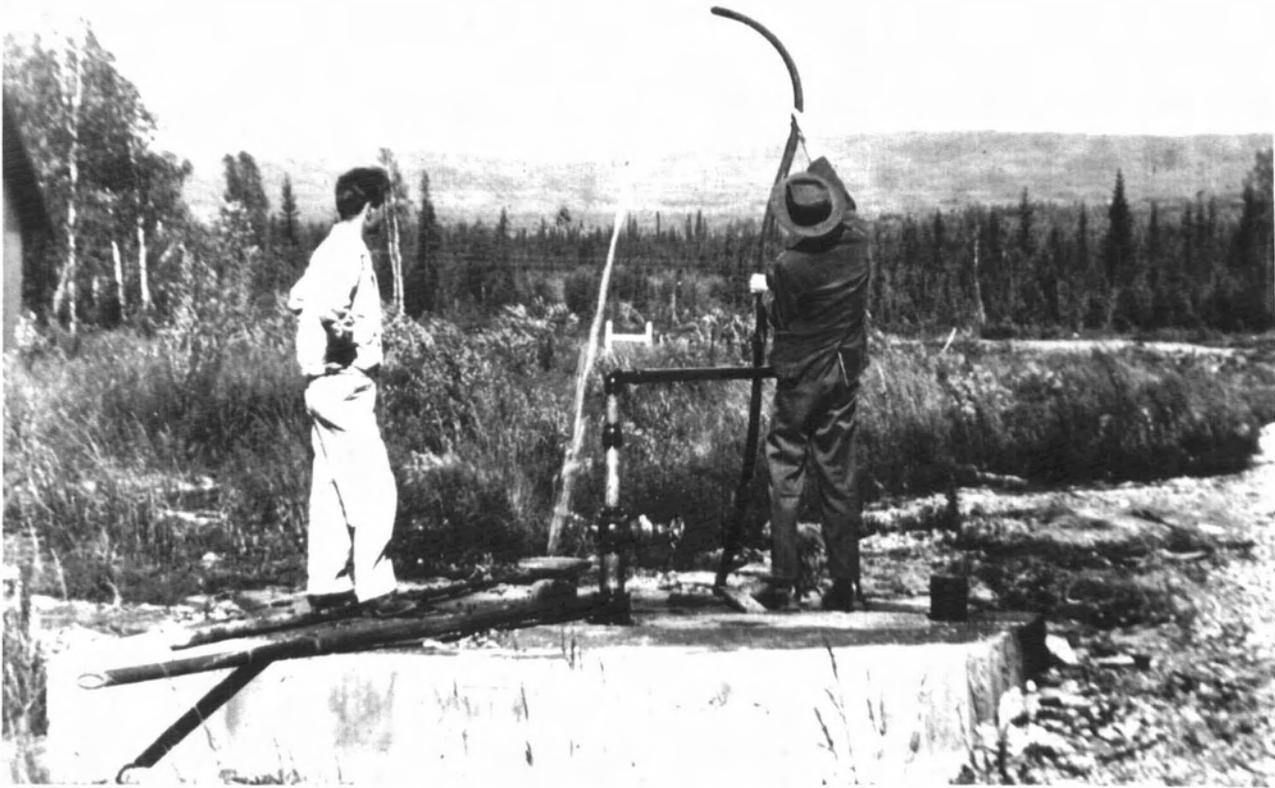
Figure 69. Hose held up to show flowing artesian water from well drilled in 1946 at the U.S. Army Cold Regions Research and Engineering Laboratory Experimental Station on Farmers Loop Road north of Fairbanks. D.G. Cederstrom of the USGS (holding hose) is standing on a 10-foot-square, 1-foot-thick concrete pad that was placed around the casing to contain the well. Eventually, escaping underground artesian water thawed a huge pit; the block cracked, then turned on end and sank out of sight. Photograph PK 655 by T.L. Péwé, July 11, 1947.

Several artesian wells that flowed without control for some time created serious problems. The most well-documented artesian well in the Fairbanks area was drilled in May 1946 to a depth of 108 feet at the U.S. Army Cold Regions Research and Engineering Laboratory Experimental Station on Farmers Loop Road (fig. 65). Two dry wells, each 165 feet deep, were drilled that year. The third hole encountered water under such high hydrostatic pressure that it gushed about 4 feet above the ground surface, carrying gravel particles as large as 2 inches in diameter. Later measurements indicated that the water pressure was equivalent to a ground level 28 feet above the existing ground surface (fig. 69). The hole was immediately cased, but water flow outside the casing thawed the surrounding permafrost.

After a slurry of 40 bags of cement was pumped down the casing to seal the well, a 40,000-gallons-per-hour pump was used to remove the water, and a 10-foot-square, 12-inch-thick, concrete slab was placed around the main casing (fig. 69). By mid-June 1946 the well was sealed. Later, it froze shut, was reopened, and again froze a number of times. In 1947 the well was thawed and was used that summer and during part of 1948. In August 1948 the final loss of control occurred. Water began escaping from beneath the 10-foot-square, concrete slab, and during the summer of 1949 the slab collapsed into an enormous, water-filled thermokarst cavity. Eventually the slab sank as much as 25 to 50 feet below the surface. Much of the unrestrained artesian water flowed downhill, underneath the surface, but above the permafrost table. Subsequent thawing of permafrost caused the overlying ground to subside

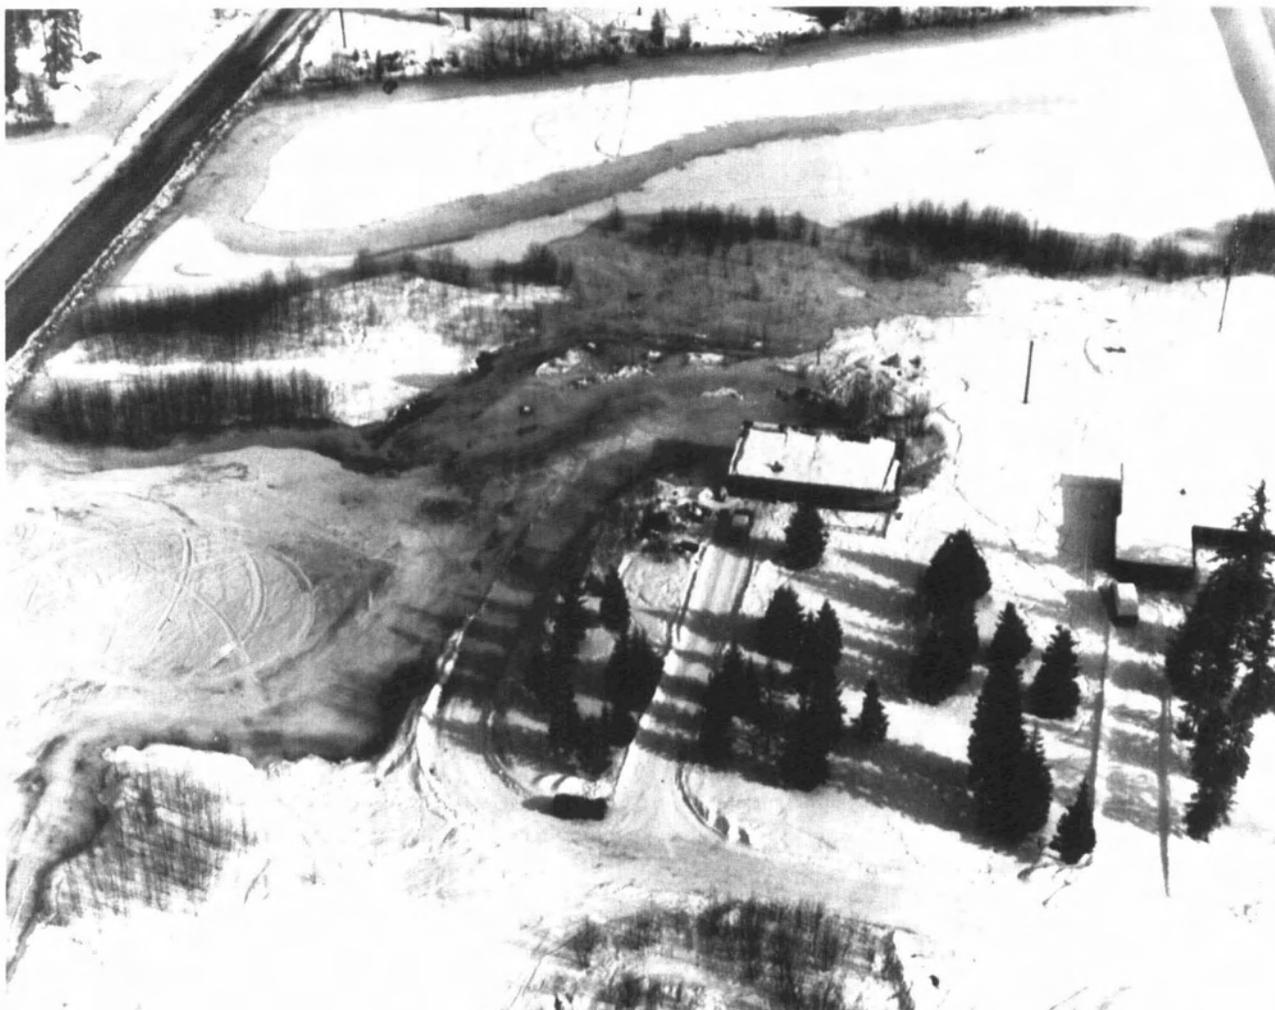
Figure 71. Aerial view of the Chena Slough and Plack Road vicinity on the Chena-Tanana Rivers flood plain in the eastern Fairbanks area. Icings filled the slough until overflow inundated the house in center of photograph. Photograph by Thomas Kever, winter 1975-76.

Slough just north of Badger Road (fig. 71). The channel of Chena Slough filled with ice and when water escaped beyond the low banks, the icing area was extended. As ice and water invaded the lower level of a home near the south bank of the slough, bicycles, tables, refrigerators and other objects were buried to a depth of about 3 feet (figs. 72-74). Because this icing occurred at least twice, the house probably should be moved. Seventy-thousand dollars is probably a conservative estimate of the damage.

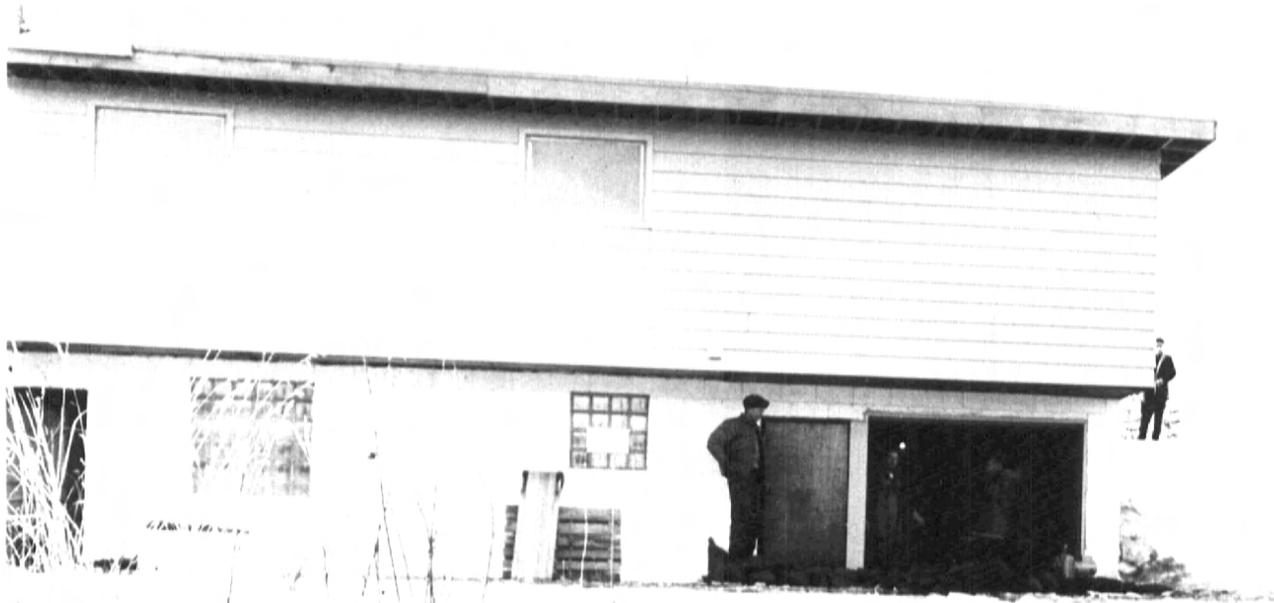
Figure 72. View of Chena Slough side of home inundated by water and seasonal icing. Photograph by Thomas Keever, winter 1975-76.

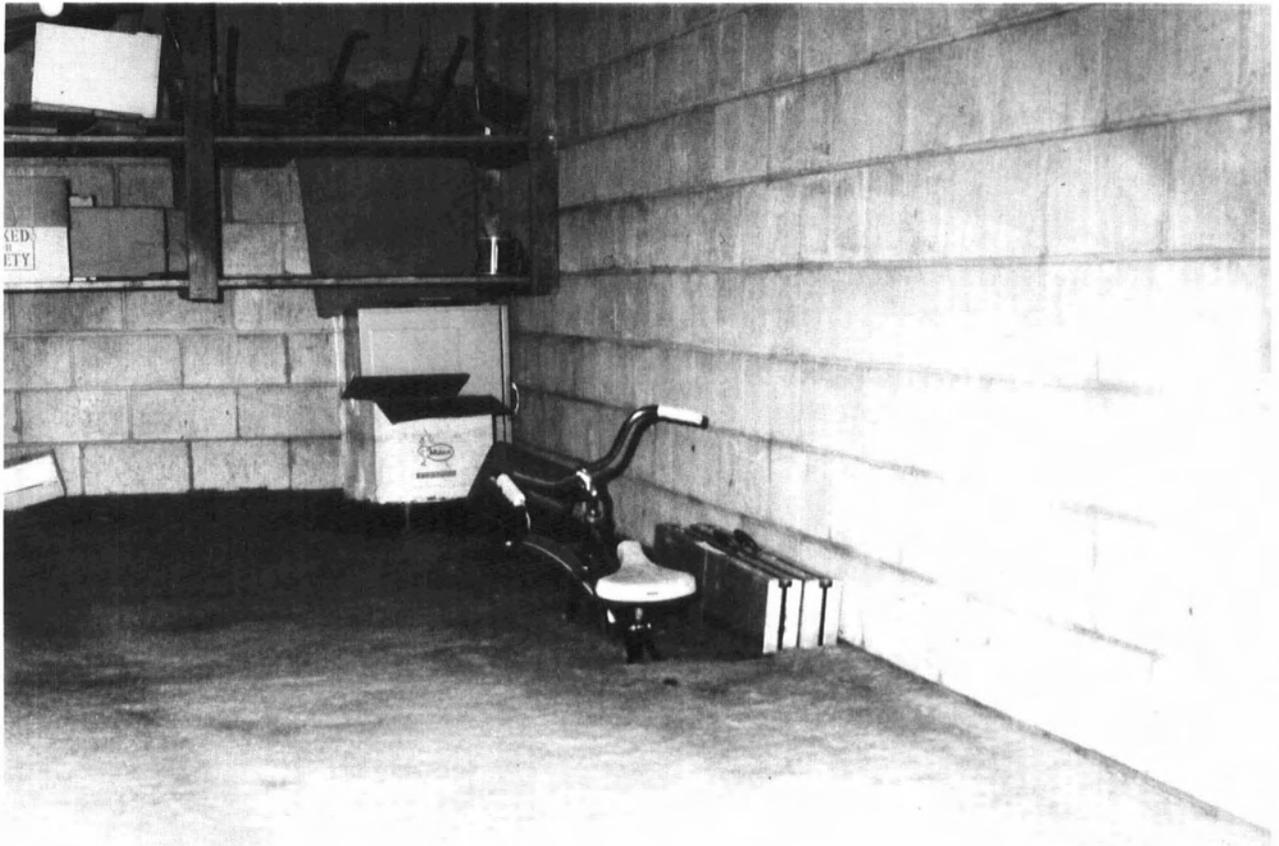
Figure 73. Garage interior of home in figure 72 showing objects buried to a depth of at least 3 feet by a stream icing in the vicinity of Chena Slough and Plack Road. Photograph by Thomas Keever, winter 1975-76.

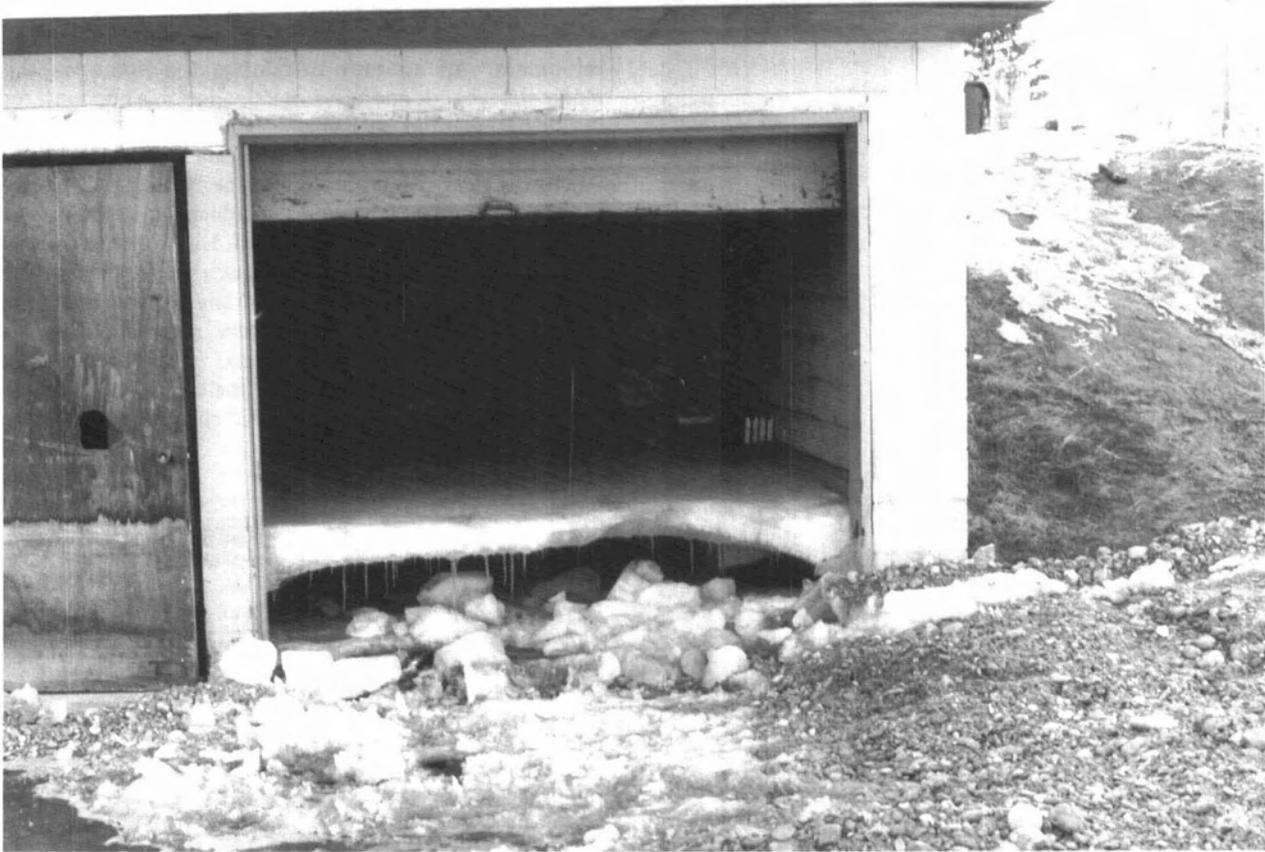
Figure 74. View of garage of home in figures 72-73 after water level of Chena Slough dropped. Photograph by Thomas Keever, spring 1976.

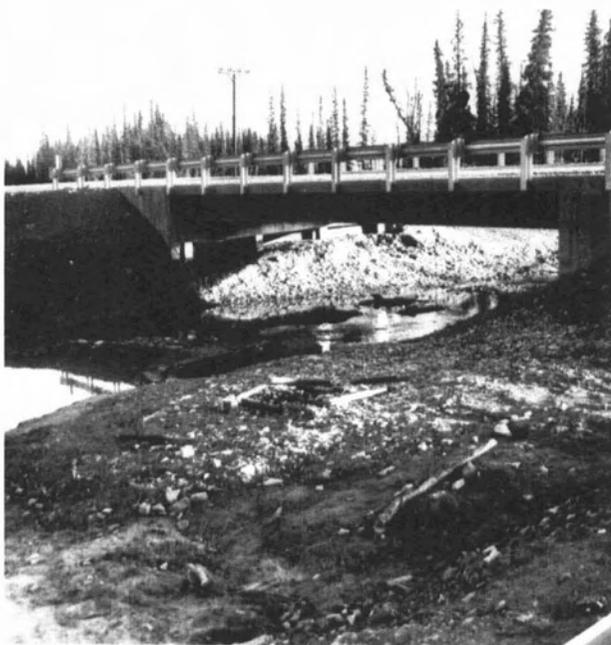
Figure 75a. Downstream view of Moose Creek from Murphy Dome Road, 12 miles northwest of Fairbanks in Goldstream Valley, showing typical open, broad, shallow channel during summer and fall. Photograph by H.R. Livingston, October 4, 1966.

During winter, a common icing form occurs on small streams in the Fairbanks area, especially where they cross highways. Streamwater freezes to the creek bottom, blocking flow and causing the small valley to rapidly fill with ice. Generally, the water freezes at a constriction caused by a culvert or small bridge (figs. 75a,b) and these areas of the stream are soon blocked by ice. The resulting icing inundates the road or

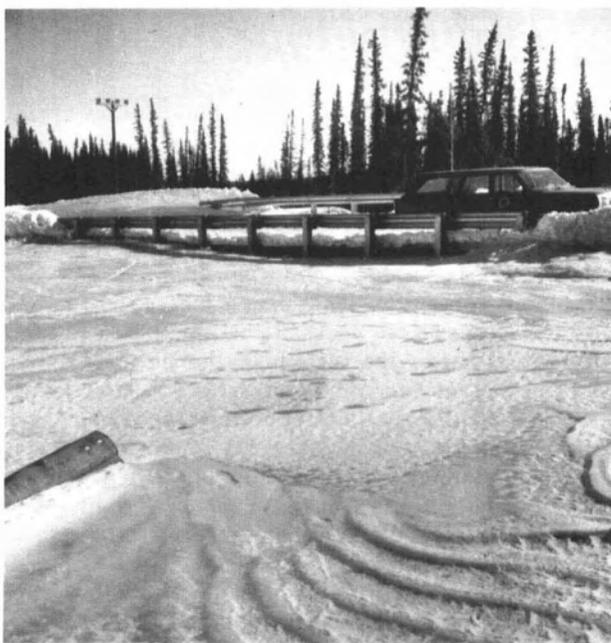
Figure 75b. Downstream view of bridge in figure 75a showing stream icing filling channel and forming on roadway. Photograph by H.R. Livingston, March 25, 1971.

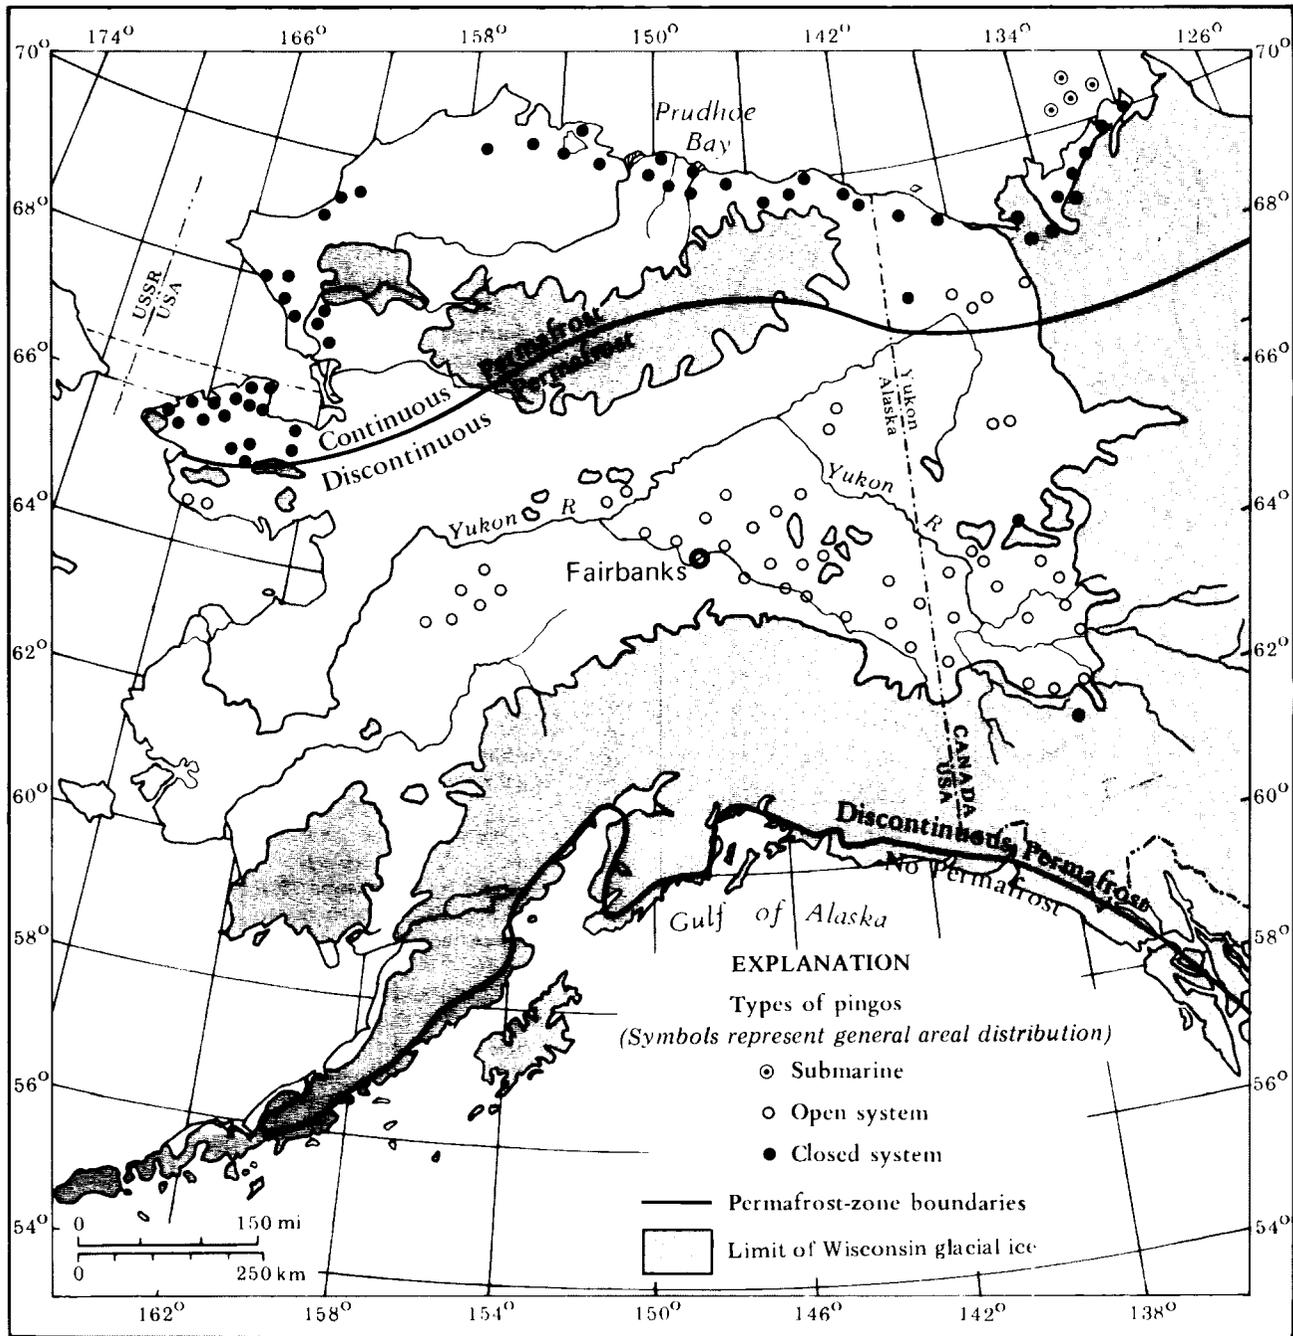
Figure 76. Distribution of open- and closed-system pingos in relation to permafrost zones and areas covered by Wisconsin glacial ice in northwest North America. The origin of pingo-like forms in shallow seas off northwestern Canada is not yet established (oral commun., A.S. Judge, March 3, 1981).

Pingos form when massive ice lenses grow in permafrost near the ground surface. The two types of pingos include the larger closed-system form, which occurs in regions of continuous permafrost (fig. 76), and smaller open-system pingos.

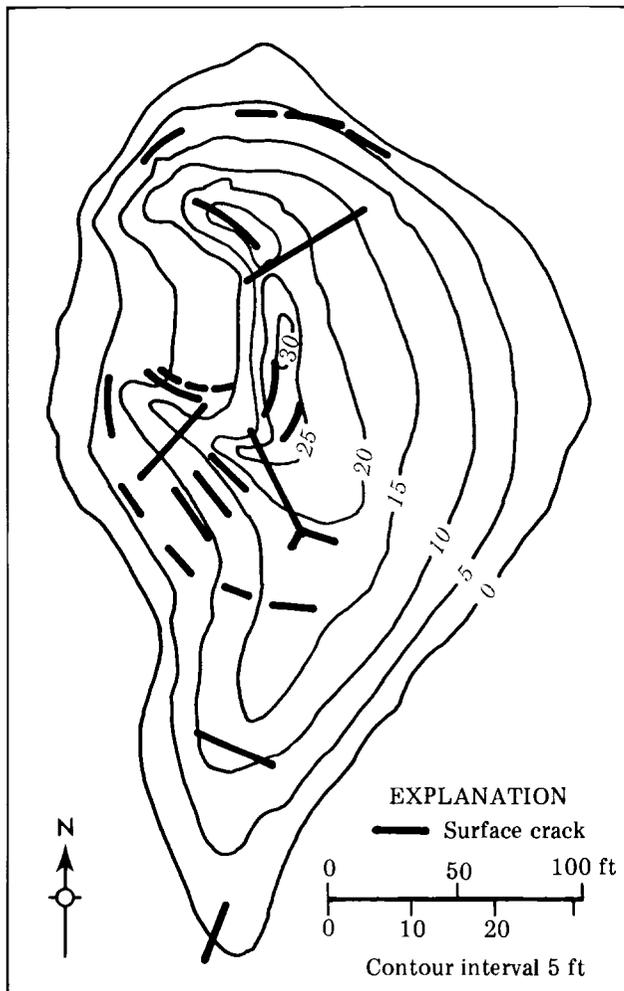
Figure 77. Sketch map of Alpha pingo in Goldstream Valley near junction of Goldstream and O'Connor Creeks northwest of Fairbanks. The pingo is composed of silt; note the breached 'crater' on the northwest flank. The elevation is approximately 600 feet and permafrost is present 3 to 10 feet below the ground surface (modified from Péwé, 1977).

deep crater is located on the northwestern side and radial and concentric cracks 1 to 3 inches wide and 10 feet long occur on the flanks. Radial cracks 2 to 150 feet long trend across the surface of the pingo (fig. 77).

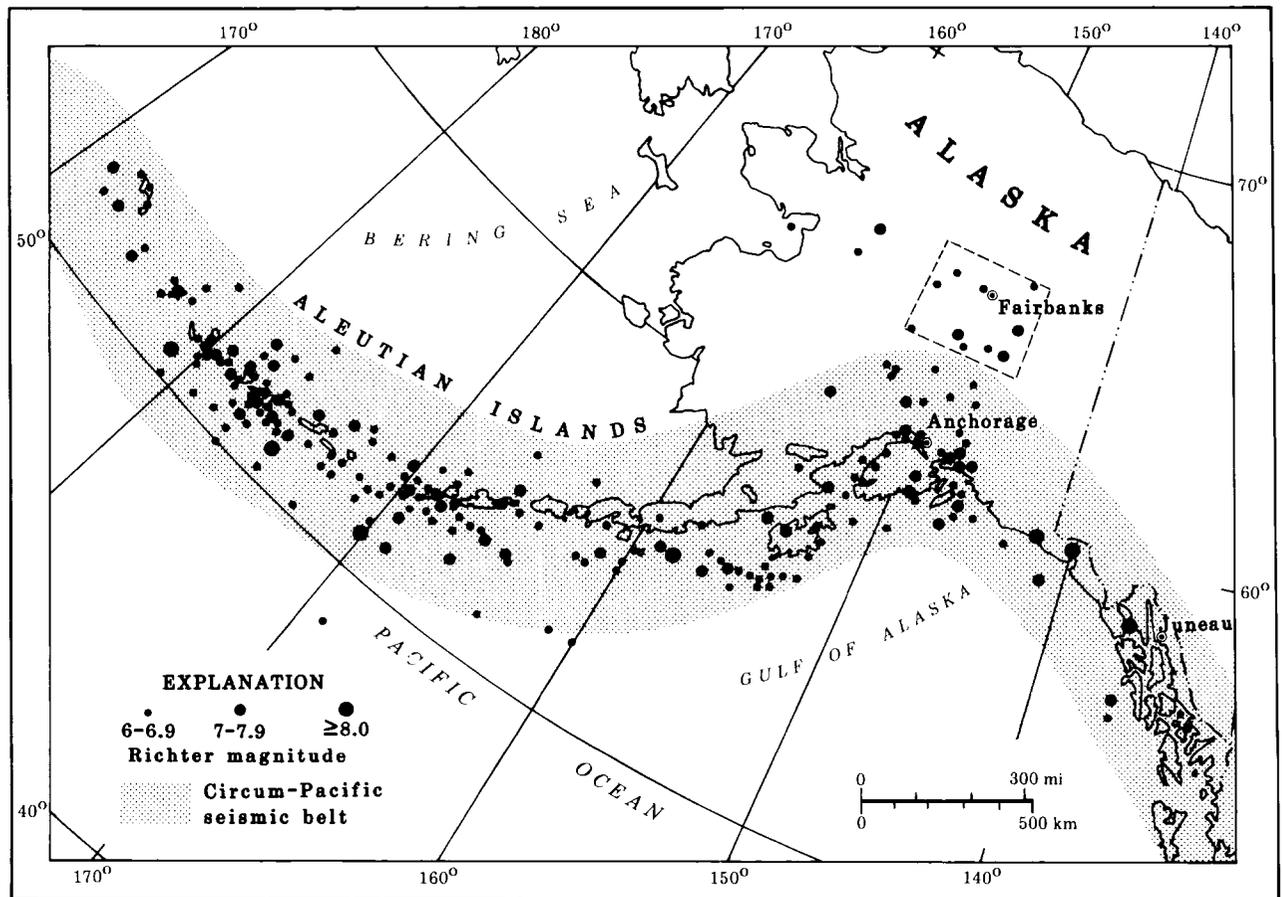
Figure 78. Epicenters of earthquakes with Richter magnitudes 6.0 and larger in Alaska from 1899 to 1967. Shaded area represents the Circum-Pacific seismic belt in Alaska. The dashed rectangle encloses area shown in figure 81 (modified from Jordan and others, 1968).

Alaska is part of the Circum-Pacific seismic belt, one of three worldwide seismic belts (fig. 78). More than 7 percent of the annual seismic-energy release in the world occurs in the Alaska seismic zone. Approximately 6 percent of the world's large, shallow earthquakes (depth less than 50 miles) occur in continental Alaska and the Aleutian Islands. Parts of Alaska situated within the Circum-Pacific belt are probably more earthquake prone than California with its well-known San Andreas fault. Although interior Alaska is not regarded as particularly earthquake prone, it is in a region that has been periodically shaken by severe shocks; these seismic events will reoccur in the future.

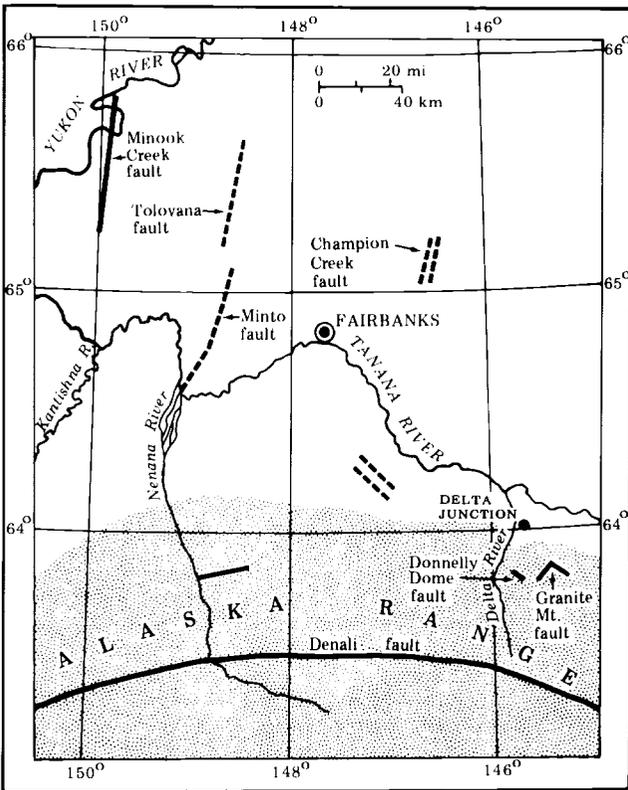
Figure 79. Active faults in central Alaska (Brogan and others, 1975; Gedney and others, 1972; Holmes and Péwé, 1965; Hudson and others, 1977; and Péwé and Holmes, 1964).

The Denali fault, located in the Alaska Range 80 miles south of Fairbanks, is the longest fault in Alaska; because it has moved in the last 10,000 years, it is generally considered active. Several smaller faults near Fairbanks show evidence of displacement and are also considered active (fig. 79), including a fault near Donnelly Dome south of Delta Junction, two near Blair Lakes in the Tanana Valley, and a small fault near Champion Creek, 52 miles northeast of Fairbanks.

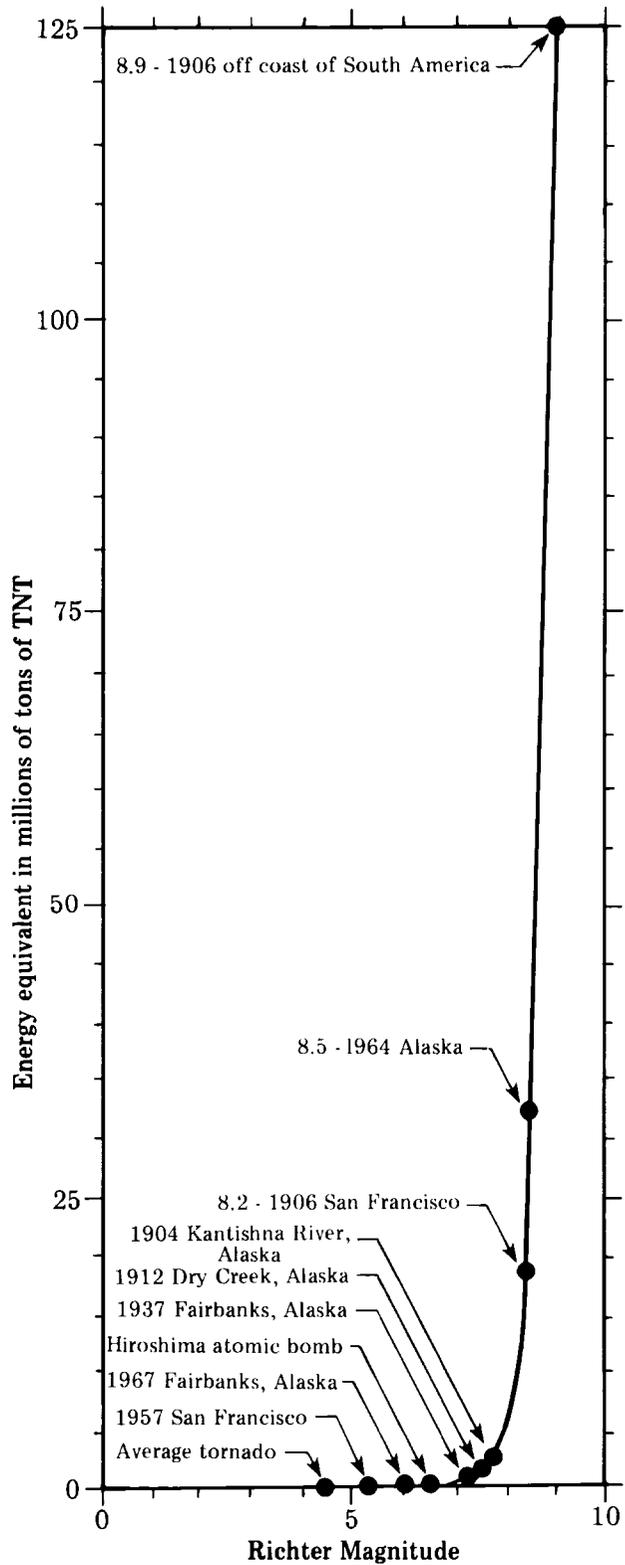
Figure 80. Earthquake energy expressed in terms of millions of tons TNT (modified from Griggs and Gilchrist, 1977).

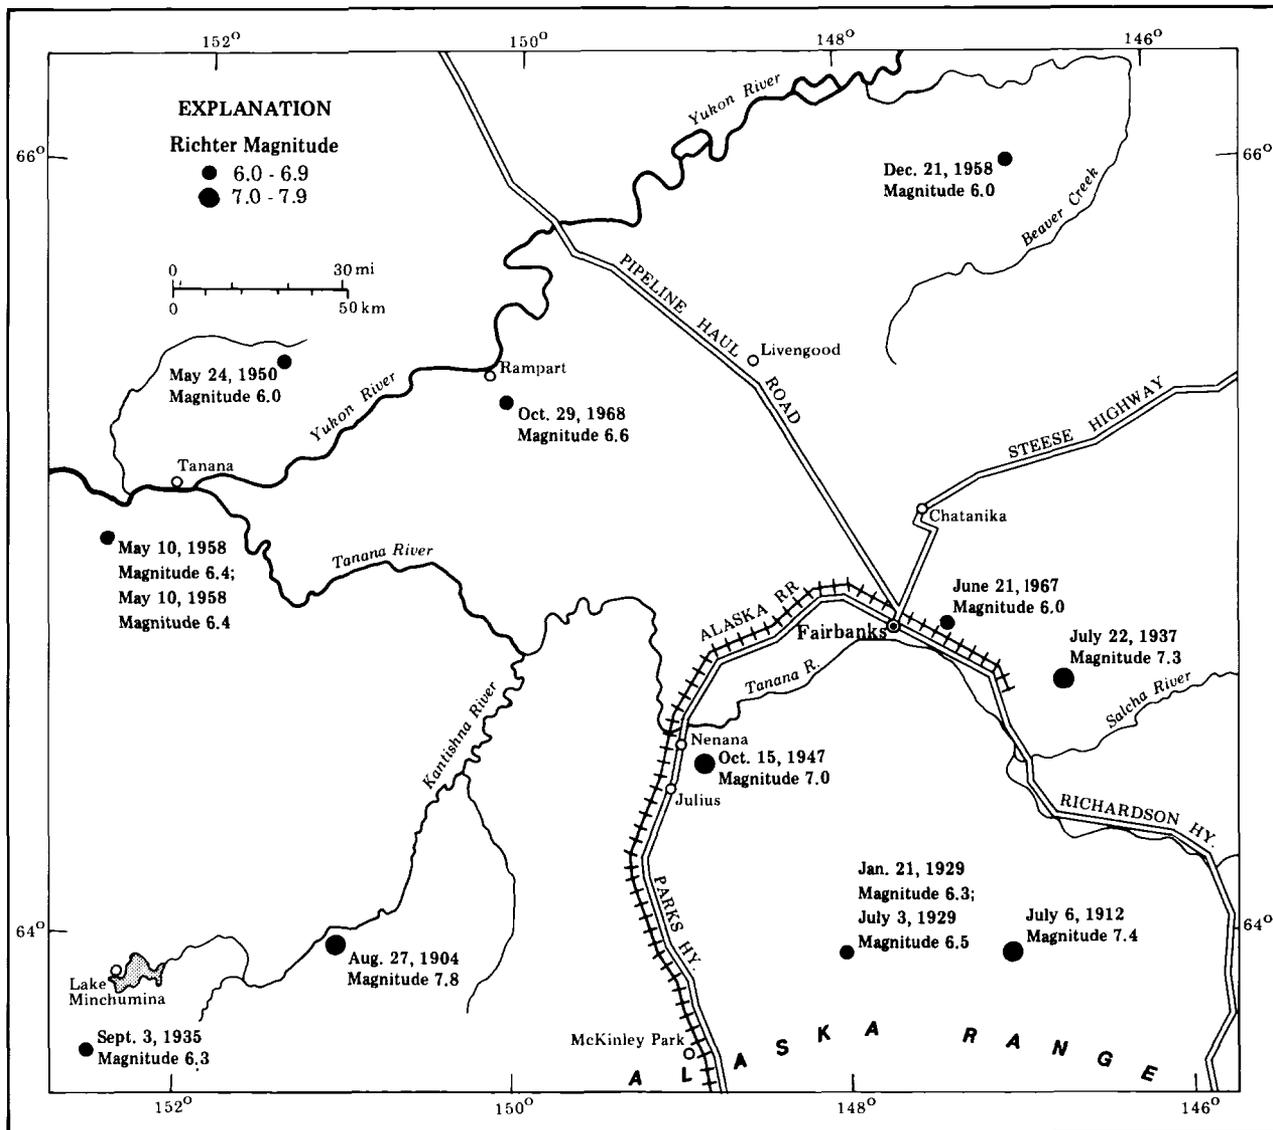
Figure 81. Distribution of earthquakes with Richter magnitudes greater than 6.0 from 1904 to 1968 in central interior Alaska. The center of the 1977 earthquake swarm in the Fairbanks area was in the same locality as the June 21, 1967 earthquakes with Richter magnitudes 6.0 (compiled by J.B. Townshend, USGS).

Large earthquakes with magnitudes up to 7.8 have been recorded in the Fairbanks area since 1904 (fig. 81). The most well-documented large event, magnitude 7.3, occurred near Fairbanks on July 22, 1937. The epicenter of the earthquake was near Salcha Bluff, about 25 miles southeast of the city along the Richardson Highway. A landslide several hundred feet long completely blocked

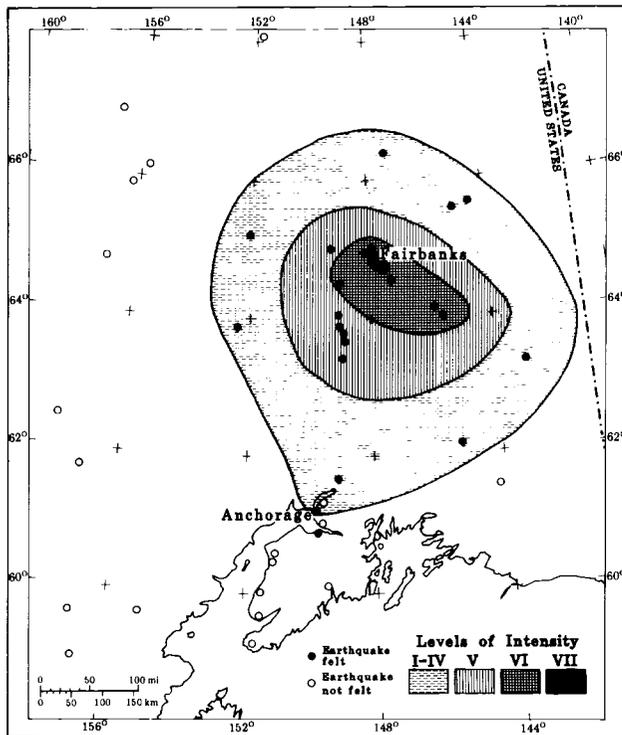
Figure 82. Modified Mercalli intensity distribution of June 21, 1967 Fairbanks earthquake. See Table 1 for definitions of intensity levels. This map was prepared from the results of a questionnaire canvass conducted by J.B. Townshend of the USGS Observatory at College and from press reports (modified from Cloud and Knudson, 1968).

On the morning of June 21, four moderately severe shocks shook Fairbanks for about 21 minutes. The largest event measured 6.0 to 6.1 on the Richter scale. The epicenter was located about 9 miles southeast of Fairbanks and, as in the 1937 and 1947 events, there were no visible movements along known surface faults. Considerable damage occurred in downtown Fairbanks, which is built on water-soaked flood-plain sand and gravel. The State Court Building on Barnett Street between Fifth and Sixth Streets reportedly suffered the most extensive damage. Cracks formed on interior and exterior walls, parts of the hanging ceiling and some fixtures fell, cabinets and shelves were overturned, and broken waterlines caused extensive flooding so that the structure was temporarily closed to the public. Damage to merchandise in several stores resulted in losses of thousands of dollars; one store reported at least \$5,000 in damage. Some large buildings swayed, and alarmed occupants fled into the streets. As shown on the Modified Mercalli Intensity distribution map of the earthquake (fig. 82), an intensity of VII was assigned to the immediate Fairbanks area.

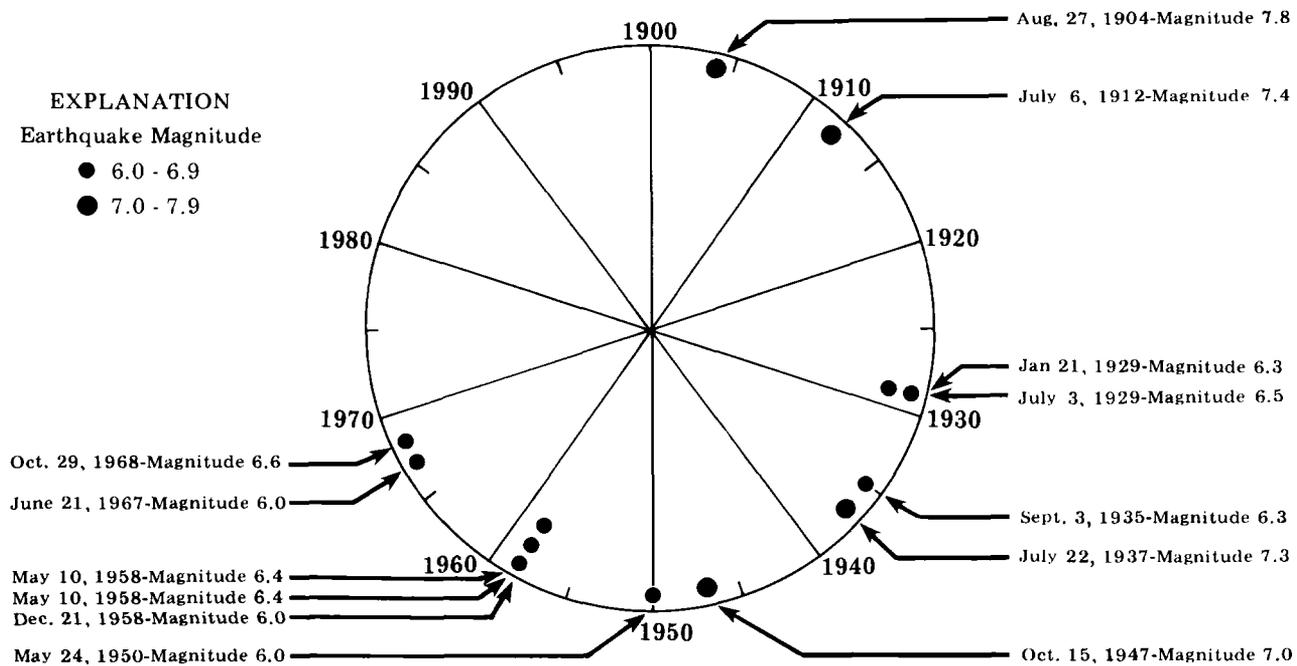
Figure 83. Time distribution of earthquakes of Richter magnitude 6.0 or greater from 1900 to 1978 in central interior Alaska (modified from Townshend, 1971).

In the Fairbanks area, serious earthquakes have occurred about every 10 years during the 20th century (fig. 83). Many residents wonder why there was no major earthquake in 1977, and the following explanation is offered. In February and March 1977, there was an anomalous resurgence of seismic activity 9 miles southeast of Fairbanks in the vicinity of the epicenter of the 1967 earthquake. Thousands of small earthquakes--as many as 200 a day--were recorded. Two or three events per day are more characteristic of the area. At least 20 quakes were felt. This earthquake swarm was unusual because it began and ended abruptly. This 1977 swarm may have taken the place of the expected single large earthquake. Although the date of the next large

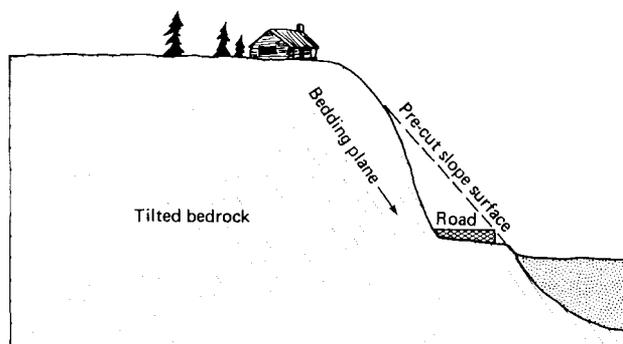
Figure 84. Diagrammatic representation of steeply dipping, bedded rocks that are susceptible to landsliding. As undercutting by road construction steepens the bluff, rocks may easily slide along the well-developed bedding planes, especially if lubricated by excessive precipitation. As a result, the house at the top of the cut could be destroyed.

(fig. 84), gliding or slipping are facilitated. This type of movement is called a rockslide.

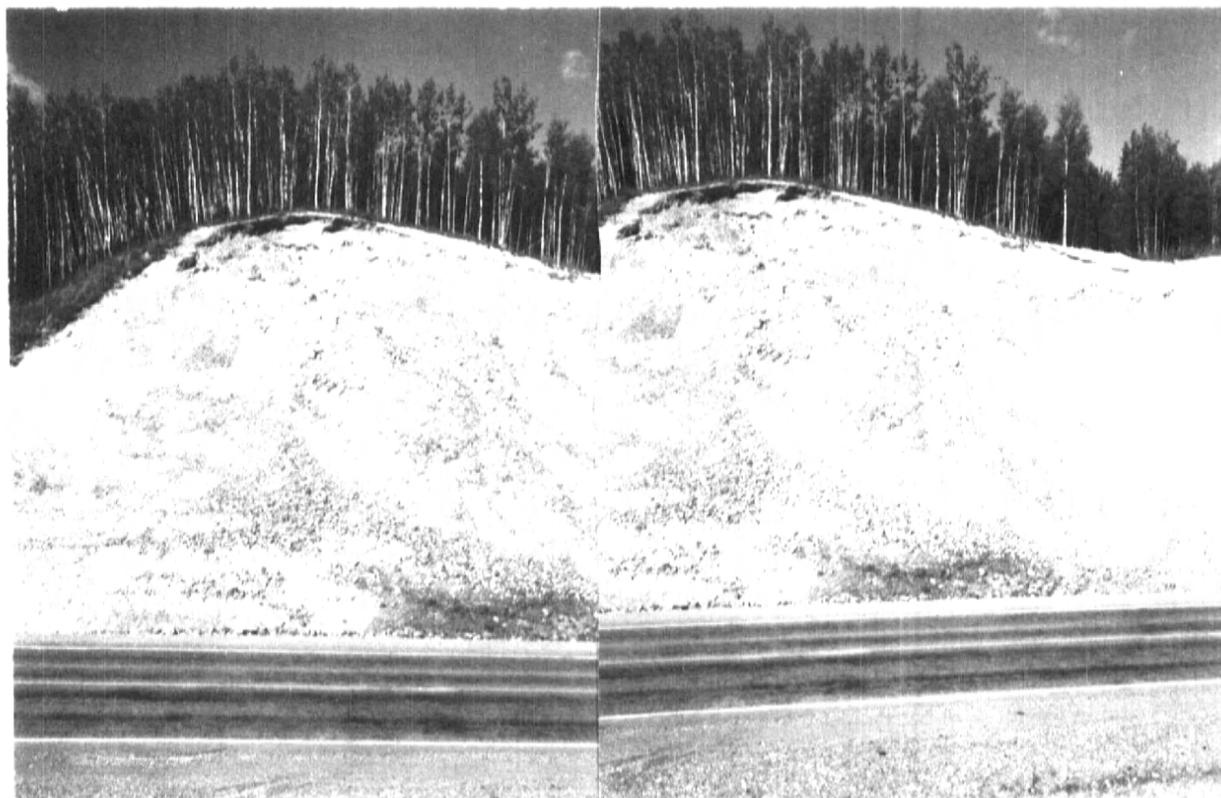
Figure 85. Stereopair of landslide near Mile 300, Richardson Highway. The landslide is in steeply dipping, weathered schist. Excavation for a road realignment undercut the bedrock. Photographs 4019 and 4020 by T.L. Péwé, July 16, 1977.

Several rockslides developed along the Richardson Highway between Miles 298 and 302 southeast of Fairbanks when the road was realigned in 1972 (figs. 85, 86). Large cracks formed at the top of the cut and many tons of rock slid down onto the highway. In addition, large failures were produced by reactivation of ancient, stabilized slides that were masked by thick loess and vegetation. Renewed movement began when the toes of the stabilized slides were removed for the new roadcuts.

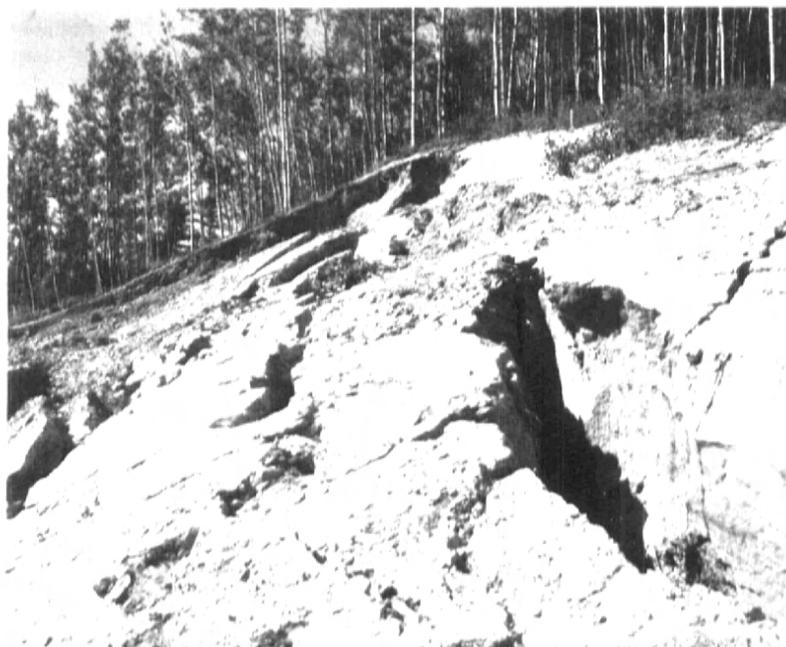
Figure 86. Head of landslide near Mile 300, Richardson Highway. Photograph 4023 by T.L. Péwé, July 16, 1977.

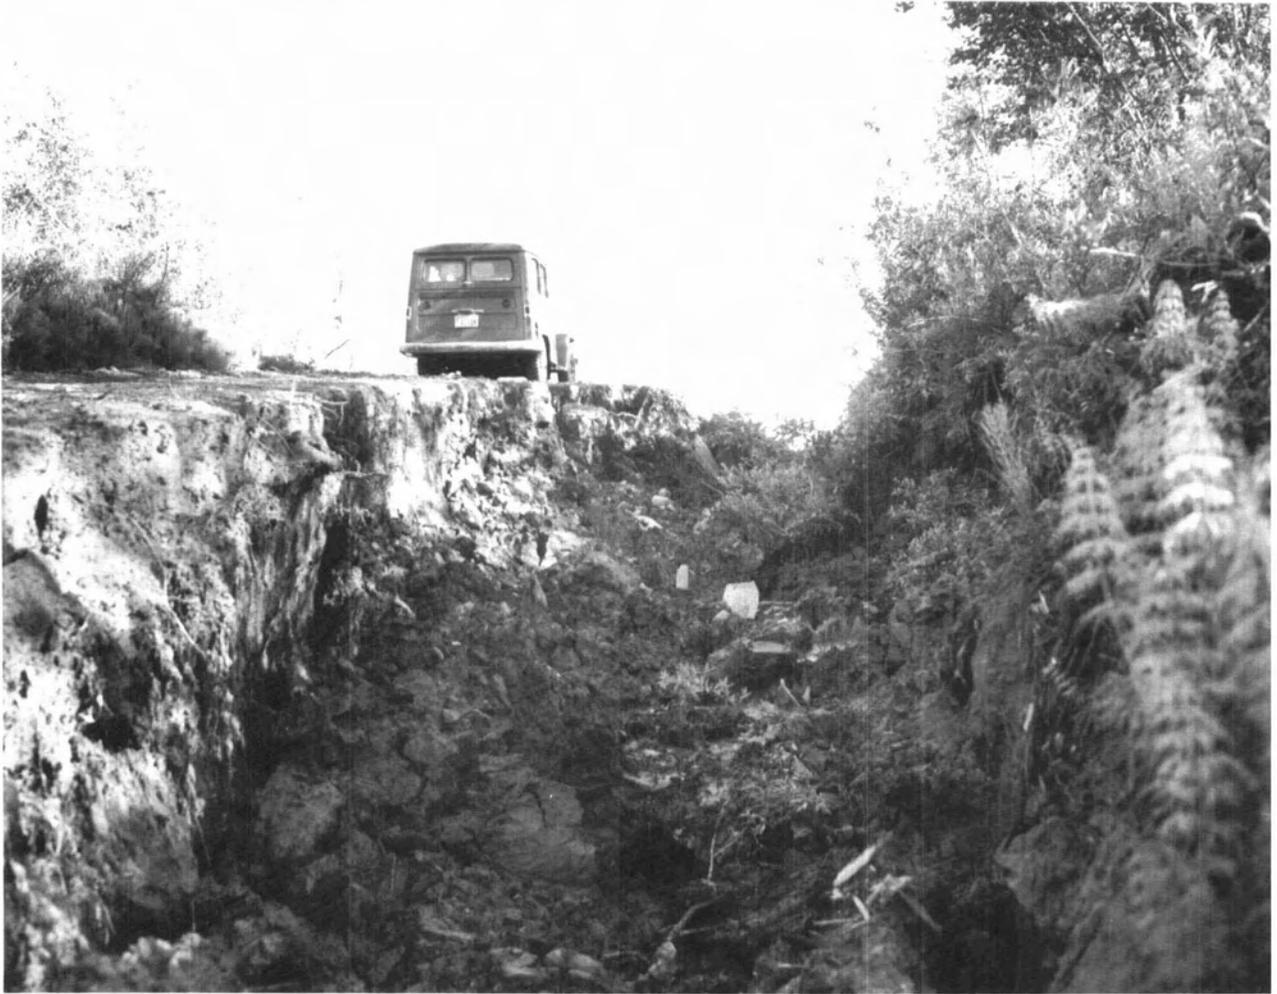
Figure 87. Deep gully eroded in loess by runoff along edge of old Sheep Creek Road near Goldstream valley northwest of Fairbanks. The gully formed because of inadequate channeling of surface water. Photograph 1170 by T.L. Pévé, July 6, 1955.

Loess gullying of roads by ditch water may create a dangerous traffic hazard in the Fairbanks area (fig. 87). Water in ruts of an unimproved road or entryway will quickly cut slashes up to 2 feet wide and 10 feet deep. Water draining away from roads will quickly erode a gully in the loess (fig. 88). In fact, drainage in steep, loess-covered areas must be carefully channeled into vegetated or otherwise erosion-protected drainageways.

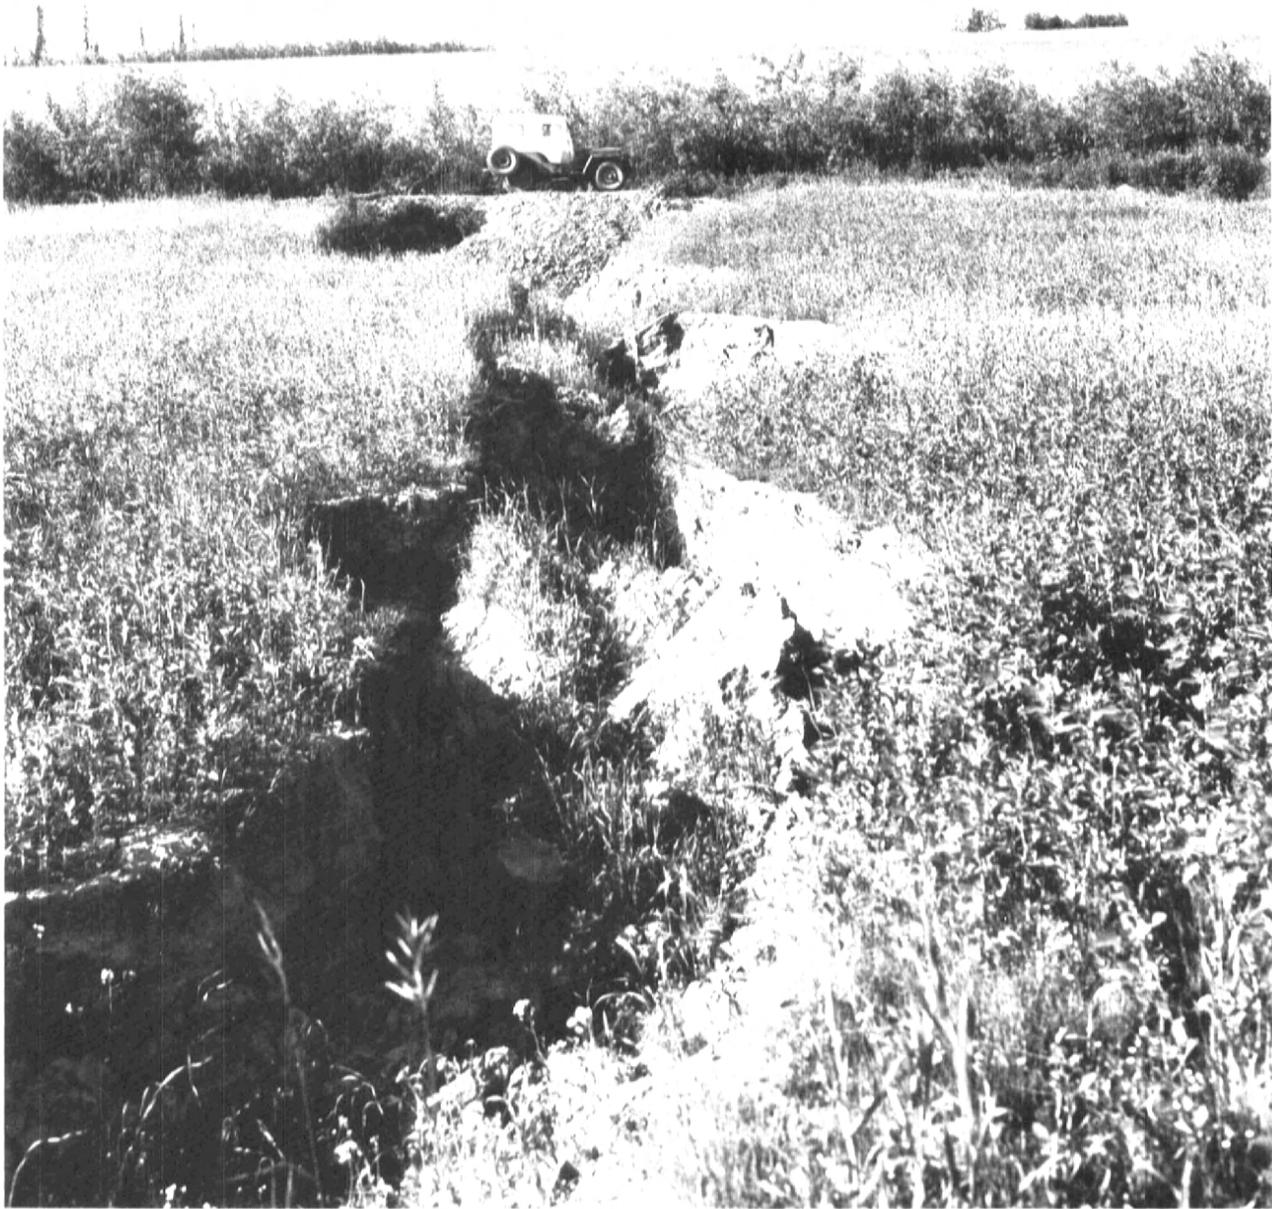
Figure 88. Large, 6-foot-deep gully formed in easily erodable loess on the south flank of College Hill, University of Alaska, Fairbanks. Most erosion occurred in a few hours during a summer storm, when upslope water was funneled across this field. Photograph 263 by T.L. Péwé, July 1, 1948.
