SPECIAL REPORT 15

**GEOLOGIC HAZARDS OF THE FAIRBANKS AREA, ALASKA**

By  
Troy L. Péwé

First Edition, 1982  
by  
Department of Natural Resources  
DIVISION OF GEOLOGICAL & GEOPHYSICAL SURVEYS  
Fairbanks, Alaska  
Reprinted 1993

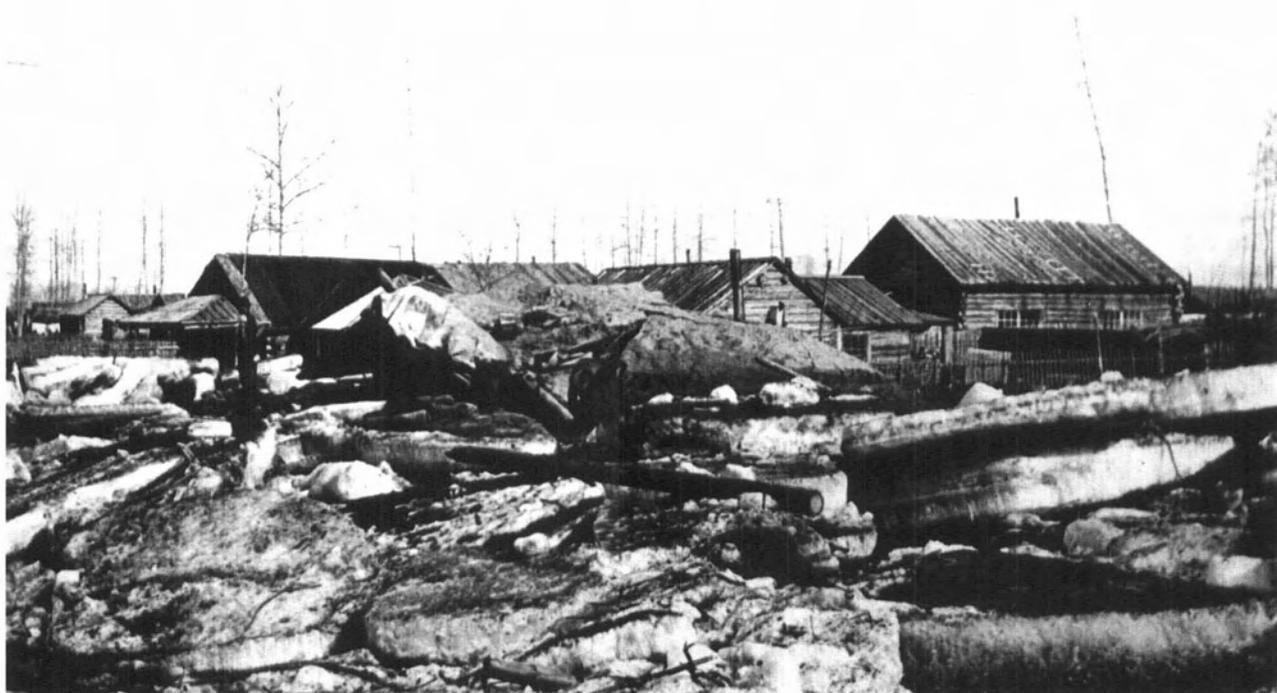
Figure 89. *Circa* 1908 flood in Fairbanks. Large blocks of river ice---accompanied by icy water---shoved against and into houses and constituted a serious hazard. Photograph 58-1026-633, Bunnell Collection, University of Alaska Archives, Fairbanks.

river (fig. 89). Records indicate that in 1905, one of the worst floods of the early part of the century carried swirling water around log cabins and commercial buildings in the city. Floodwaters extended to beyond Sixth Street and it was estimated that bulldozing by large blocks of ice did more than a half a million dollars (1905 value) in damage.

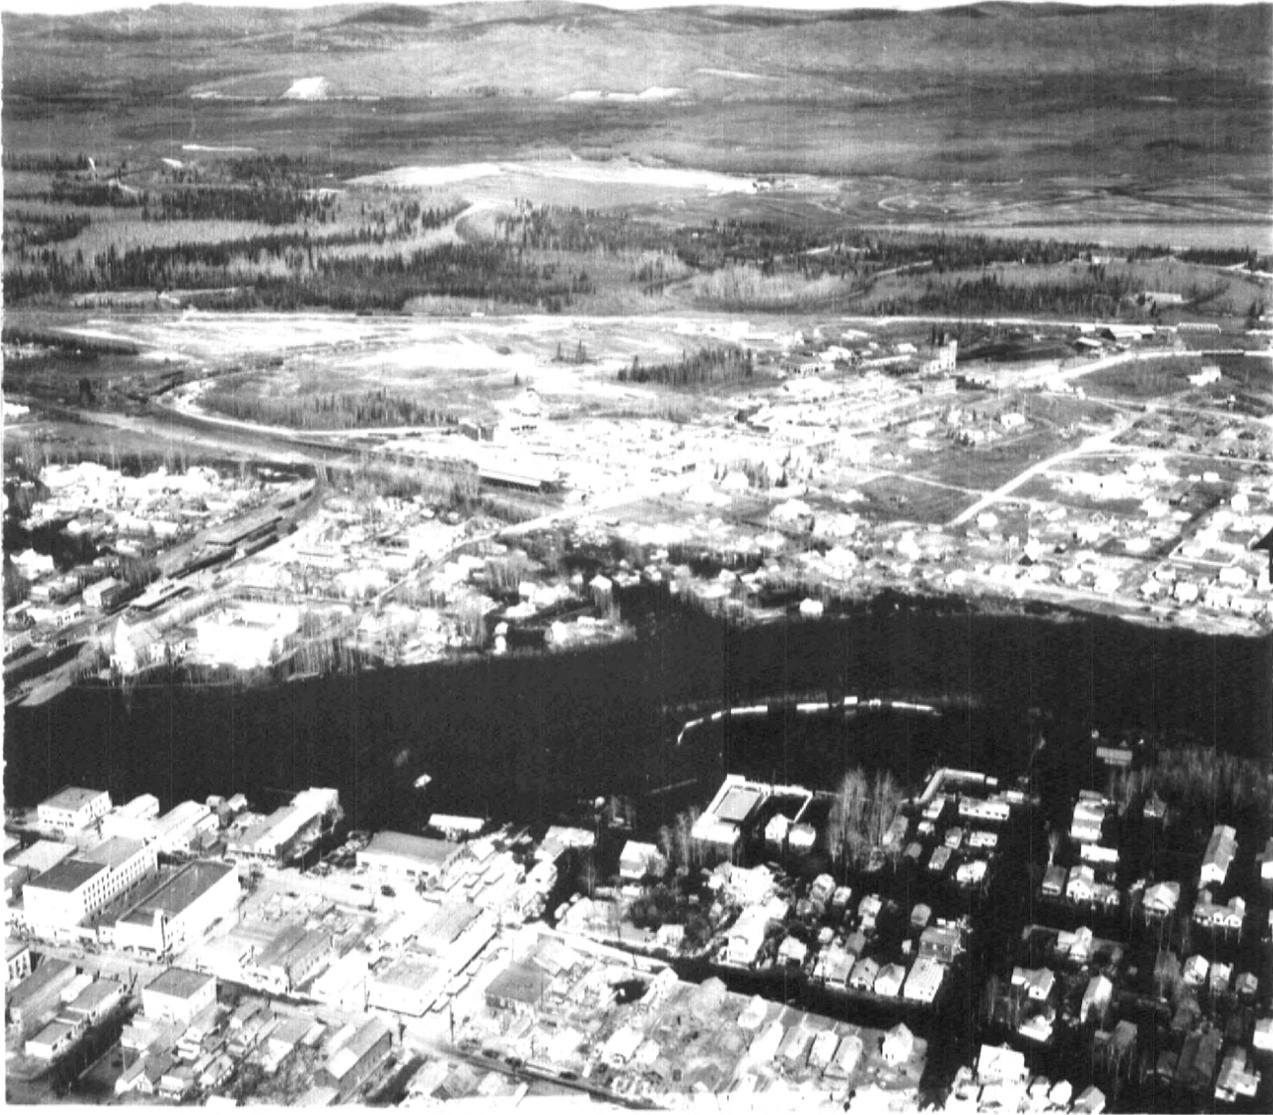
Figure 90. Oblique aerial view of Fairbanks during maximum flood stage of the Chena River, May 20, 1948. Low areas on slip-off slopes of the meandering river were under several feet of water. On May 21, a maximum flow of 24,200 cubic feet per second was reached. Water levels indicate this was a 25-year flood. Photograph 24-72PL-R-8M112-72RS, U.S. Air Force.

In 1948 flooding of the Chena River submerged much of downtown Fairbanks, and lowlands on the inside of meandering stream channels were inundated. Hundreds of thousands of dollars in losses occurred in the city and at Ladd Field, now Fort Wainwright (fig. 90).

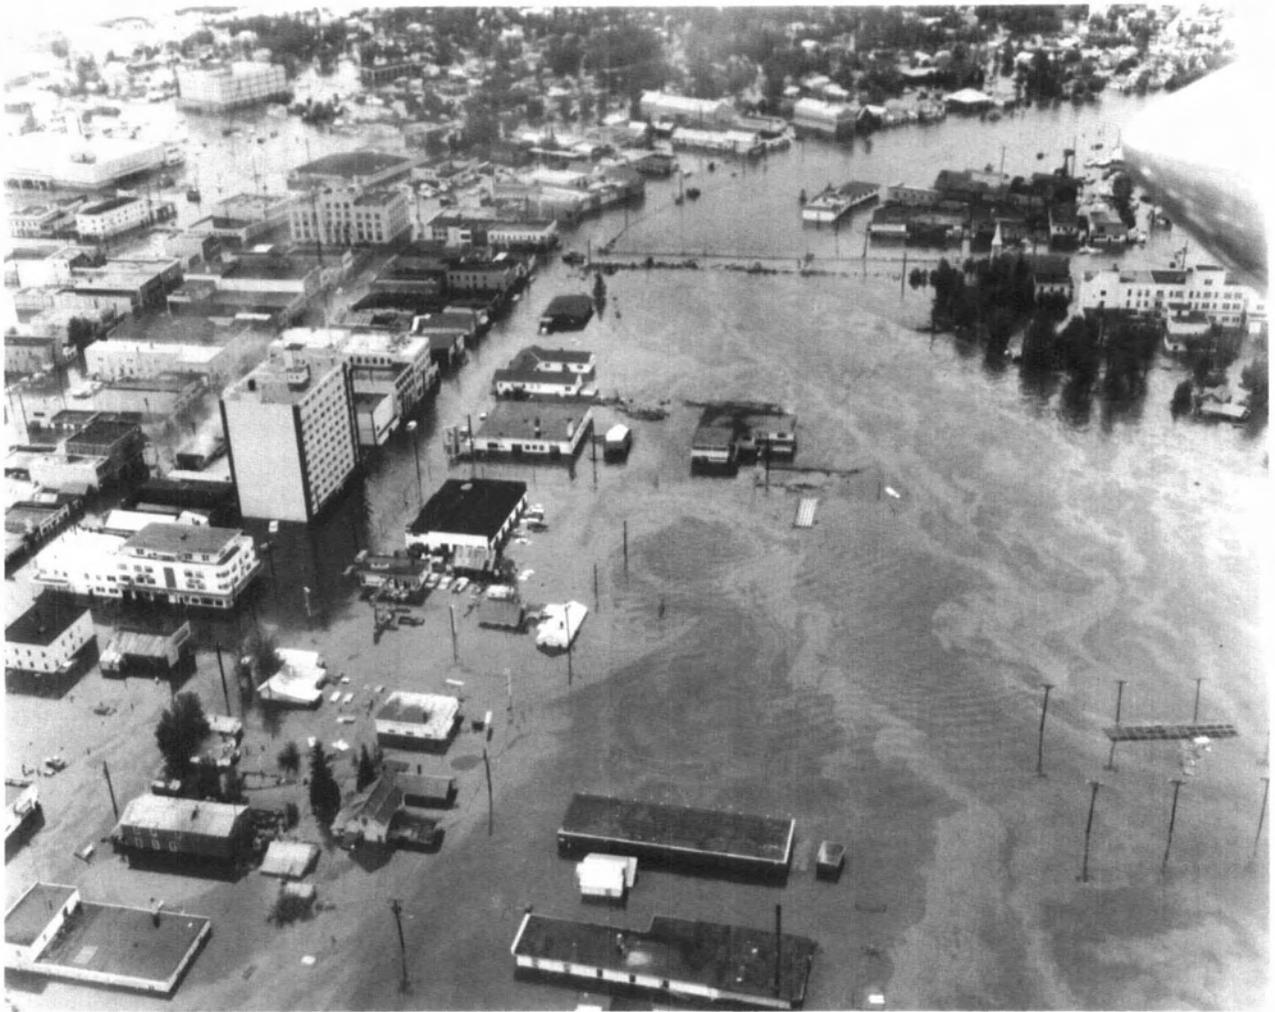
Figure 91. Oblique aerial view (to the west) of the flooding Chena River, August 15, 1967 at Fairbanks. Water was 3.9 feet deep in the downtown area and inundated the Cushman Street Bridge. Photograph courtesy of the Alaska Railroad.

The 1967 flooding of the Chena River at Fairbanks is best described as a flowing lake that extended upstream and downstream from the city for several miles (fig. 91). About 95 percent of Fairbanks was flooded; locally water was as deep as 5 feet (figs. 92a,b). Except for a few artificial islands, most notably Fairbanks International Airport, the flood plain was inundated. Flood damage and the reaction of the city and its residents were succinctly summarized by Childers and others (1972, p. A33-A39).

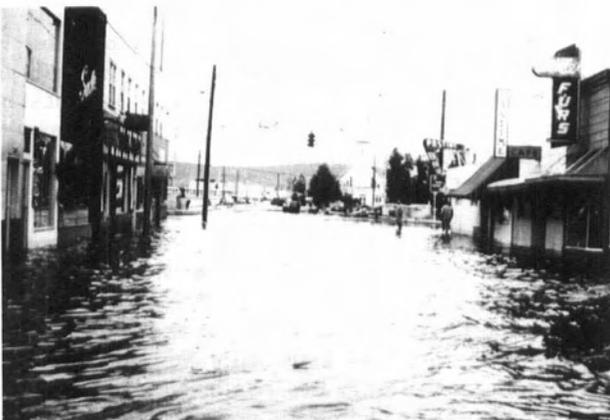
Figure 92a. View north along Cushman Street of downtown Fairbanks during the mid-August 1967 Chena River flood. Photograph by Thomas Snapp.

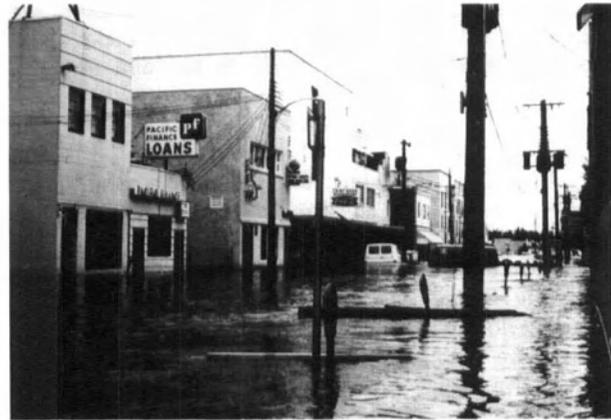
Figure 92b. View of Third Avenue west toward Cushman Street during the mid-August 1967 Chena River flood. Photograph by Thomas Snapp.

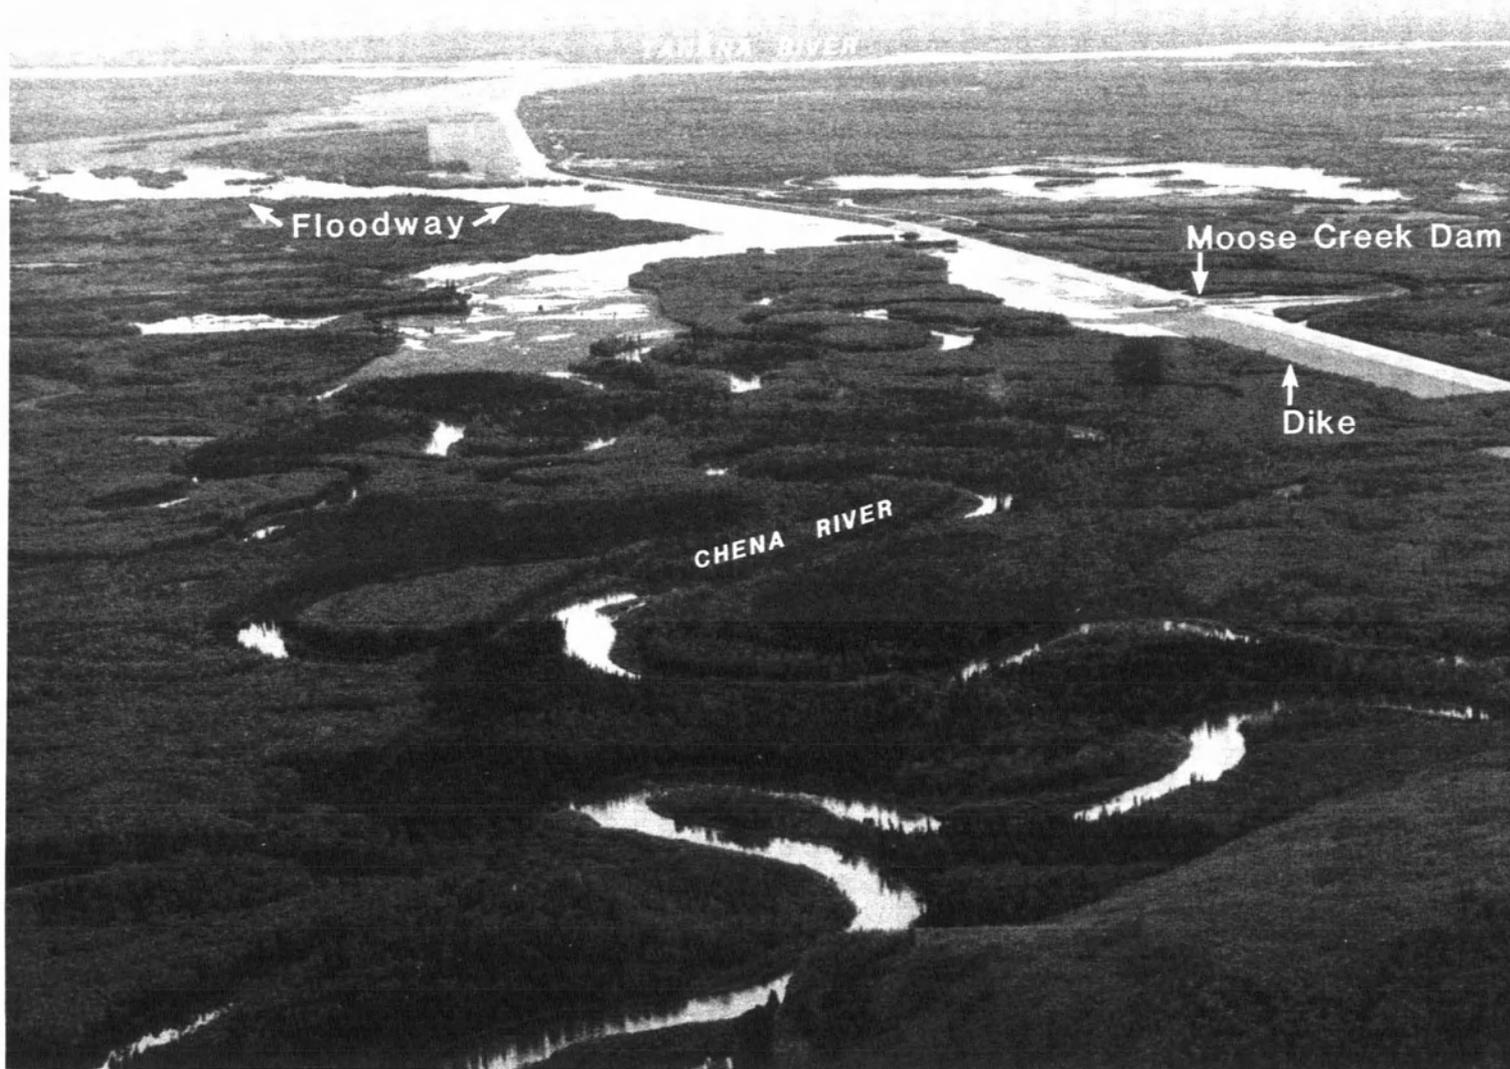
Figure 93. Oblique aerial view to the southwest of the Moose Creek dam and dike on the Chena River. These structures were designed to divert Chena River flood waters along the floodway to the Tanana River in the distance. Photograph by J.W. Stuhler, U.S. Army Corps of Engineers, Alaska District, July 1981.

Structural methods to reduce flooding include reservoir and levee construction and channel improvements. Except for the dike built along the Tanana River in mid-1940s to prevent Tanana River water from entering Chena Slough, no major structural methods were seriously considered until after the 1967 flood, when the U.S. Army Corps of Engineers outlined an impressive flood-control project (fig. 93). This plan, called the Chena River Lakes Project, includes construction of a levee system along the Tanana River as well as reservoir storage in the Chena River and its tributaries behind an earth-filled dam. This \$165-million plan provides protection for Fairbanks and adjacent Fort
