ENGINEERING-GEOLOGIC MAP, ALASKA HIGHWAY CORRIDOR, DELTA JUNCTION TO THE CANADA BORDER, ALASKA

by
R.D. Reger¹ and T.D. Hubbard²
2016

Department of Natural Resources
DIVISION OF GEOLOGICAL & GEOPHYSICAL SURVEYS

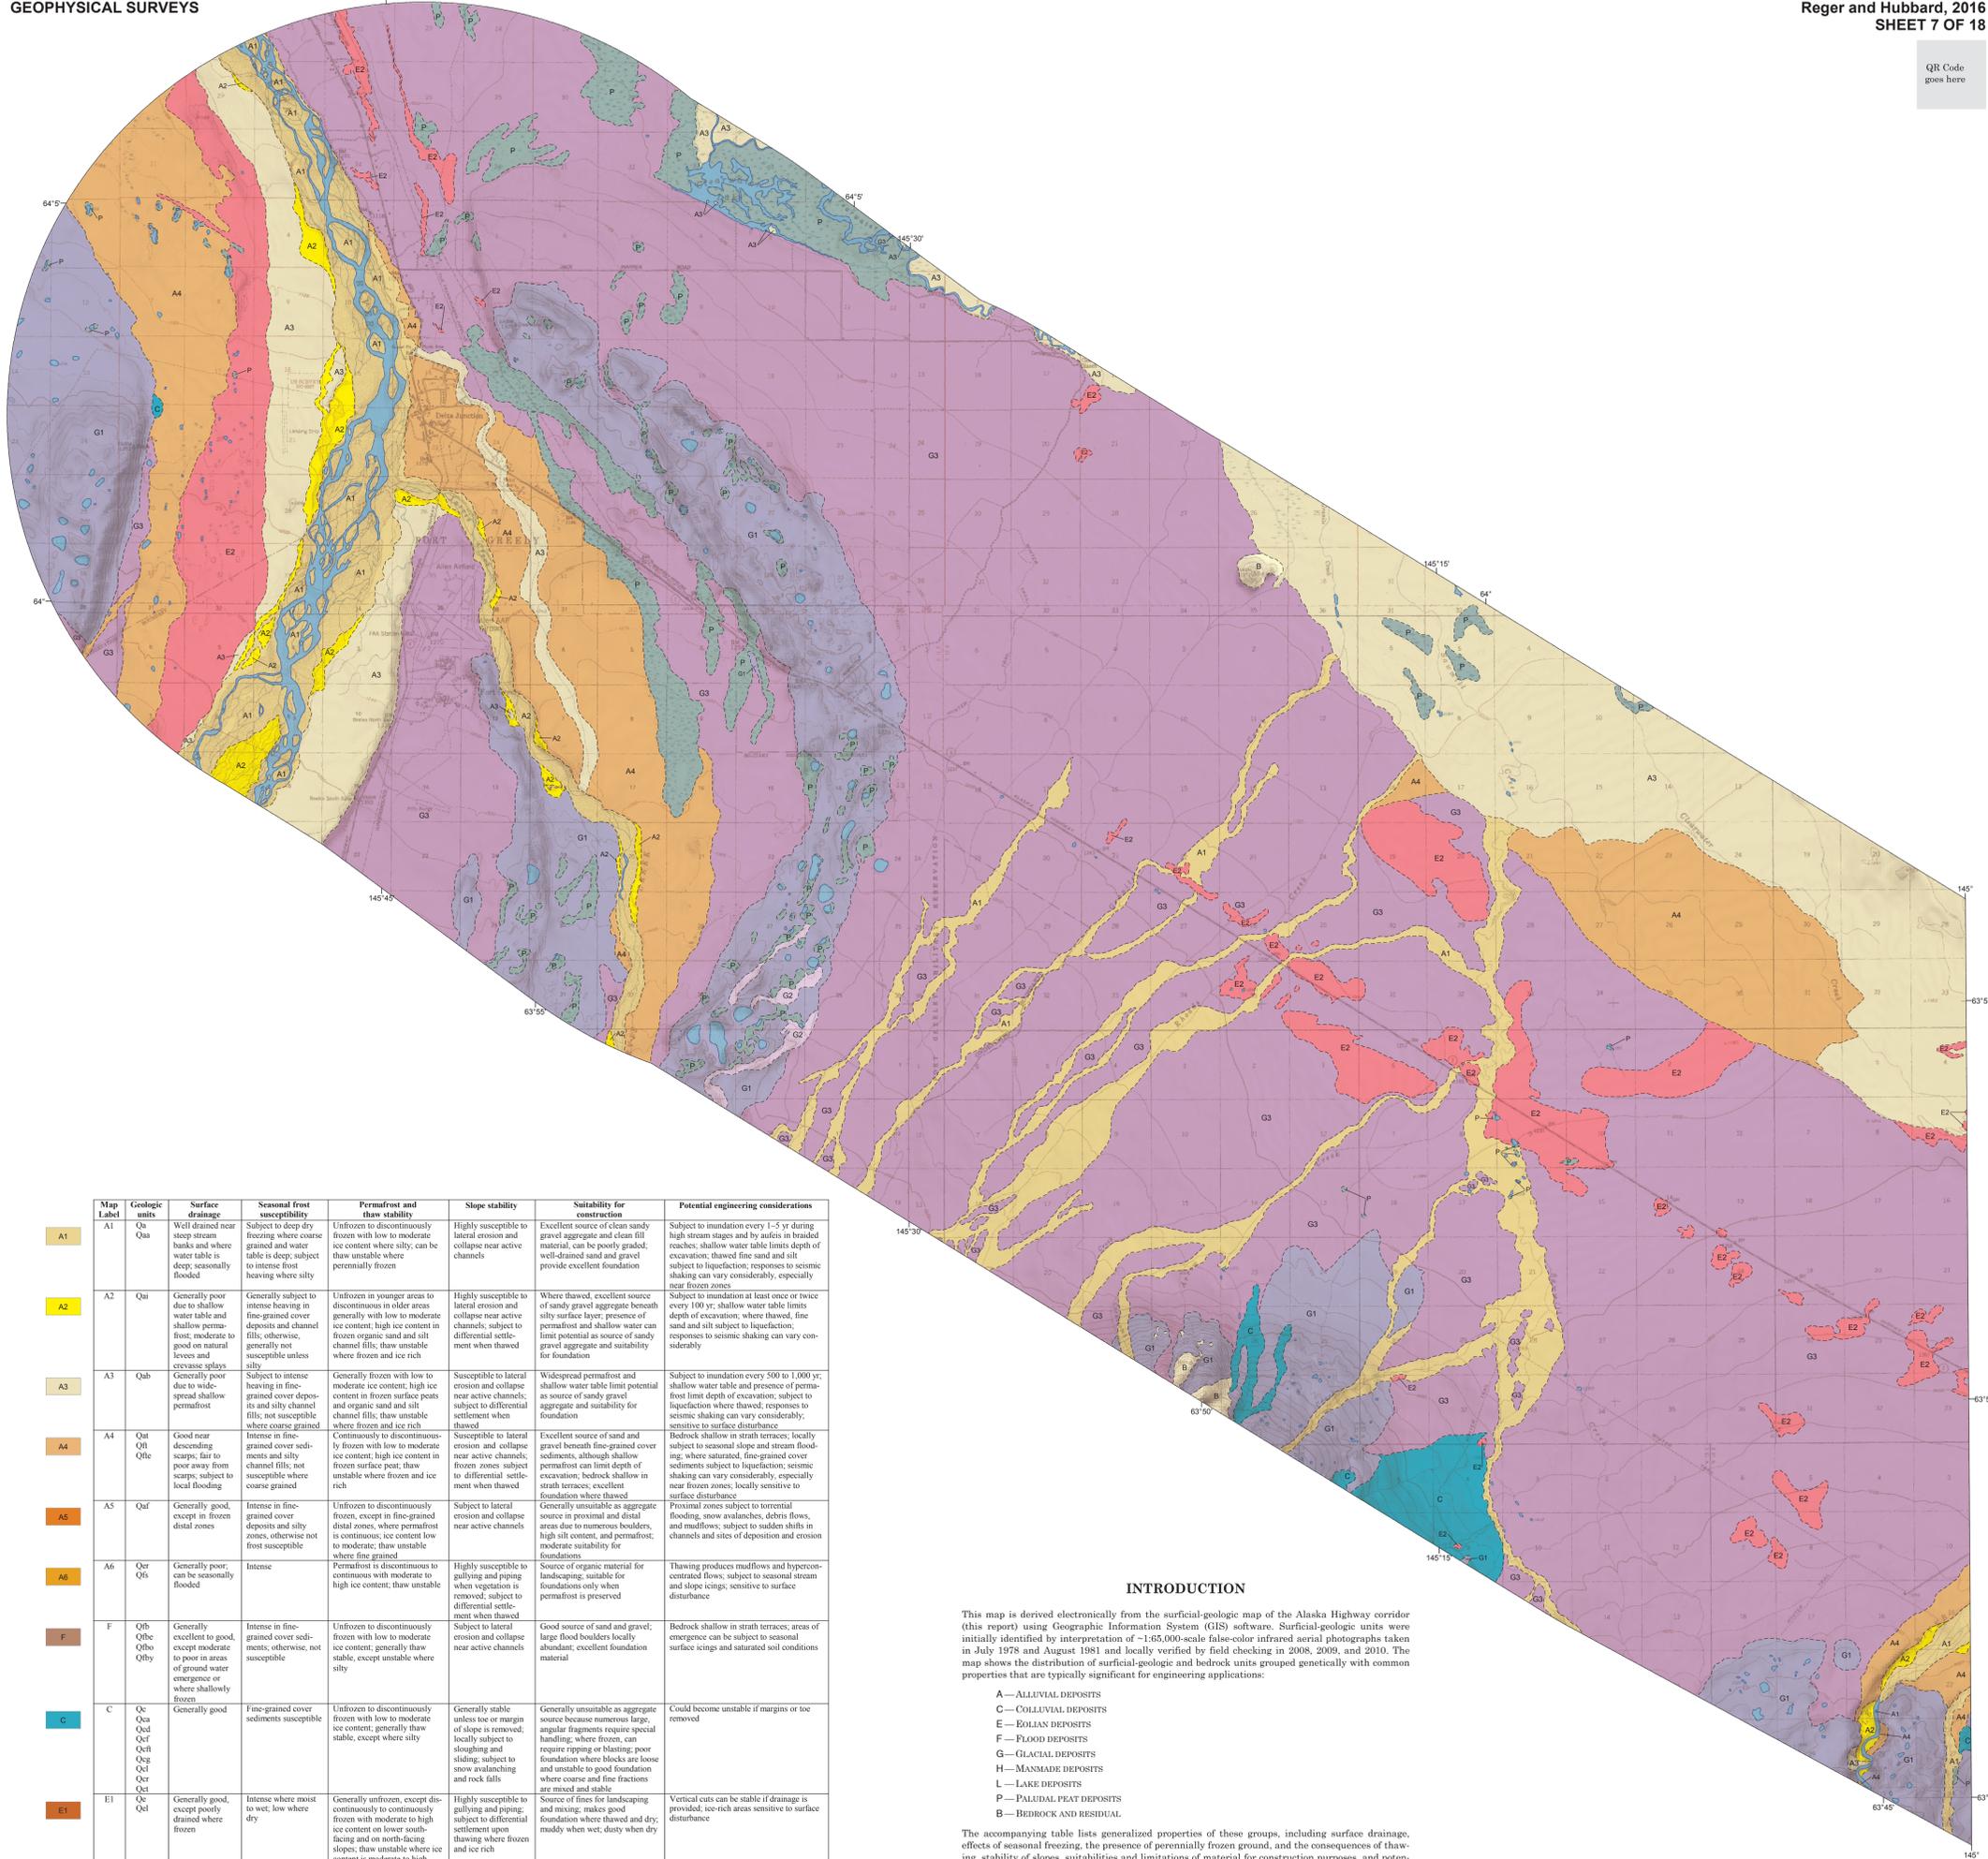
This map is derived electronically from the surficial geologic map of the Alaska Highway corridor (this report) using Geographic Information System (GIS) software. Surficial-geologic units were initially identified by interpretation of 1:625,000-scale false-color infrared aerial photographs taken in July 1978 and August 1981 and locally verified by field checking in 2008, 2009, and 2010. The map shows the distribution of surficial-geologic and bedrock units grouped genetically with common properties that are typically significant for engineering applications:

The accompanying table lists generalized properties of these groups, including surface drainage, effects of seasonal freezing, the presence of perennially frozen ground, and the consequences of thawing, stability of slopes, suitability and limitations of material for construction purposes, and potential constraints. Physical properties of map units are interpretive, based on extrapolation from verified localities and from previously published reports and data. Potential geologic hazards are inferred from the typical physical properties of map units, including sediment texture and ground-ice content, and their typical topographic settings. Except for a few test pits, no subsurface investigations or significant laboratory analyses were performed for this publication. The reader is cautioned that this map is intended only as a general guide, and that unvaluated geologic resources and hazards may be present. Detailed geotechnical investigations should be conducted prior to utilization of any map units for engineering purposes.
