Landslides in Alaska

Alaska Division of Geological & Geophysical Surveys

IC 65 | <http://doi.org/10/14509/29849>

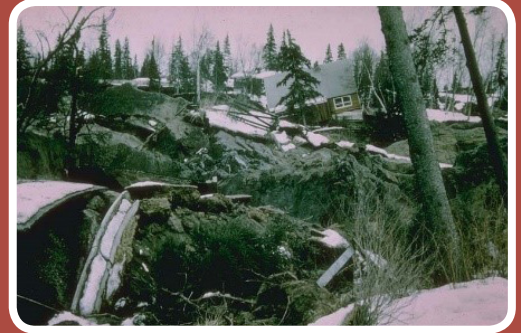
Landslide damage, 1964 Great Alaska Earthquake

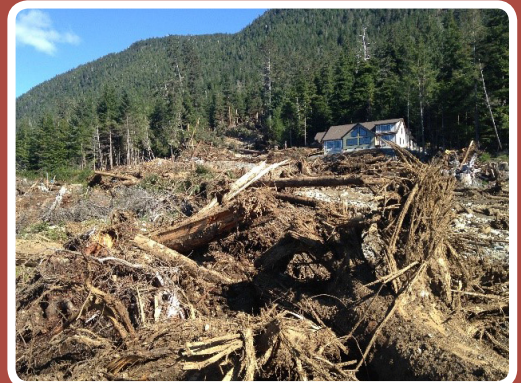
Sitka Debris Flows. On August 18, 2015, heavy rains resulted in numerous landslides in and around Sitka, Alaska. More than 45 landslides were initiated during this rainfall event. Four debris flows (very water-rich landslides) impacted homes and infrastructure in Sitka, and this one took the lives of three Sitka residents.

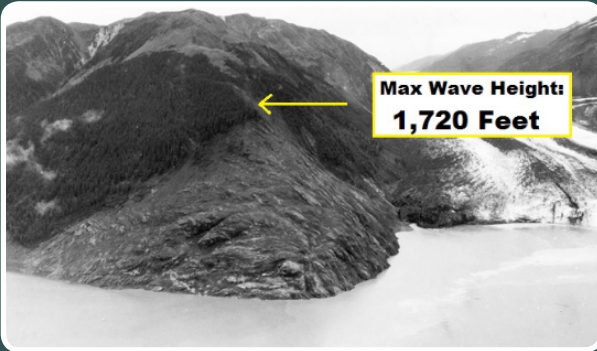
Lituya Bay Landslide. On July 9, 1958, a magnitude 8 earthquake along the Fairweather Fault dislodged about 40 million cubic yards of rock from a mountainside, sending it 3,000 feet downslope into Gilbert Inlet. The wave that followed surged 1,720 feet up a mountain slope and left trimlines along the bay that are still visible today.

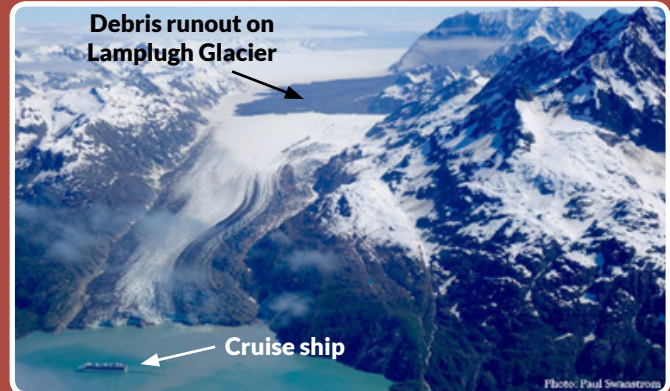
Lamplugh Glacier Snow-Ice-Rock Avalanche. On June 28, 2016, a massive landslide crashed onto a glacier in Glacier Bay, Southeast Alaska. More than 100 million tons of rock, snow, and ice slid down a mountainside, sending debris six miles down Lamplugh Glacier. Snow-ice-rock avalanches like this are becoming more common with receding glaciers.

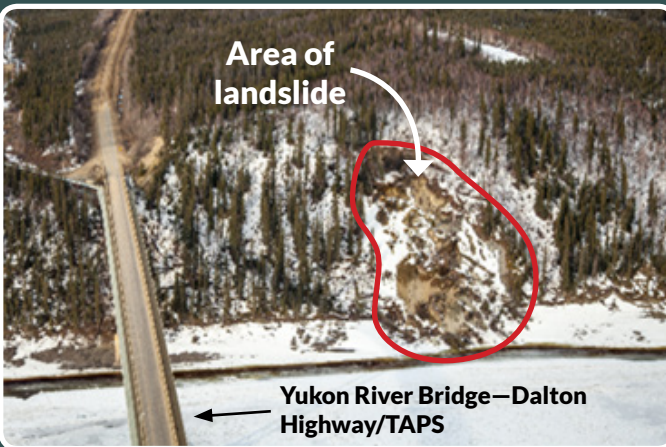
Yukon River Bridge Landslide. In 2012 a landslide occurred approximately 375 feet from the Dalton Highway bridge over the Yukon River. The Dalton Highway and the Trans-Alaska Pipeline System rely on the bridge to connect Fairbanks to the Prudhoe Bay oilfields, ensuring an uninterrupted corridor for the transportation of supplies and personnel. Any compromise to the bridge's integrity could potentially have immediate and severe consequences to the state's economy and environment. Although there was no damage to the bridge foundation, the landslide's close proximity to the bridge raised concerns over additional potential failures.

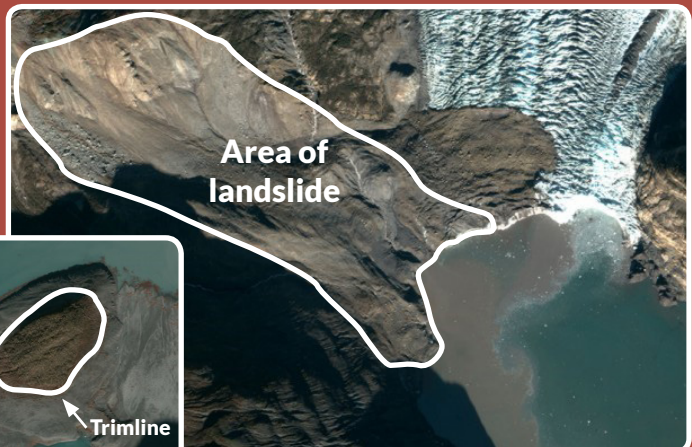
Icy Bay Landslide. After a period of heavy rains, a mountainside near Tyndall Glacier collapsed on October 17, 2015, dropping 200 million tons of rock into a fjord of Icy Bay. The displaced water generated a wave that denuded vegetation more than 500 feet up on a hillside across from the slide.
