PUBLIC-DATA FILE 92-10

**ANALYSIS OF POTABLE WATER-SUPPLY OPTIONS  
GAMBELL, ALASKA**

Resistivity Survey for Ground Water  
Village of Gambell, St. Lawrence Island, Alaska

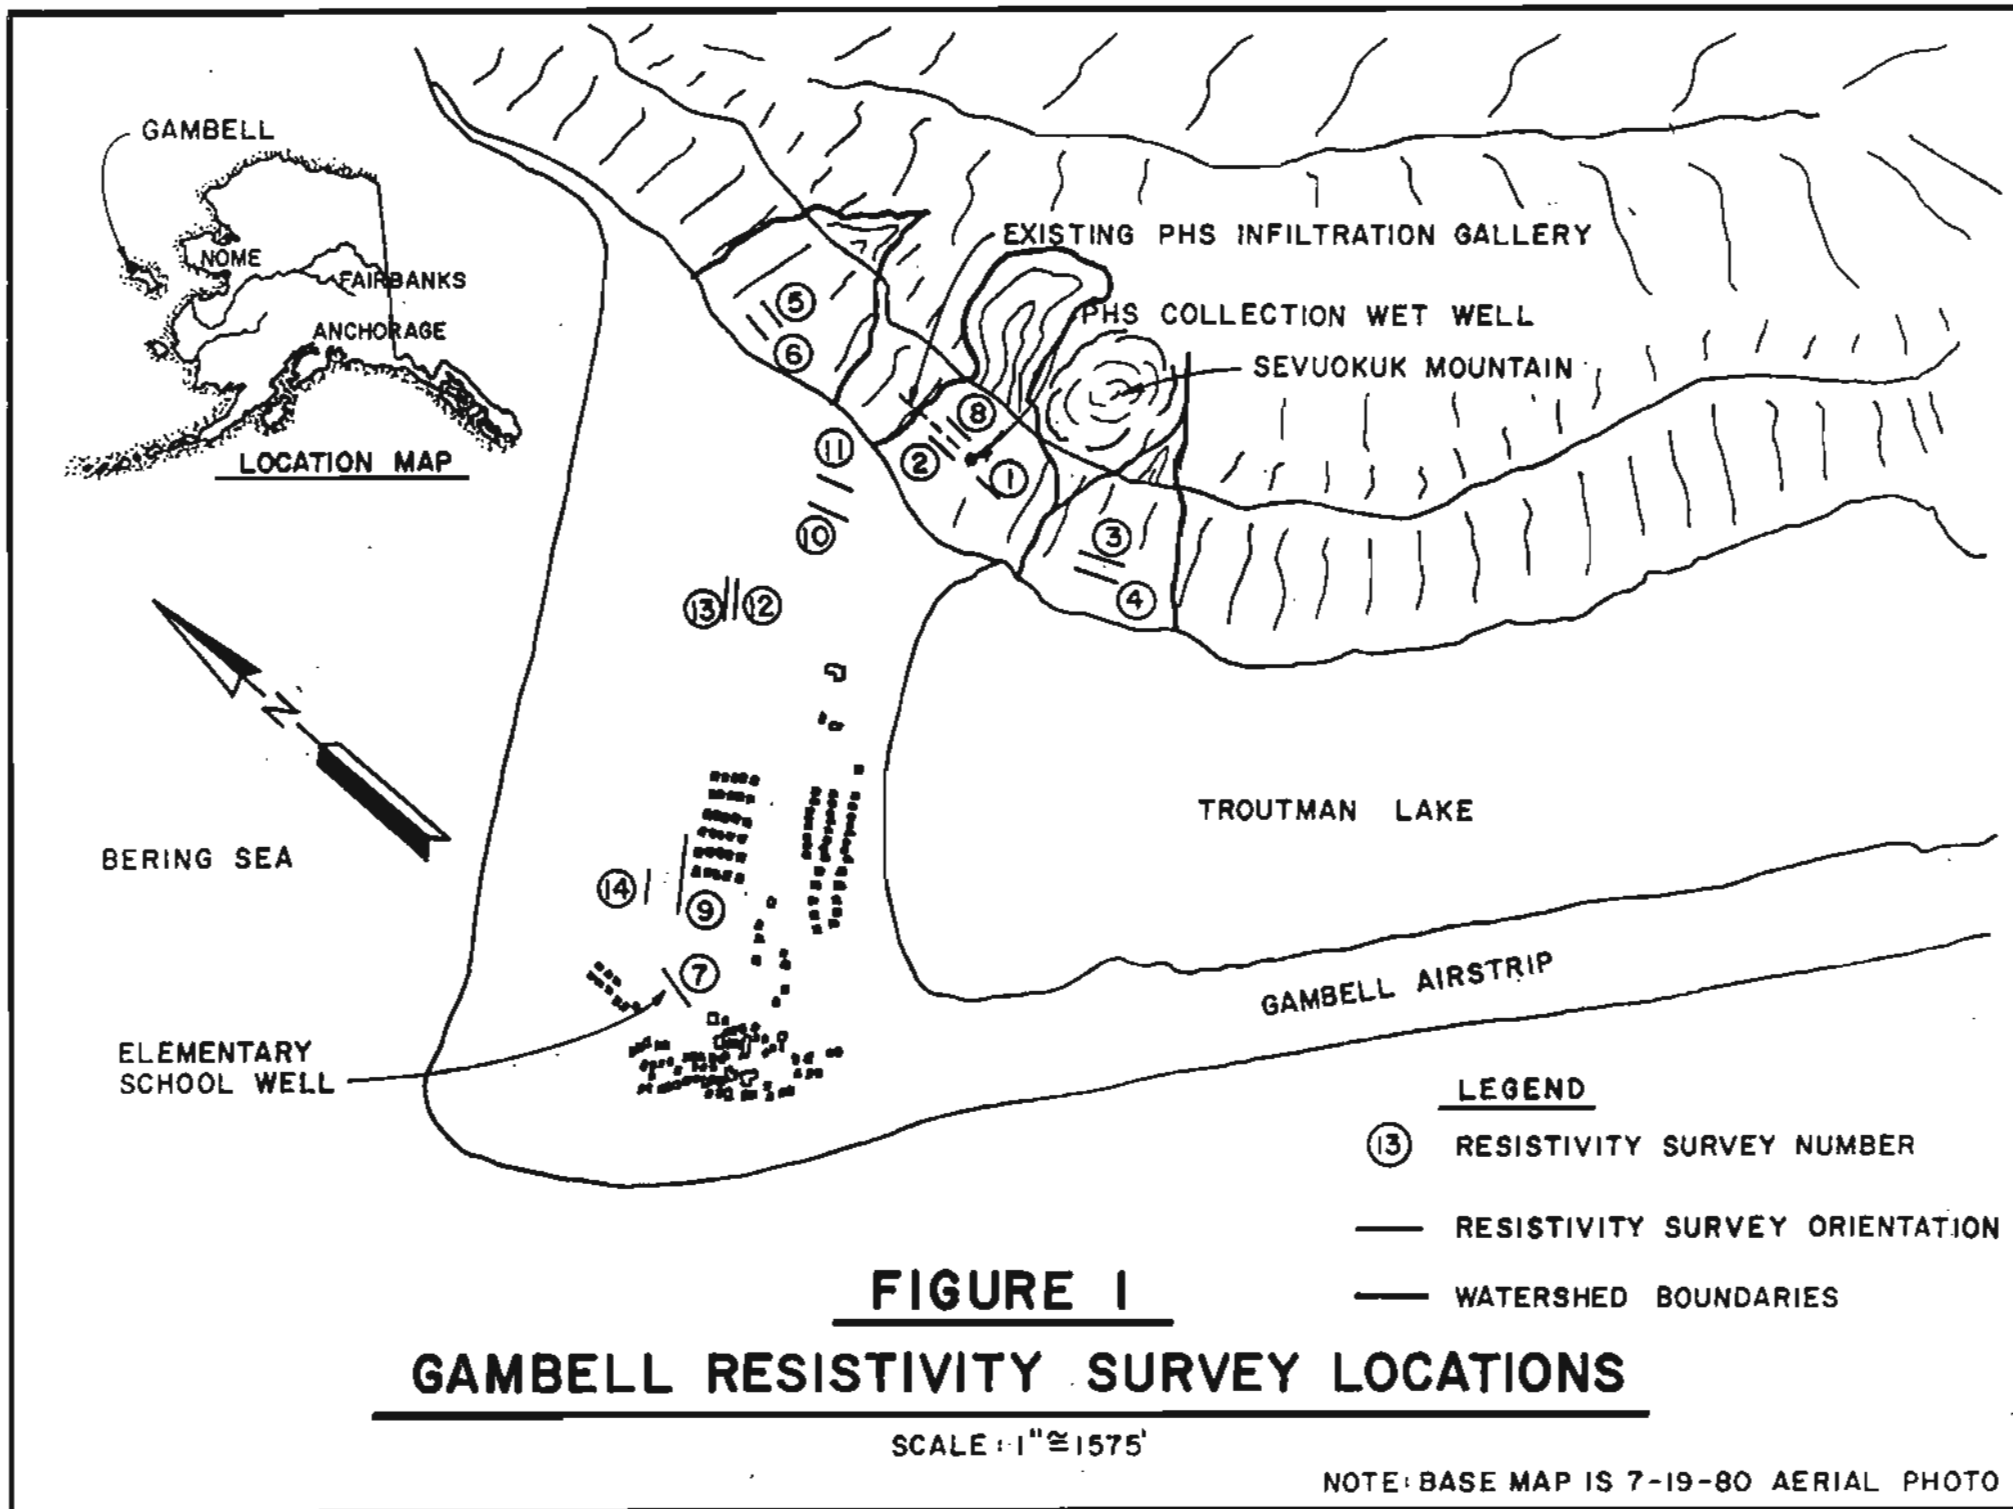
A direct-current resistivity survey was conducted at 14 locations in Gambell, Alaska. The purpose of the survey was to locate a year-round source of fresh water. Soundings were taken using both Schlumberger and Wenner array configurations at all of the following locations except for location no 9. See Figure 1 for sounding locations.

<u>Sounding No.</u>	<u>Approximate Sounding Location</u>
1, 2, 8	In the vicinity of the existing PHS Infiltration Gallery and VSW emergency gallery.
3, 4	In the watershed south of the existing gallery watershed.
5, 6	In the watershed north of the existing gallery watershed.
10, 11	A gravel area at the base of Sevuokok Mountain in between archaeological sites Ayveghyaget and Mayughaq.
12, 13	North of the Gambell High School on the crest and trough of a relict beach line.
7	In the vicinity of the elementary school well.
9, 14	North of Subdivision A.

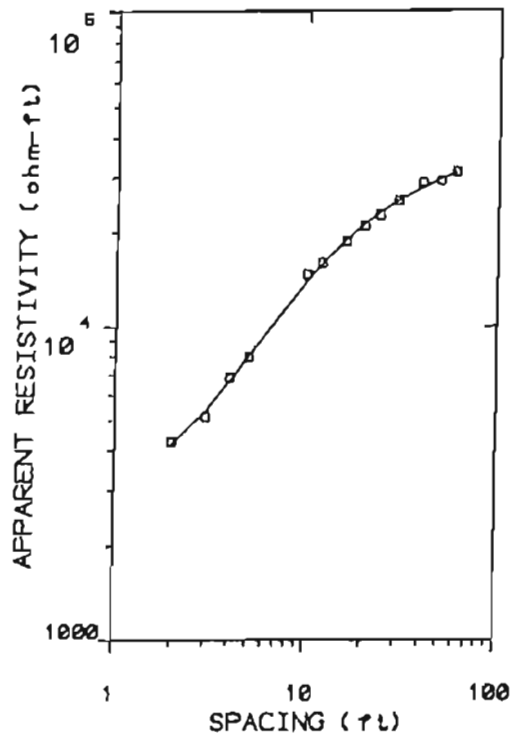
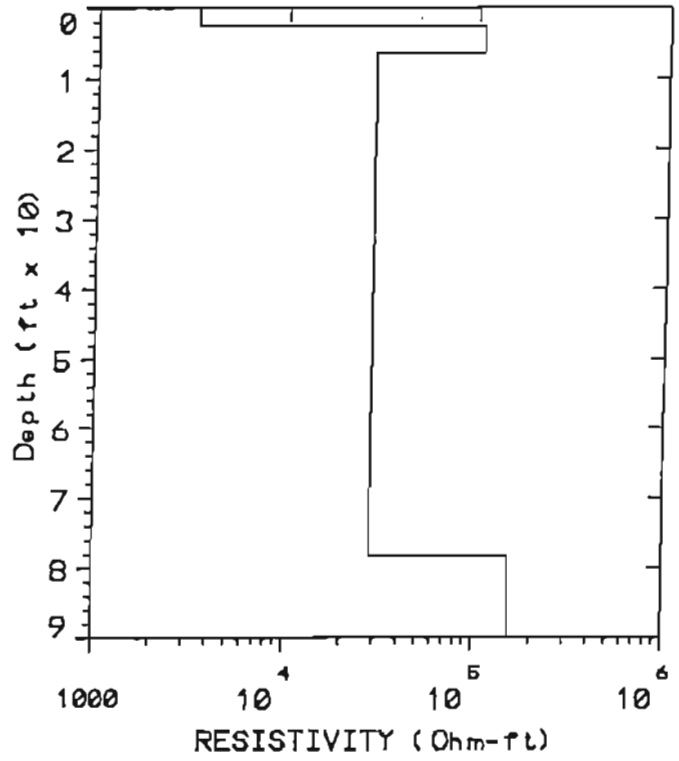
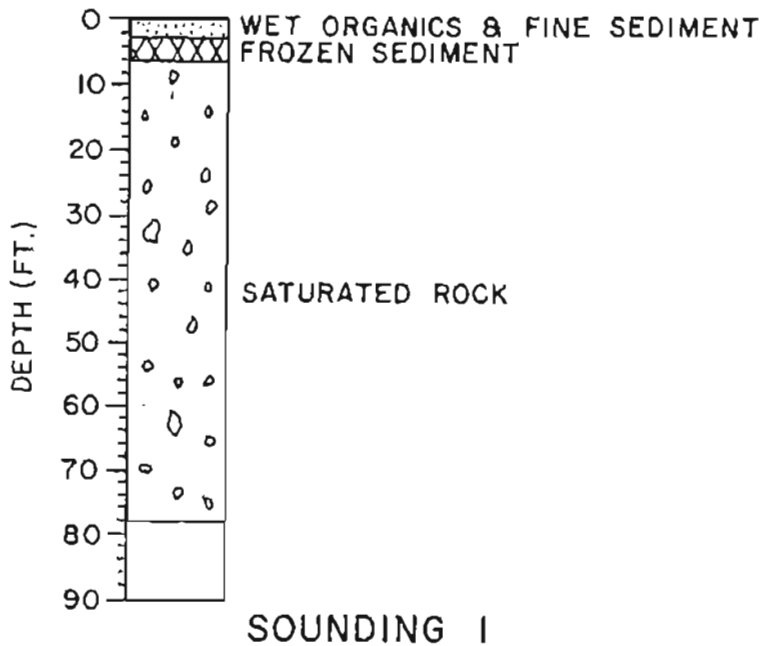
for: CE2	Gambell Water
by: Williams Consulting	below and S of gallery
Date Set: SLIWI	Date: June 18, 92
Location: ARBY BEDROCK	Sounding: 1
	Azimuth: N54E

The wet saturated sediments are interpreted to consist of mostly sand and gravel with some layers of fine grained material. An interpreted lithologic profile was sketched for each array and is shown with the model outputs.

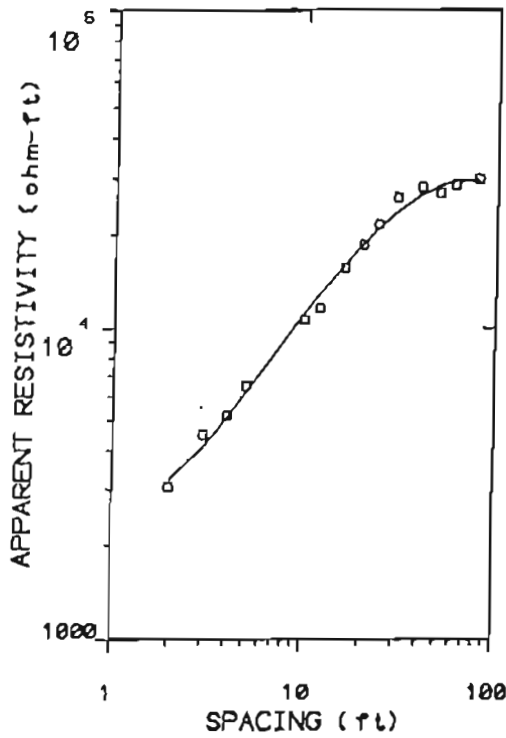
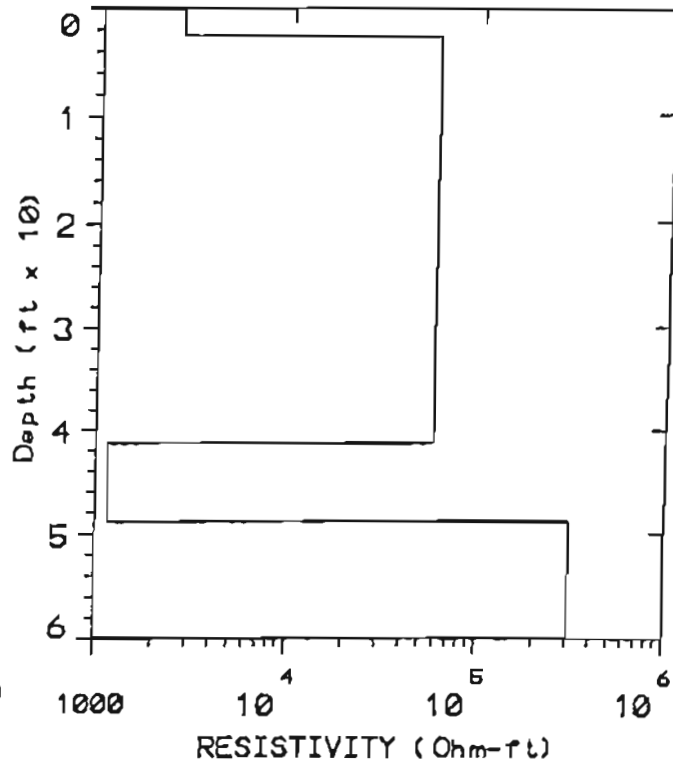
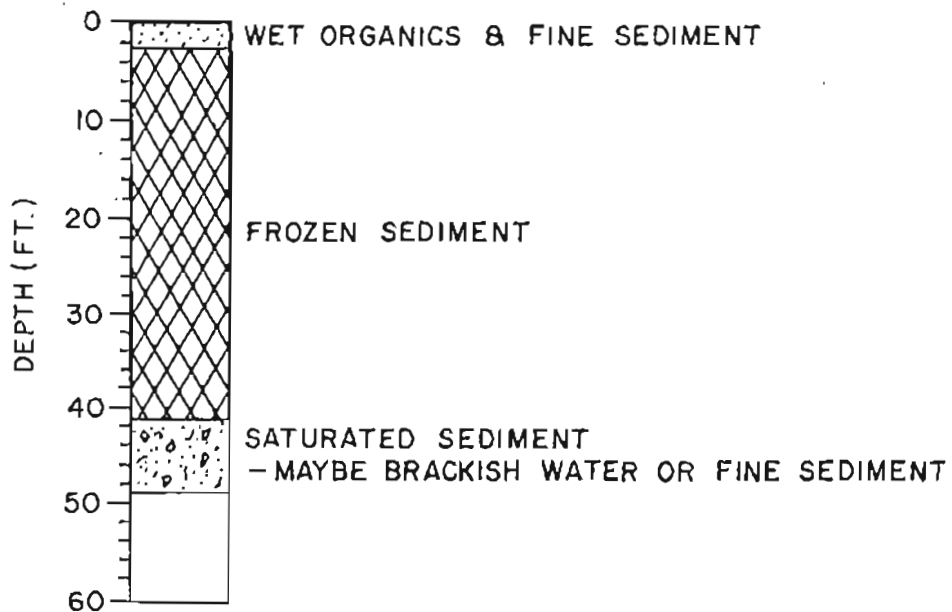
SOUNDING 2

for: CE2	Gambell Water
by: Williams Consulting	below gallery
Date Set: SL142	St. Lawrence Island, Aleale
Date: June 18, 92	Asimuth: N70E
Equipment: ABET RECORDER	Sounding: 2

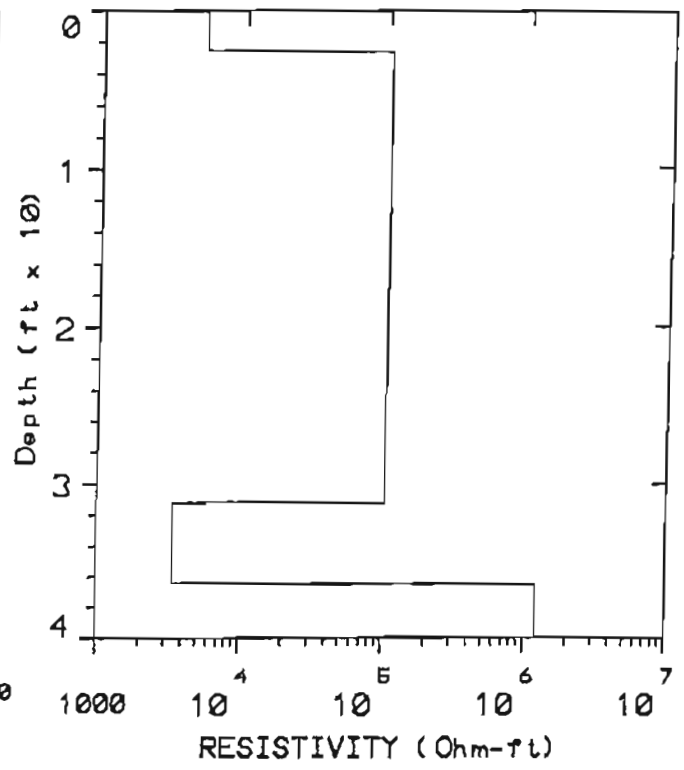
Plate: 10a

for: CE2	Gambell Water
by: Williams Consulting	below gallery site
Date Set: SLIS2	St. Lawrence Island, Alaska
Equipment: ADON 300000	Azimuth: N70°
Sounding: 2

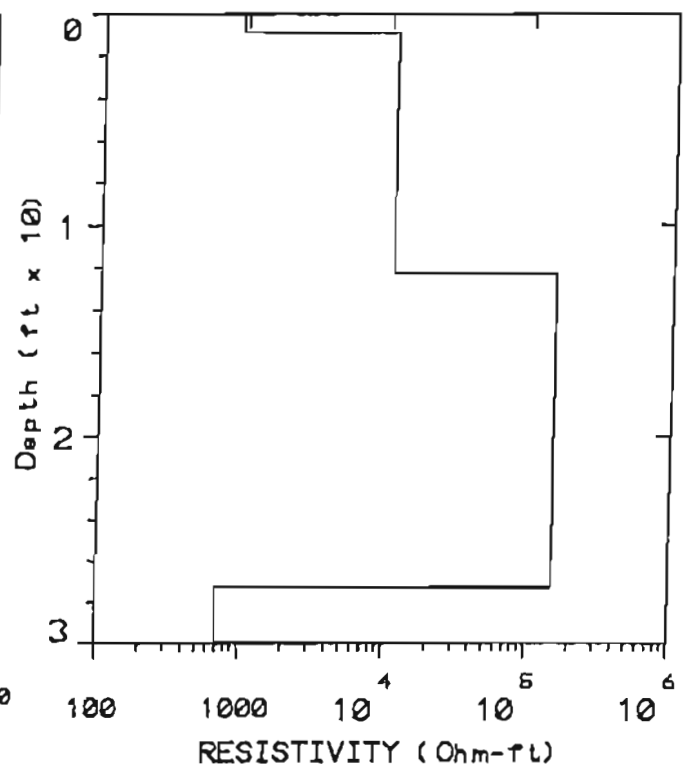
Plate 10a

for: CE2	Gambell Water
by: Williams Consult	northern watershed high
Date Set: SLISE	Date: June 19, 92
Equipment: ADD1 NC2000	Sounding: 5
	Altitude: N45E

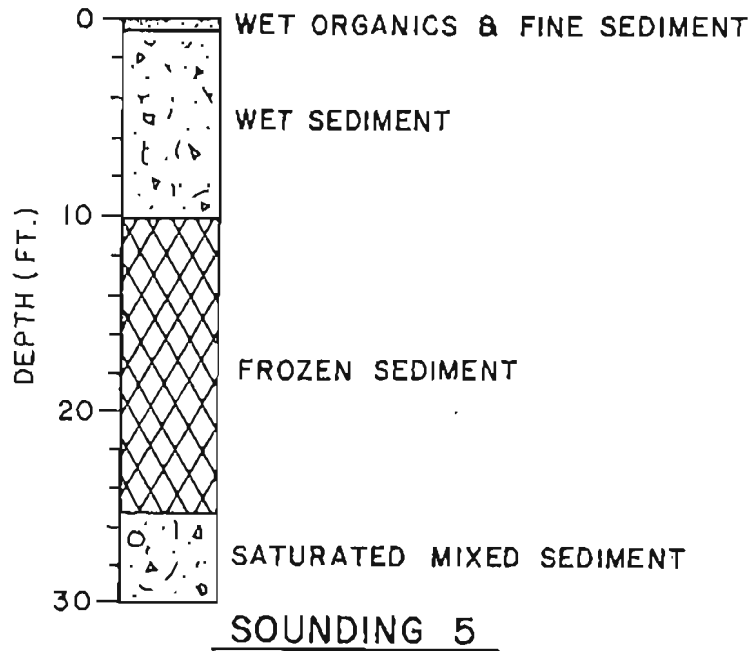
Plate 10a

for: CE2	Gambell Water
by: Williams Consulting	north watershed upper
Date Set: SL15	St. Lawrence Island, Alaska
Date: June 19, 92	
Location: A001 SECTION	Arithmetic: NONE
Sounding: 5

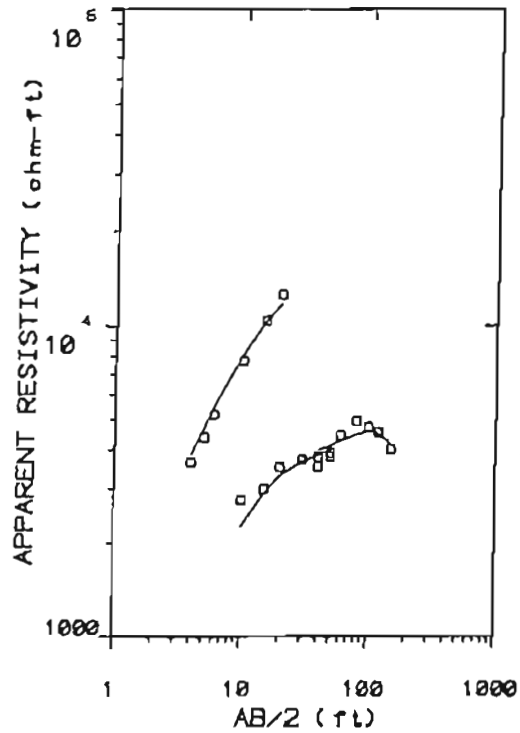
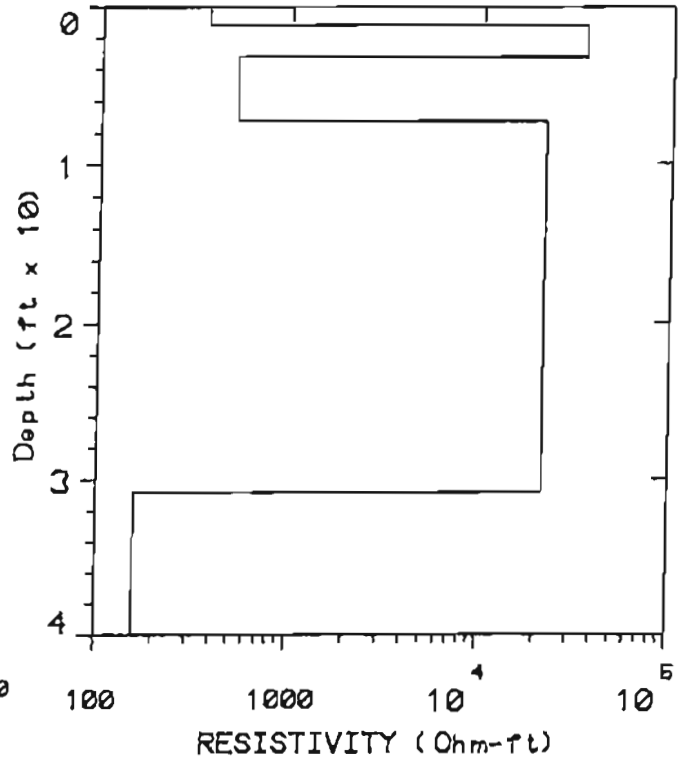
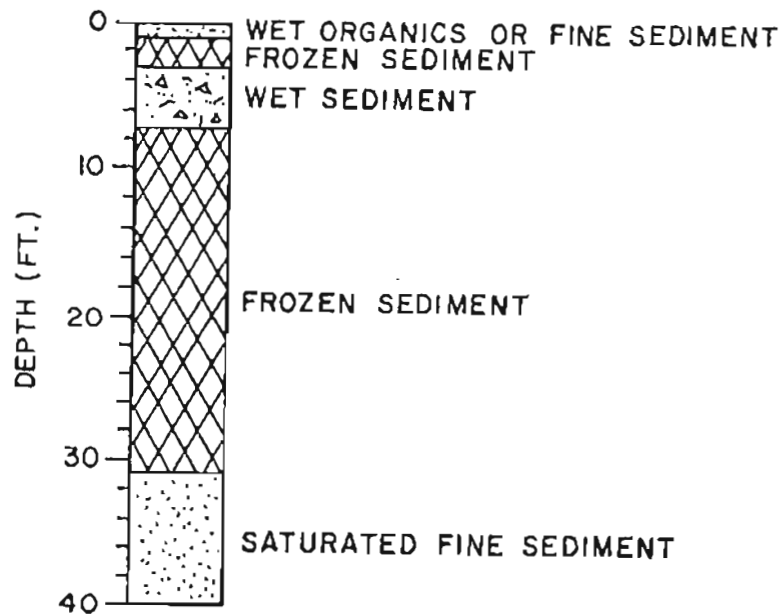
SOUNDING 6

for: CE2	Gambell Water
by: Williams Consulting	northern watershed low
Date Set: SLIS6	St. Lawrence Island, Alaska
Equipment: ABEM 8600B	Azimuth: N45E
Date: June 20, 92	
Sounding: 6

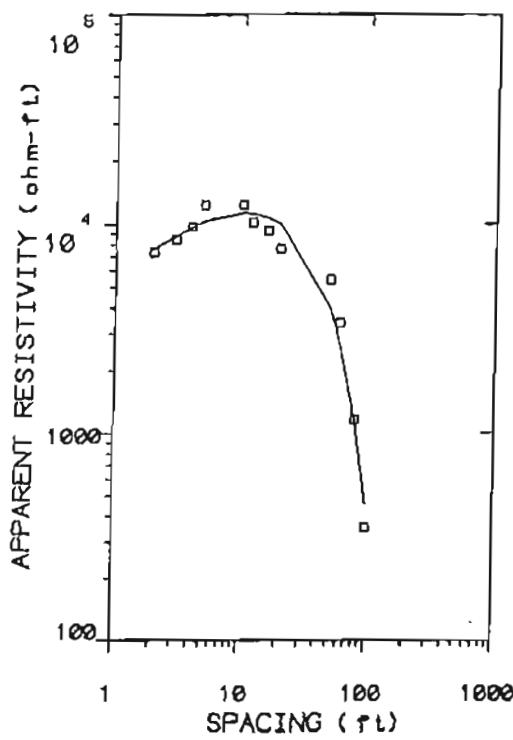
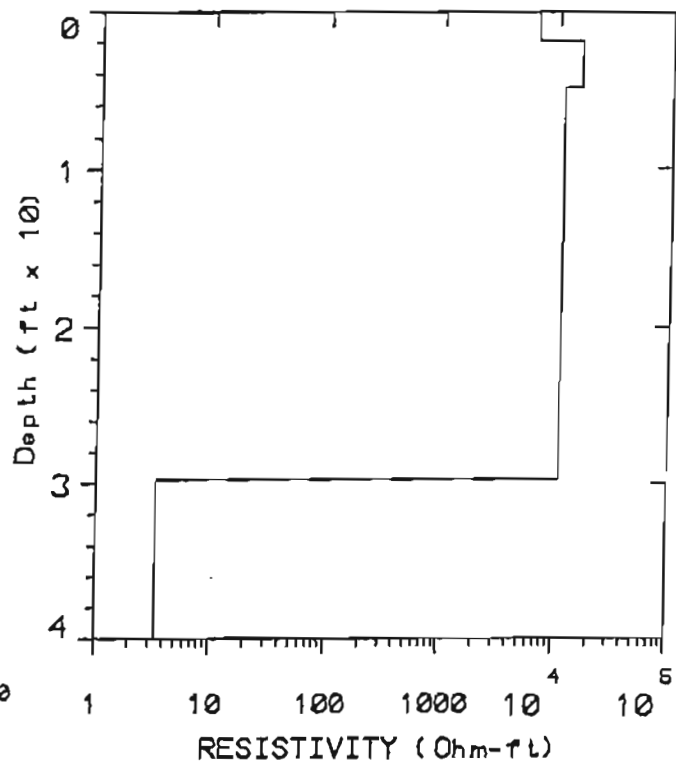
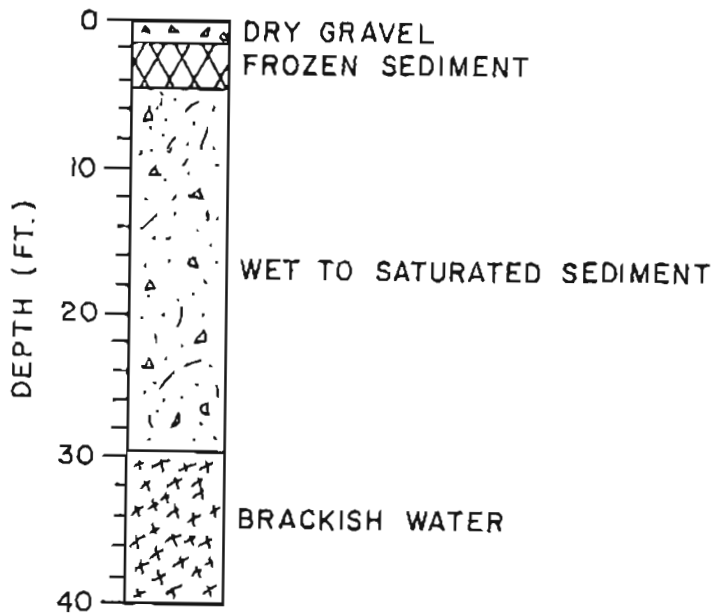
SOUNDING 7

for: CE2	Gambell Water
by: Williams Consulting	by old village well
Date Set: SLW7	Date: June 19, 92
Location: NAD 83 82000	Sounding: 7
	Arithmetic: MBE

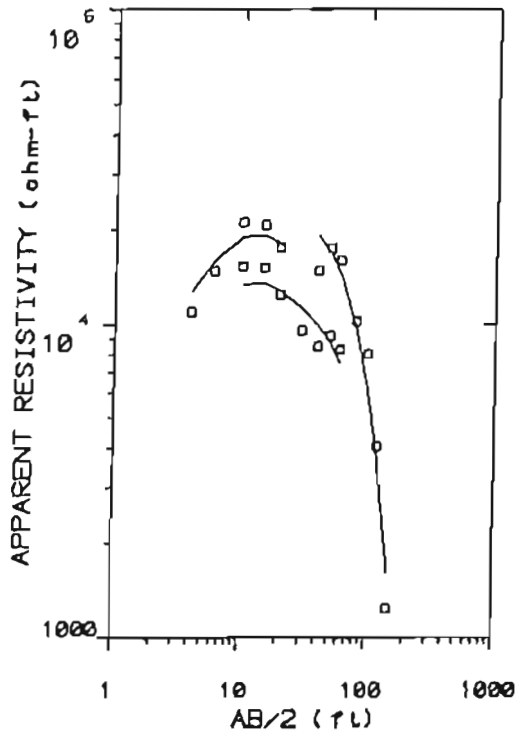
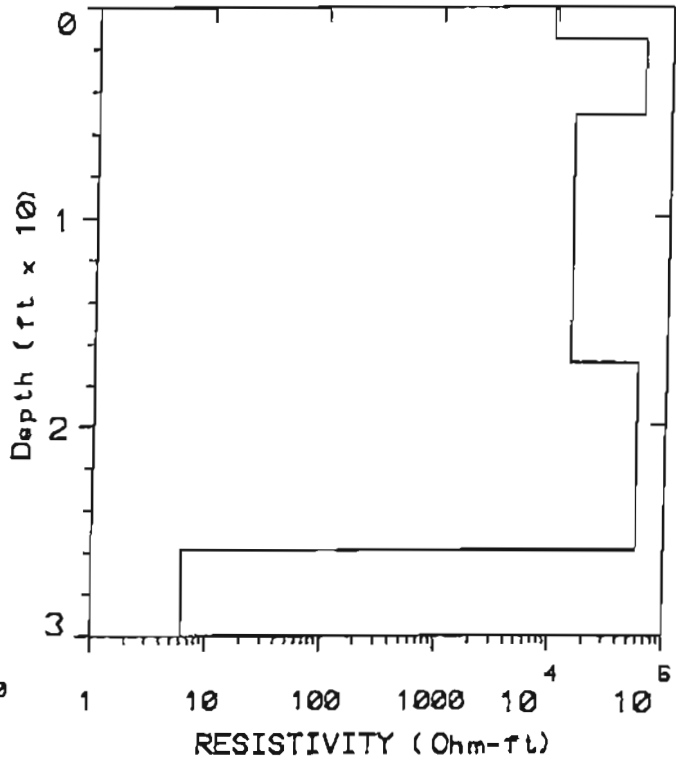
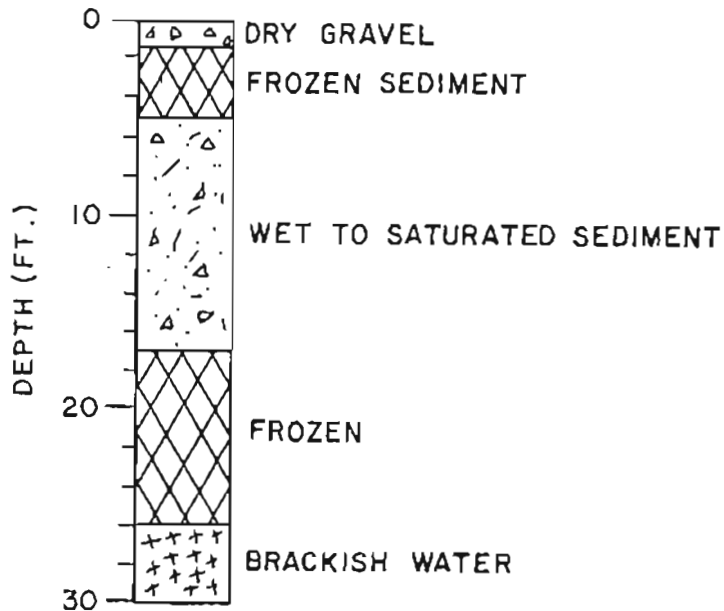
SOUNDING 7

for:	CE2	Gambell Water
by:	Williams Consulting	by old village well
Date Set:	SLIS7	St. Lawrence Island, Alaska
Equipment:	ABEM 6200B	Asimuth: N45E
	Sounding: 7

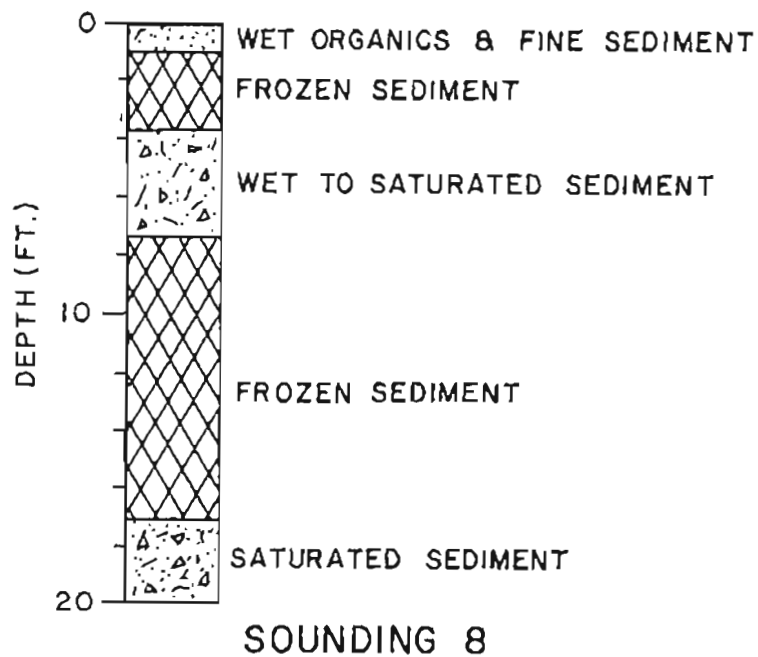
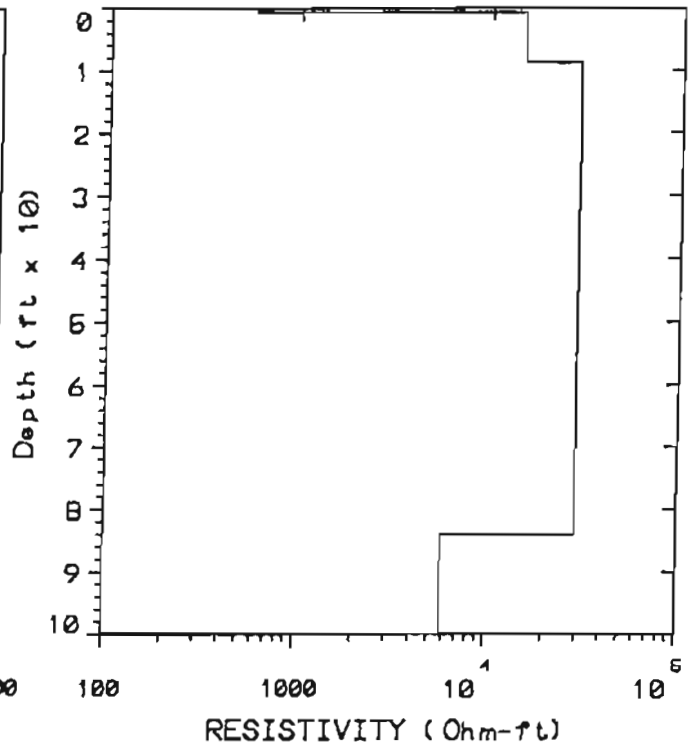
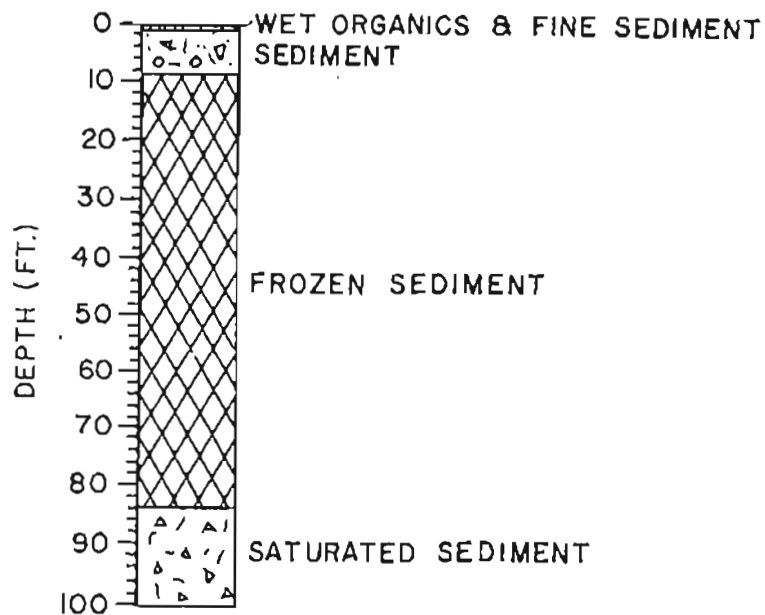
SOUNDING 8

For: CE2		Gambell Water
by: Williams Consulting		above gallery
Date Set: SLWB	Date: June 19.92	St. Lawrence Island, Alaska
Equipment: ADP1 MC20000	Sounding: 8	As Inv. . . .

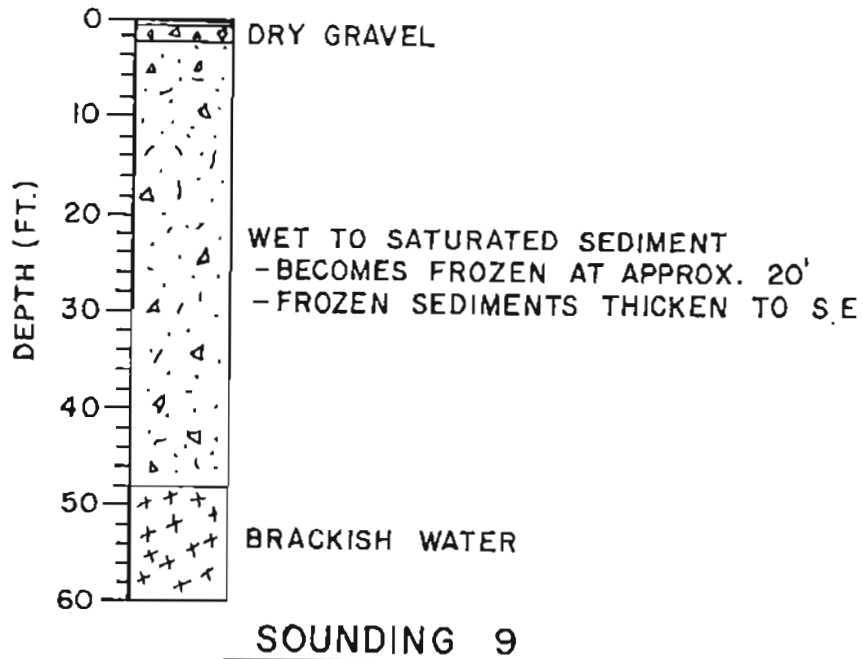
Plate 10a

For: CE2	Gambell Water
by: Williams Consulting	beach area NE Leachner quarter
Date Set: SLI19	Date: June 19, 92
Equipment: ADEK SCOROS	Sound (ng): 9
	Arithmetic: NASH

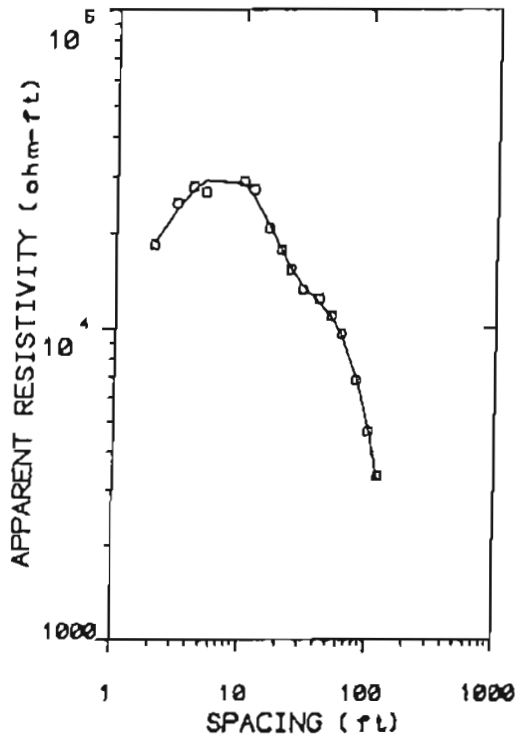
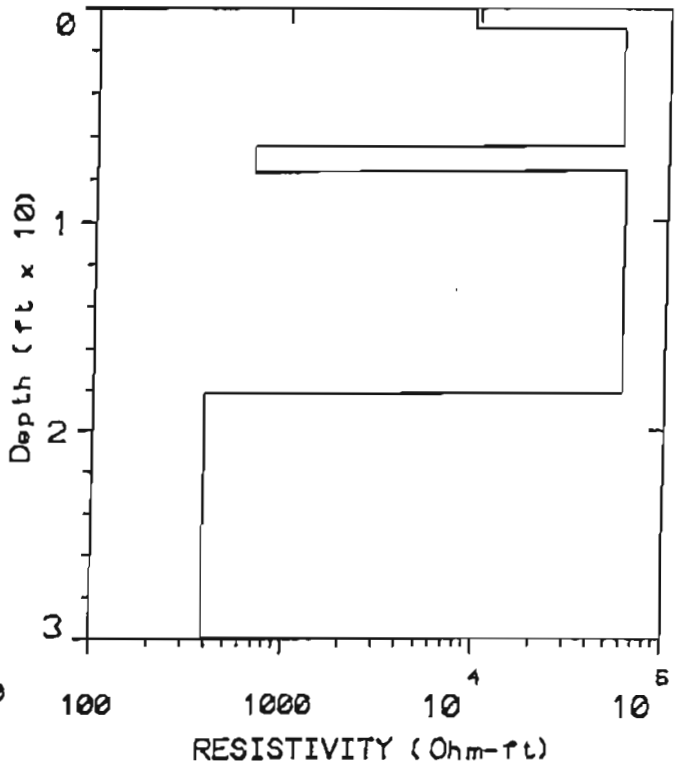
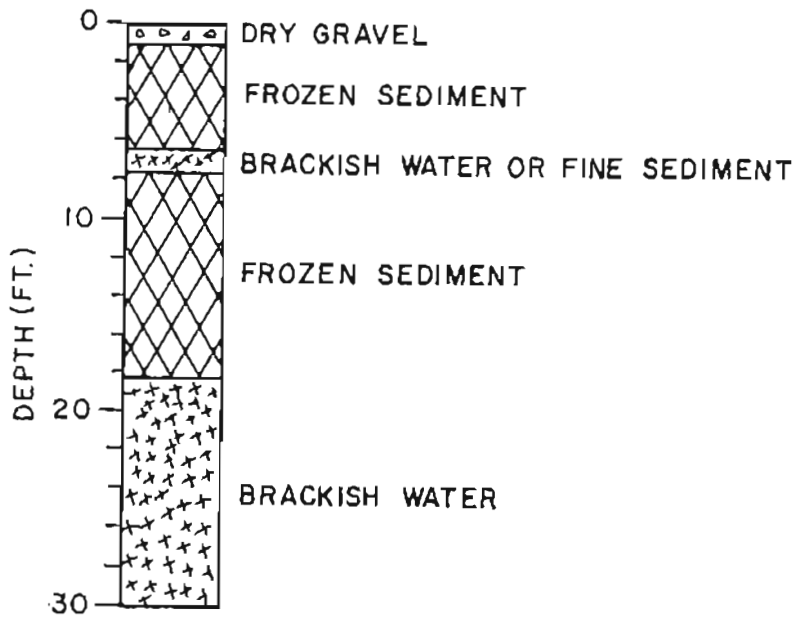
SOUNDING 12

for: CE2		Gambell Water
by: Williams Consulting		beach area behind snow fence
Date Set: SL1412	Date: June 20, 92	St. Lawrence Island, Alaska
Equipment: ARES 300000	Sounding: 12	Asimuth: NSS

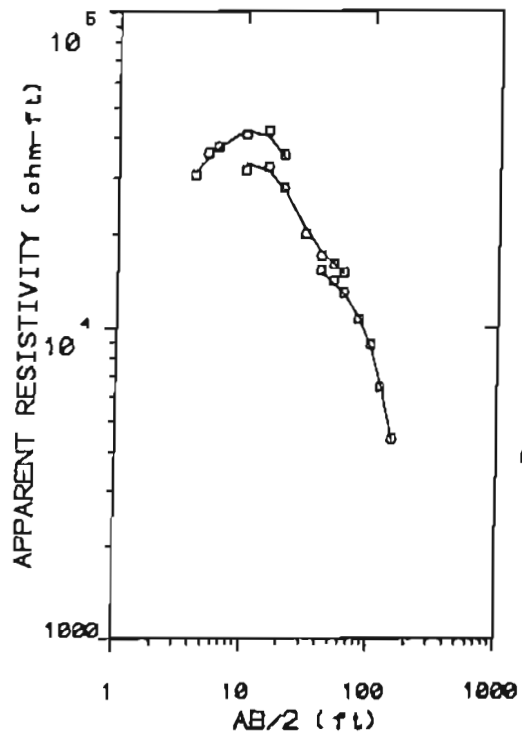
Plate 18a

port CE2		Gambell Water
by Williams Consulting		between beach ridges NE of fan
Date Sali SLIS12	Date: June 20, 92	St. Lawrence Island, Alaska
Estimate: ASDI 1230000	Sounding: 12	Arithmetic: NBSJ

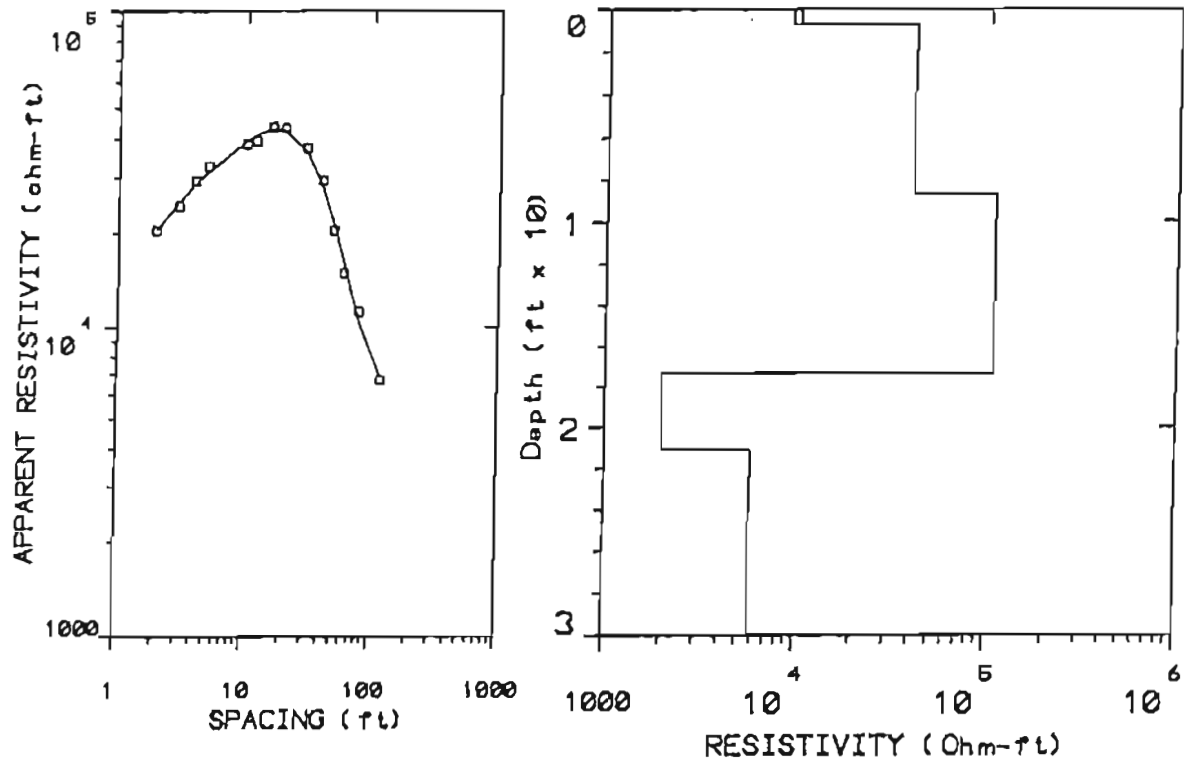
SOUNDING 14

form CE2		Gambell Water	
by: Williams Consulting		1000' N of teach quarters	
Date Set: 8/14/92	Date: June 20, 92	St. Lawrence Island, Alaska	
Equipment: AGON MICROLOG	Sounding: 14	Azimuth: N27E
