Geological Sketch
of
TREASURY HILL
Surface & Underground Workings
Ank Group
Juneau Gold Belt.
Alaska

Sketch & Samples Rv,
J. C. Roehm
Associate Engineer.

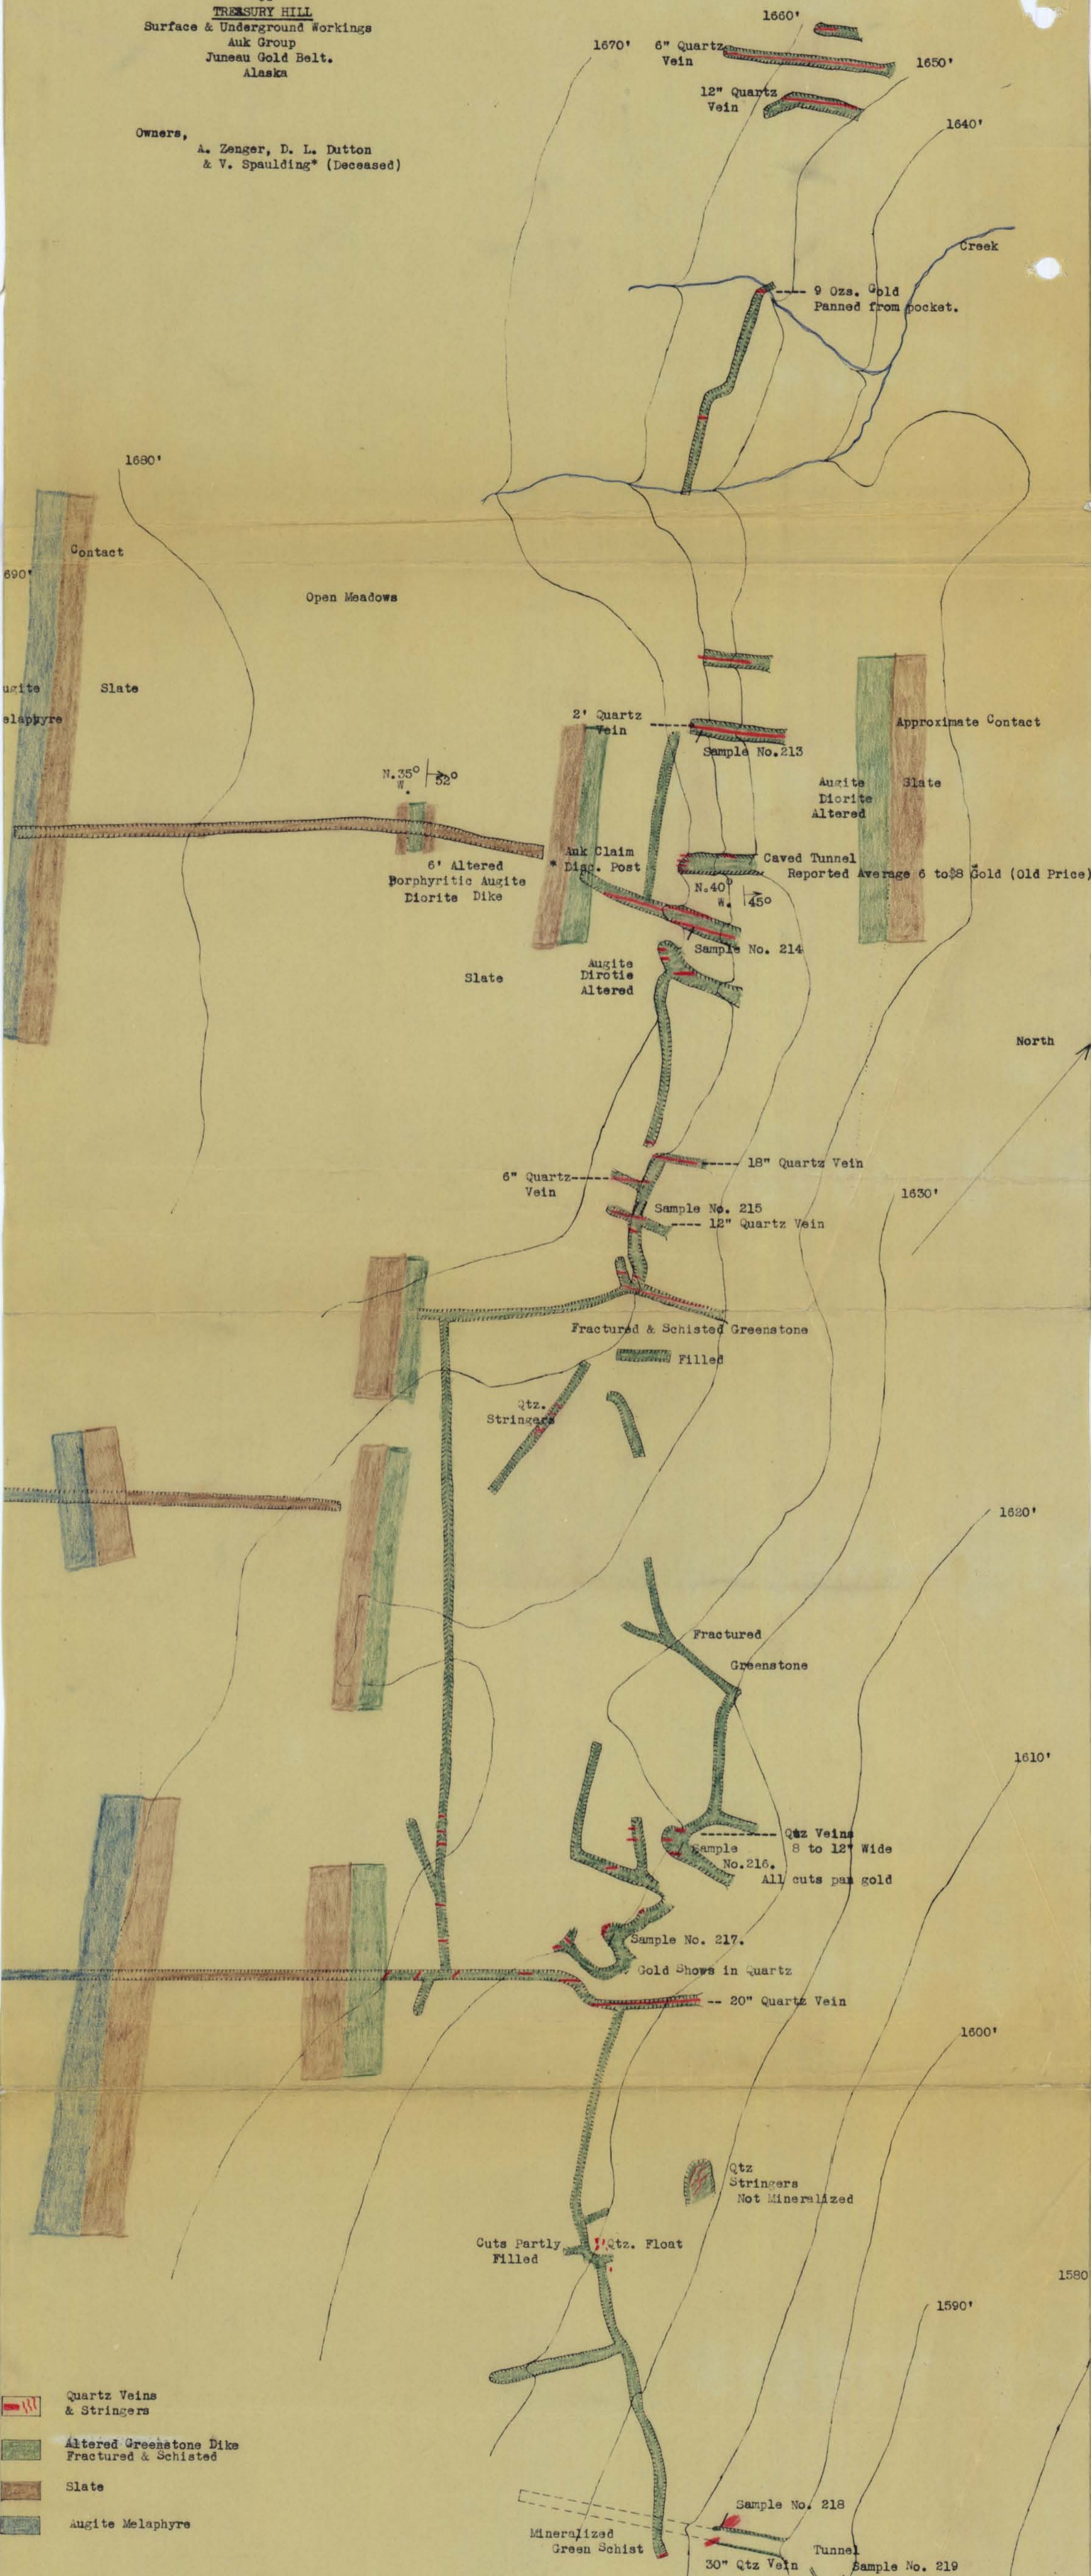
- Quartz Veins & Stringers
- Altered Greenstone Dike Fractured & Schisted
- Slate
- Augite Melaphyre

Assays					
Sample No.	Location	Description	Width	Gold Ozs. Per Ton	Silver Ton
213	Sketch - End Cut	Across Six Qtz Stringers	10' 5"	0.20	0.2
214	" " "	" Several "	10'	0.06	0.2
215	" " "	" " "	11'	Trace	Trace
216	" Top of Cut	" " "	11'	Trace	0.3
217	" Side of Cut	" Mostly Quartz	8'	0.02	0.4
218	" Portal of Tunnel	" Quartz Vein	2' 8"	Trace	0.2
219	" Tunnel Dump	Grab from dump.		Trace	0.2
