PRELIMINARY REPORT OF RUFF AND TUFF MINING COMPANY,
COLUMBIA GLACIER AREA, PORT VALDEZ DISTRICT
September 14, 1936.

SUPPLEMENTARY REPORT OF RUFF AND TUFF MINE
(To be added to preliminary report of September 4, 1936)
August 31, 1938

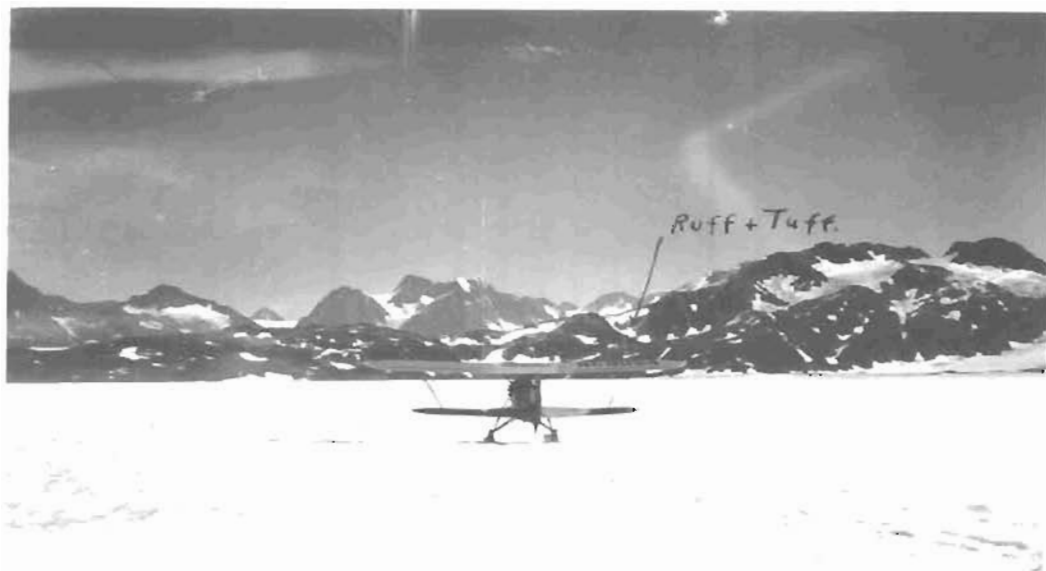
Location of Ruff & Tuff Mine, King Island in foreground.

Note roughness of topography in background. Winter and spring landing field in foreground.

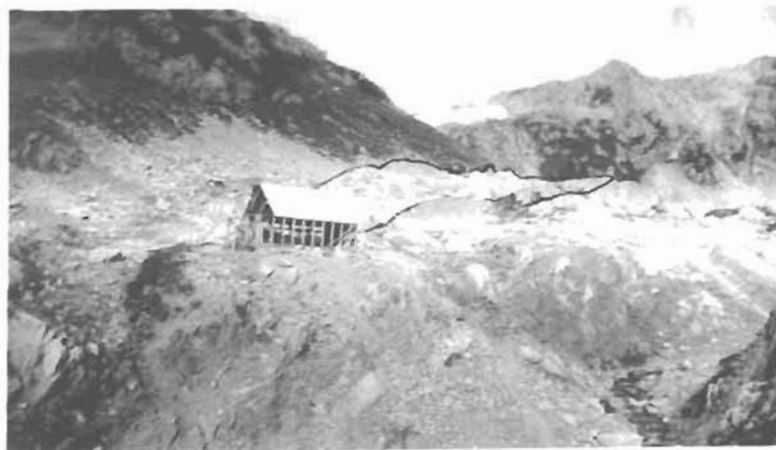
Outcrop of diorite sill and mill building under construction.

The geology consists of a small sill of altered diorite, 270' in length in closely folded, graywacke and argillaceous slates. (Note the above photo) Its lenticular axis conforms to the strike and dip of the schistosity and apparent bedding of the highly schistose sediments. These sediments are highly metamorphosed from what appears to be regional metamorphism and strike nearly east-west and the schistosity dips 60-65° N. The diorite sill was intruded either during the folding or after and was probably of a more plastic nature than the sediments. As a result a schistose structure was not produced, but the opposite effect of cross fracture was the result with numerous fractures nearly at right angles to the schistosity in the sediments. These fractures are filled with silica, making numerous quartz stringers and gash veins. (Note photo below)

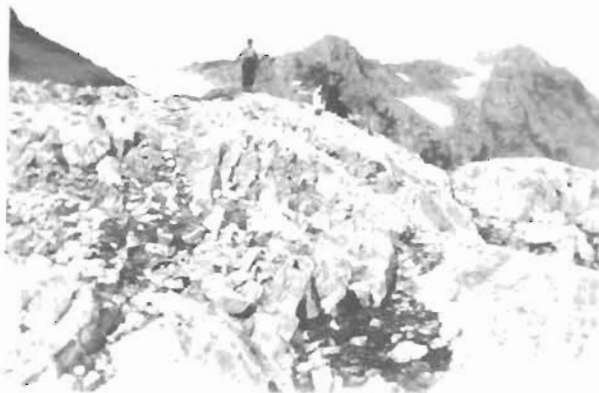
Showing the numerous parallel cross fractures filled with silica. Most of these carry visible gold.

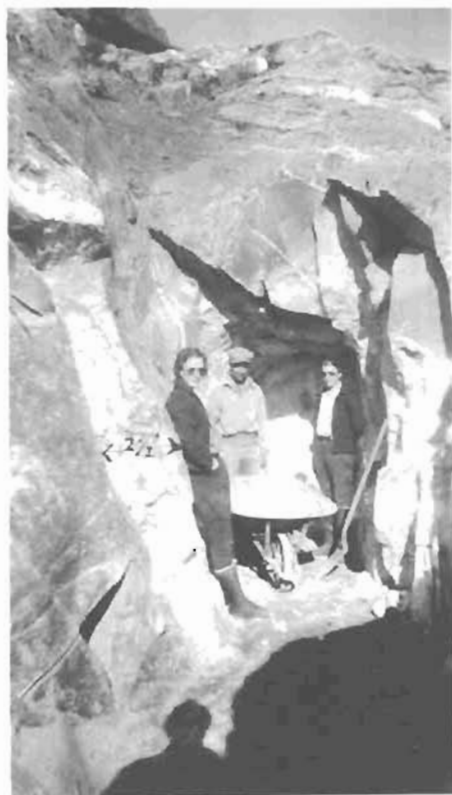
No. 1 vein. This vein was discovered when the opencut was extended into the diorite. It has a developed length of nearly 40' and a width of 18" to 2½'. This vein strikes N. 73° E. and dips 75° S. The walls are free in most portions and a slight movement was noted on the hanging wall. A slight difference was noted in the mineralization of each vein. No. 1 vein appears to be more basic in its mineralization which consists of pyrite, galena and sphalerite. Free gold can be seen with the mineralization and usually associated with the galena and sphalerite. A few crystals of specularite were noted. This vein is wholly within the altered diorite.

No. 1 blind vein in
altered diorite.

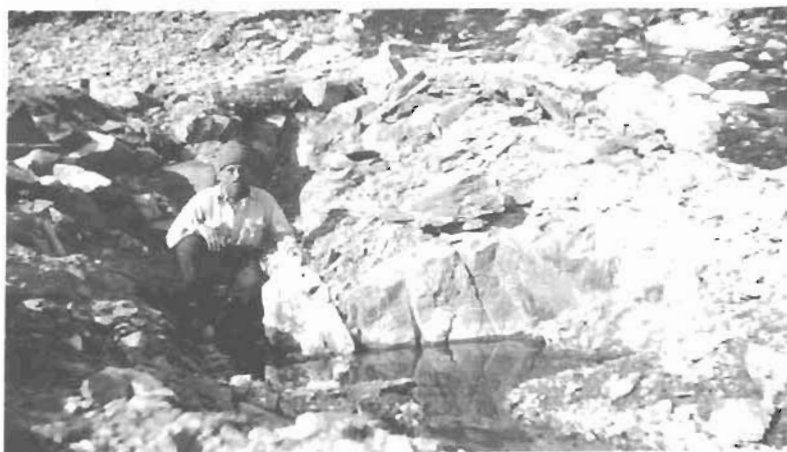
No. 5 vein. This quartz vein has an exposed length over 50' and averages 18" in width. Six inches of this width shows a darker and more intensely mineralized quartz. The dip is toward the east, and nearly vertical. The mineralization of this vein shows a higher temperature mineralization of pyrite, chalcopyrite, galena, arsenopyrite and free gold. It extends from fractured graywacke north into schistose slate. The gangue minerals are quartz, chlorite, calcite and a greenish mica, the latter in spots in the veins of the intrusive itself.

J. Hoar, manager for the company
and showing No. 5 vein.

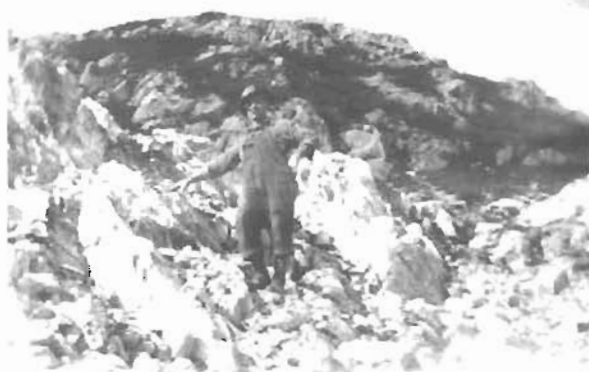
Numerous veinlets, bunches and gash veins occur scattered through the intrusive itself. Gold can be seen in most of them. However, the mineralization in most of the small veins is lacking and the gold occurs free in the whitish quartz. They show a somewhat

parallel arrangement across the sill at right angles to the elongation of the mass. Some bunches are a few feet long and up to 2 to 3' in width, while the gash veins and stringers vary from less than an inch up to 12 to 14" in widest places.

Showing some of larger bunches of quartz in diorite.

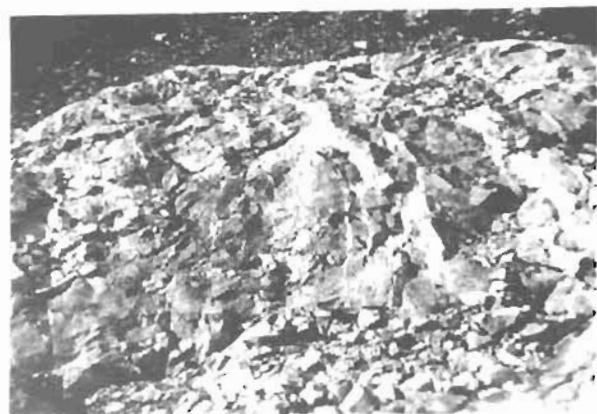
Showing parallelism of small veinlets in diorite.

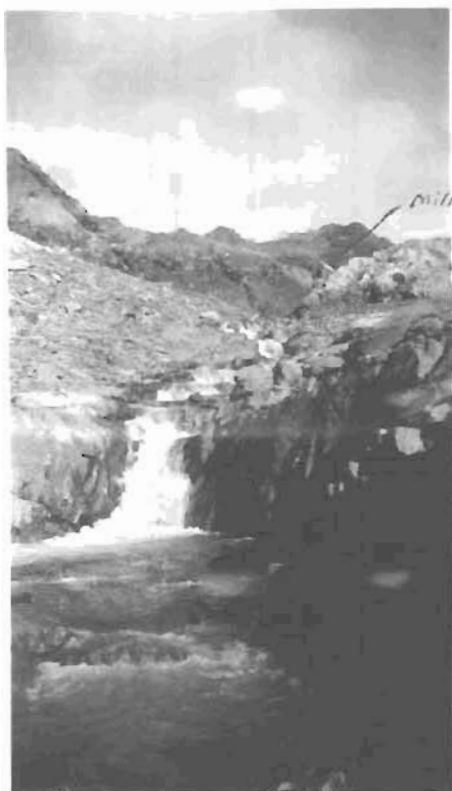
Showing small creek alongside outcroppings with mill in background.

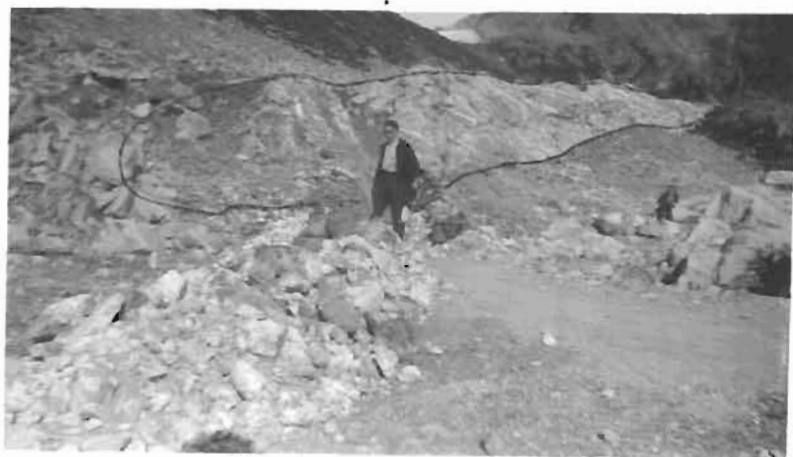
Outcrop of diorite sill and mill
~~building under construction.~~

The geology consists of a small sill of altered diorite, 270' in length in closely folded, graywacke and argillaceous slates. (Note the above photo) Its lenticular axis conforms to the strike and dip of the schistosity and apparent bedding of the highly schistose sediments. These sediments are highly metamorphosed from what appears to be regional metamorphism and strike nearly east-west and the schistosity dips 60-65° N. The diorite sill was intruded either during the folding or after and was probably of a more plastic nature than the sediments. As a result a schistose structure was not produced, but the opposite effect of cross fracture was the result with numerous fractures nearly at right angles to the schistosity in the sediments. These fractures are filled with silica, making numerous quartz stringers and gash veins. (Note photo below)

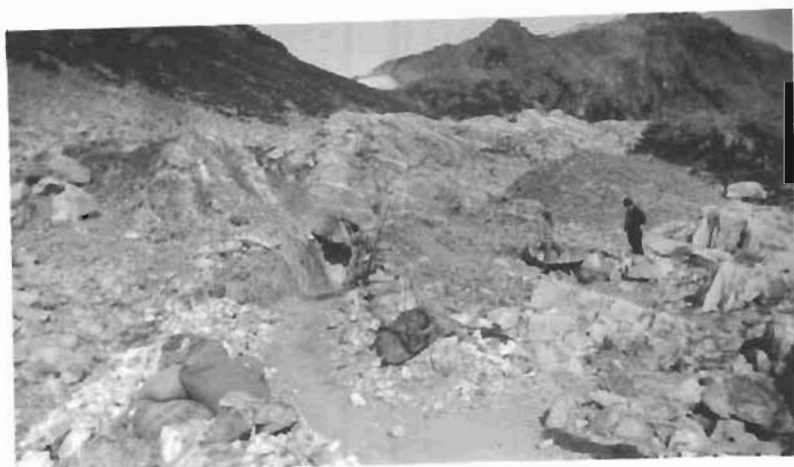
Showing the numerous parallel cross fractures filled with silica. Most of these carry visible gold.

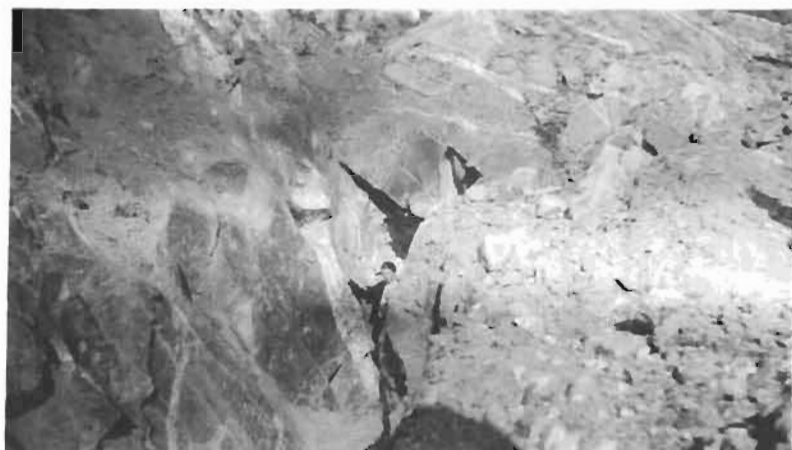
No. 1 vein. This vein was discovered when the open cut was extended into the diorite. It has a developed length of nearly 40' and a width of 18" to 24". This vein strikes N. 73° E. and dips 75° S. The walls are free in most portions and a slight movement was noted on the hanging wall. A slight difference was noted in the mineralization of each vein. No. 1 vein appears to be more basic in its mineralization which consists of pyrite, galena and sphalerite. Free gold can be seen with the mineralization and usually associated with the galena and sphalerite. A few crystals of specularite were noted. This vein is wholly within the altered diorite.

No. 1 blind vein in
altered diorite.

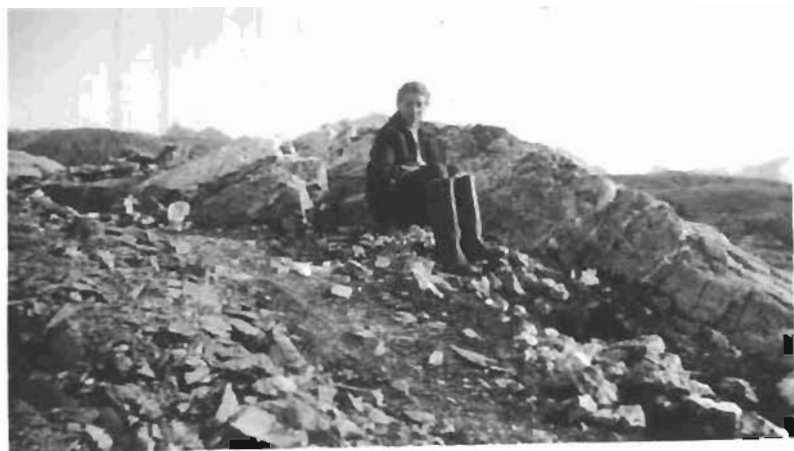
parallel arrangement across the sill at right angles to the elongation of the mass. Some bunches are a few feet long and up to 2 to 3' in width, while the gash veins and stringers vary from less than an inch up to 12 to 14" in widest places.

Showing some of larger bunches of quartz in diorite.

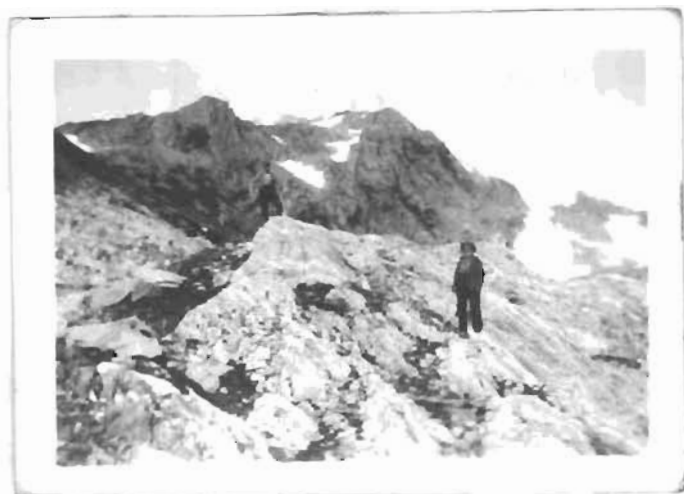
Showing parallelism of small veinlets in diorite.
