**Bureau of Mines
Report of Investigations 4932**

**NONMETALLIC DEPOSITS ACCESSIBLE TO THE ALASKA
RAILROAD AS POSSIBLE SOURCES OF RAW MATERIALS
FOR THE CONSTRUCTION INDUSTRY**

**BY F. A. RUTLEDGE, R. L. THORNE, W. H. KERNS,
AND J. J. MULLIGAN**

**UNITED STATES DEPARTMENT OF THE INTERIOR
Douglas McKay, Secretary
BUREAU OF MINES
J. J. Forbes, Director**

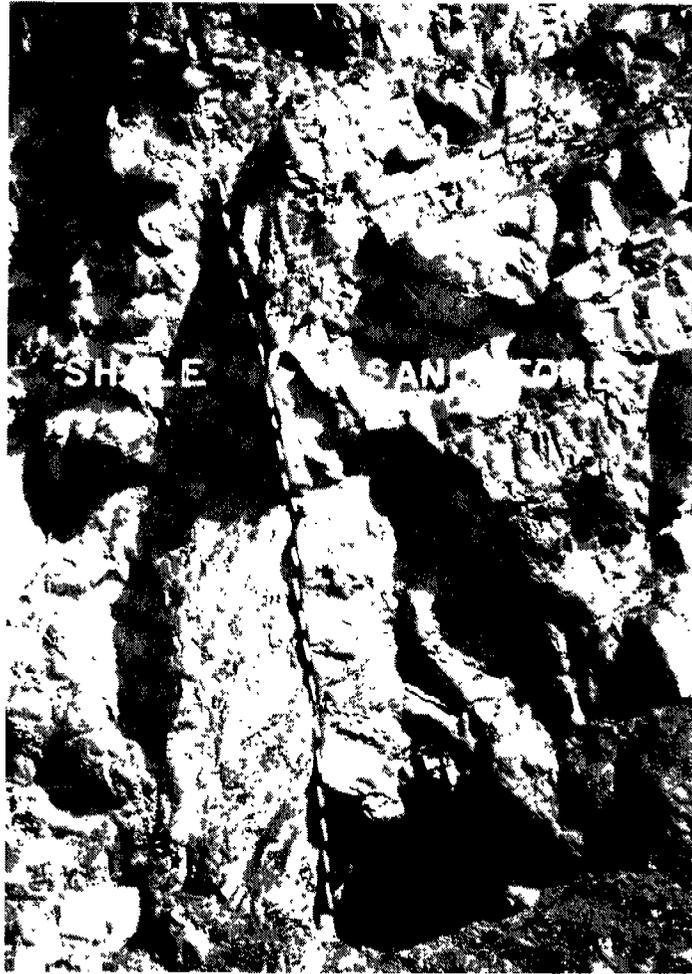
Figure 24. - Close-up view of boundary fault,
mile 67.
