Base modified from U.S. Geological Survey published
map of dam site on Power Creek

Geology by Don J. Miller

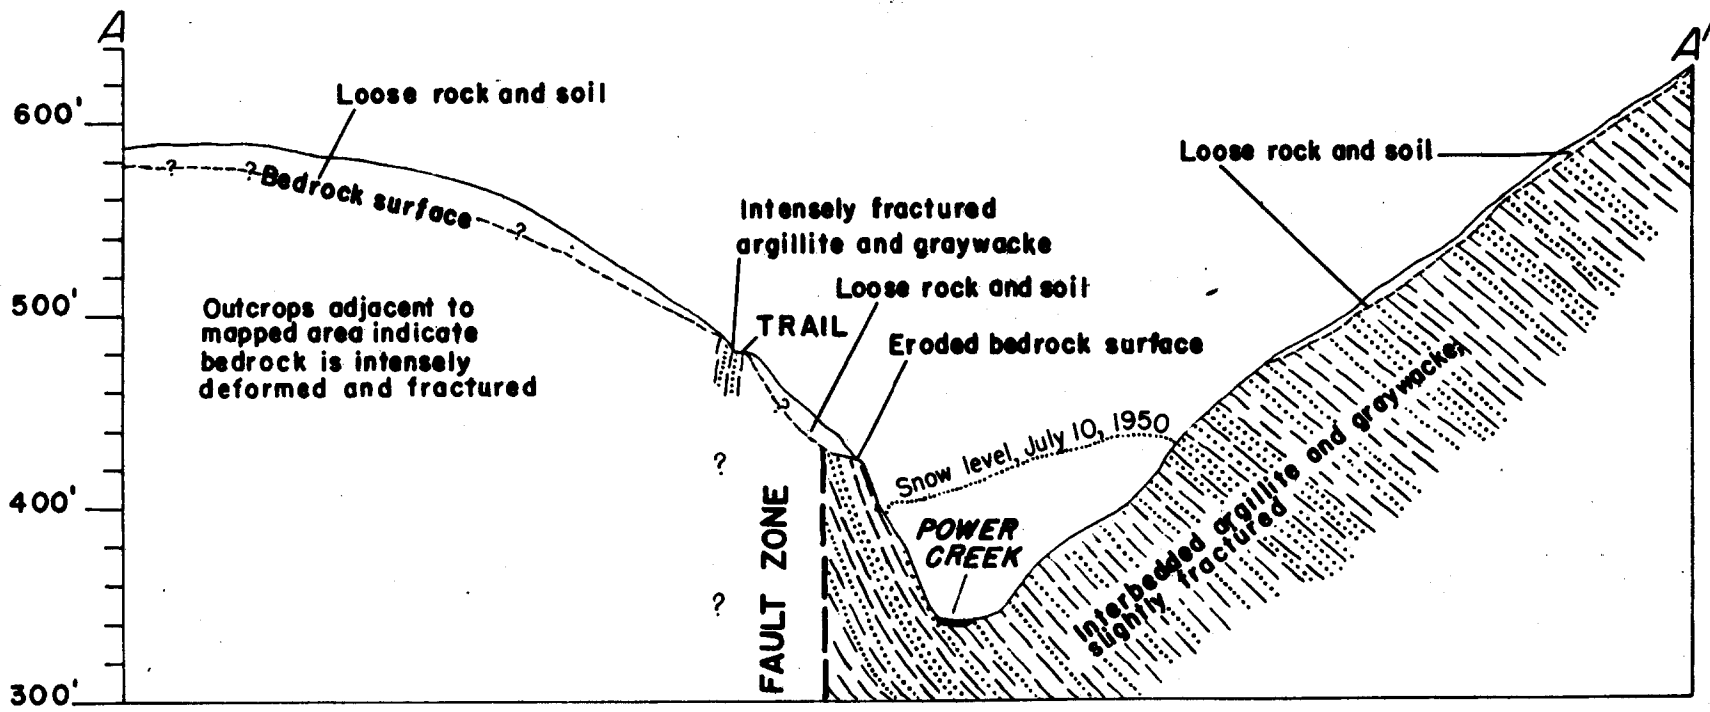
Horizontal and vertical scales are equal
SECTION ALONG THE LINE A-A'

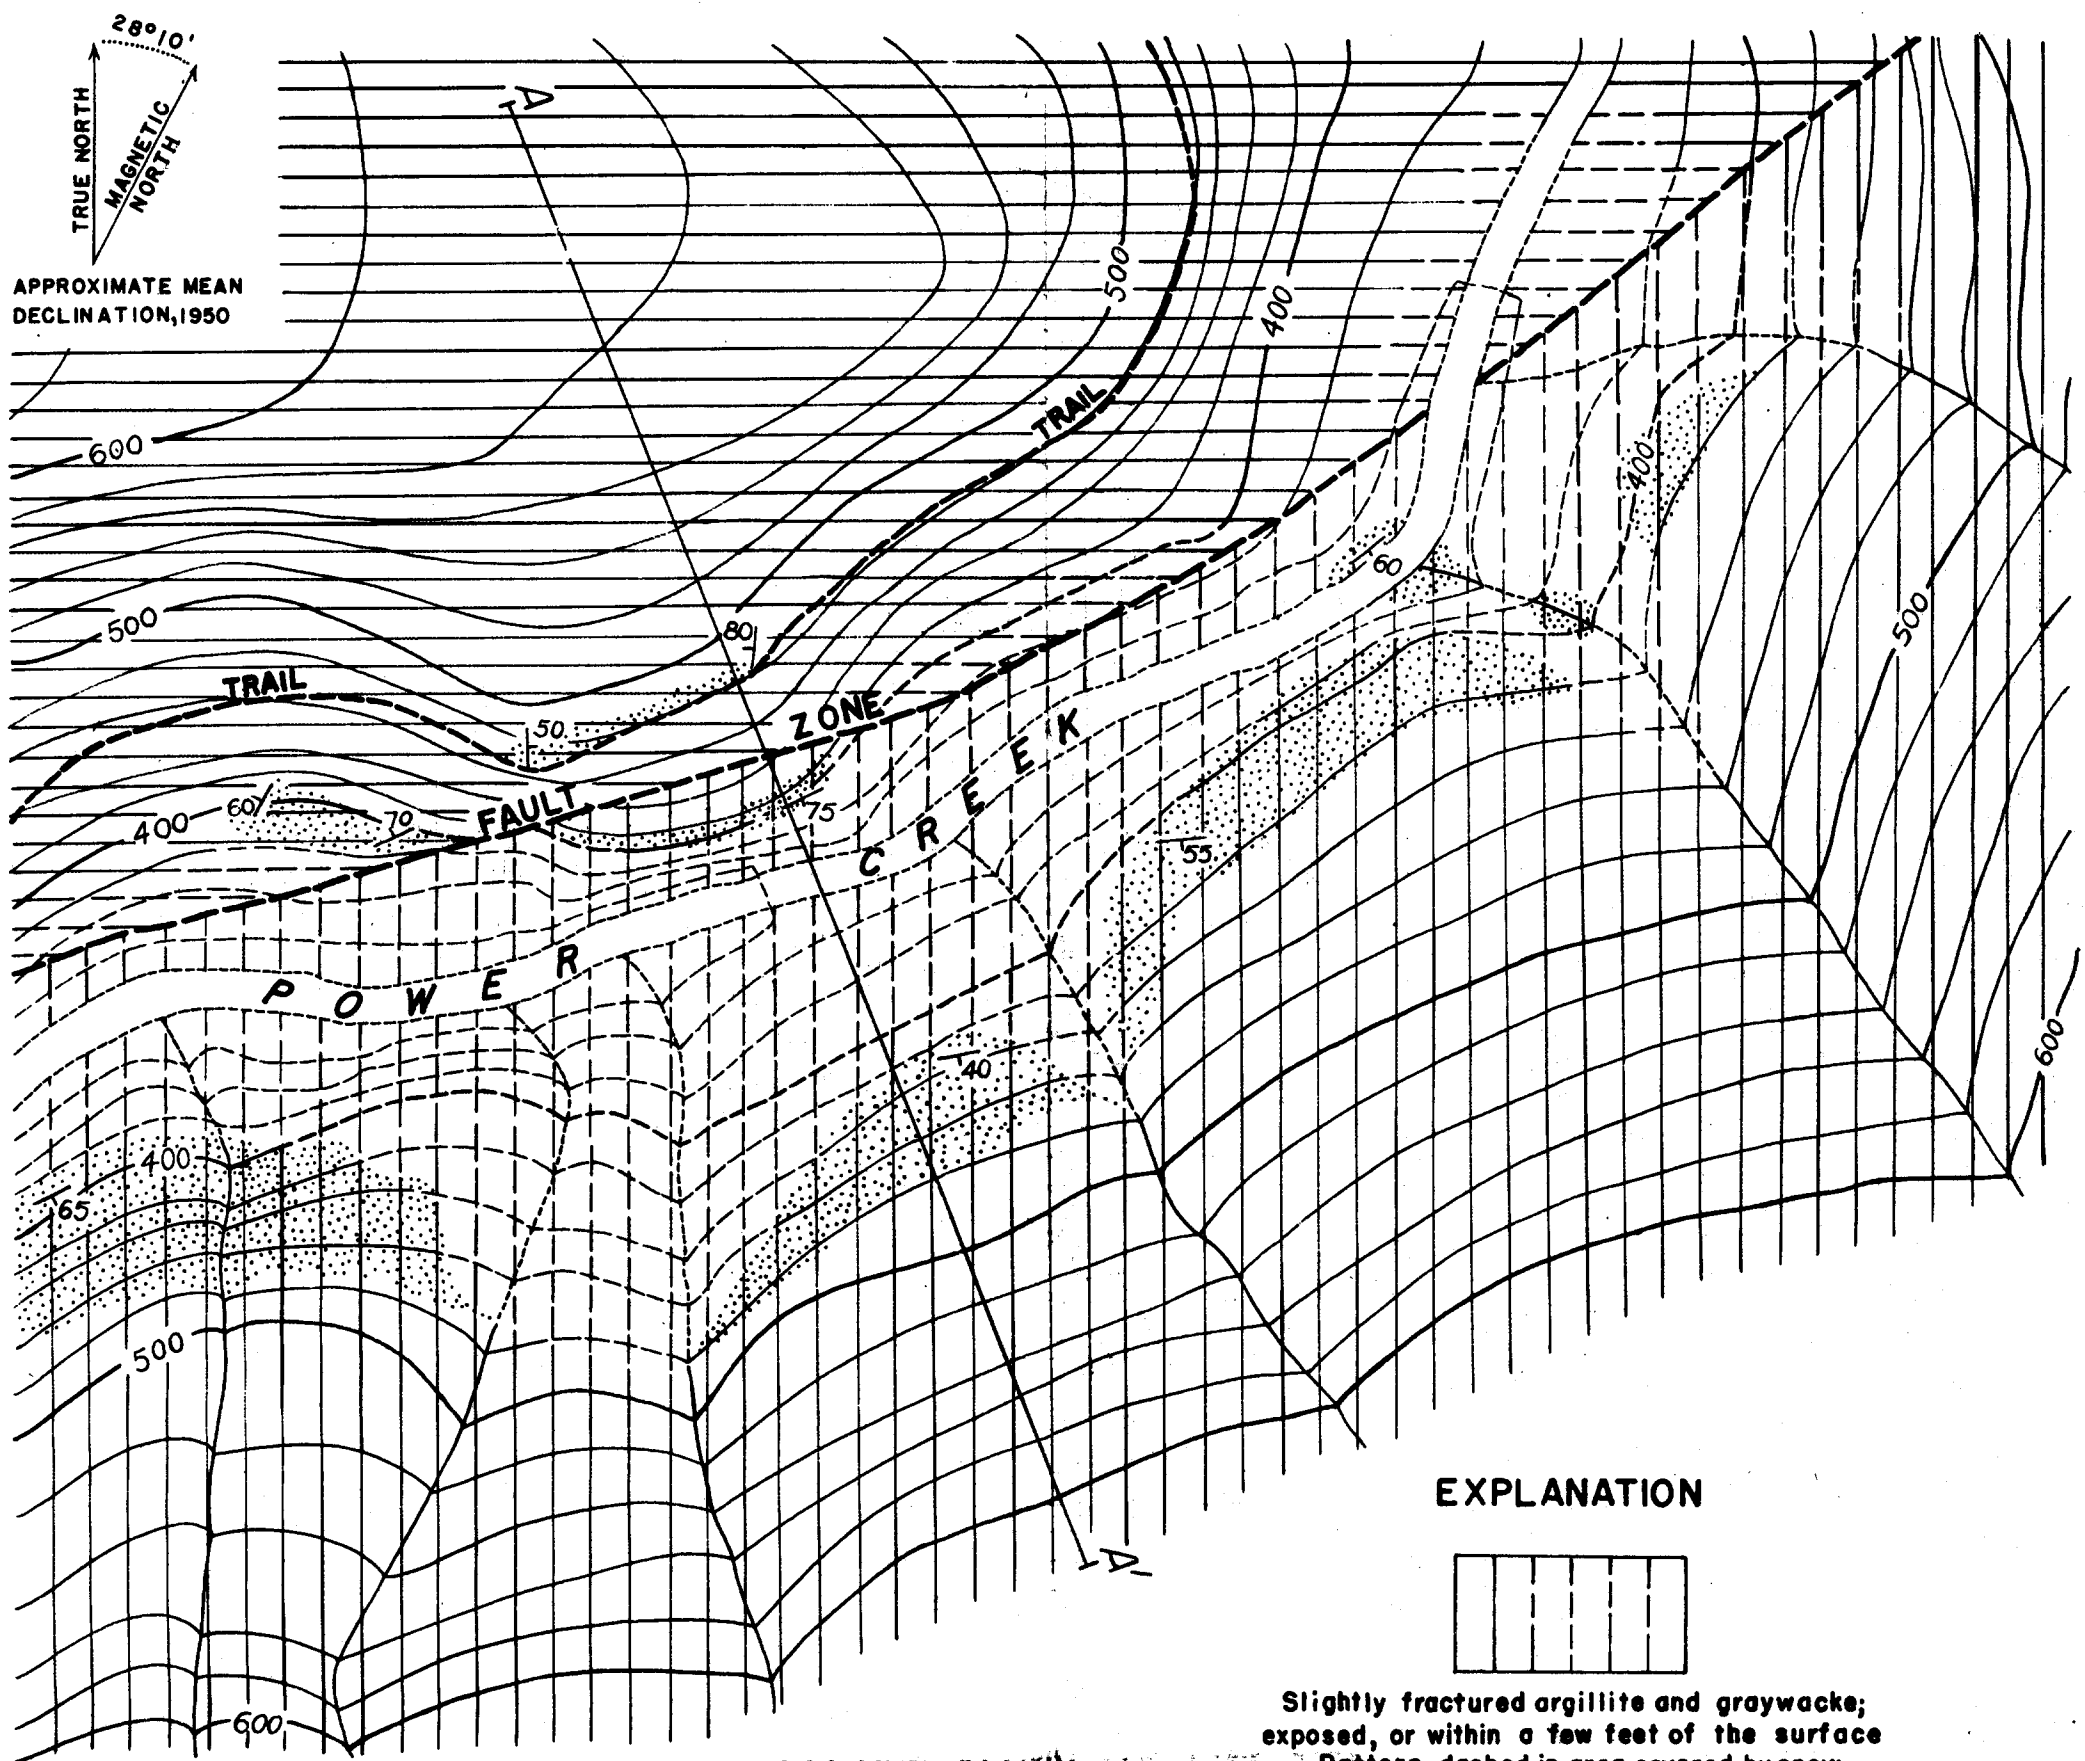
Contour interval 20 feet
Datum is mean sea level

Contours, stream pattern, and geologic patterns dashed
in area covered by snow on July 10, 1950. Observed out-
crops of bedrock indicated by dot pattern
