PRELIMINARY REPORT OF PORTAGE GOLD MINES, LTD.,  
POE BAY, PRINCE WILLIAM SOUND DISTRICT, VAL-  
DEZ PRECINCT, PORT WELLS AREA  
September 22, 1936.

12.5, 15.3  
108-121  
SUPPLEMENTARY REPORT TO ACCOMPANY PRELIMINARY REPORT  
OF PORTAGE GOLD MINES, LTD., POE BAY,  
PRINCE WILLIAM SOUND, ALASKA  
August 16, 1938

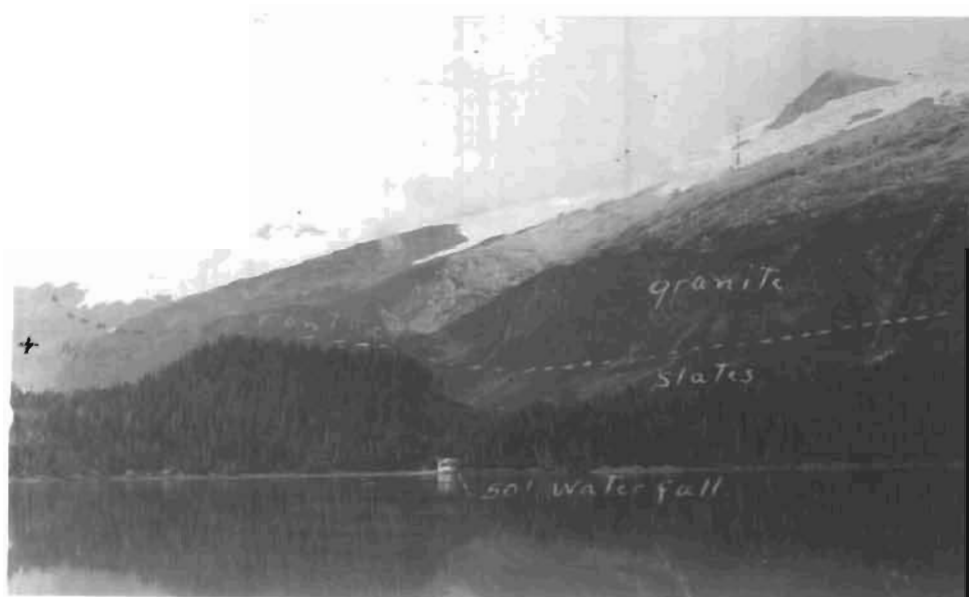
Looking north from head of Poe Bay showing granite-slate contact and 50' water fall.

The geology in this area is very favorable for gold deposition due to the existence of a slate and granite contact that shows considerable mineralization. This contact is located (see above photograph) along the east side of the valley in a northerly direction cutting the schistosity of the slates at nearly a right angle. Several light greenish to gray dikes extend from the contact into the slates at various angles. The slates consist of wide bands of black graphitic slates, interbanded narrow graywackes and slates of a more argillaceous nature. Along and in the vicinity of these dikes small quartz veins
