TSUNAMI INUNDATION MAPS OF WHITTIER AND WESTERN PASSAGE CANAL, ALASKA

by D.J. Nicolsky, E.N. Suleimani, R.A. Combellick, and R.A. Hansen
2011

State of Alaska
Department of Natural Resources
DIVISION OF GEOLOGICAL & GEOPHYSICAL SURVEYS

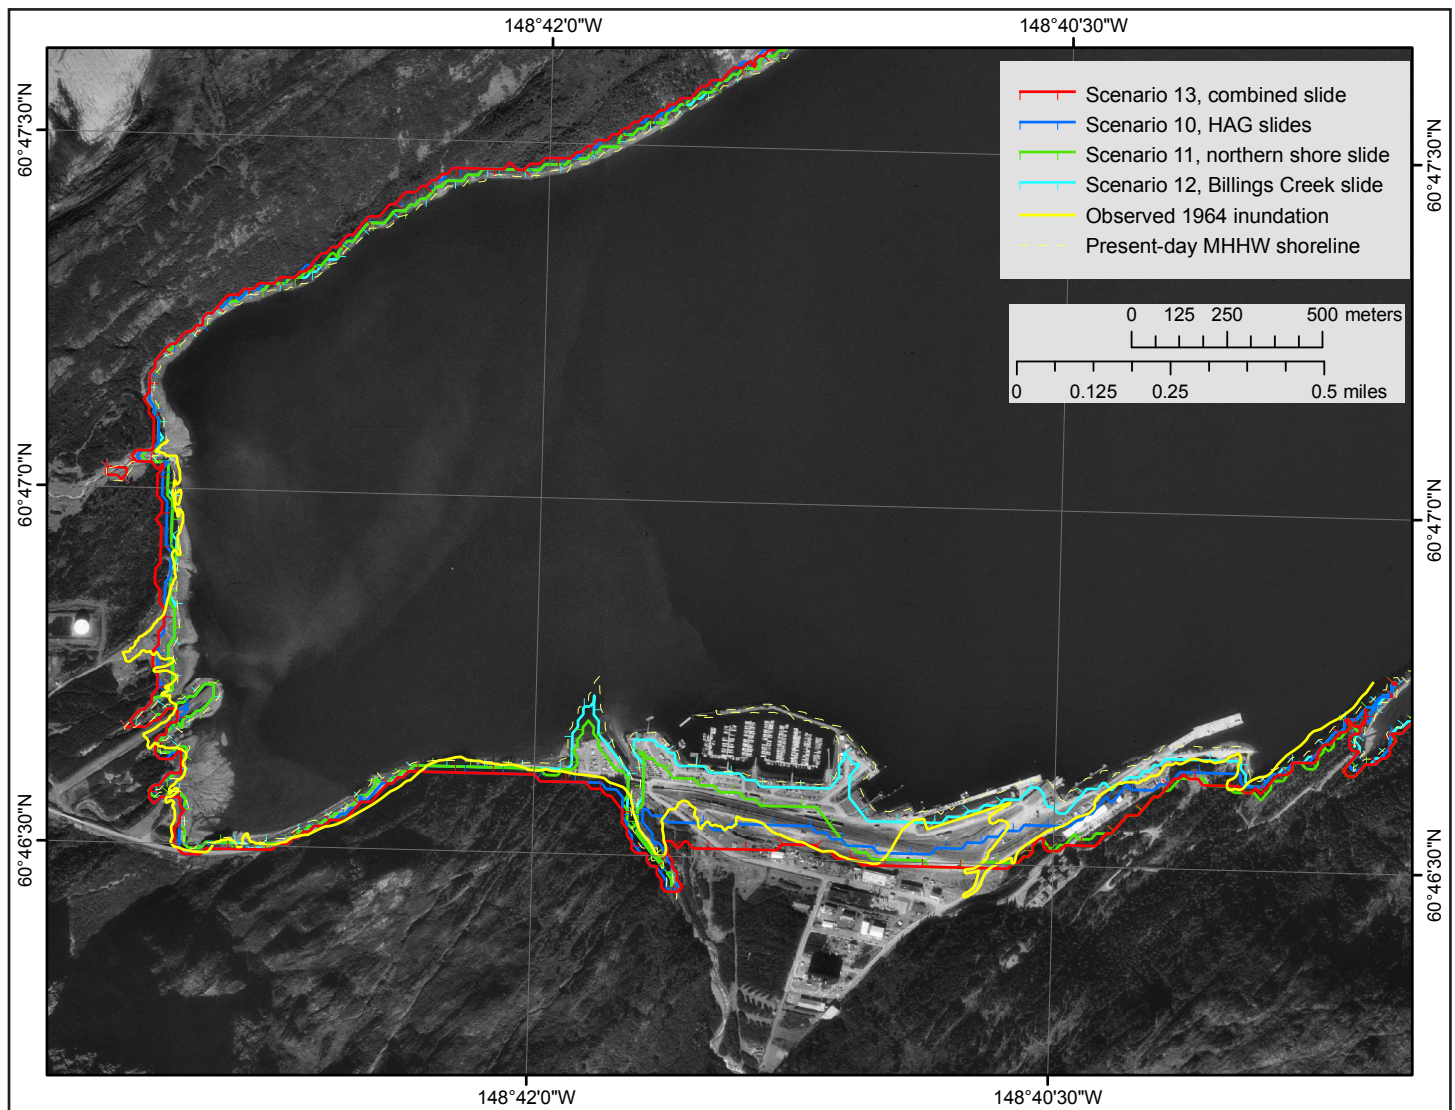
Maximum computed potential runup by landslide-generated tsunami waves in Passage Canal for scenarios 10–13. The yellow line represents observed inundation after the 1964 tsunami. The present-day MHHW shoreline is shown by a dashed yellow line. Locations of points 3 and 15 are shown by rectangles.
