## REPORT OF INVESTIGATIONS 2014-3 NICOLSKY & OTHERS SHEET 4 OF 7

## TSUNAMI INUNDATION MAPS OF THE VILLAGES OF CHENEGA BAY AND NORTHERN SAWMILL BAY, ALASKA

by D.J. Nicolsky, E.N. Suleimani, R.D. Koehler 2014

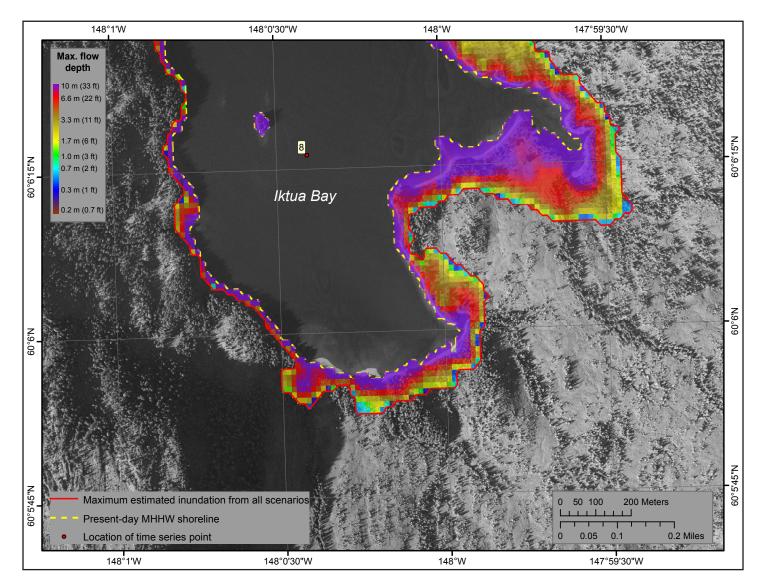
Maximum composite potential inundation resulting from all scenarios in the southern part of Iktua Bay, and the maximum composite flow depths over dry land. Large uncertainties in the DEM in Iktua Bay could severely degrade the accuracy of numerical results. The present-day MHHW shoreline is shown by a dashed yellow line.
