GEOLOGIC MAP OF THE TYE LAKE RESERVOIR SITE
FIGURE 3

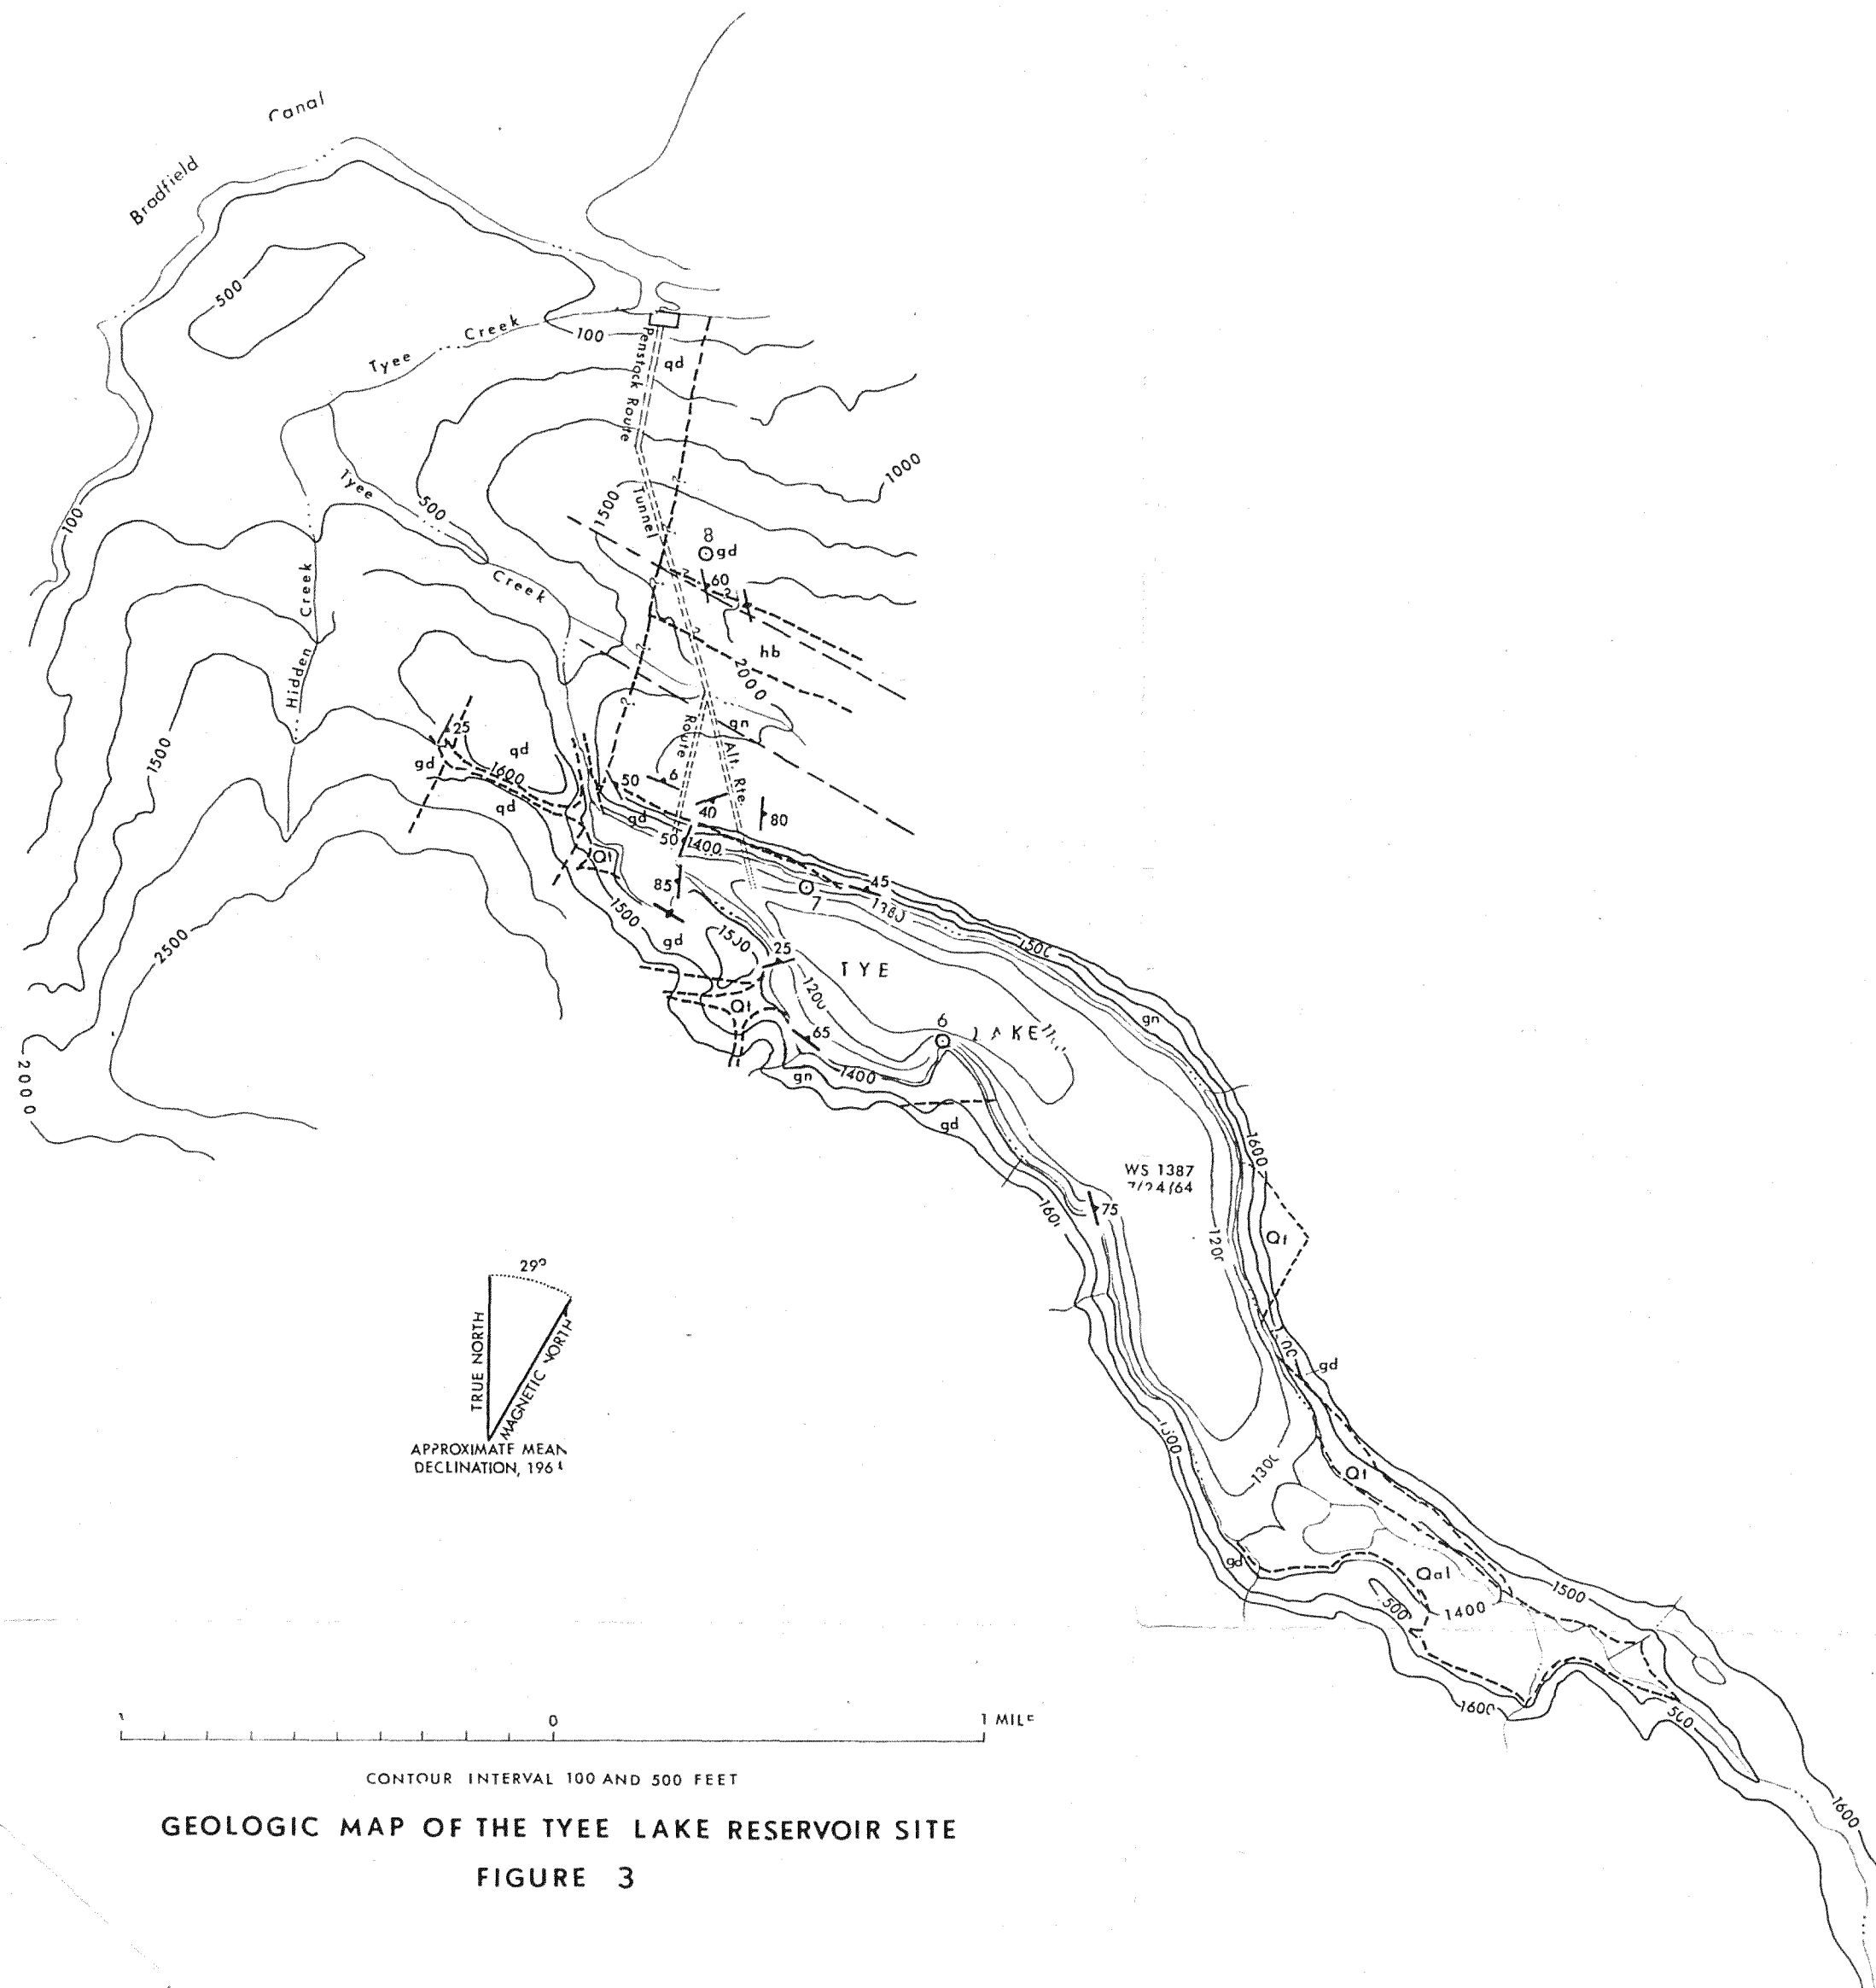
Sand, gravel, and silt, probably sorted and stratified at the head of Tye Lake

Coarse-grained, massive, and homogeneous. Cut by pegmatite dikes and veins and thick aplite dikes

Medium-grained, inhomogeneous, with gneissic banding. Grades to quartz monzonite and quartz diorite

Coarse-to medium-grained rock composed predominantly of hornblende, with some biotite and interstitial andesine feldspar. Cut by irregular pegmatite veins and dikes

Distinctly banded fine-to medium-grained biotite gneiss. Very inhomogeneous, with parting parallel to banding developed locally, with interbanded gneissic quartz diorite, granodiorite, and granite

Probably represent zones of close spaced or persistent joints
