Overview of Environmental and Hydrogeologic Conditions at Deadhorse, Alaska

Open-File Report 95-437

By Michael G. Alcorn and Joseph M. Dorava

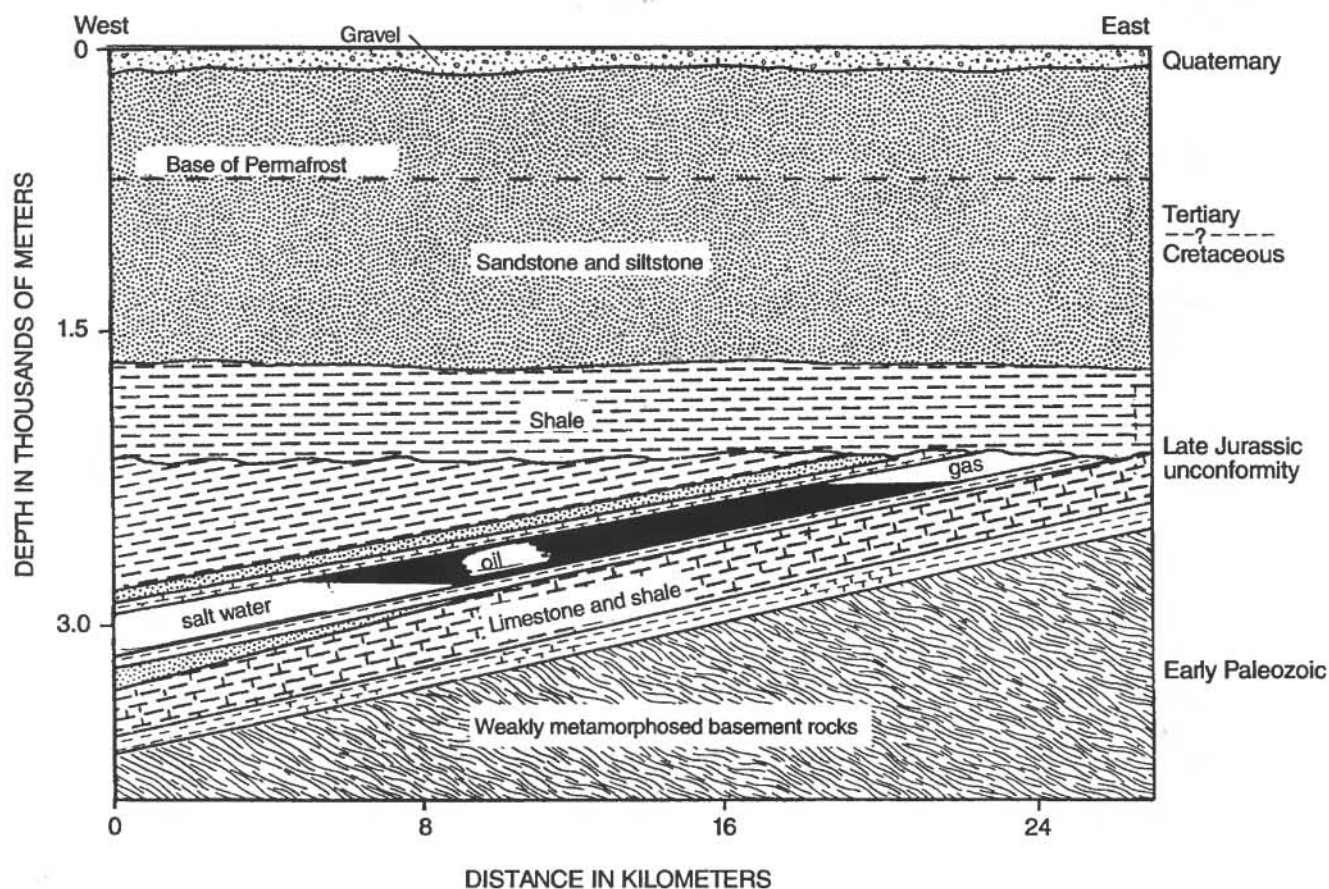
Figure 2. West-to-east cross-sectional drawing of the subsurface geology at Prudhoe Bay. Modified from Sohio Alaska Petroleum Company, 1982.

The geology of the Arctic Coastal Plain is well characterized due in part to the extensive exploration for petroleum in the region over the past several decades. Unconsolidated sediments of Quaternary age overlie sandstones, siltstones, conglomerates, and shales of Tertiary and Cretaceous age (Moore and others, 1994; Tailleux and Weimer, 1987; Rawlinson, 1983; U.S. Geological Survey, 1983). This sequence overlies dipping strata of shales, oil-bearing sandstones, limestones, and weakly metamorphosed sedimentary basement rocks of Paleozoic age. A simplified geologic cross section representing the subsurface geology under Deadhorse is shown in figure 2. The unconsolidated sediments consist of interbedded fluvial and glaciofluvial gravels, sands, and silts that range in thickness from 10 to 60 m (Ecology and Environment, Inc., 1992; Rawlinson, 1986; Detterman and others, 1975). Further geologic information may be found in reports by Dinter and others (1990), Gryc (1988), and Black (1964).
